# Inspection Form

United States Department of Transportation  
Federal Transit Administration

Inspection Date	YYYY	MM	DD	Report Number	20160703-WMATA-MRV-1		
	2016	07	03				
Rail Agency Name	Washington Metropolitan Area Transit Authority			Rail Agency Department	TRST	Sub- Department	
Rail Agency Department Contact Information	Name		Email		Office Phone		Mobile Phone
	[REDACTED]		[REDACTED]		[REDACTED]		
Inspection Location	SafeTrack Surge 2-D&G Junction

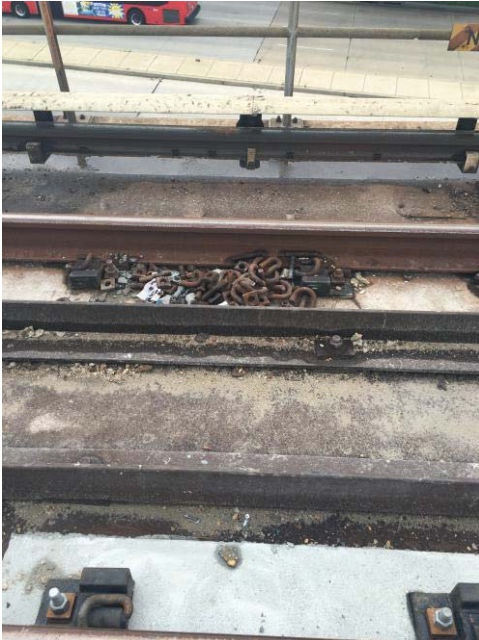
**Construction Debris on Right of Way**

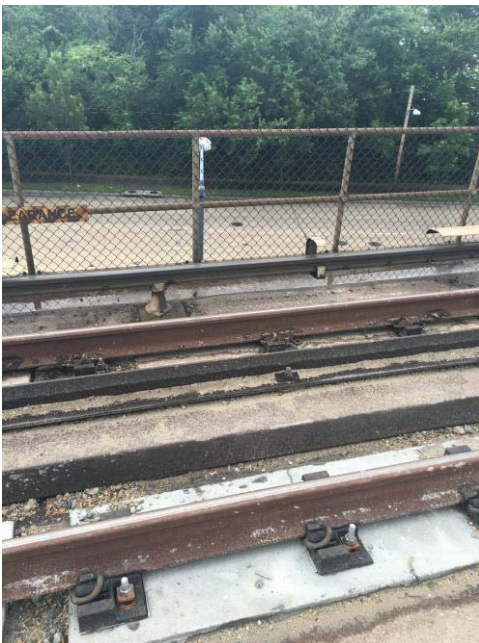
**Missing Third Rail Coverboard**

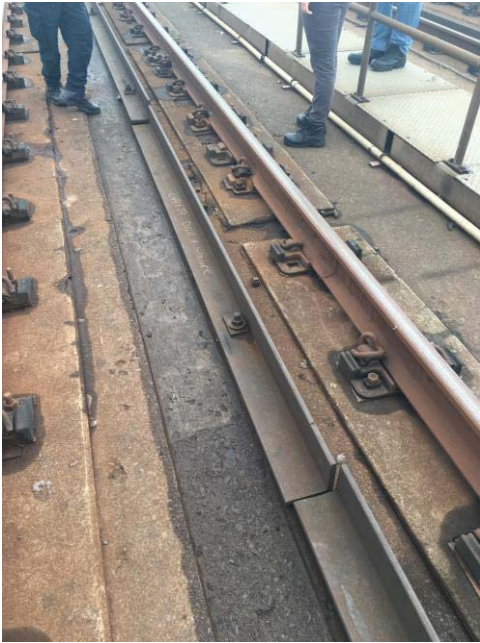
Unsecured Emergency Guard Rail

Remedial Action	<ul style="list-style-type: none"><li>• WMATA must secure all emergency guard rails on aerial structure</li><li>• WMATA must remove all obstructions from safety walk at D1 188+70 and D1 188+40</li><li>• WMATA must mitigate rail burn at D1 278+00</li><li>• WMATA to properly torque all rail fastener nuts throughout work zone.</li><li>• WMATA to replace chain marker sign at D1 265+00</li><li>• WMATA to remove construction debris from work area</li><li>• WMATA to replace Tunnel light at D1 192+00</li><li>• WMATA to replace cover board at D1 263+00</li><li>• WMATA to properly seal cables at D2 174+00</li></ul>
-----------------	--

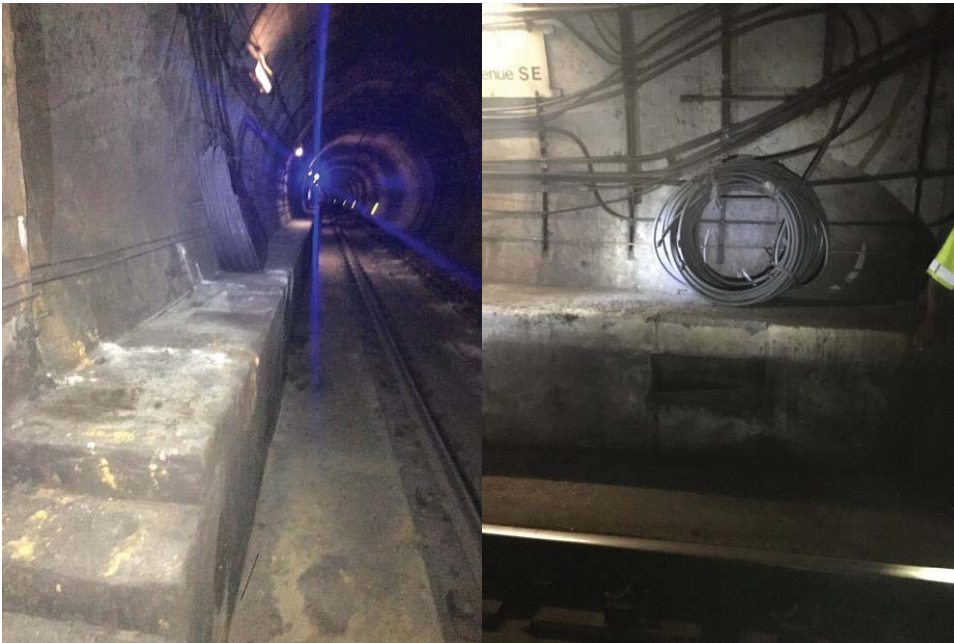
Obstacle on safety walk

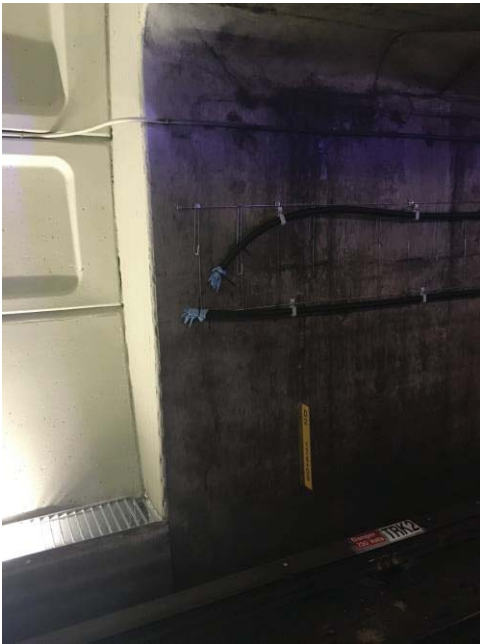
Improperly Sealed Communications Cables

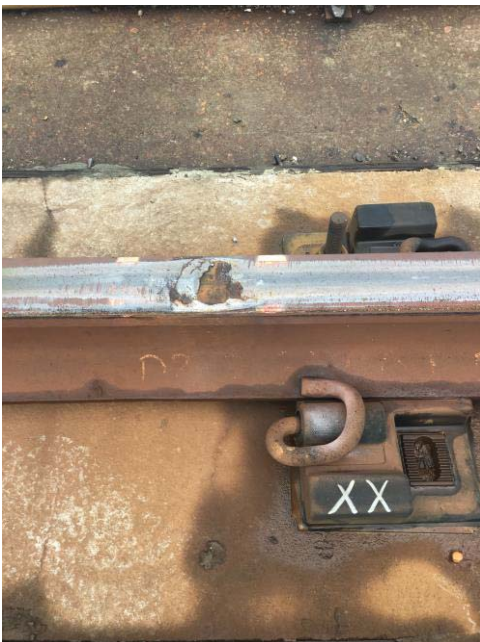
Wheel Burn on Running Rail

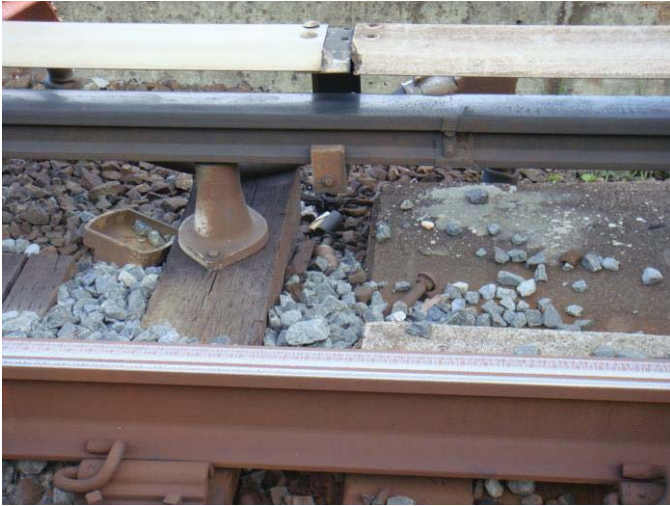
Figure 1 - C2 CM407+90 - Broken insulator - 3rd rail joint

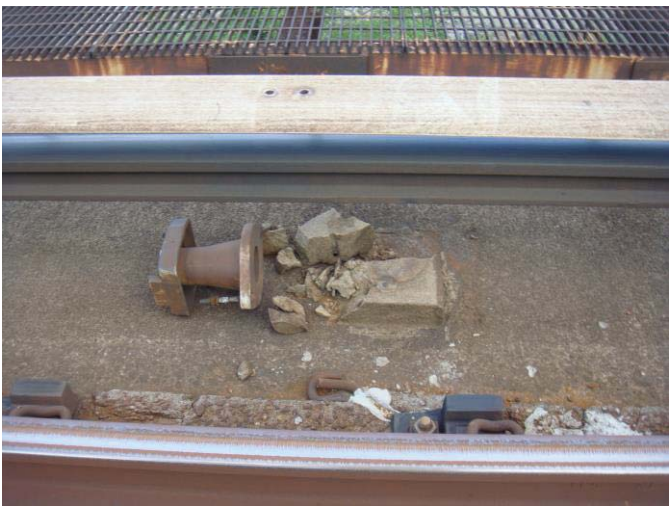
Figure 2 - C2 CM406+60 - broken insulator grout pad

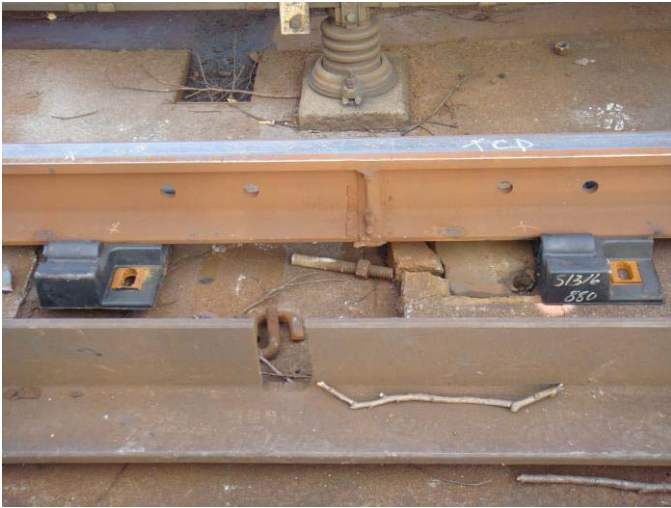
Figure 3 - C2 CM376+30 - Right Rail Support - deteriorated grout pad

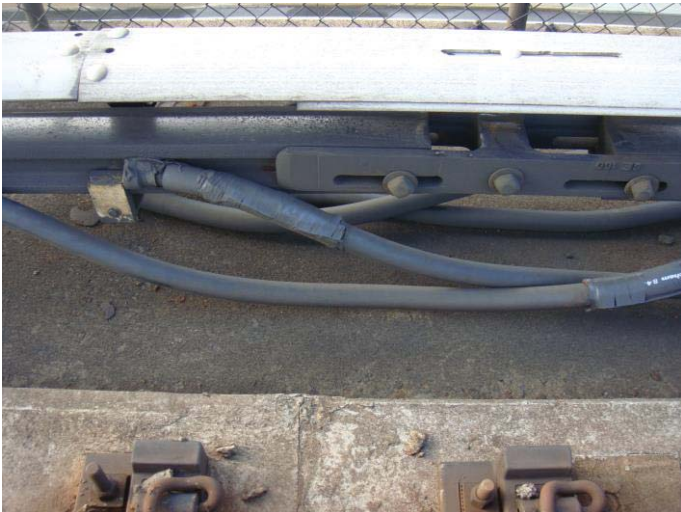
Figure 4 - C1 CM391+60 - 3rd Rail expansion joint cable with electrical tape

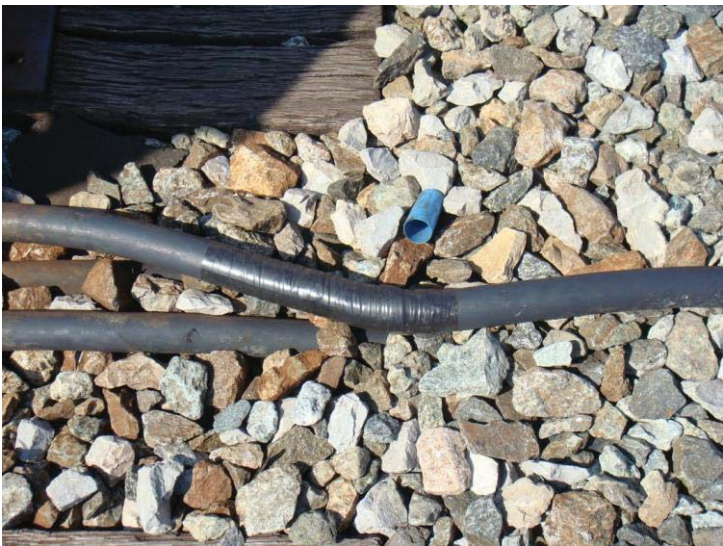
Figure 1 - Taped 3rd rail return cable at D1 CM313+20

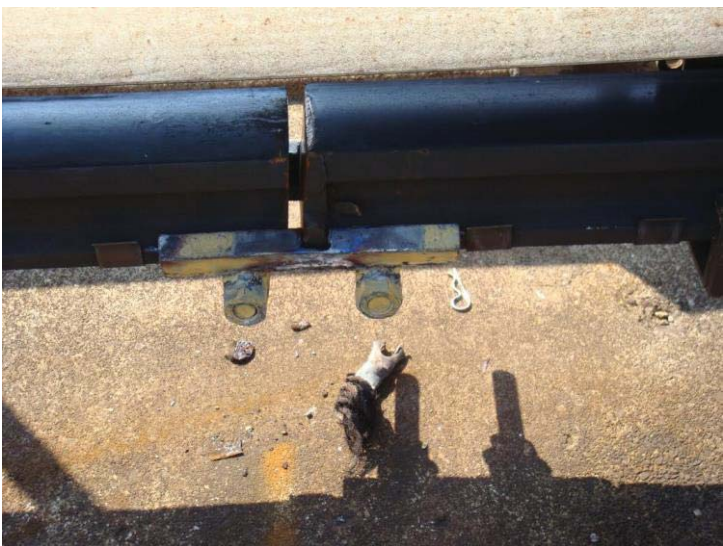
Figure 2 - CM308+00 and CM307+75 Track 1&2 - 3rd rail incomplete weld

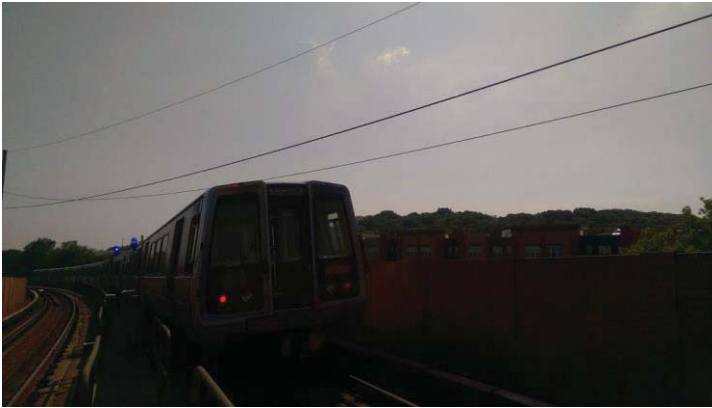
Figure 3 - CM305+00 - low hanging transmission line - (Photo courtesy of WMATA unit #634)

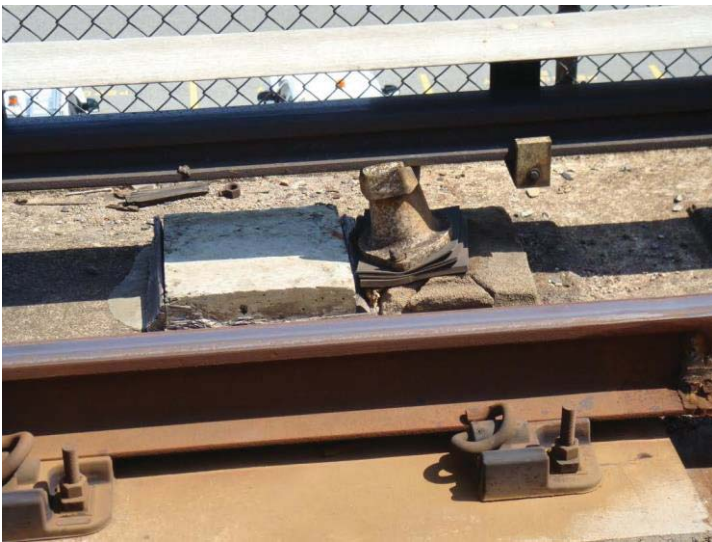
Figure 4 - D2 CM296+40 - New grout pad adjacent to crumbled one

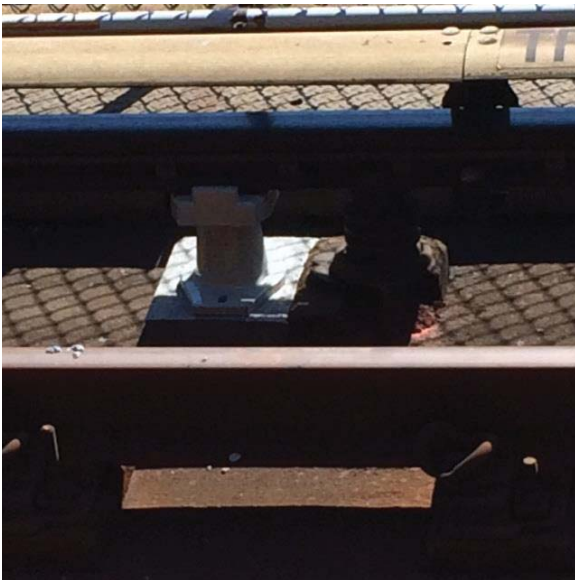
Grout pad and insulator replaced at three locations along the Reagan National Airport platform.

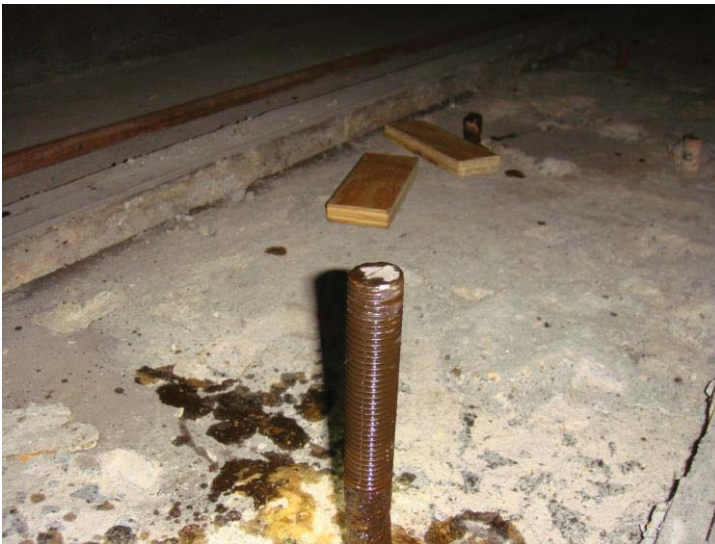
Figure 1 - new grout pad with oiled stud bolts

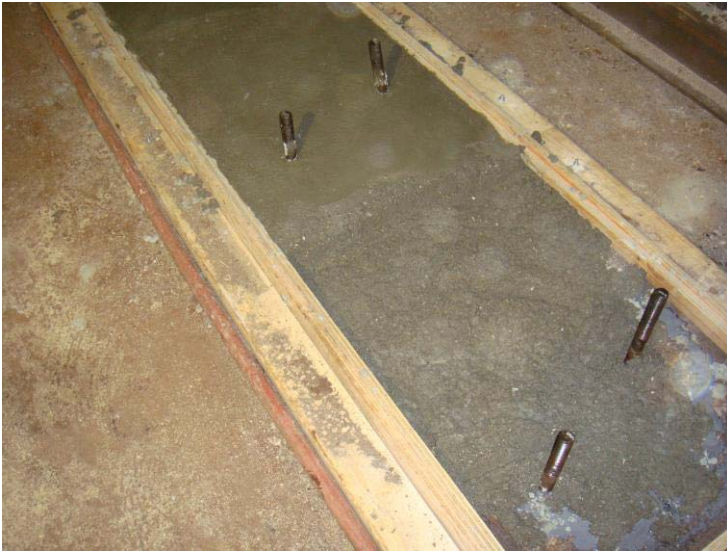
Figure 2 - New grout pad

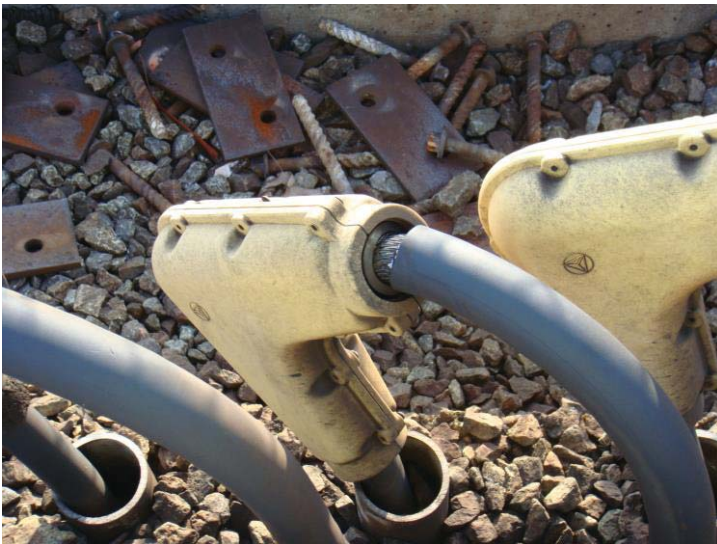
Figure 3 - C1 CM354+80 exposed third rail boot, no sleeves

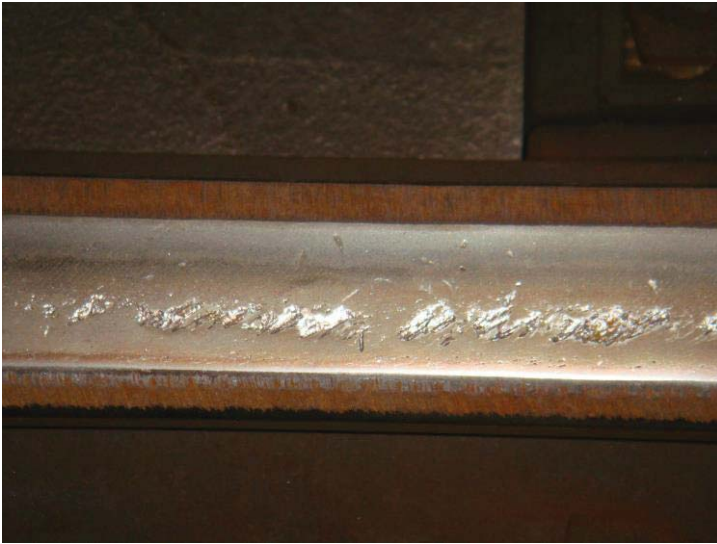
Figure 4 - C2 CM345+80 - surface condition

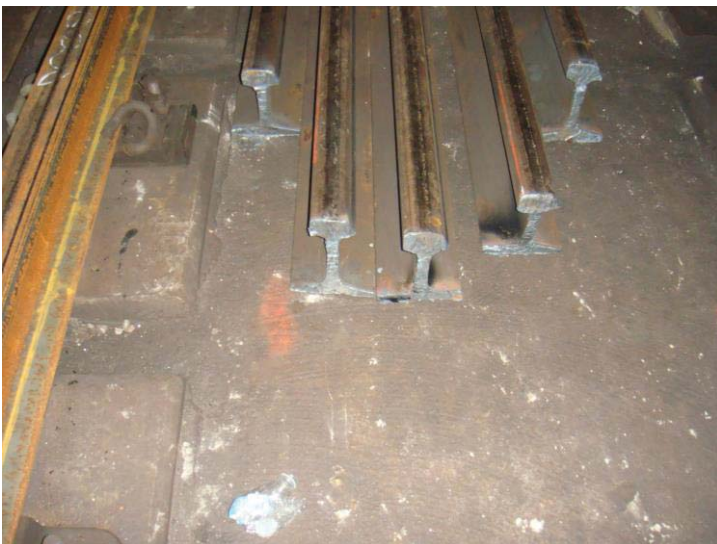
Figure 5 - removed rail - note right side side-wear

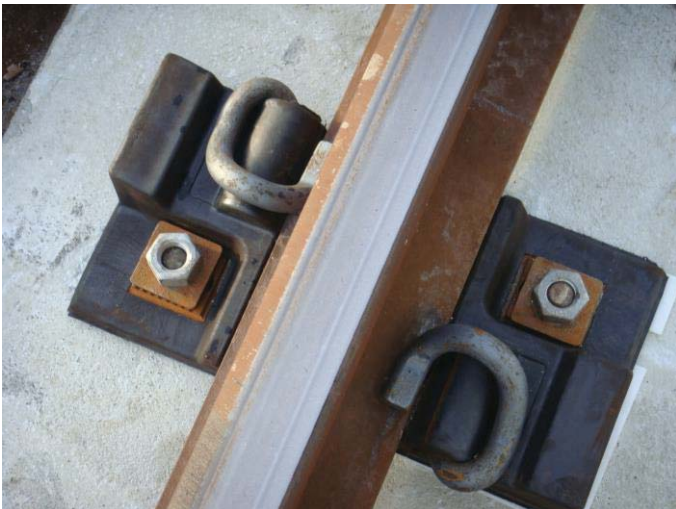
Figure 1 - short stud bolts securing fastener. Also noted stud bolts in excess of 3-inches above base of rail. CM376+00 through CM379+00

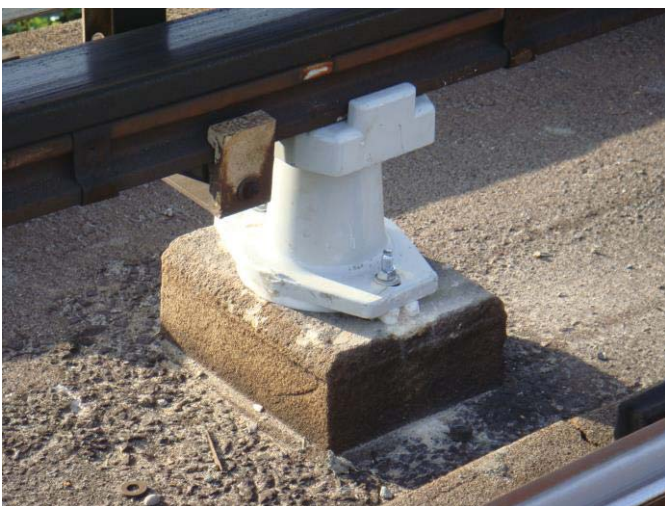
Figure 2 - Incorrect shim - C1 CM377+00 (Noted in other areas as well)

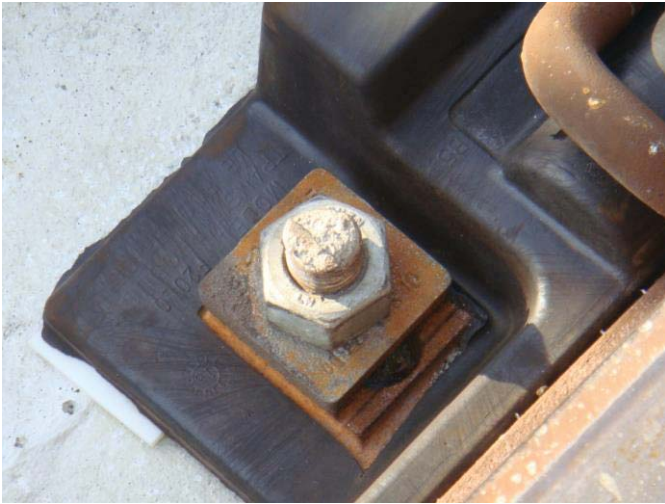
Figure 3 - Ground off stud bolts - observed throughout the new grout pad area from CM376+00 - CM379+00

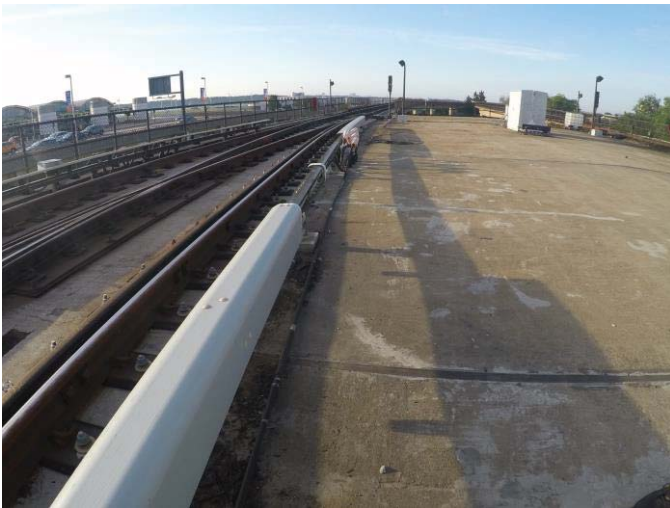
Figure 4 - Missing cover boards CM371+00 track 1 & 2

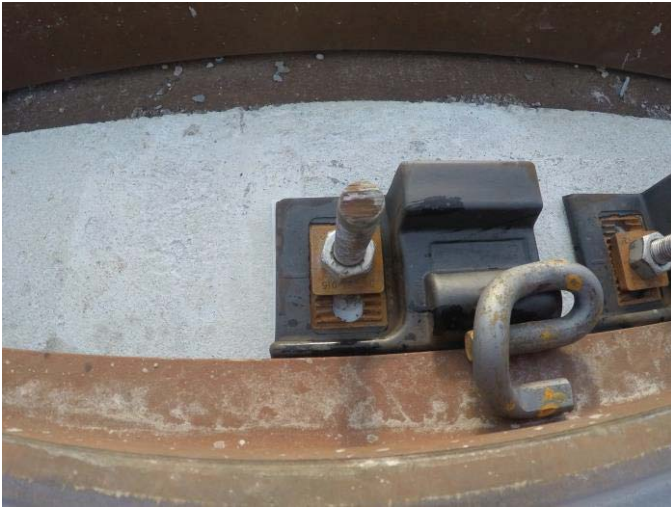
Figure 5 - Stud bolt in excess of 3" above base of rail - signs of having been cut

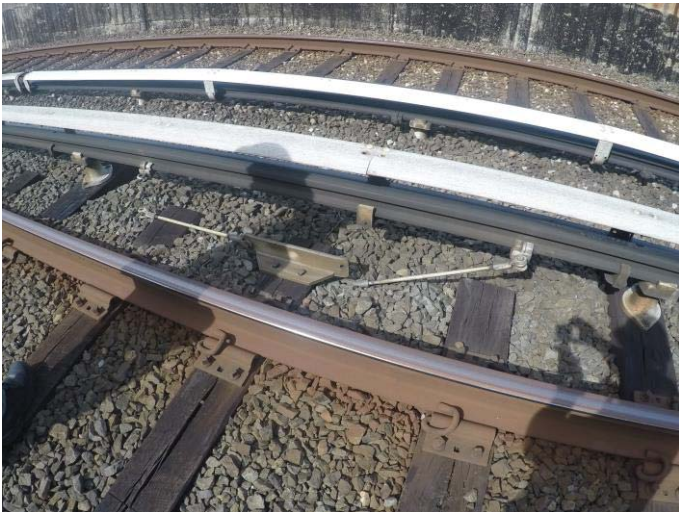
Figure 6 - Third rail anchor not attached - C1 CM417+00 and C1 CM475+00

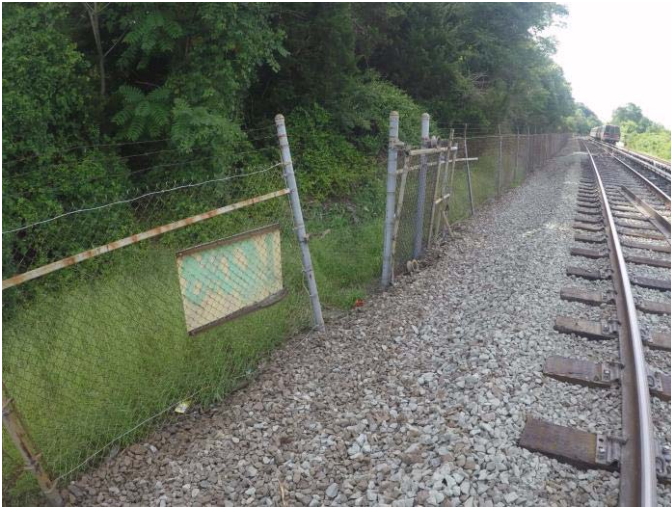
Figure 7 - Open Gate - C1 CM424+00

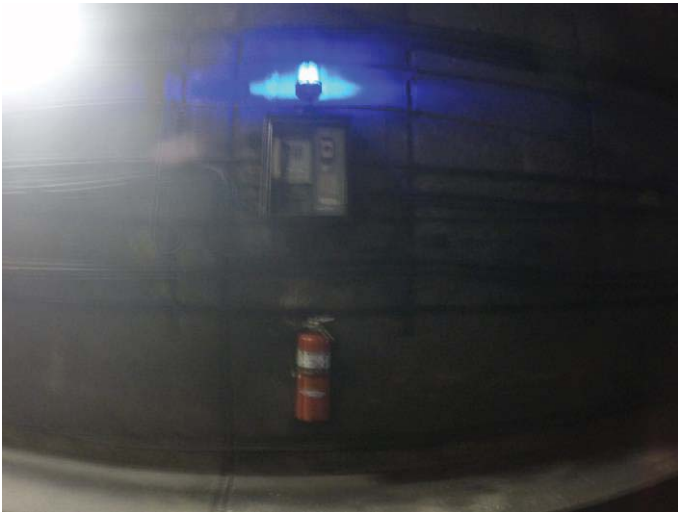
Figure 8 - ETS Box No Door - C1 CM501+00

<ul style="list-style-type: none"><li>• C1 CM375+00 – gage rod left in, not attached (Note: ERT team removed the gage rod during the repair effort noted above.)</li><li>• Cover boards throughout the work area are missing and should be replaced.</li></ul>		
Remedial Action	<ul style="list-style-type: none"><li>• WMATA to replace coverboards on Track 1 and 2 at CM371+00.</li><li>• WMATA to secure fasteners on the left rail at C1 CM376+70.</li><li>• WMATA to replace shim at C1 CM377+00.</li><li>• WMATA to mitigate 90° found between non-defective fasteners on the left rail at C1 CM378+30.</li><li>• WMATA to replace deteriorated fasteners on right rail from C1 CM380+30 to C1 CM380+80.</li><li>• WMATA to replace 5 third rail grout pads at C1 CM399+00.</li><li>• WMATA to replace broken third rail grout pads at C2 CM406+50, 60, 70.</li><li>• WMATA to mitigate disconnected third rail anchor at C1 CM417+70.</li><li>• WMATA to attach expansion joint cables to the kindorf at C1 CM422+50.</li><li>• WMATA to mitigate damaged/open access gate at C1 CM424+00.</li><li>• WMATA to repair disconnected third rail anchor at C1 CM475+00.</li><li>• WMATA to replace ETS door at C1 CM501+00.</li></ul>

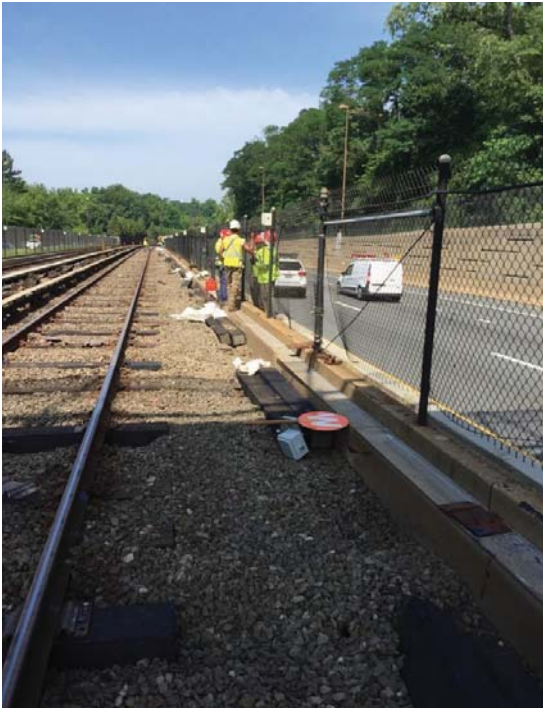
Figure 1 - TRST personnel working on exterior wayside fence adjacent to travel lane of route 66

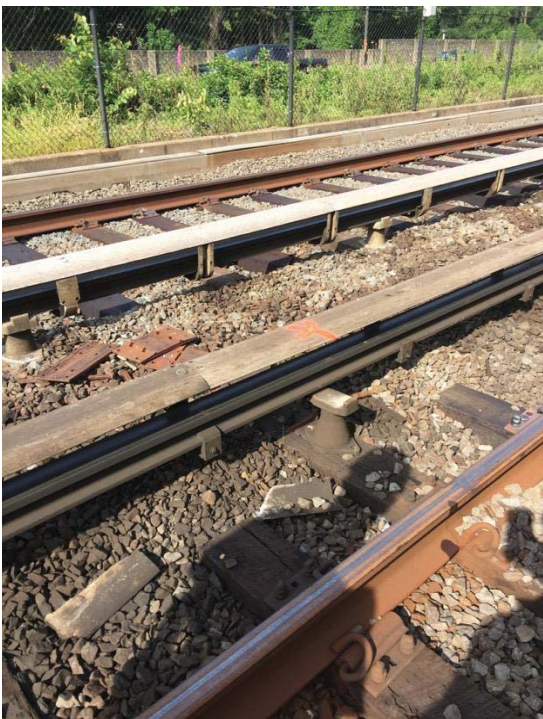
<ul style="list-style-type: none"><li>• K2-382+40 Third rail displace from third insulators (See Photo #2)</li></ul>		
Remedial Action	WMATA should address the following noted items that were not previously addressed: <ul style="list-style-type: none"><li>• WMATA to specify protection requirements for working in close proximity to highway and ensure those protections are in place.</li><li>• WMATA to ensure employees have access to water</li></ul>

**Figure 2 - K2 CM382+40 - Third Rail displaced from insulators**

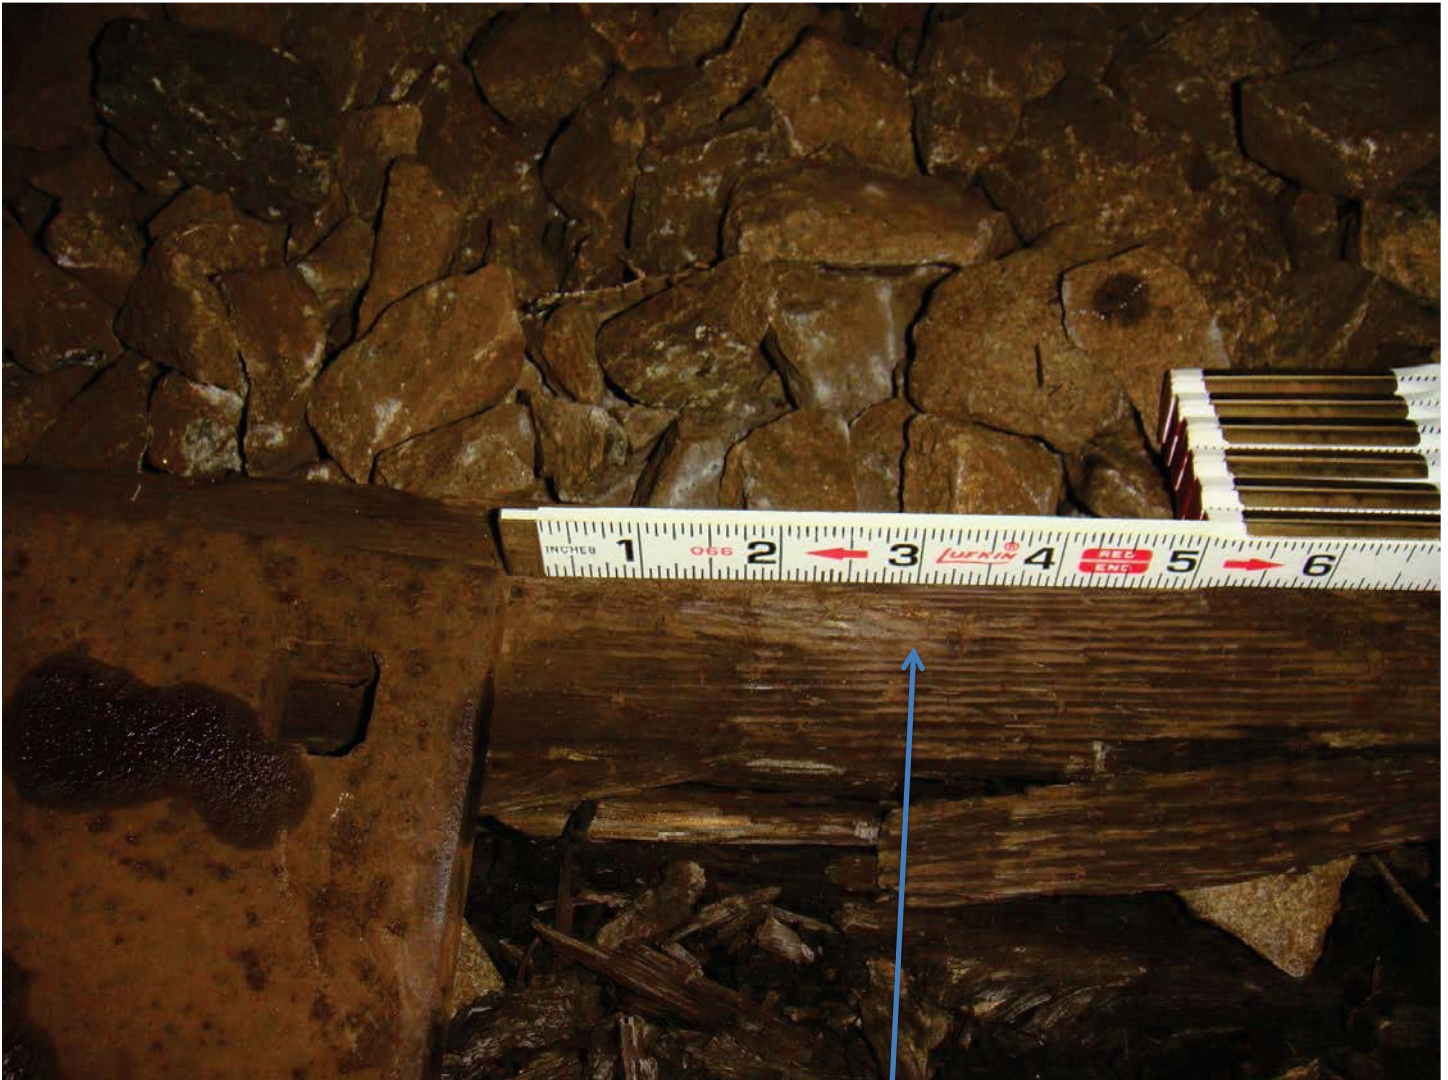
Photo shows that the tie plate moved approximately 3-inches laterally.

Photo taken at POD of 56  $\frac{1}{4}$ " – when combined with lateral movement the gage would be 59  $\frac{1}{4}$ "

The tie condition is also evident in this photo. The center is completely rotted.

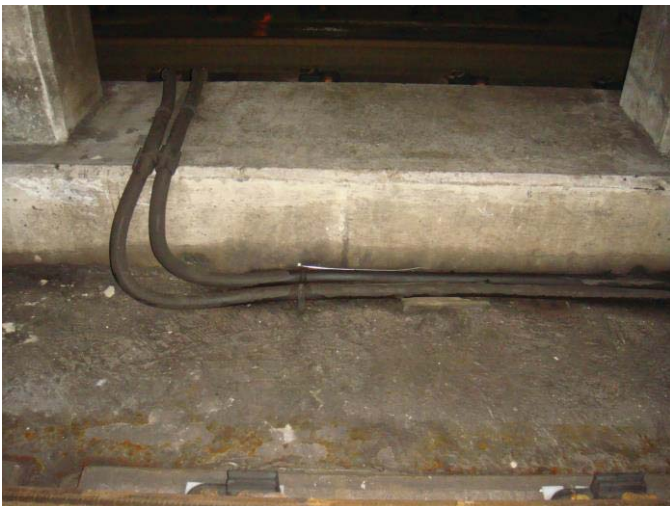
Figure 1 - Unsupported third rail return cable

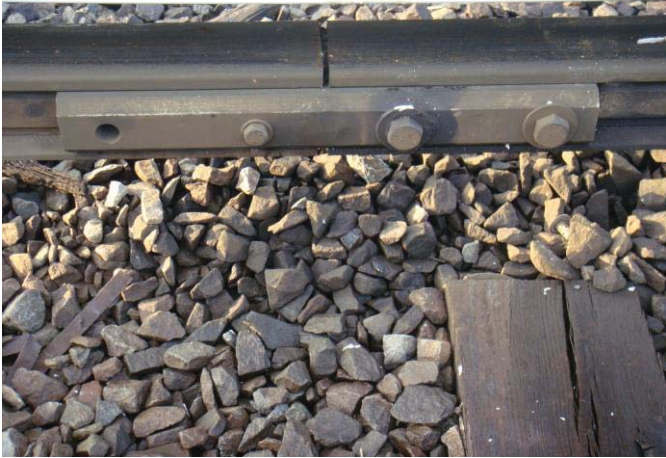
Figure 2 - Condition identified in three locations as indicated above

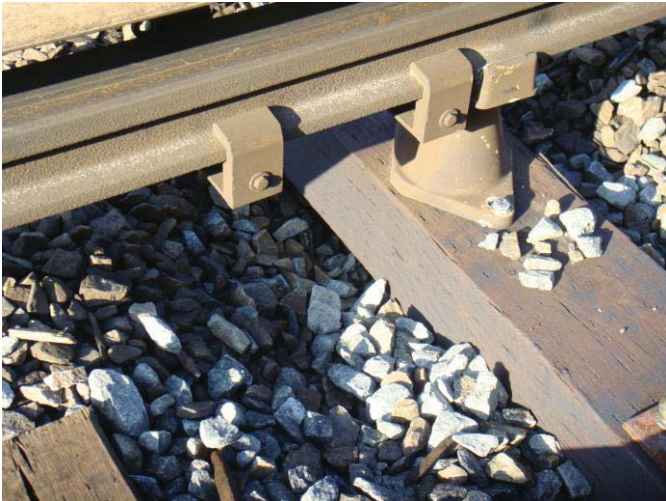
Figure 3 - No ballast support under third rail ties

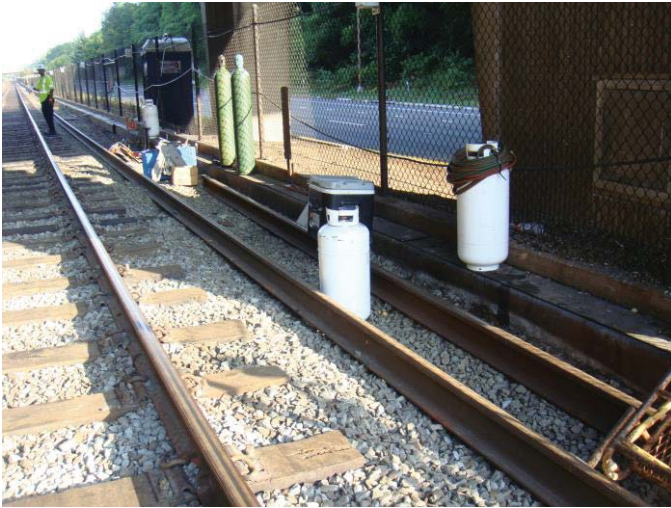
Figure 4 - Un-secure CGC Cylinders adjacent to Rt. 66

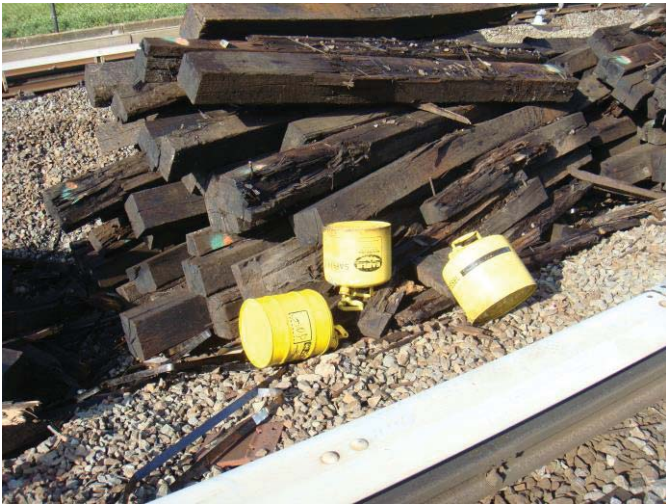
Figure 5 - Discarded diesel fuel cans
