Inspection Form

United States Department of Transportation
Federal Transit Administration

Inspection Date	YYYY	MM	DD	Report Number	20160601-WMATA-TW-1		
	2016	06	01				
Rail Agency Name	Washington Metropolitan Area Transit Authority			Rail Agency Department	Rail Operations Control Center	Sub- Department	
Rail Agency Department Contact Information	Name		Email		Office Phone		Mobile Phone
	[REDACTED]		[REDACTED]				[REDACTED]
Inspection Location	Carmen Turner Facility 3500 Pennsy Drive Landover, MD 20785

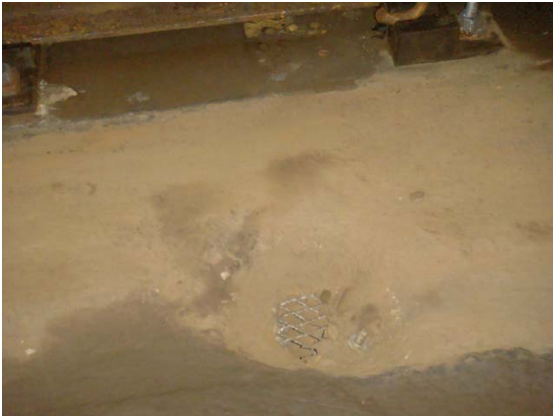
Figure 1 - New Screen but down approximately 4-inches below grade - multiple locations

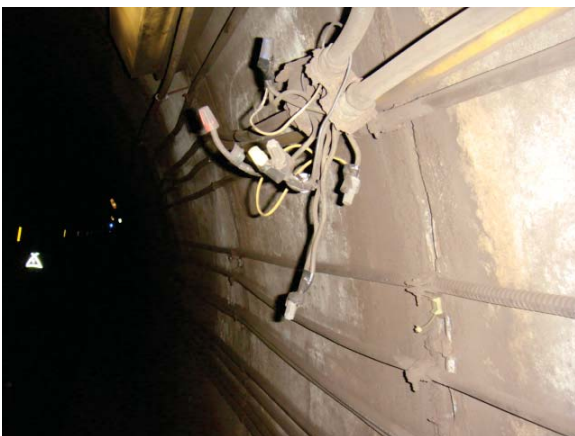
Figure 3 - Exposed wiring feed to florescent fixture

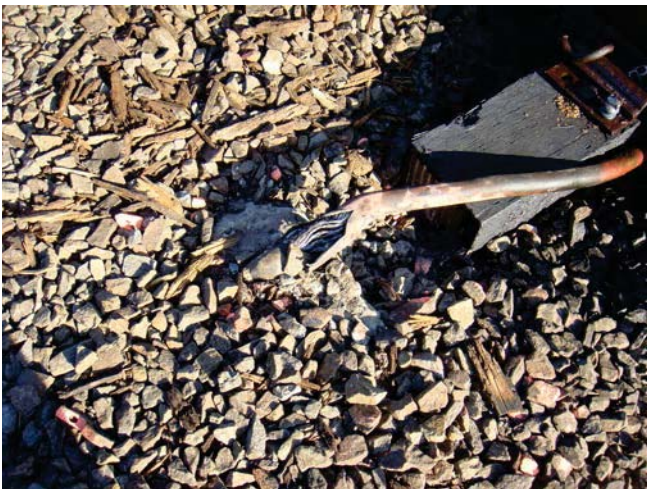
Figure 1 - Damaged 3rd Rail Return Cable

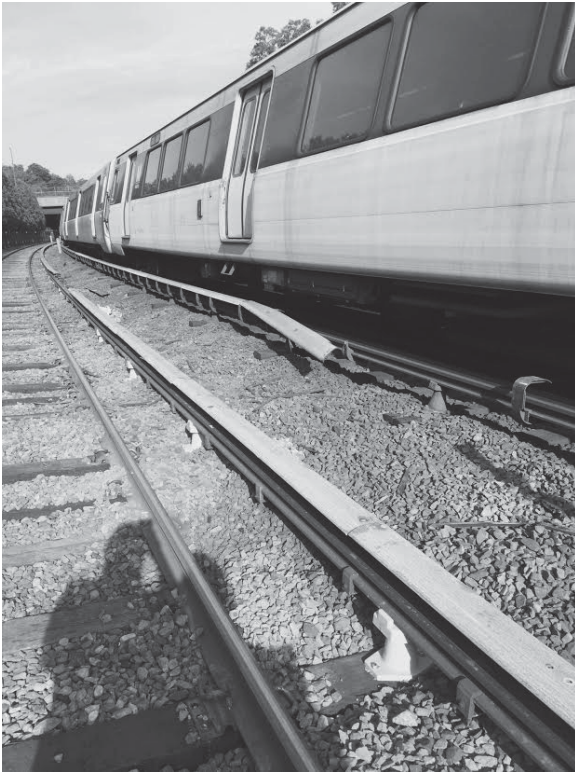
Figure 2 - Hanging Cover Board observed on track #2

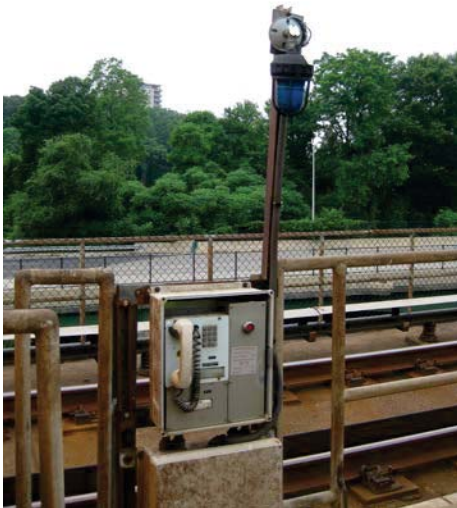
Non-functional ETS box @ CM A2 523+40
No blue lantern.

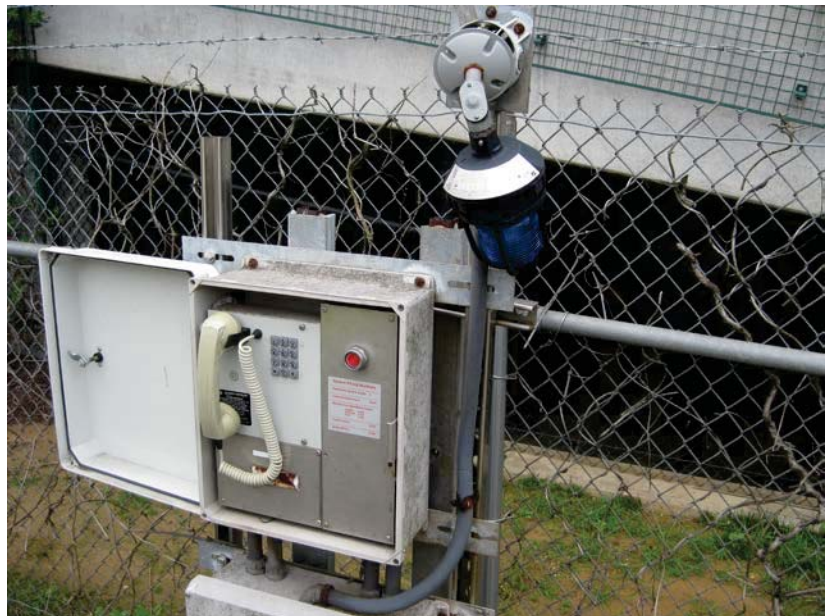
Although ETS is functional, lantern is OOS & full of water @ CM A2 558+80
(adjacent to the Parking Structure)

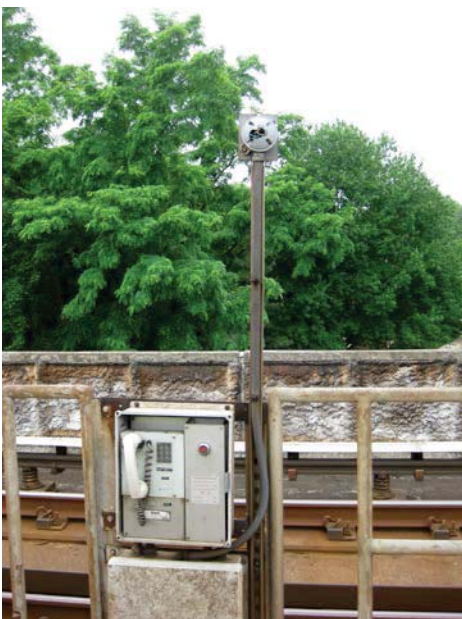
Non-functional ETS Box/Missing blue Illumination @ CM A2 531+40

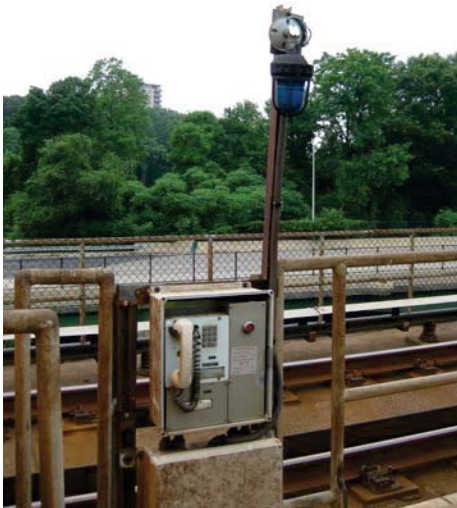
Non-funtional ETS box @ CM A2 523+40
No blue lantern.

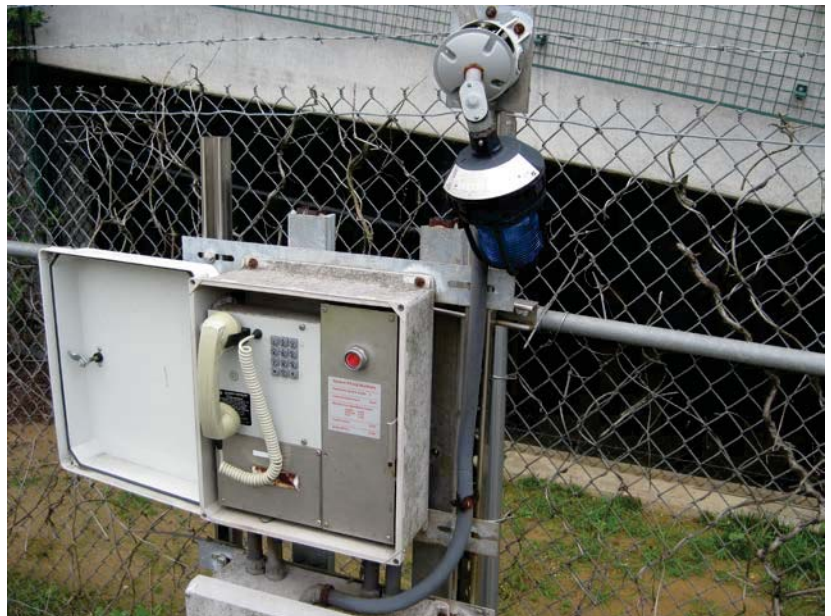
Although ETS is functional, lantern is OOS & full of water @ CM A2 558+80
(adjacent to the Parking Structure)

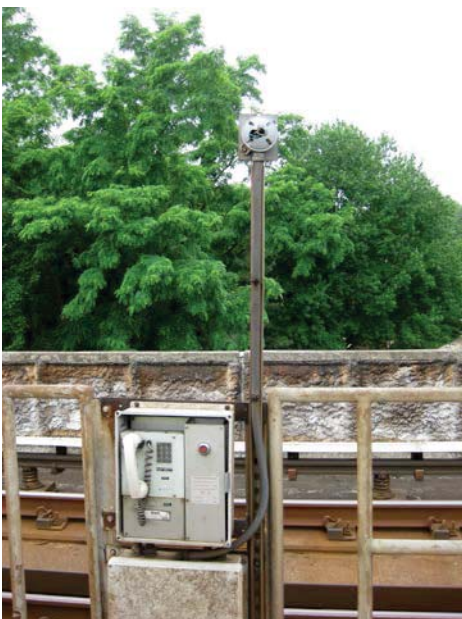
Non-functional ETS Box/Missing blue Illumination @ CM A2 531+40

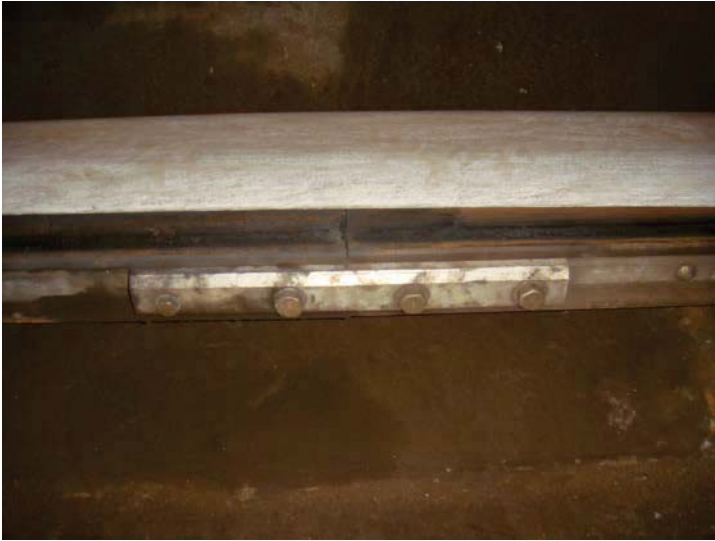
Figure 1 - A2 CM384+70 - eliminated third rail expansion joint - incorrect hardware

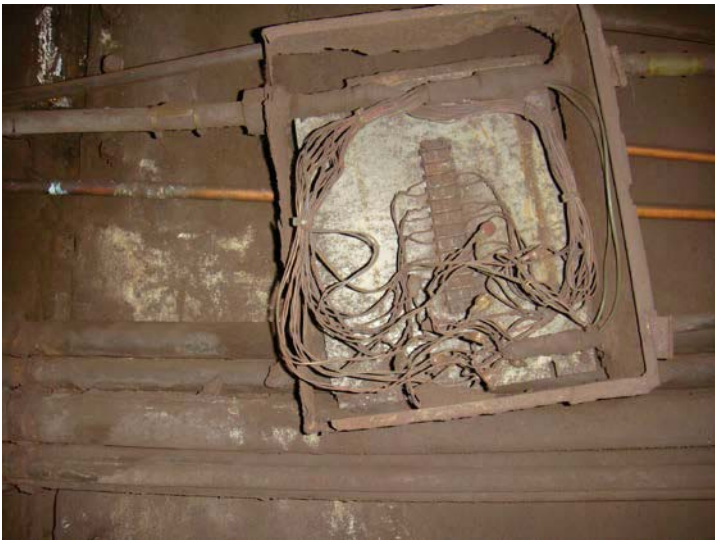
Figure 2 - A2 CM381+50 - communication splice box rotted with exposed wires

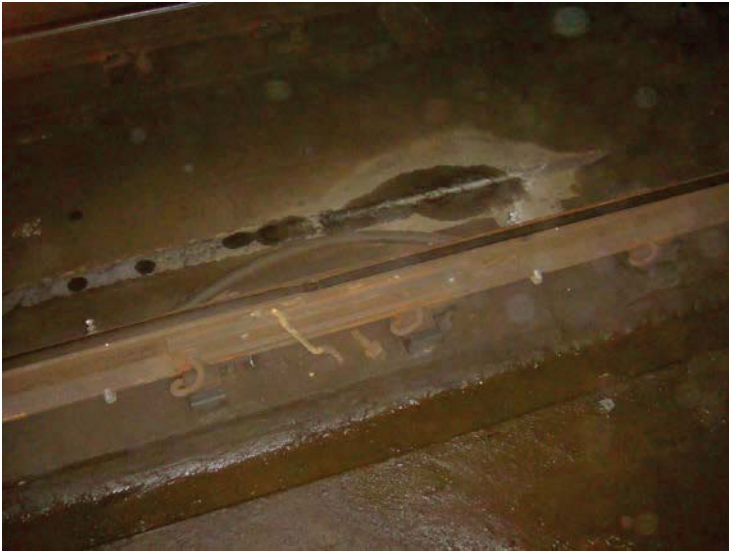
Figure 3 - A2 CM361+35 - Broken bolt in joint bar

Recommended Finding?		No		
							Remedial Action Required?		Yes		
							Recommended Reinspection?		Yes		
Remedial Action	<ul style="list-style-type: none"> WMATA to repair broken bolt found in the joint bar at A2 CM 361+35. WMATA to replace missing nut on bolt found on joint bar at A2 CM 358+60. WMATA to mitigate tunnel leak at A2 CM 351+70.

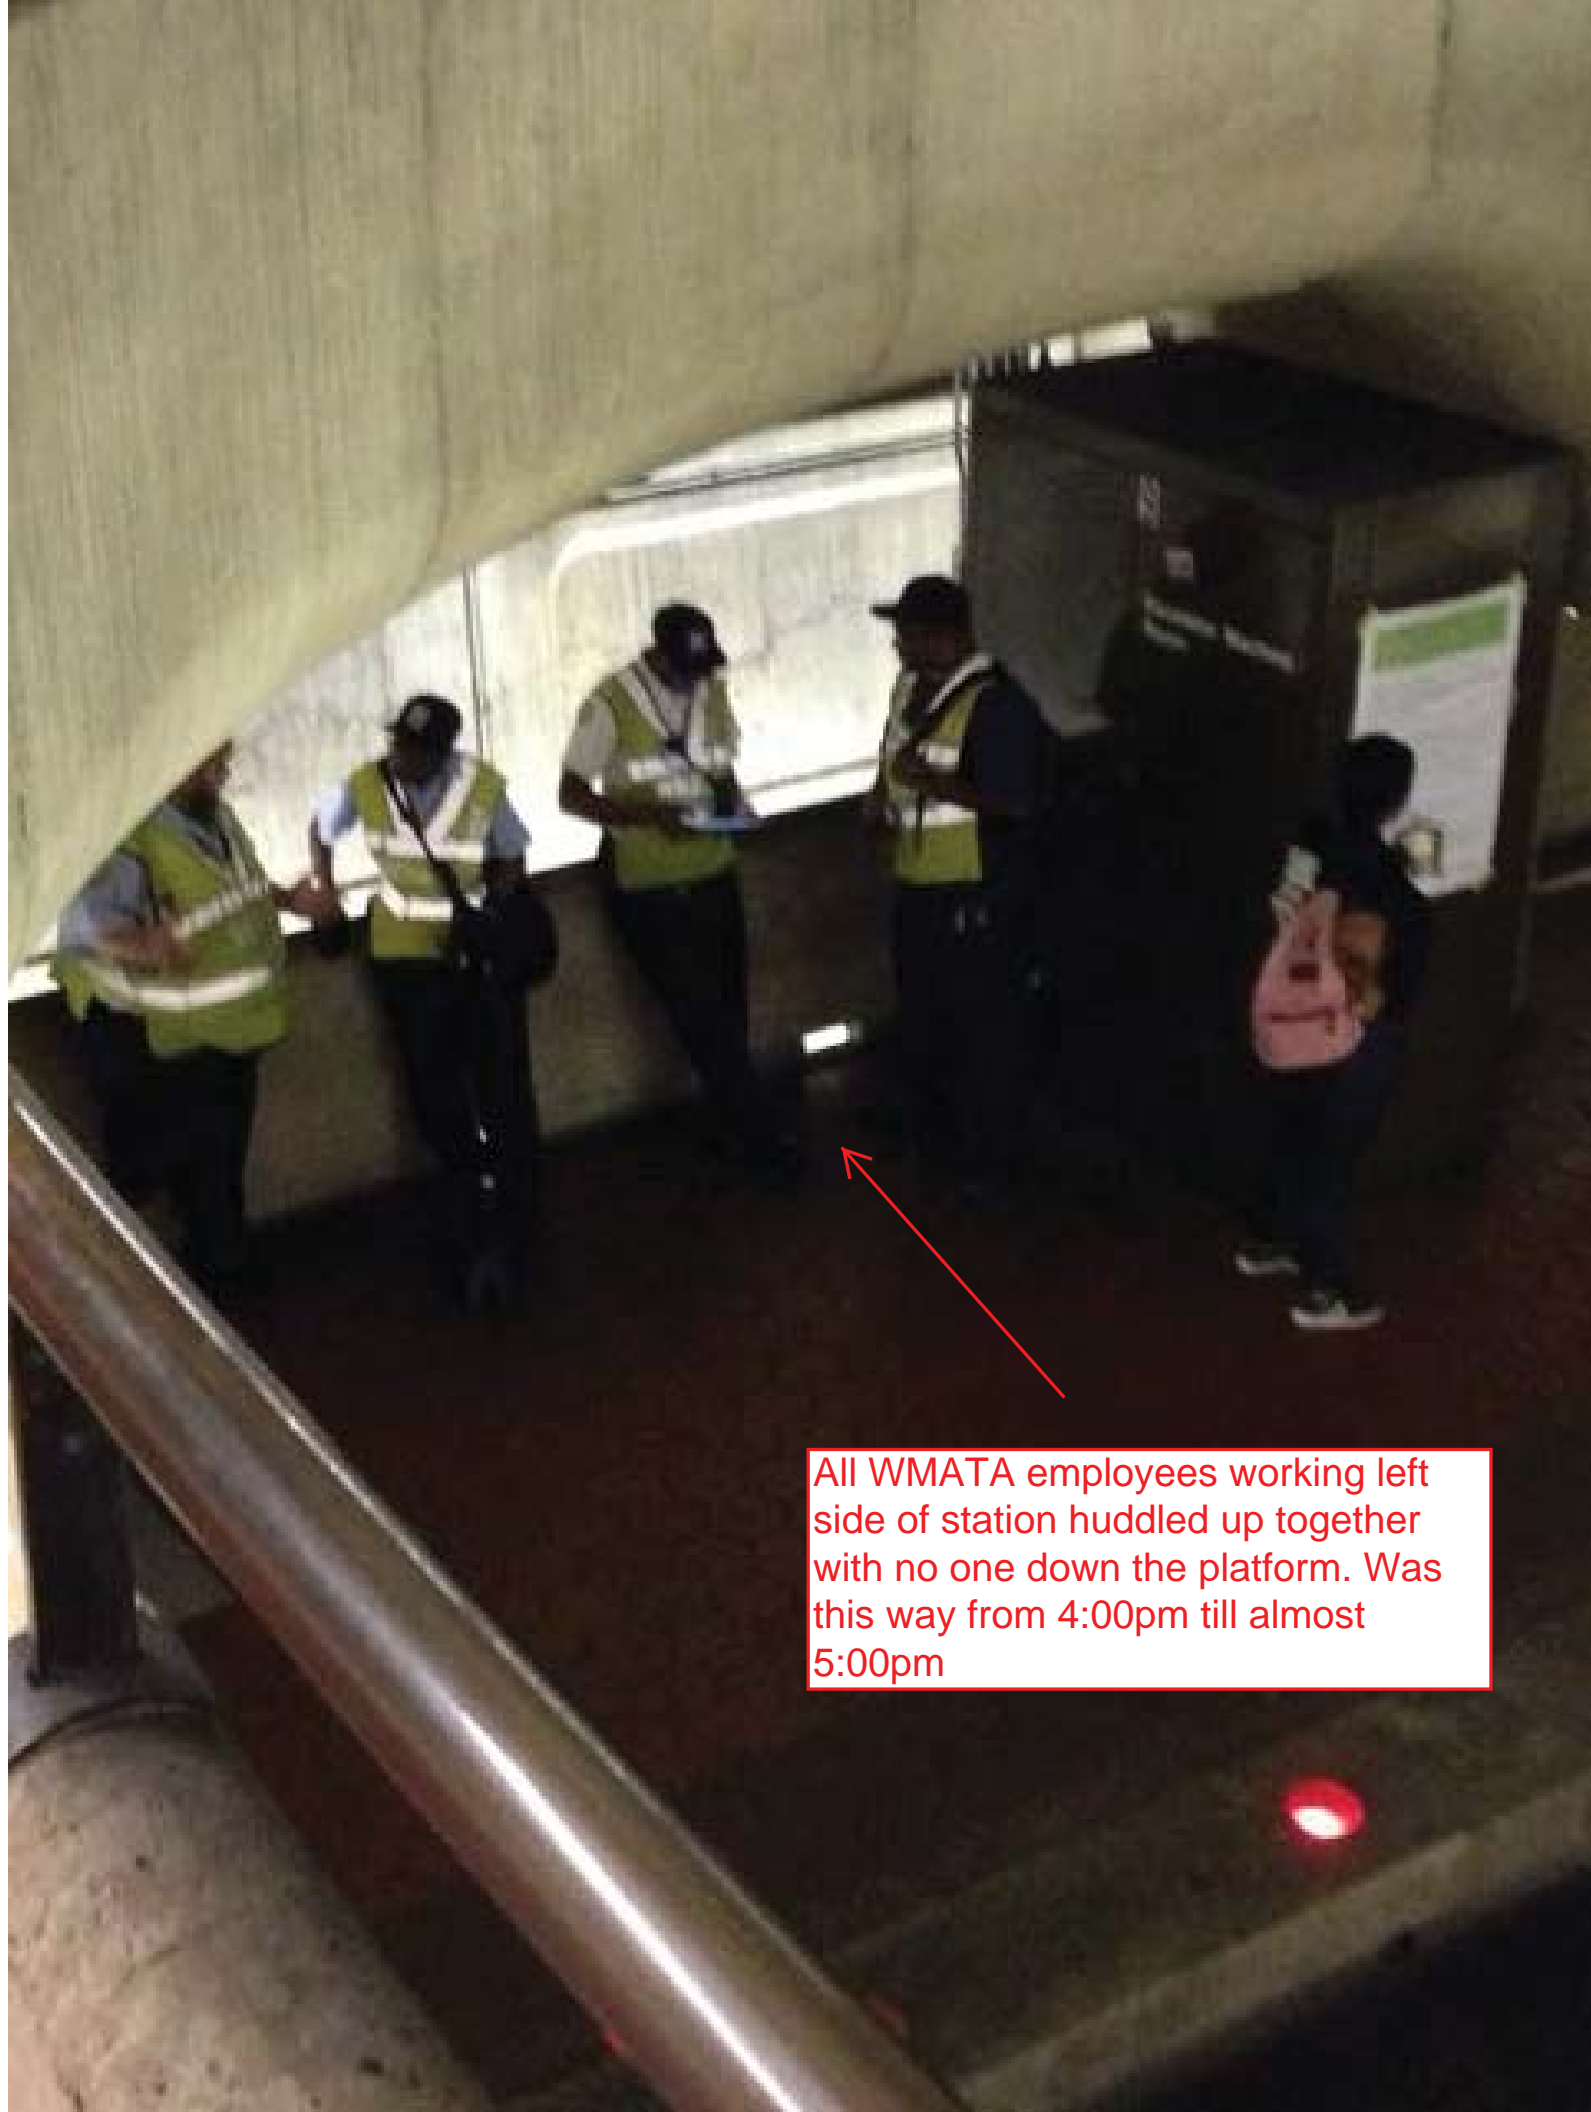
All WMATA employees working left side of station huddled up together with no one down the platform. Was this way from 4:00pm till almost 5:00pm

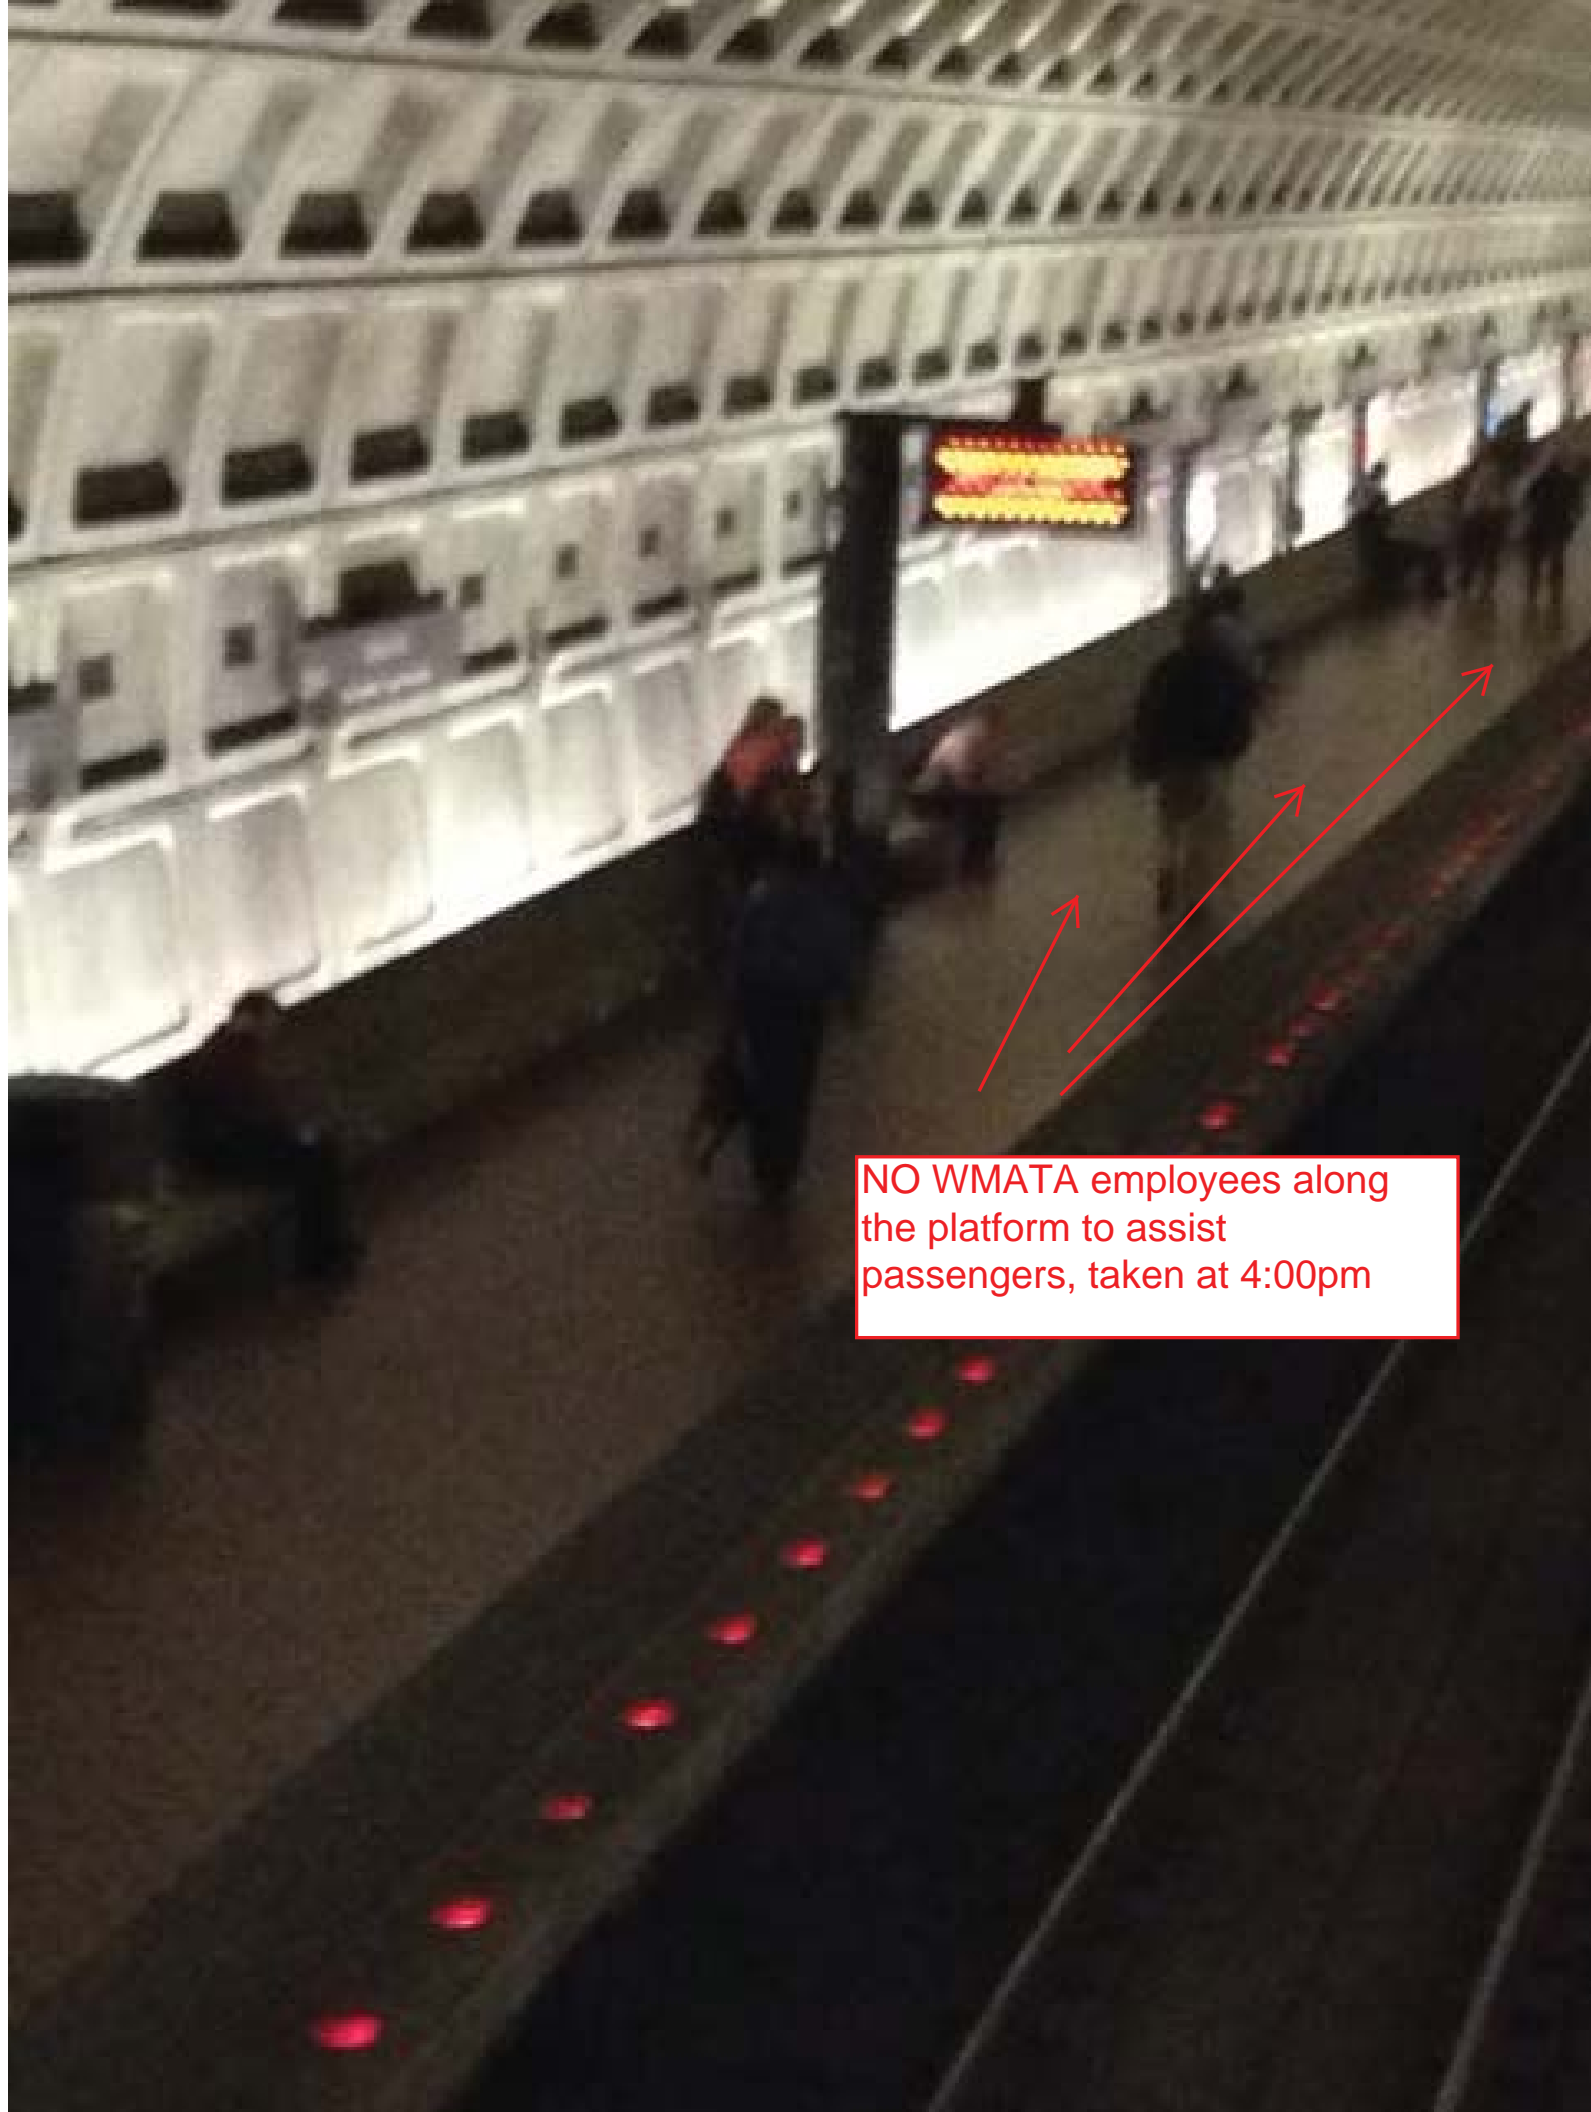
NO WMATA employees along
the platform to assist
passengers, taken at 4:00pm

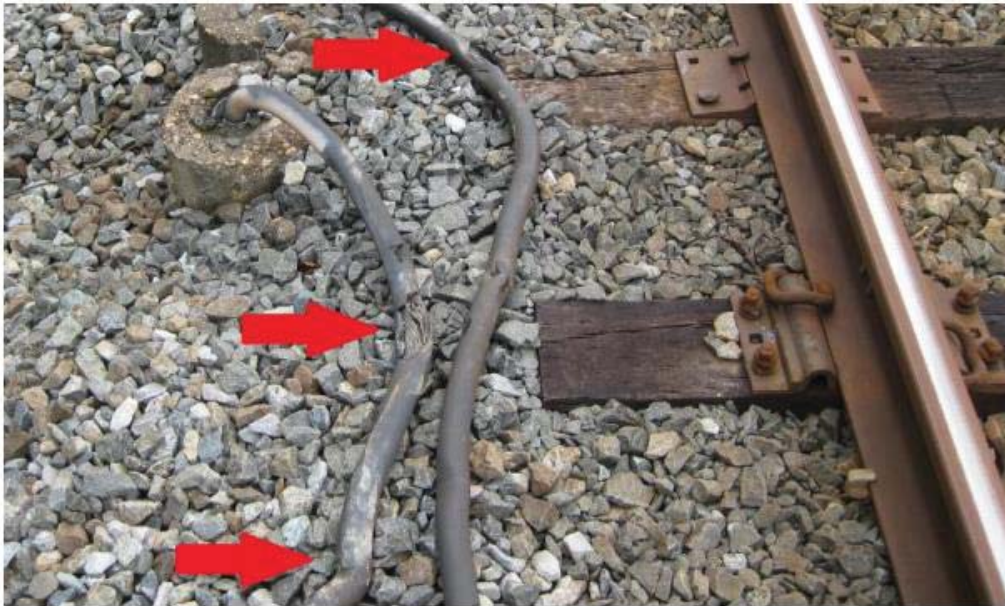
A2-551+40- Track Circuit / Impedance Bond with frayed/missing insulation on negative power return cables (insulation is missing on cables with exposed/frayed wires- 1000 mil cable)

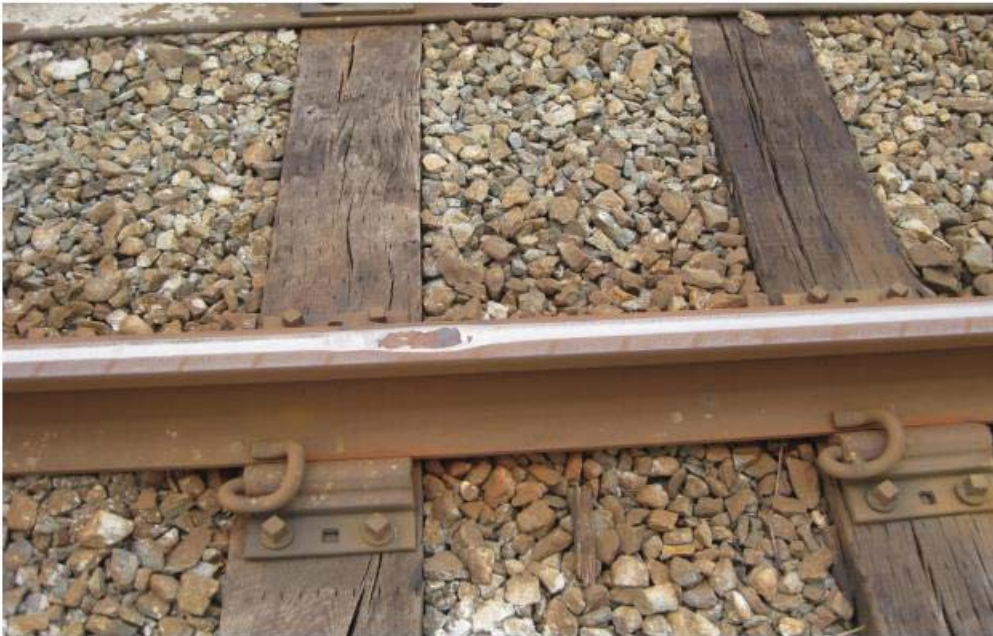
A2-515+80- Severe rail surface defects (spalling) from vertical track deflection (Location- wood tie transition to DF aerial transition)

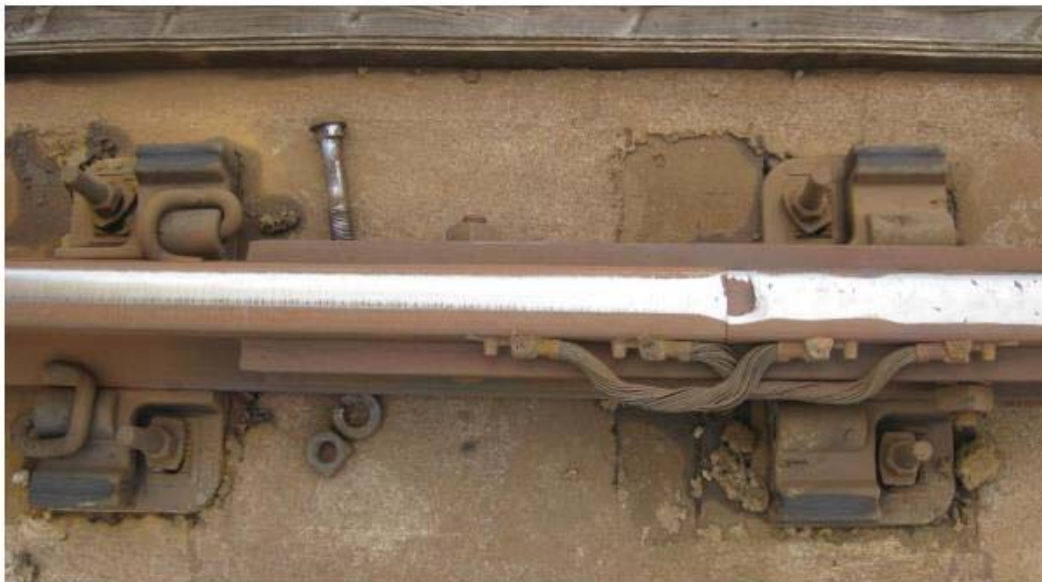
A2-537+50 LR- Suspended rail joint with missing bolt in rail end (this is a 4- bolted suspended joint, where 1- bolt is only holding at one rail end- there is also a rail head surface defect at the joint causing severe pounding to the DF aerial structure)

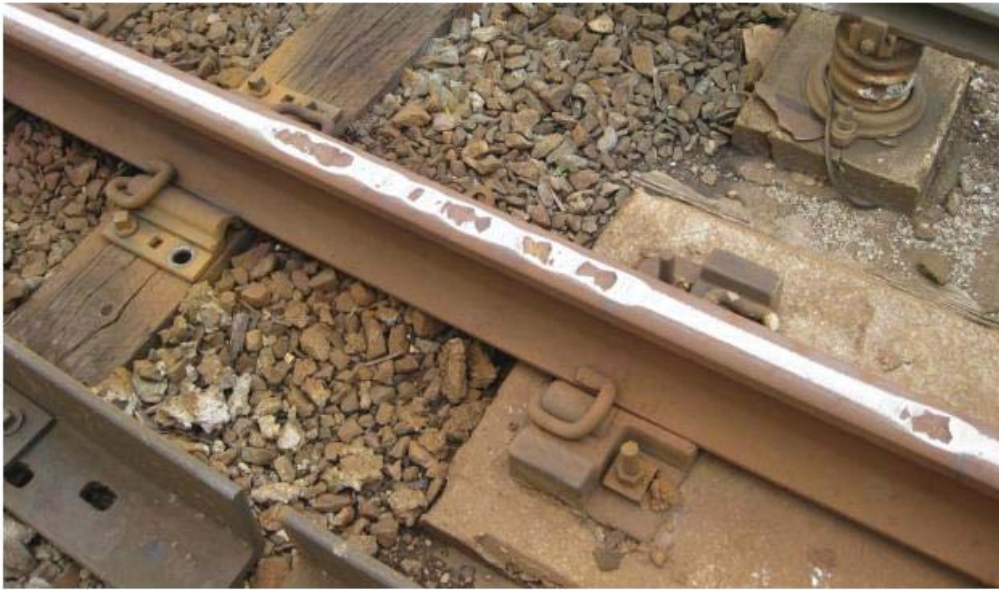
A2-516+00 LR- Severe rail surface defects (spalling) from vertical track deflection (Location-wood tie transition to DF aerial transition)

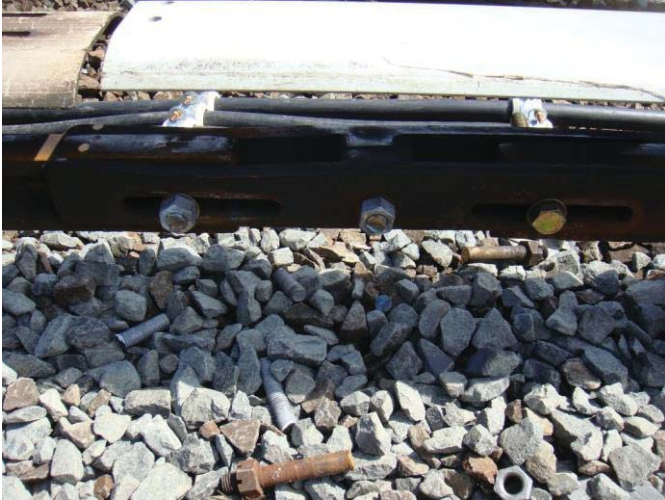
Figure 2 - K1 CM 392+10 - incorrect bolts in the third rail expansion joint

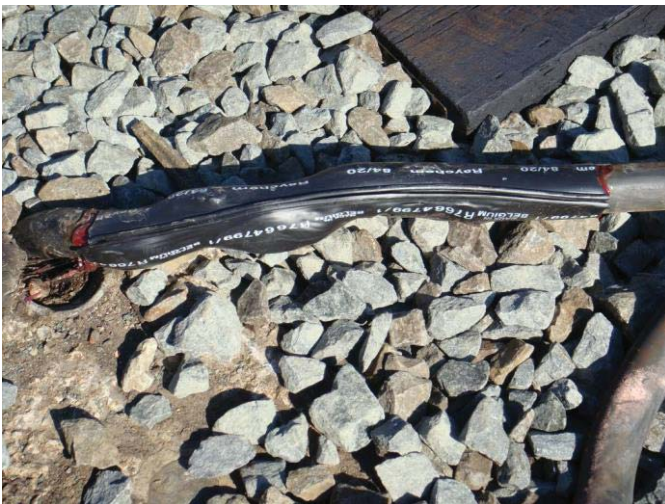
Figure 3 - K1 CM 336+90 - third rail return cable with shrink wrap - requesting engineering check

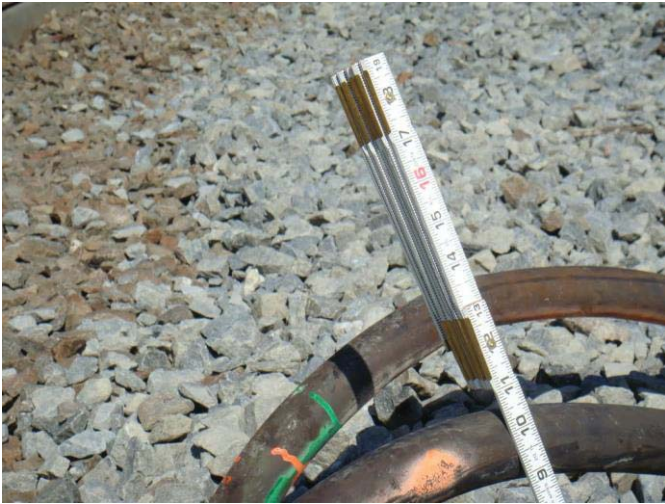
Figure 4 - K1 CM 371+00 - 10" high return cables on field side of rail

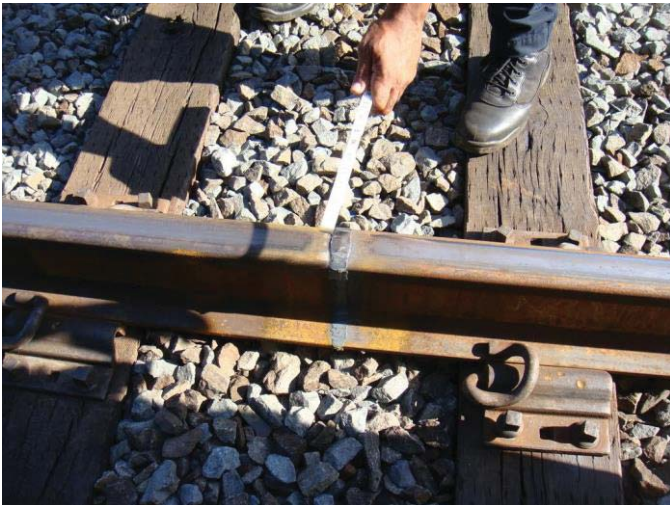
Figure 5 - K1 CM 329+00 - Mismatched rail ends - unfinished weld

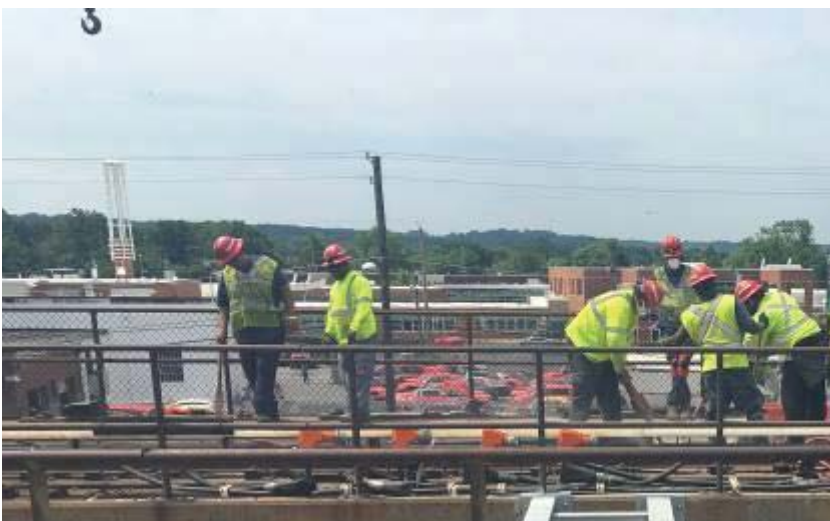
Exposed cables under aerial structure

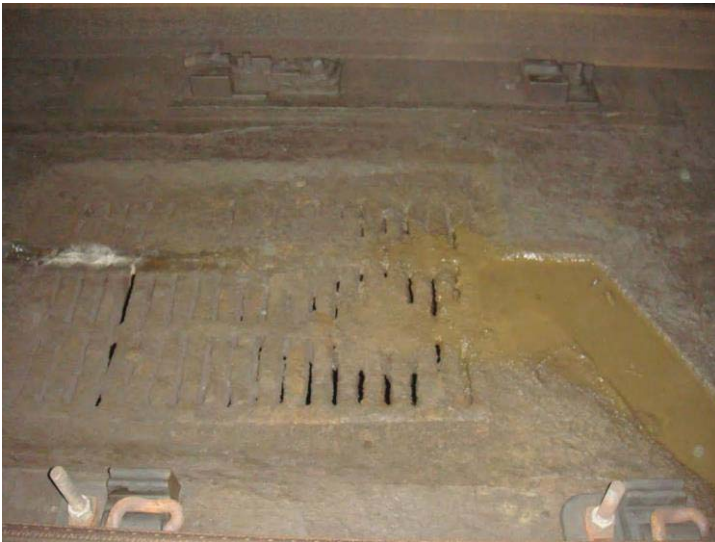
Figure 1 - A1 CM 381+00 - drain cover fouled with mud - similar conditions at other noted drains covers

<ul style="list-style-type: none">• A1 CM 345+00 - running rail surface defect - appears to be head checking• A1 CM 374+00 - clogged drain• A1 CM 377+80 Drain clogged• A1 CM 381+00 - cannot read chain marker and the drain is clogged with mud		
Remedial Action	<ul style="list-style-type: none">• WMATA to mitigate eight corroded fasteners, instable plates, and missing/corroded Pandrol clips found in the area of A1 CM 374+80.• WMATA to mitigate four missing Pandrol clips at A1 CM 385+00 - A1 CM 387+50, that were identified in a previous inspection report but not addressed.• WMATA to replace tie plate at A1 CM 322+50.• WMATA to mitigate wet and suspended joing on the left rail at A1 CM 349+00.• WMATA to tighten lose bolt in the left rail at CM 305+00.• WMATA to assess radio coverage at A1 329+00 to A1 CM 334+50.• WMATA to tighten loose bolt at CM 307+50.• WMATA to mitigate tripping hazard and holes/missing slats in the drain cover at A1 CM 305+10.• WMATA to replace handle on ETS Box A91.• WMATA to remove mud under third rail at A1 CM 342+40.• WMATA to mitigate running rail surface defect at A1 CM 345+00.• WMATA to unclog drains at A1 CM 374+00, A1 CM 377+80 and A1 CM 381+00.

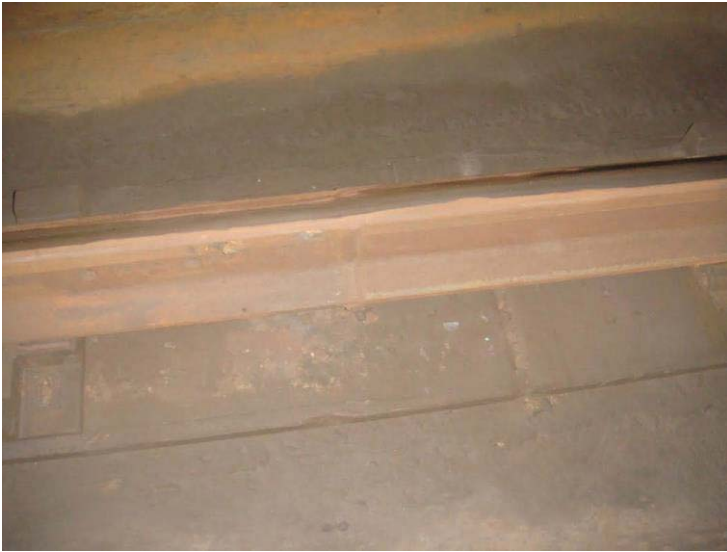
Figure 2 - A1 CM 349+00 - unsupported joint

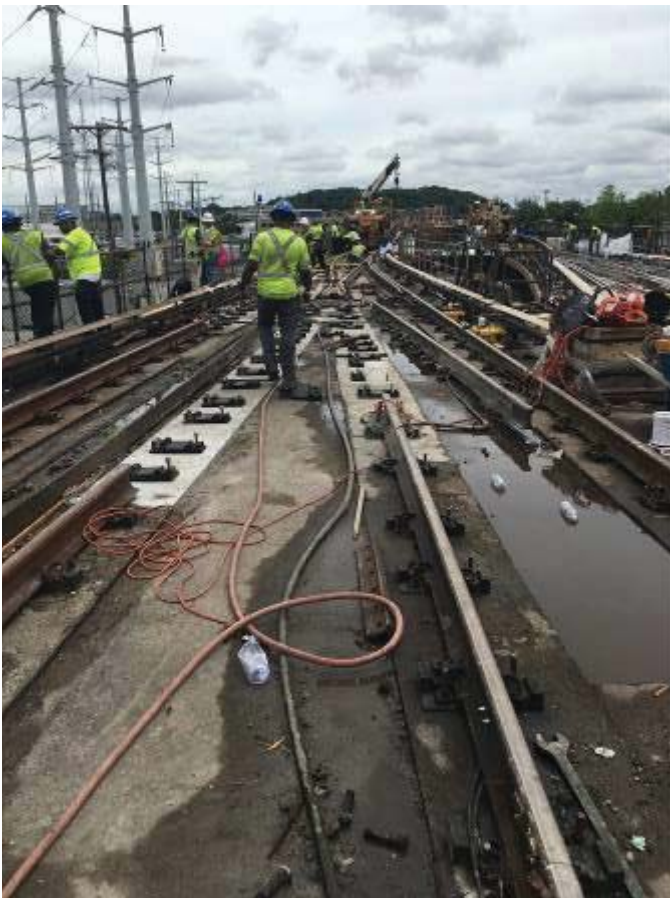
Standing Water on Aerial

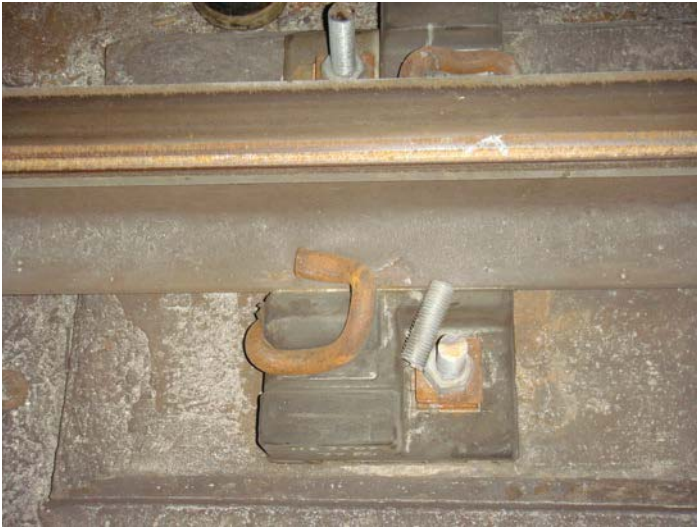
Figure 4 - Long Stud Bolts – evidence of cut bolts, both sides of fastener

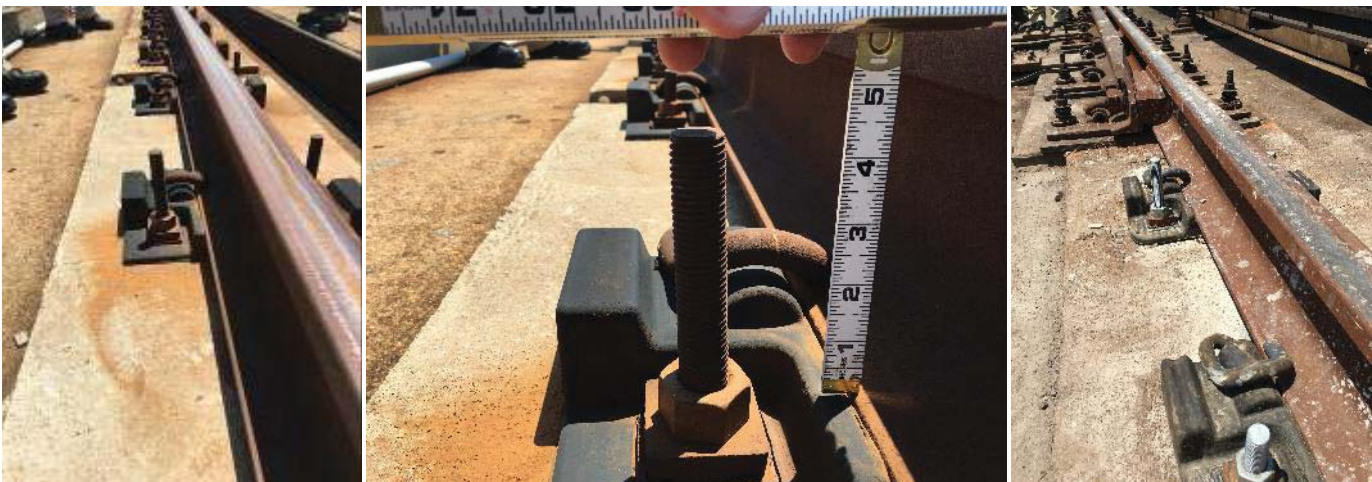
High Stud Bolts

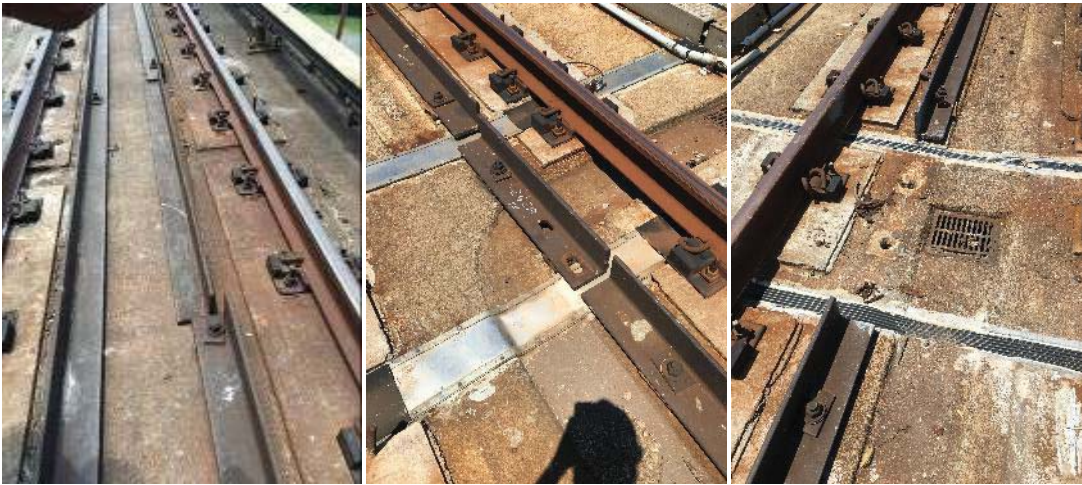
Unsecured or Missing Bridge Emergency Guard Rails

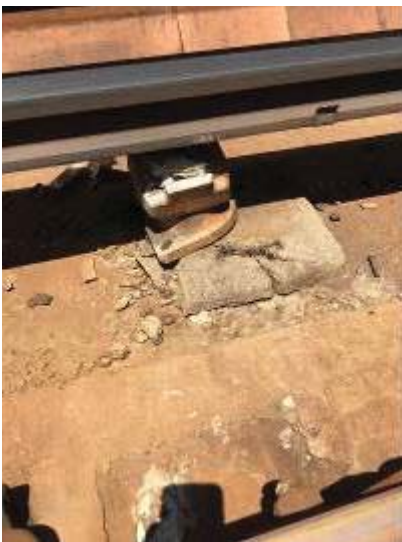
Broken Insulator D2 305+50

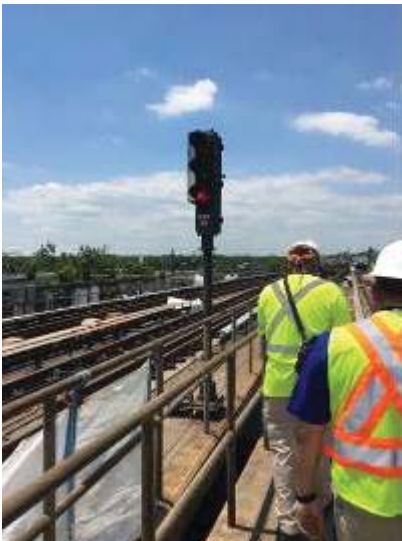
Red Signal Light Out D98-38 Signal
