Inspection Form

United States Department of Transportation
Federal Transit Administration

Inspection Date	YYYY	MM	DD	Report Number	20161201-WMATA-WP-1		
	2016	12	01				
Rail Agency Name	Washington Metropolitan Area Transit Authority			Rail Agency Department	Track	Sub- Department	
Rail Agency Department Contact Information	Name		Email		Office Phone		Mobile Phone
	[REDACTED]		[REDACTED]				
Inspection Location	Twinbrook (A13) to Rockville (A14)

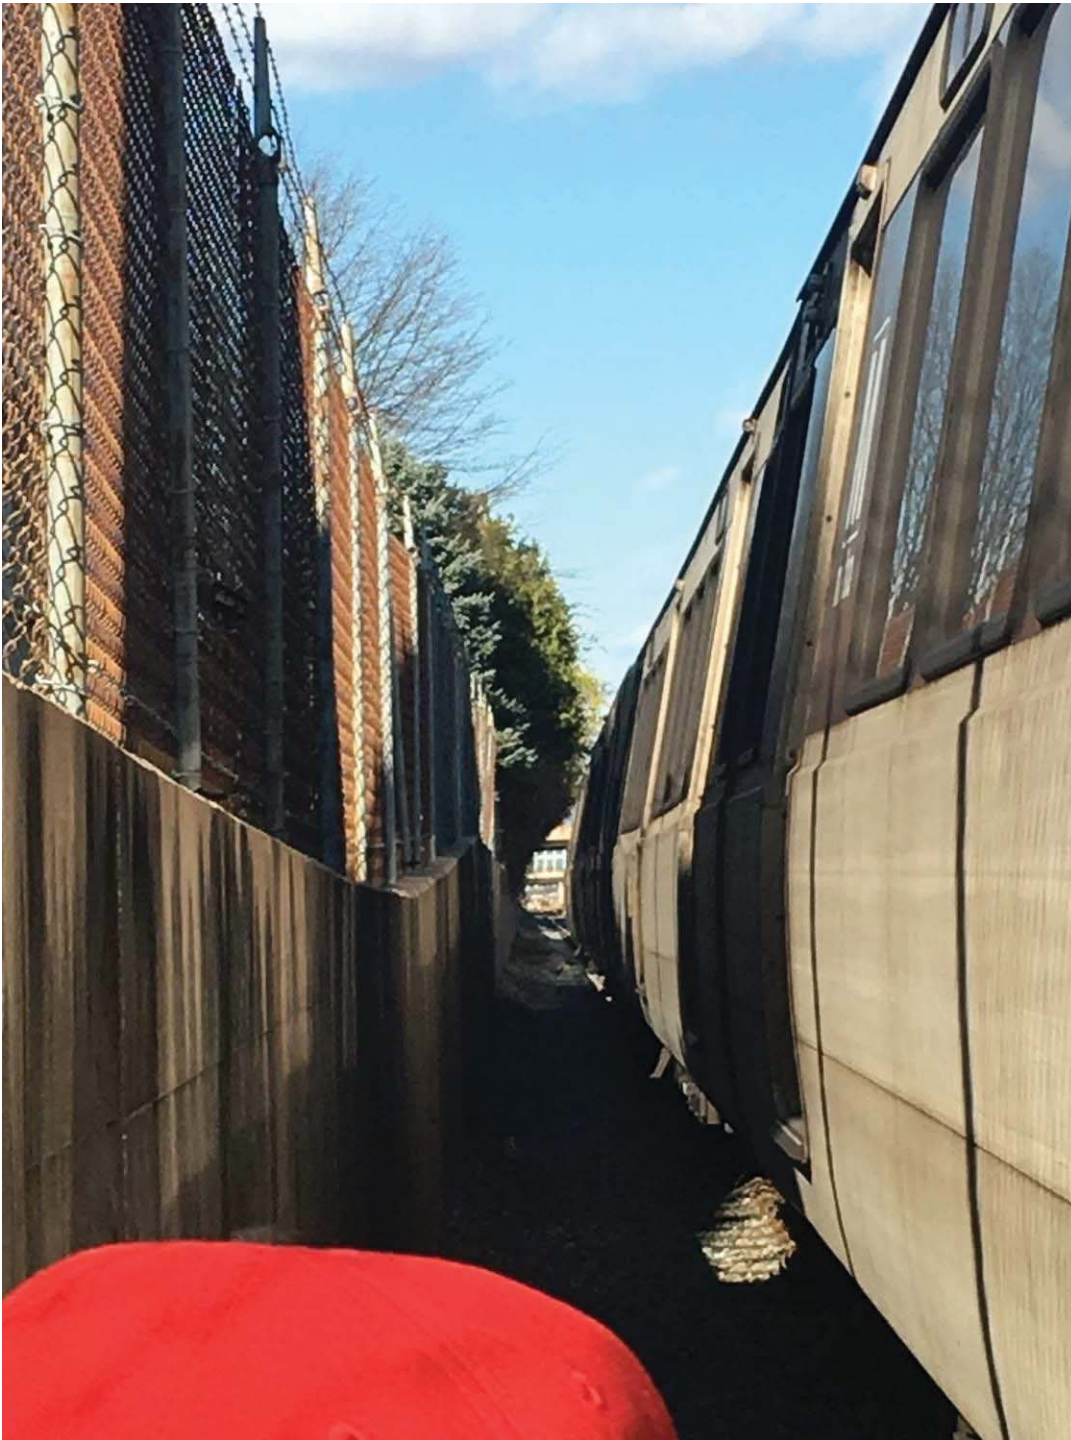
Vegetation growing close to dynamic envelope of train

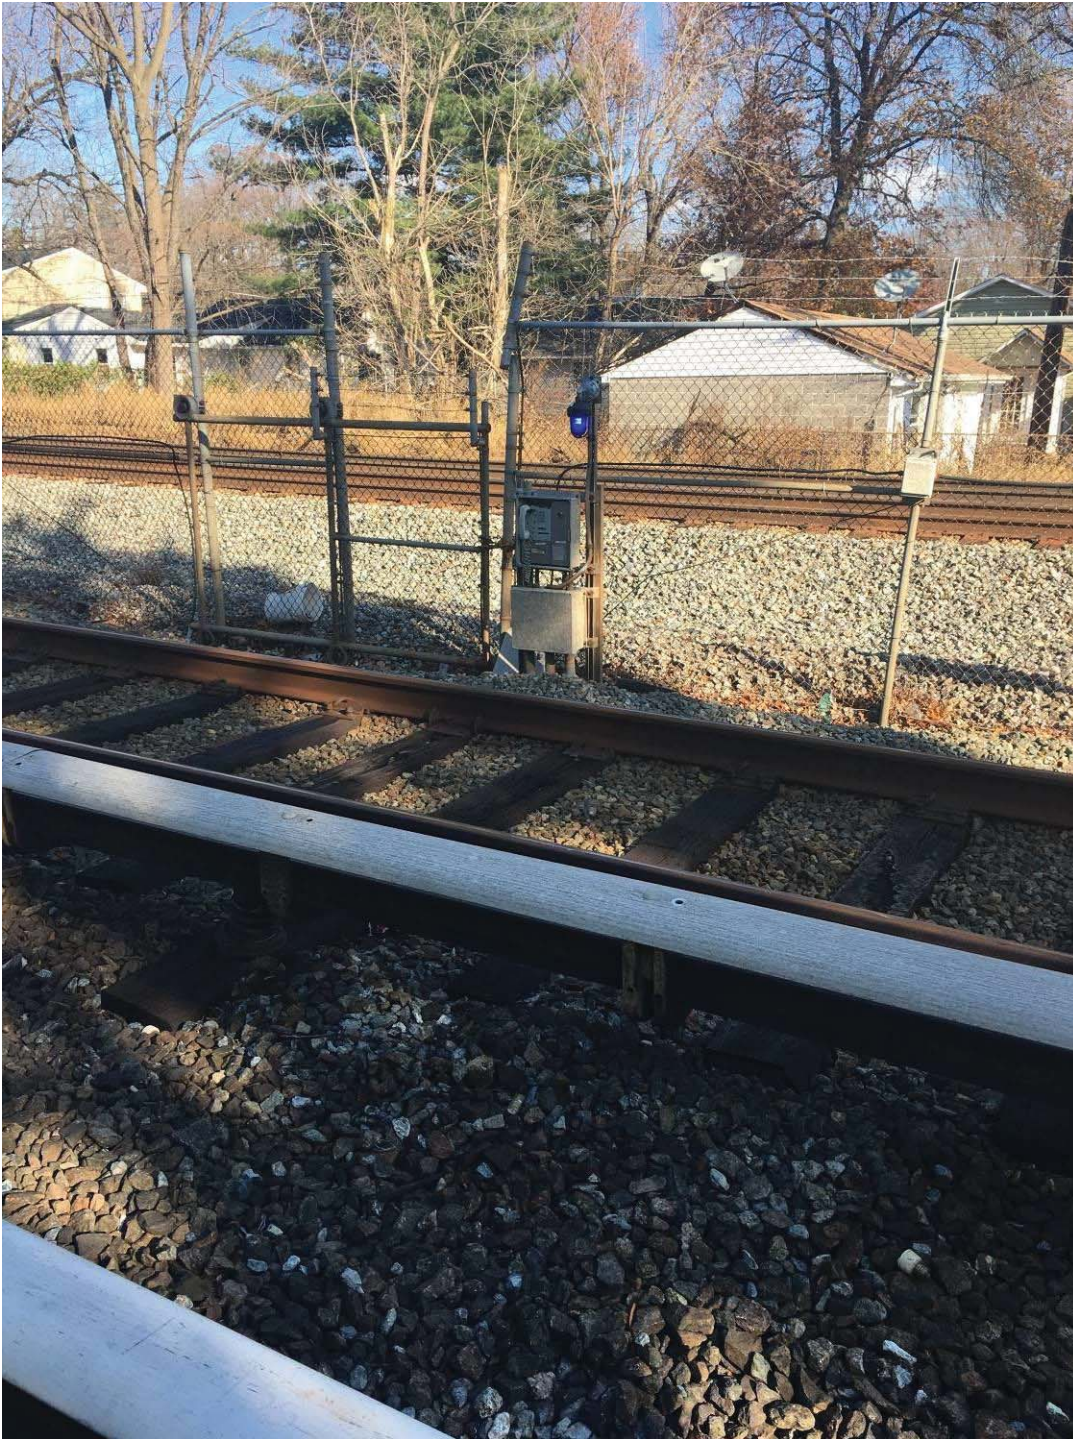
ETS Box with door missing A2 747+00

Remedial Action	1. WMATA must replace the door on the ETS Box at A2 747+00.

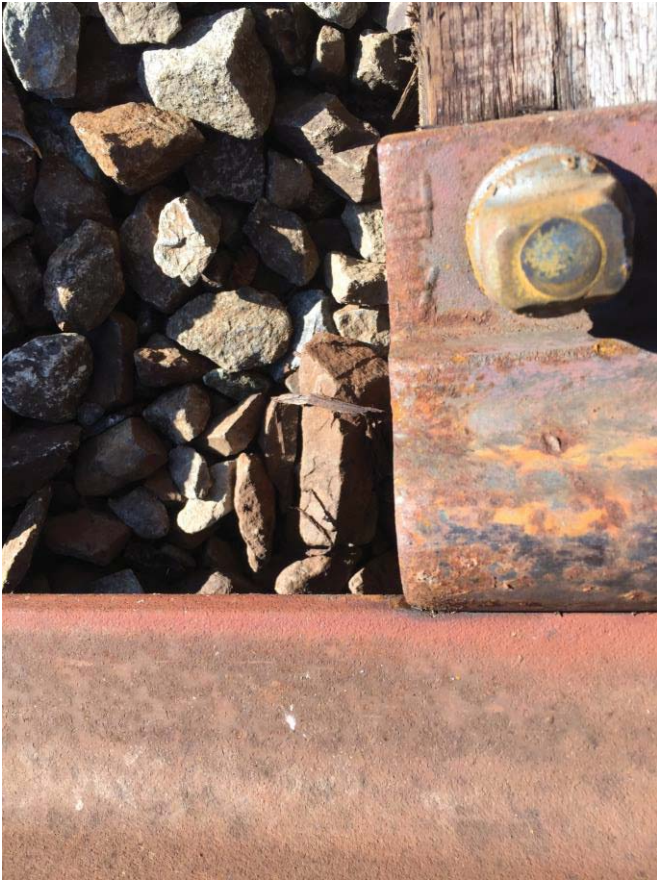
Figure 1 - Plate overhanging tie by one inch.

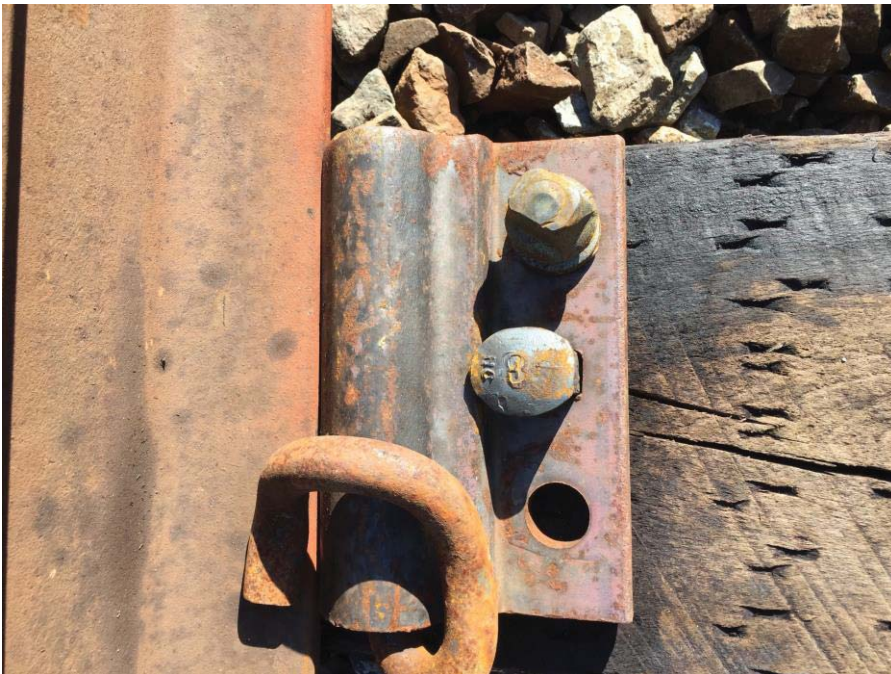
Figure 2 - Plate not centered.

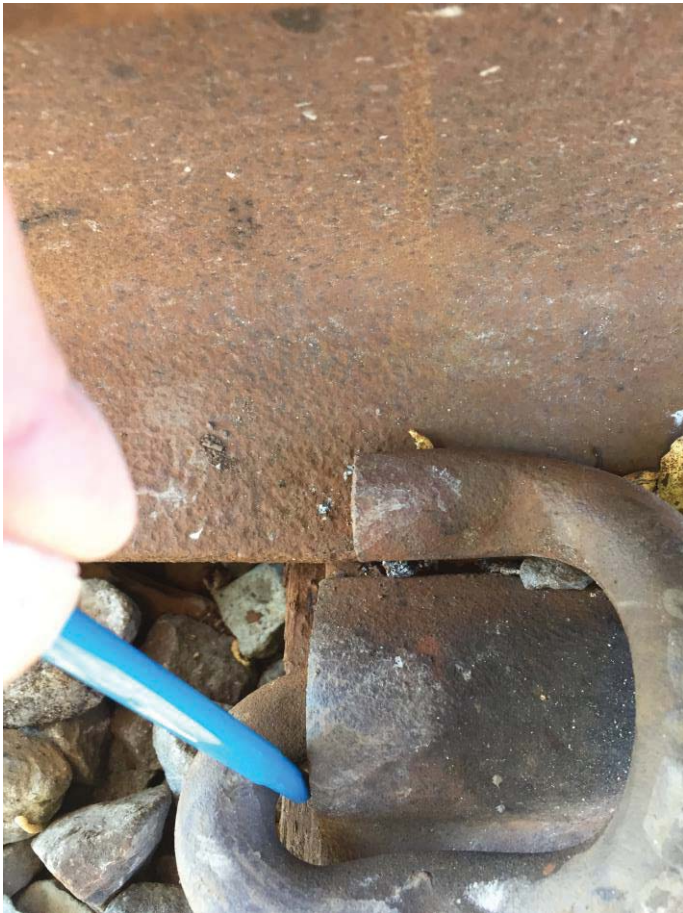
Figure 3 – Tight spacing.

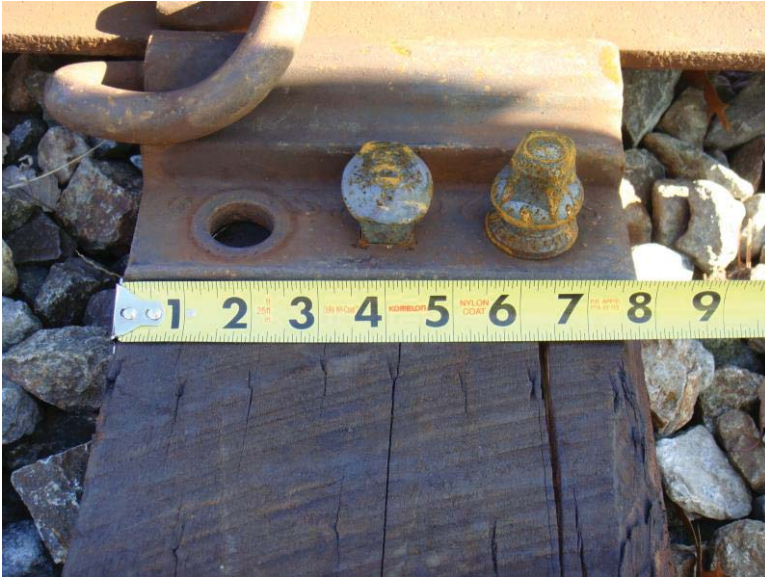
<p>General Observations:</p> <ul style="list-style-type: none"> The FWSO team noted non-conformant crossties at the following locations: <ul style="list-style-type: none"> B1 CM274+60 – 7 ¾" B1 CM202+60 – 7 ¾" B1 CM181+40 – 7 ¾" The team noted new crossties, new ballast, new insulators, and new grout pads and fasteners. ETS boxes were all labeled, and the blue lights were all operational. <p>No exceptions were taken to the work that has been completed in this area.</p> <p>Note: The non-conformant crossties are an issue under discussion with WMATA at this time.</p>		
<p>Remedial Action</p>	<p>WMATA must address and repair the following items:</p> <ol style="list-style-type: none"> At B05 – 3A Switch the guard rail has two loose bolts that need to be tightened. At B05 – 1A Switch the house top has no cotter pin inserted on the #1 and #4 nuts. At B1 CM189+90 the newly poured grout pad on the right rail is crumbling. It appears that the concrete mix was not correct. This is the area where the ballasted track meets up with the direct fixation area in the portal. See photo below. At B1 CM174+00 the grout pad is crumbling on the left rail. There is poor support under four (4) pads in a row. The distance between effective fasteners exceeds 140 inches.

Figure 1 - B1 CM274+60 - 7 3/4" Crosstie - note split in line with fastener

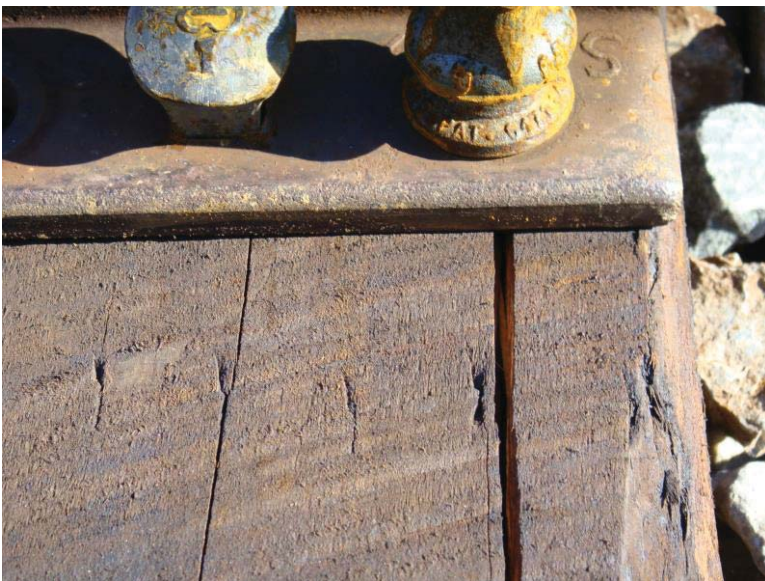
Figure 2 – Same tie - Close up of split on left rail

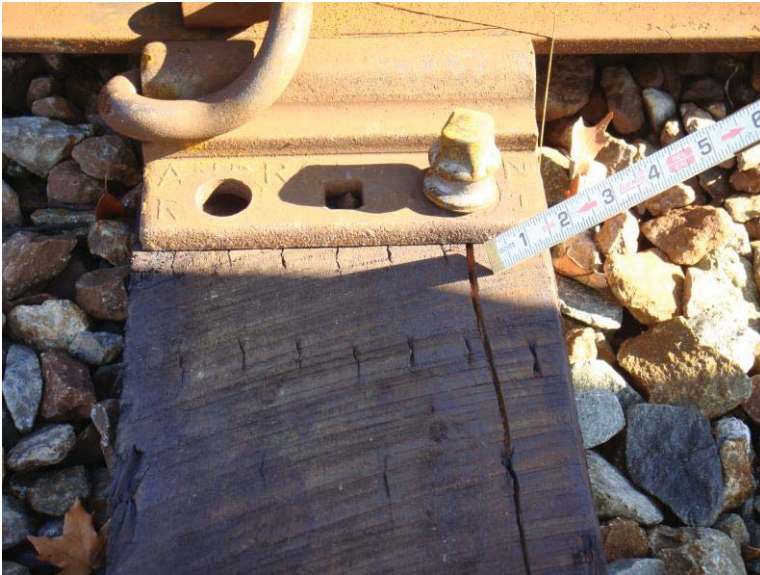
Figure 3 - Same tie - close up of split on right rail

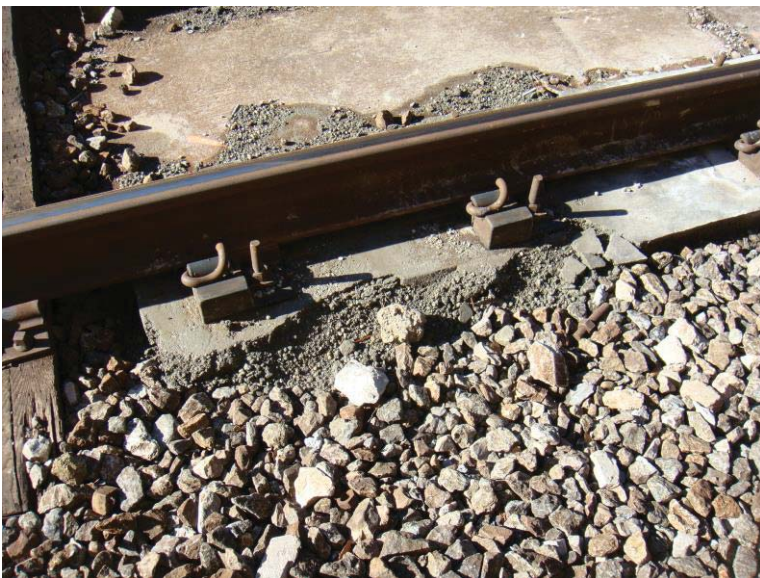
Figure 4 - B1 CM189+90 - Concern about concrete mix on new grout pad

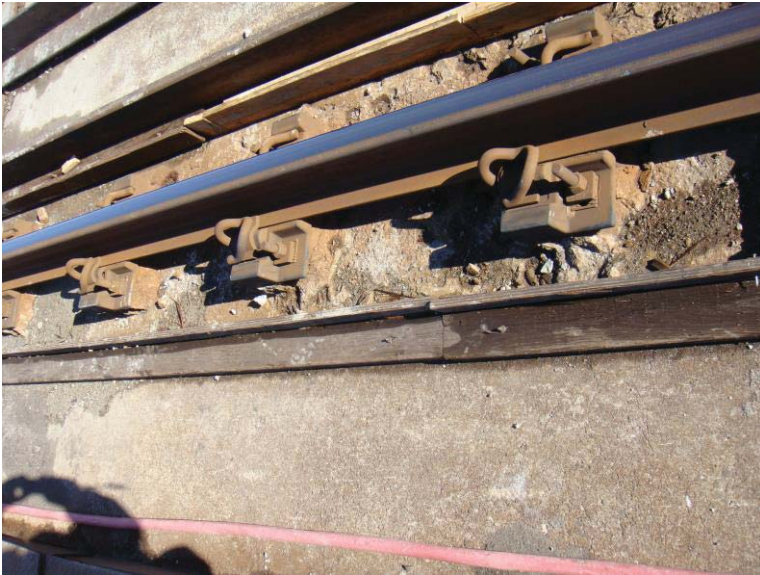
Figure 5 - Grout Pad at B1 CM174+00 left rail scheduled for completion 12/10/16

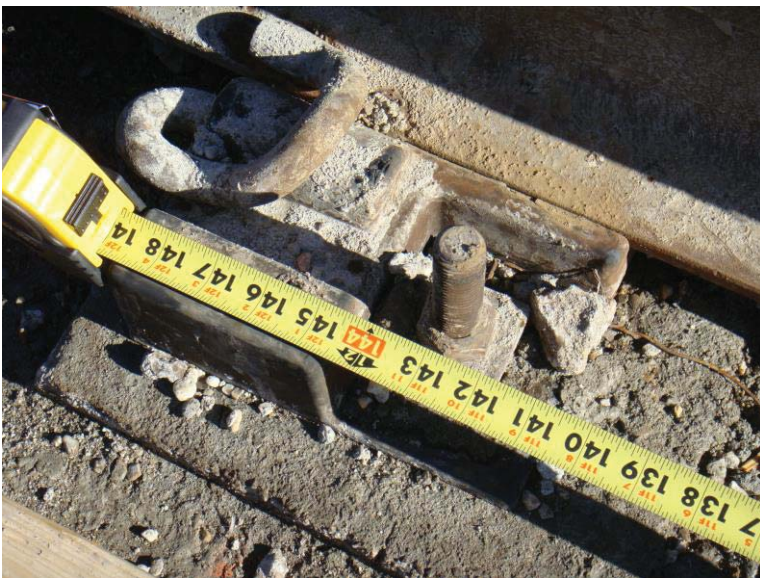
Figure 6 - 144" between effective fasteners at B1 CM174+00

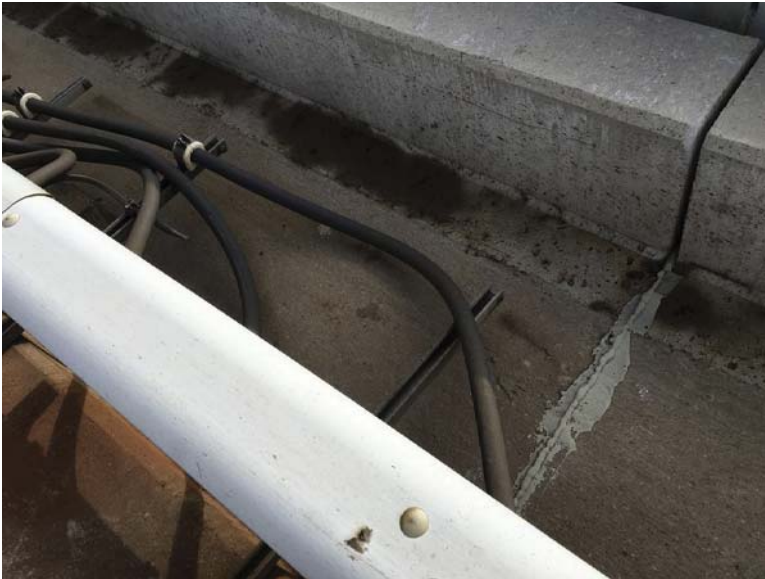
FIGURE 1 – CABLE LYING ON DECK AND MISSING FIBERGLASS STANDOFF WITH KINDORF STRAP

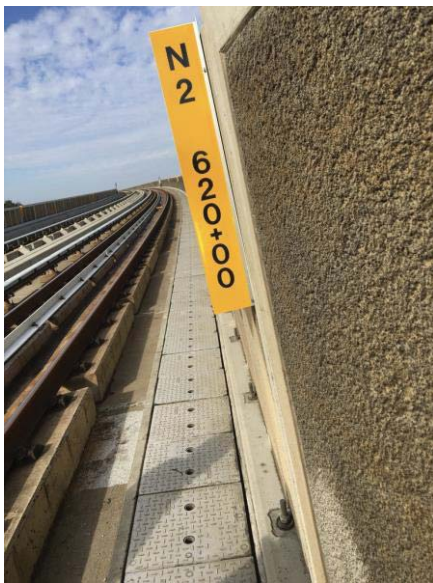
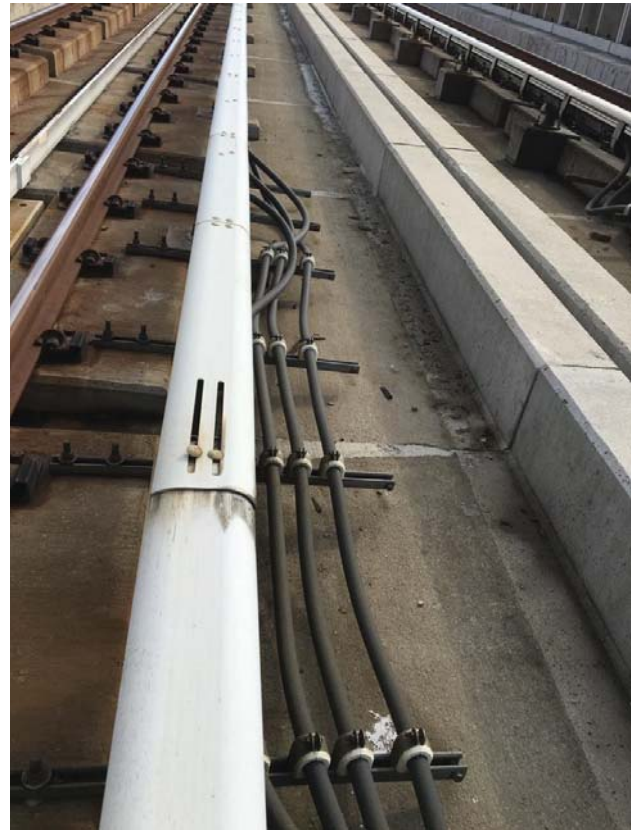
FIGURE 2 – CABLES LYING ON DECK AND MISSING FIBERGLASS

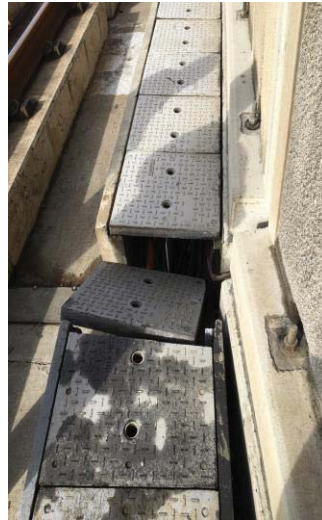
FIGURE 3 – WALKING PAVERS ON CLEARANCE ZONE COLLAPSED

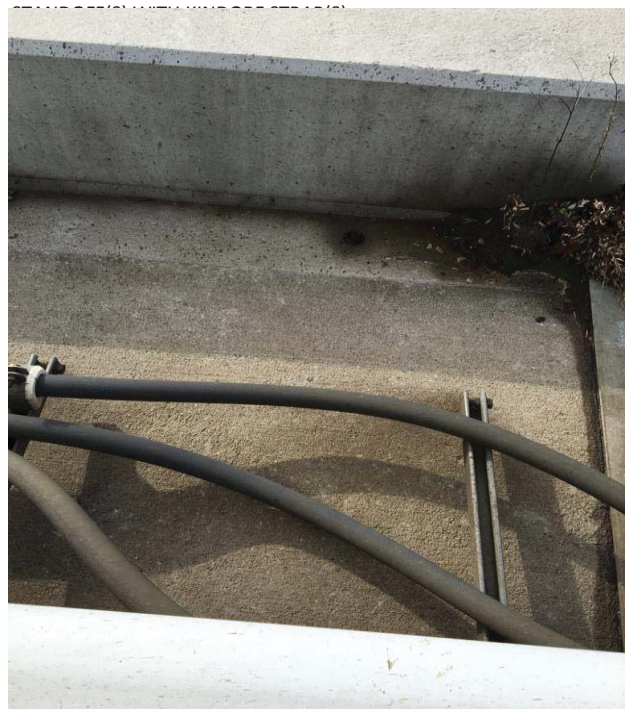
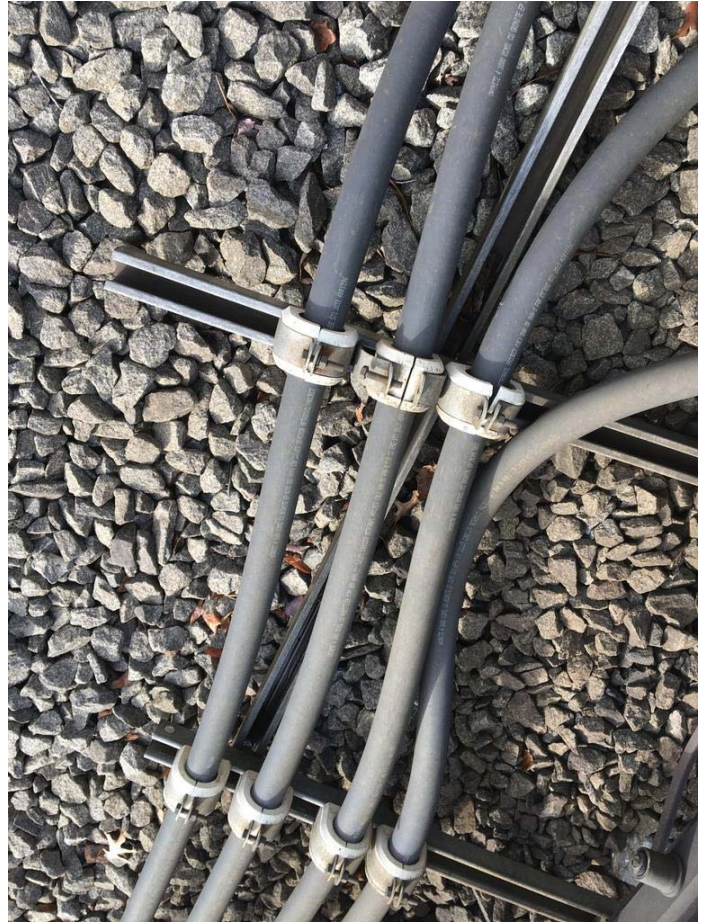
FIGURE 4 – CABLES LYING ON DECK AND MISSING FIBERGLASS STANDOFF(S)
WITH KINDORF STRAP(S); LOOSE NUT/BOLT ASSEMBLY ON KINDORF STRAP

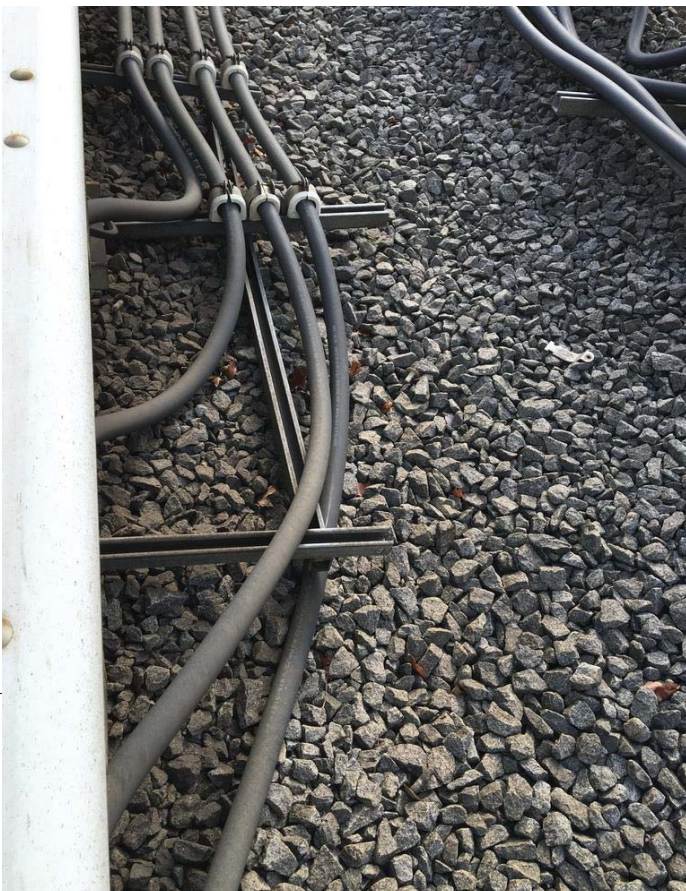
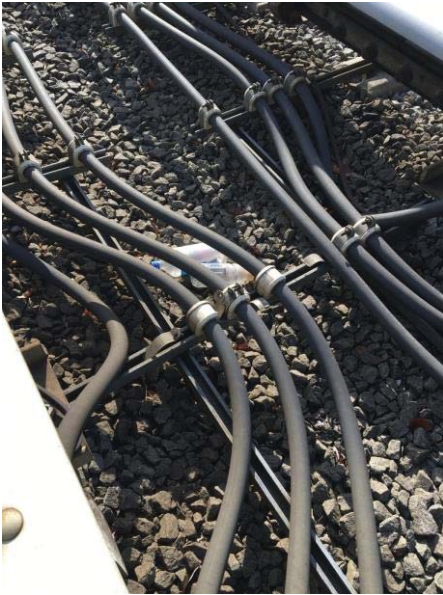
FIGURE 5 – CABLES LYING ON DECK AND MISSING FIBERGLASS STANDOFF(S) WITH KINDORF STRAP(S); LOOSE NUT/BOLT ASSEMBLY ON KINDORF STRAP

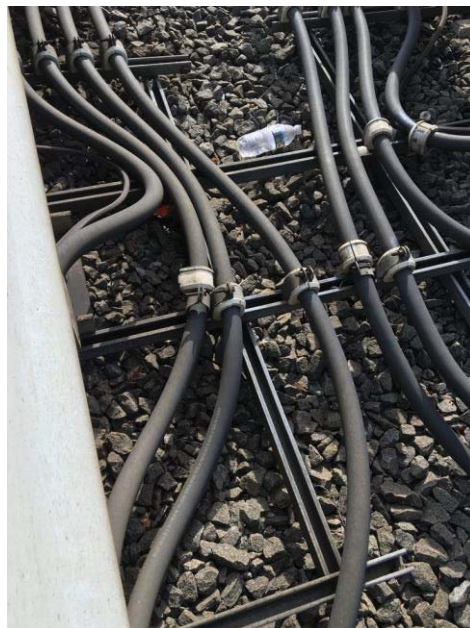
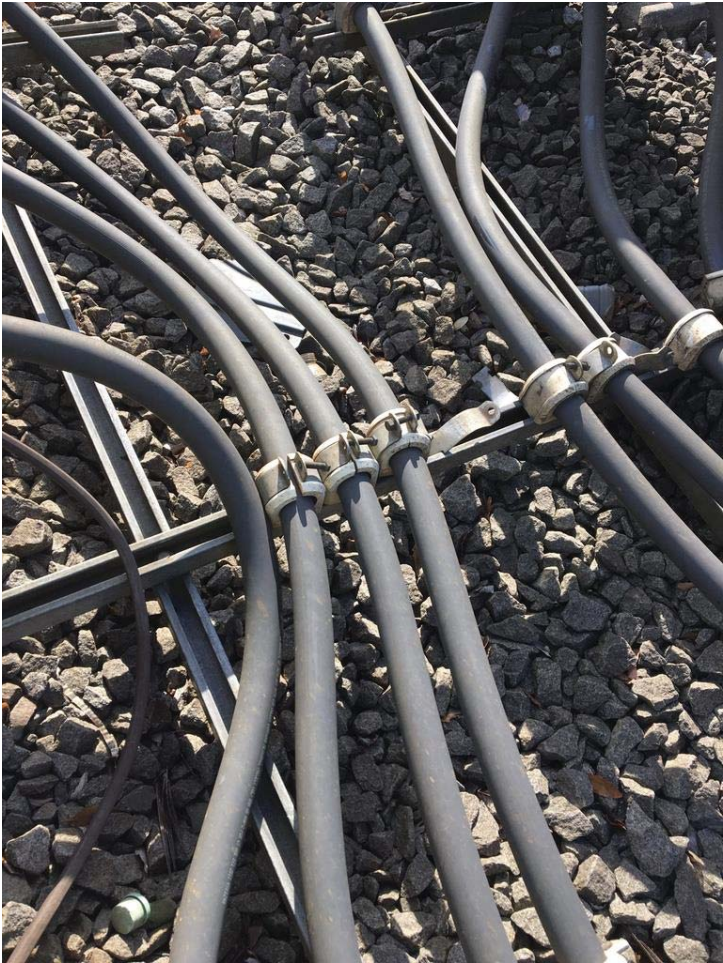
FIGURE 6 – CABLES LYING ON DECK AND MISSING FIBERGLASS STANDOFF(S) WITH KINDORF STRAP(S); LOOSE NUT/BOLT ASSEMBLY ON KINDORF STRAP

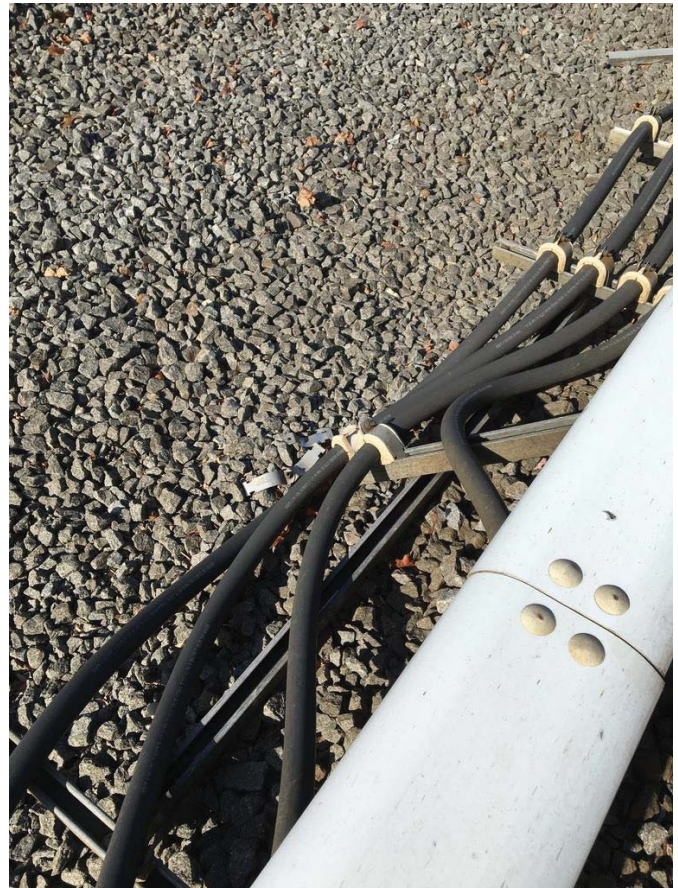
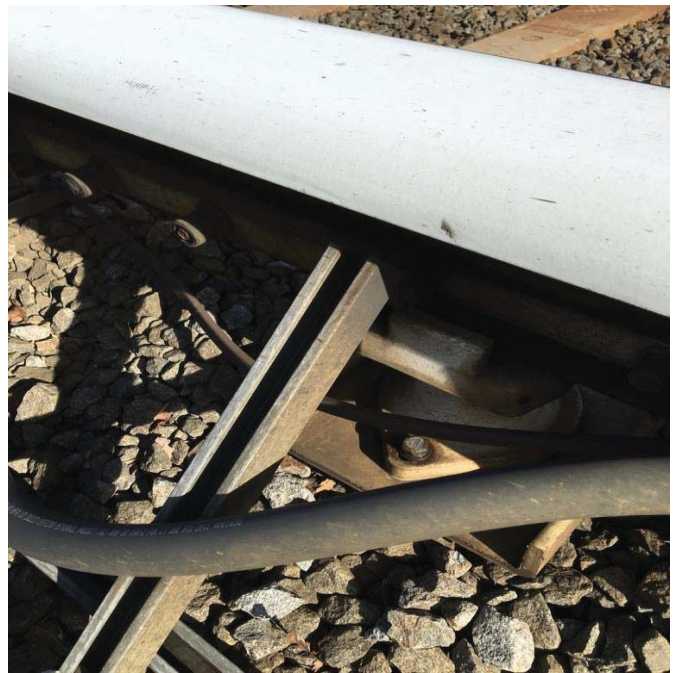
FIGURE 7 – CABLES LYING ON DECK AND MISSING FIBERGLASS STANDOFF(S)
WITH KINDORF STRAP(S); METAL KINDORF LOOSE AND VERY CLOSE TO 3RD RAIL

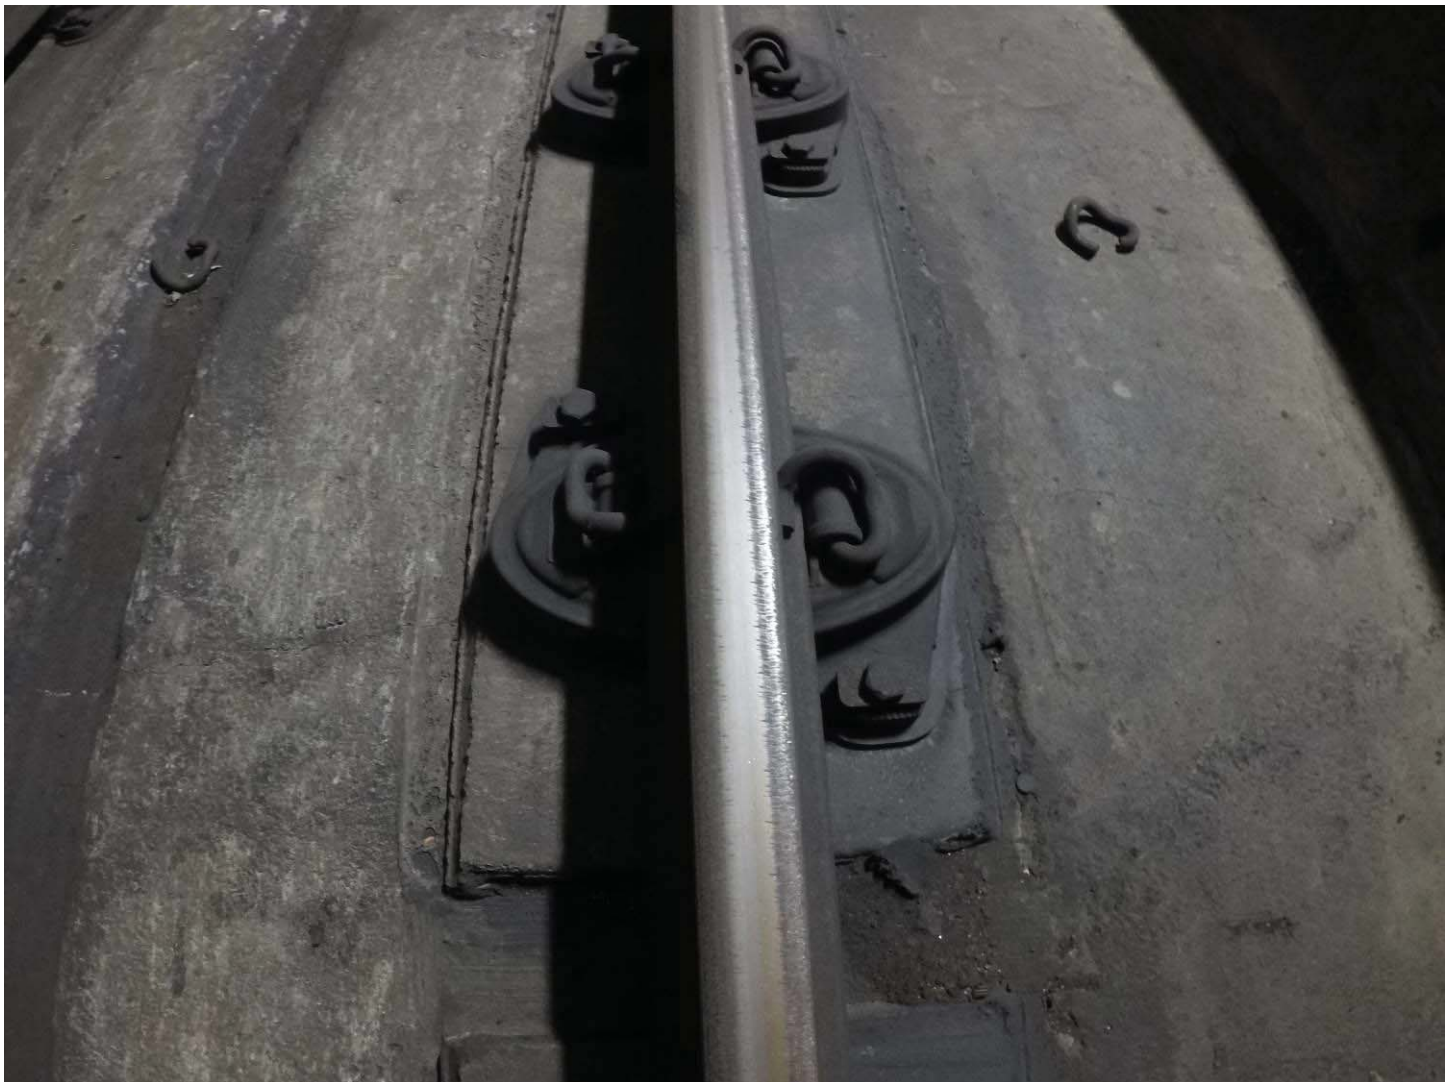
Description	<p>FWSO performed a track inspection from Georgia Ave (Station E05 - CM 179+00) to CM 200+00 on both main tracks for the E Line to follow-up on vibration complaints from the public that live above this tunnel section. In this area, WMATA has installed Cologne Egg Fasteners, designed to reduce the magnitude of vibrations transferred to the tunnel structure and the environment above.</p> <ul style="list-style-type: none"> FWSO observed numerous Pandrol e-Clips broken from apparent stress risers from the shoulders on Cologne Egg style direct fixation fasteners. The e-Clips are held in place by the shoulders while it bears against the base of the rail. The broken e-Clips were located between chain markers 185+00 and 198+00 on tracks 1 and 2. Most of the broken e-Clips had fresh breaks—most likely occurring on the same day of the inspection—which explains why the clips had not been replaced yet. Other than the e-Clips, most of the Eggs' direct fixation components (i.e. elastomer, anchor bolts, grout pads, etc.) were in relatively good condition and not failing. FWSO observed that track 2 had the preponderance of missing e-Clips. A WMATA representative placed a medium speed restriction (40 mph) on track 2. While many broken clips were found, no track conditions were found. The WMATA representative put the speed restriction in place as a preventive measure. Maintenance was scheduled for that evening. FWSO observed that track 1 had recent maintenance completed to replace numerous broken e-Clips. However, even some of the recently replaced e-Clips had already snapped. FWSO observed that the F17 style direct fixation fasteners in the limits of our inspection did not have broken or missing clips. These fasteners do not have the same vibration dampening properties as the Cologne Egg fasteners. FWSO noted that the use of the 7000-series rail car trains—which weigh significantly more than the previous series rail cars—and the location adjacent to a station in which trains are applying additional force by 	Number of Defects	1

<p>braking or accelerating could be contributing factors. FWSO will continue to investigate this issue with WMATA track engineering.</p> <p>Additional observations:</p> <ul style="list-style-type: none">• There was a significant structural leak with continuous water flow dripping along the entire top of the tunnel at E1 CM 181+30.• Two trains failed to comply with Permanent Order T-16-07 Rev 1. These speed violations while passing roadway workers occurred with back-to-back trains at approximately 11:10 a.m. and 11:12 a.m. (EST) at E2 CM 192+00. Our WMATA escort notified ROCC.		
Remedial Action	1. WMATA must mitigate significant water leak at CM E1 181+30.

Cologne Egg fasteners with broken e-clips nearby

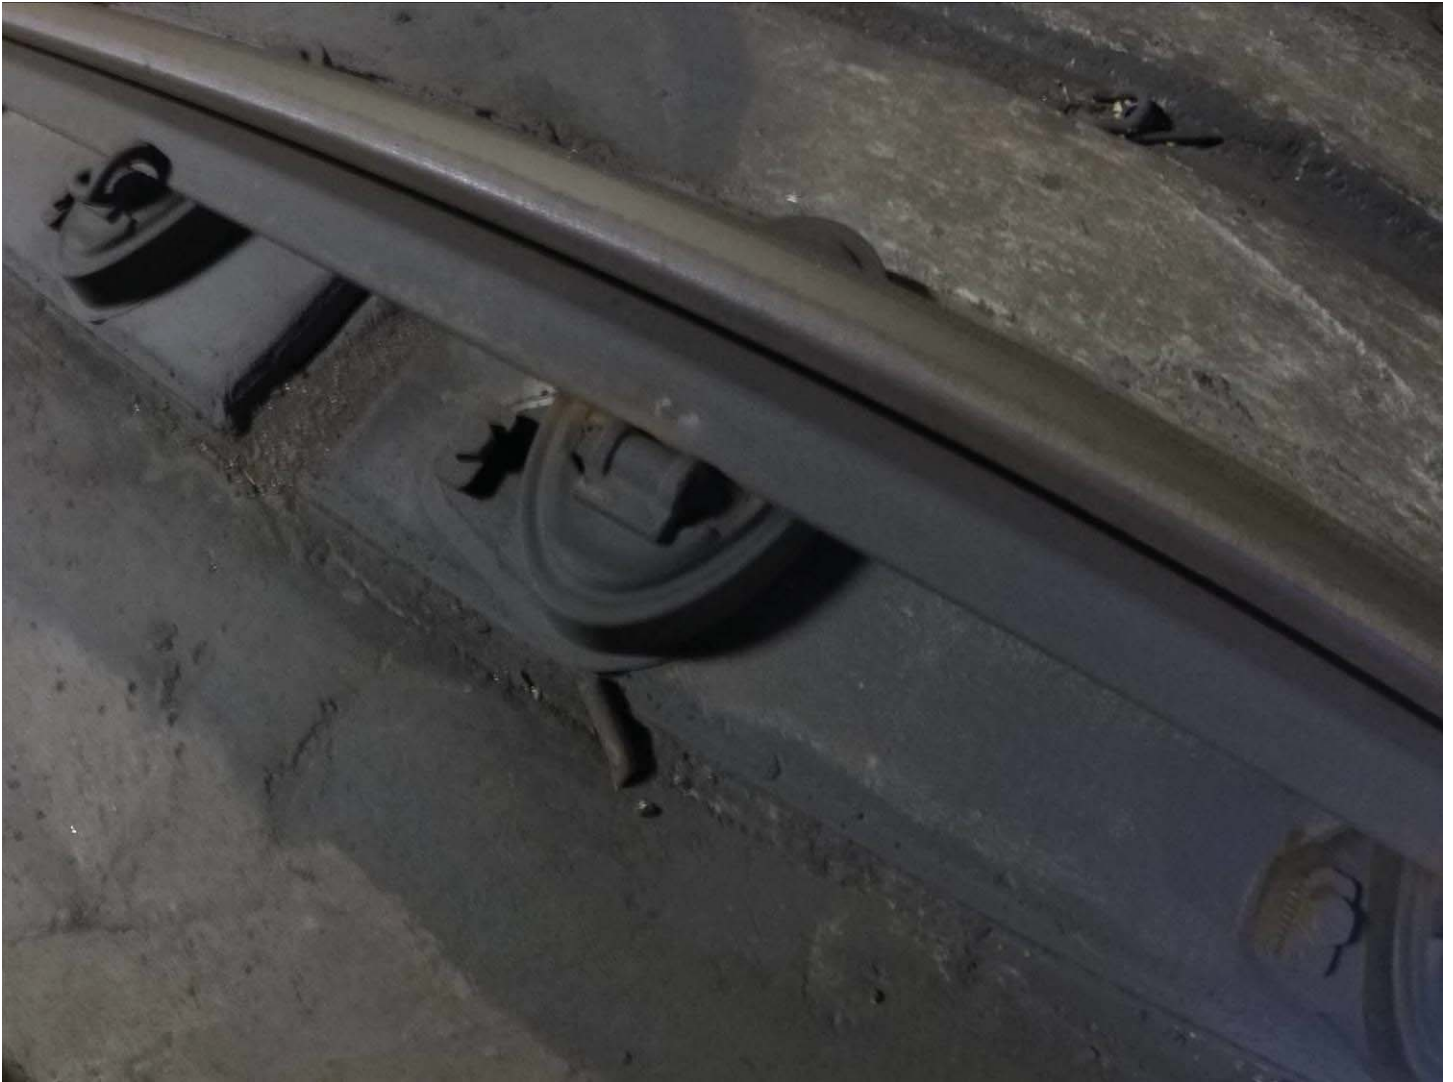
Cologne Egg Fastener with broken e-clip

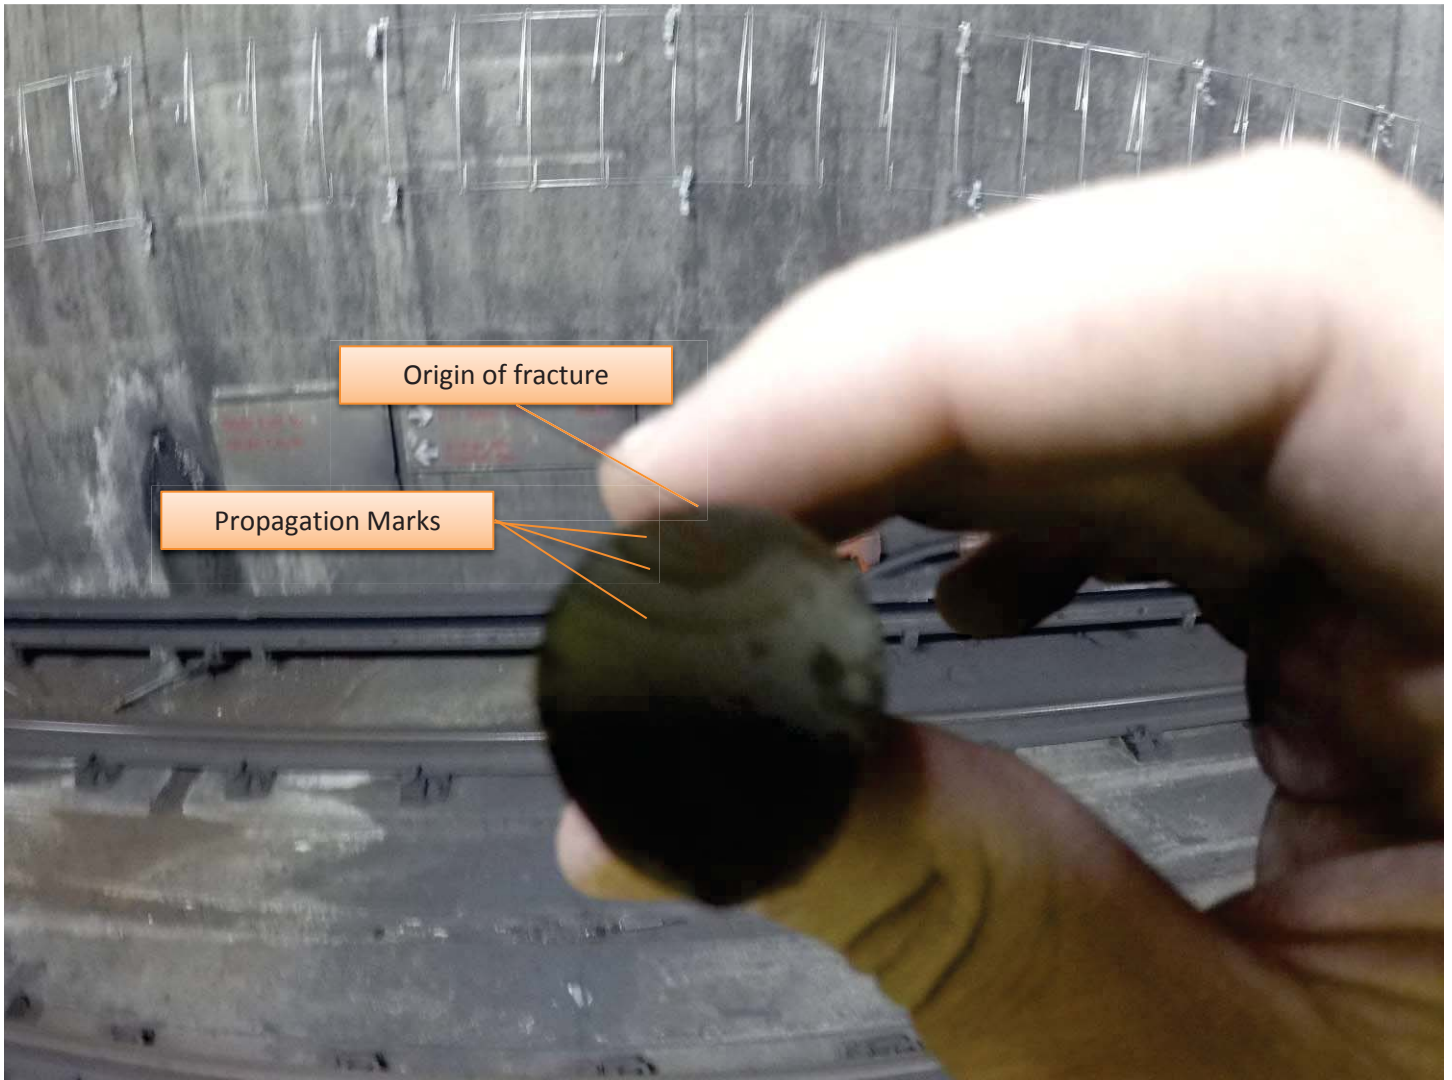
Signs of material fatigue and crack propagation on e-clip

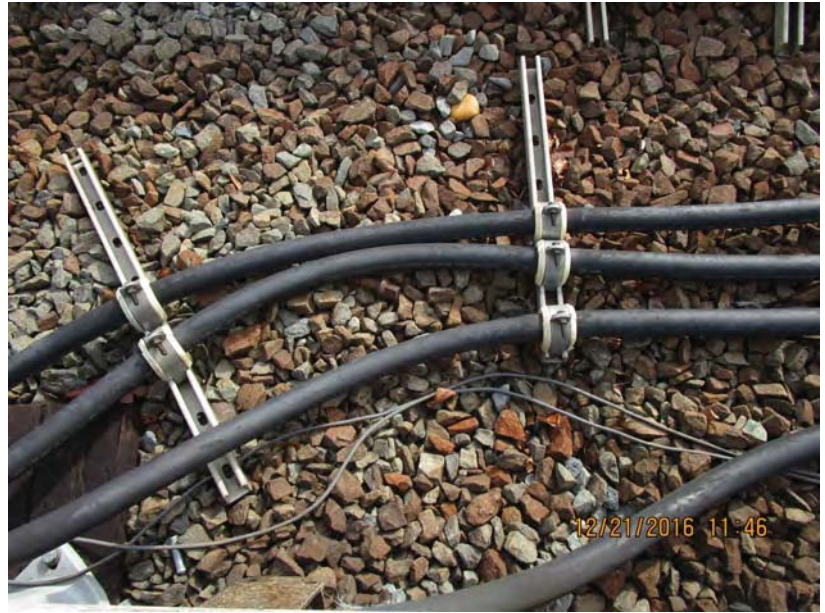
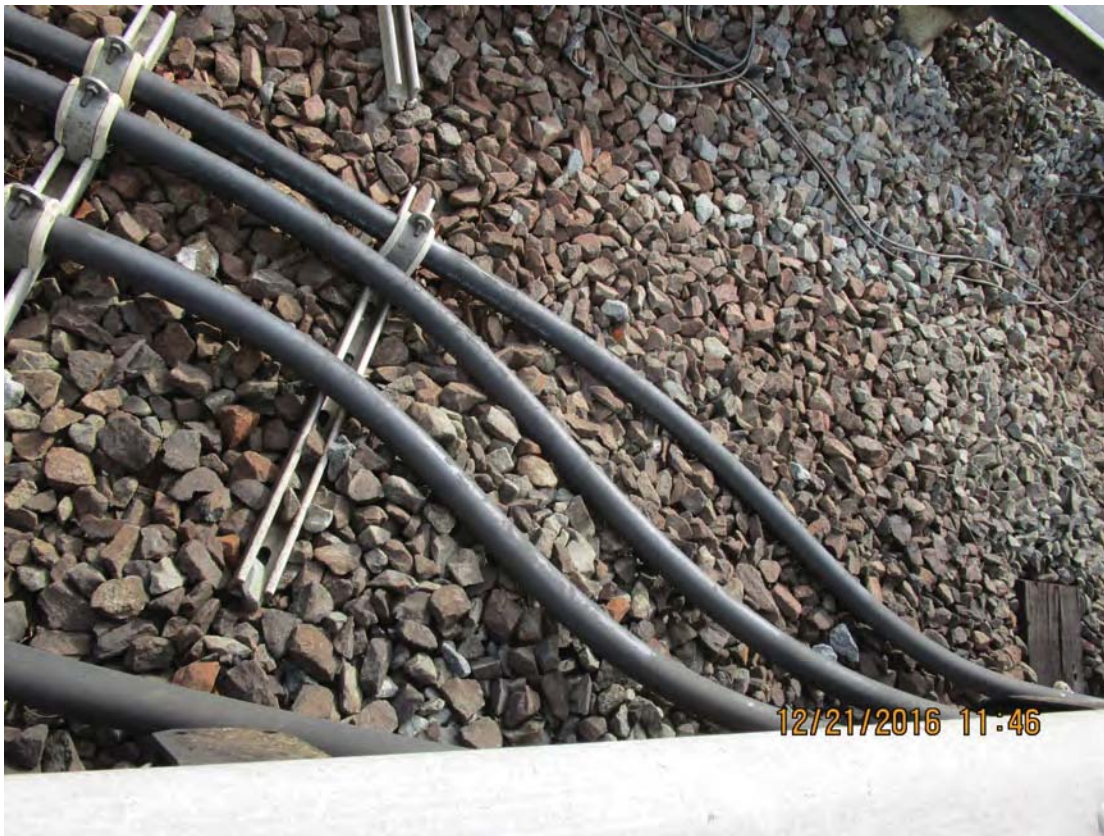
FIGURE 1 - CABLES LAYING ON DECK (BALLAST) f

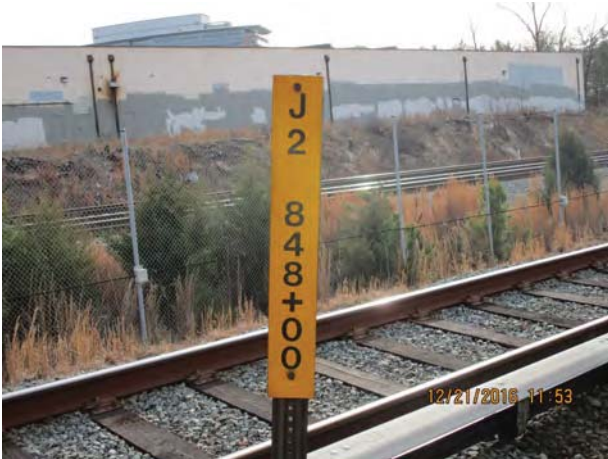
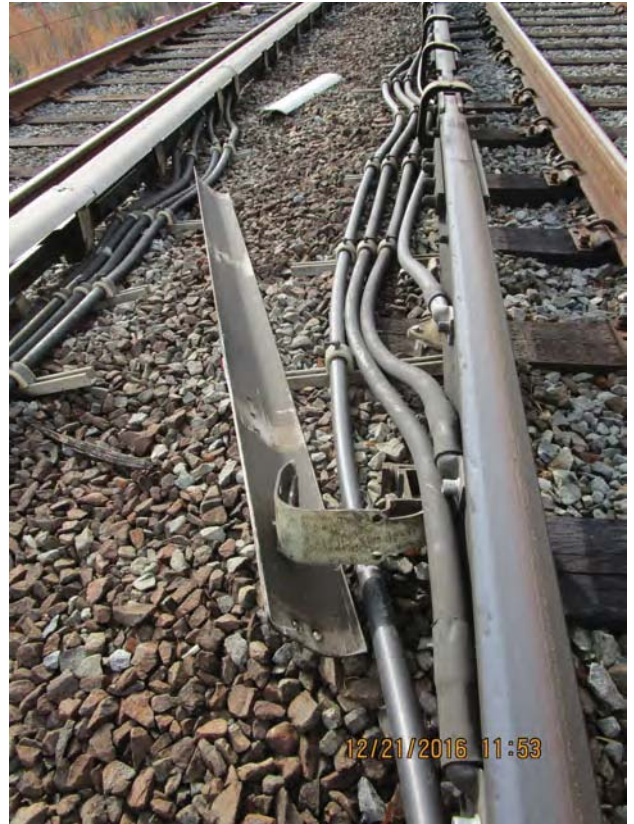
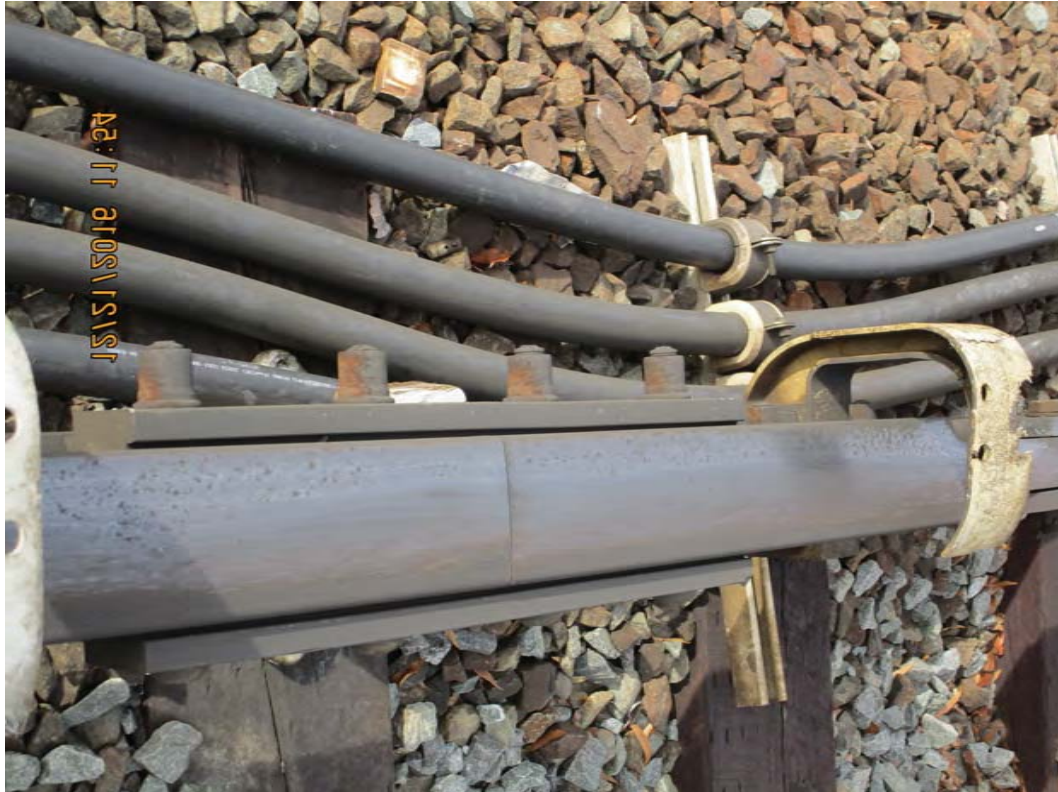
FIGURE 2 - CABLES LAYfNG ON DECK (BALLAST) AND 3RD RAfL COVERBOARD BROKEN AND NEEDS f TO BE REPLACED f
