Inspection Form

United States Department of Transportation
Federal Transit Administration

Inspection Date	YYYY	MM	DD	Report Number	20161201-WMATA-WP-1		
	2016	12	01				
Rail Agency Name	Washington Metropolitan Area Transit Authority			Rail Agency Department	Track	Sub- Department	
Rail Agency Department Contact Information	Name		Email		Office Phone		Mobile Phone
	[REDACTED]		[REDACTED]				
Inspection Location	Twinbrook (A13) to Rockville (A14)

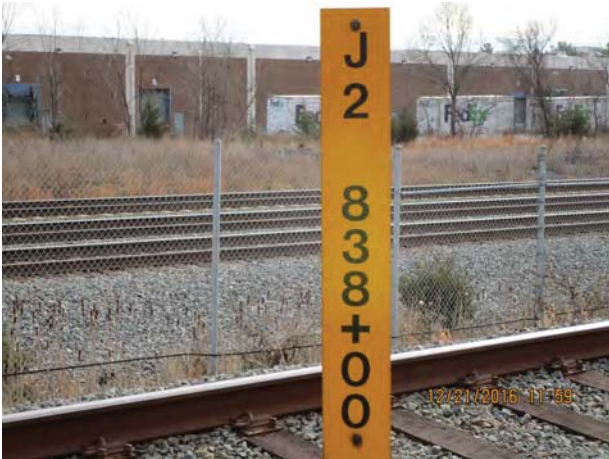
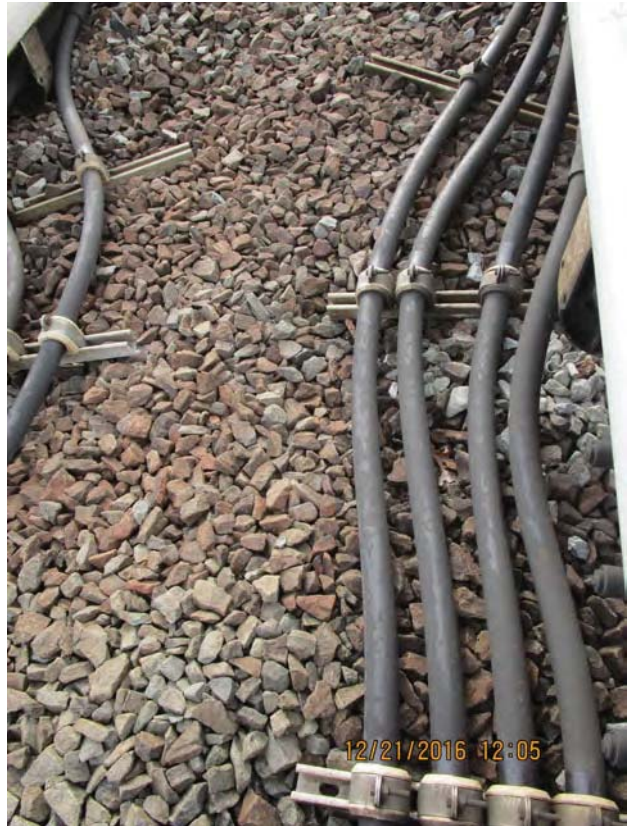
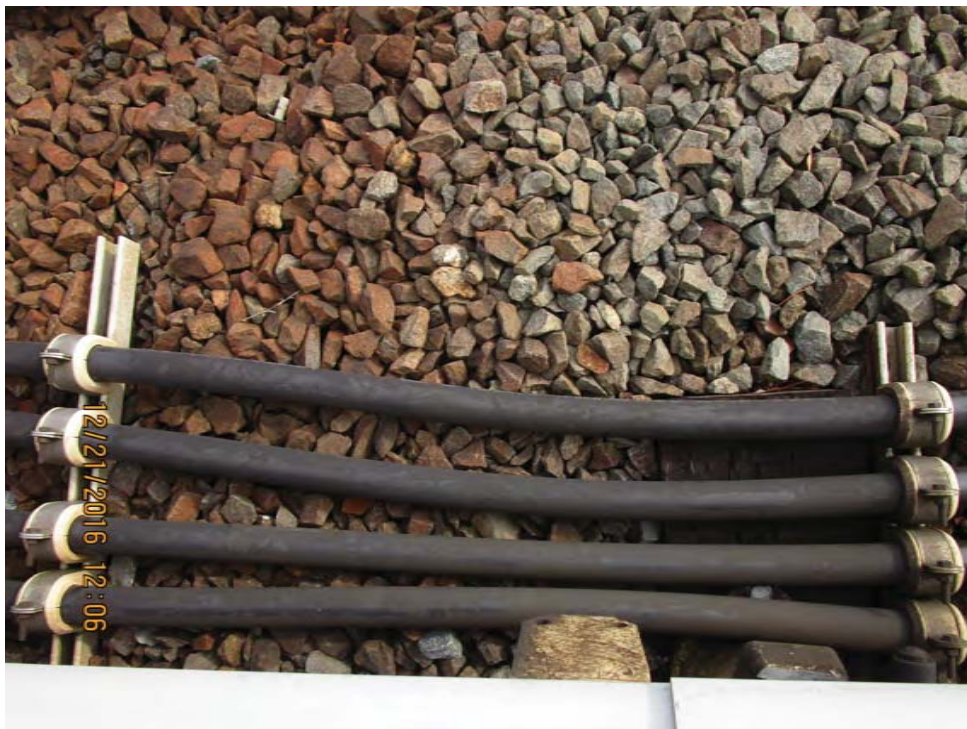
FIGURE 3 - CABLES LAYING ON DECK (BALLAST) f

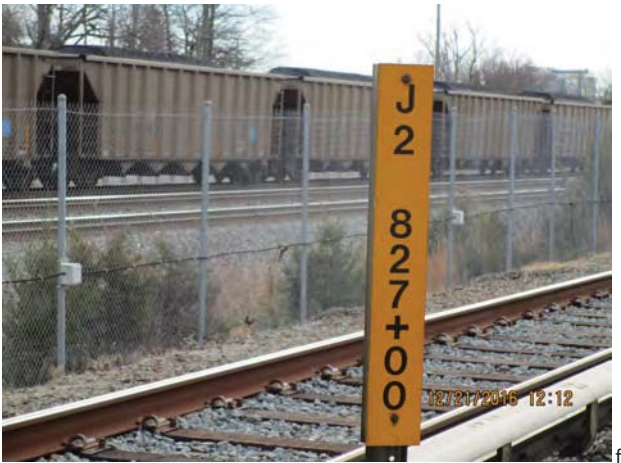
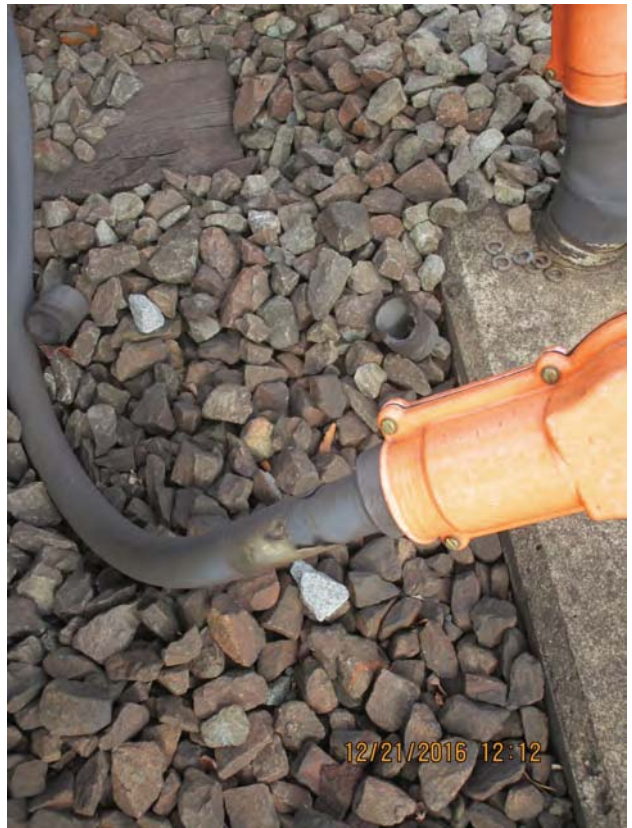
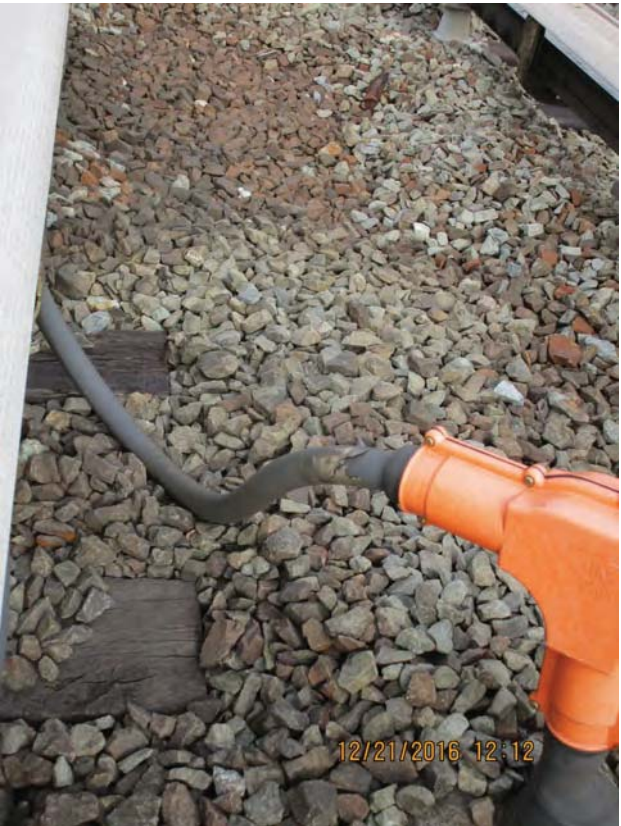
FIGURE 4 - CABLE FROM STUB-UP ON Tf E DECK f

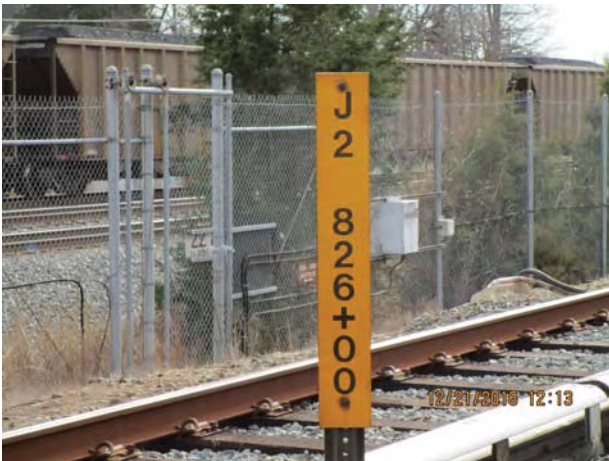
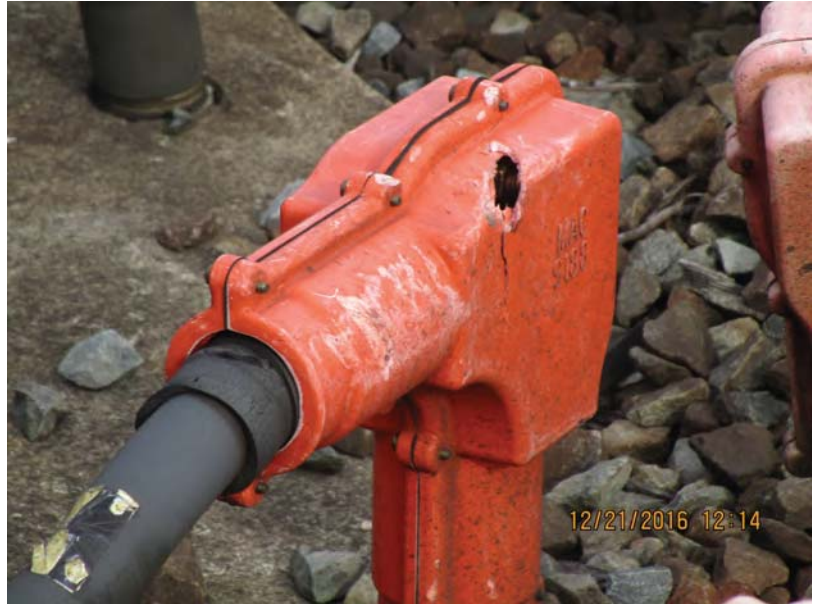
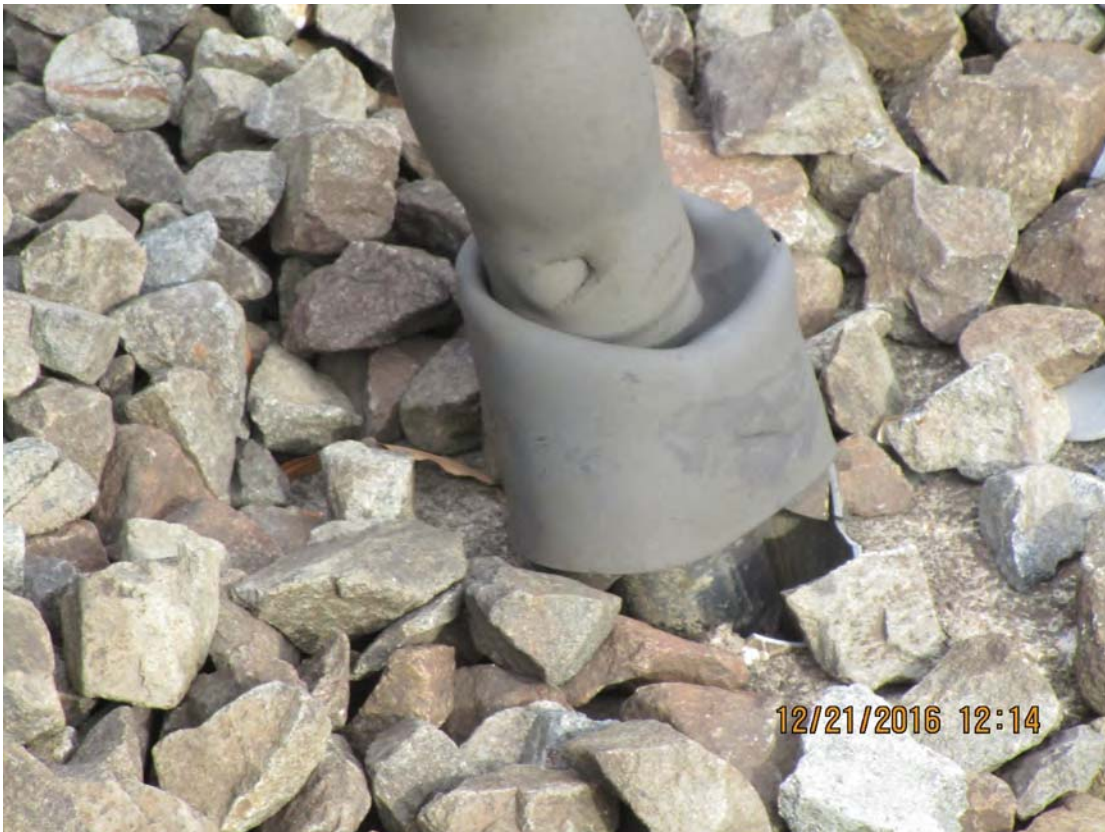
FIGURE 5 - STUB-UP CONDUIT COMPROMISED ON FEEDER CABLE TO 3RD RAfL, BROKEN ORANGE BOOT Tf AT NEEDS TO f
BE REPLACED, AND 3RD RAfL COVER BOARD NEEDS REPLACEMENT f

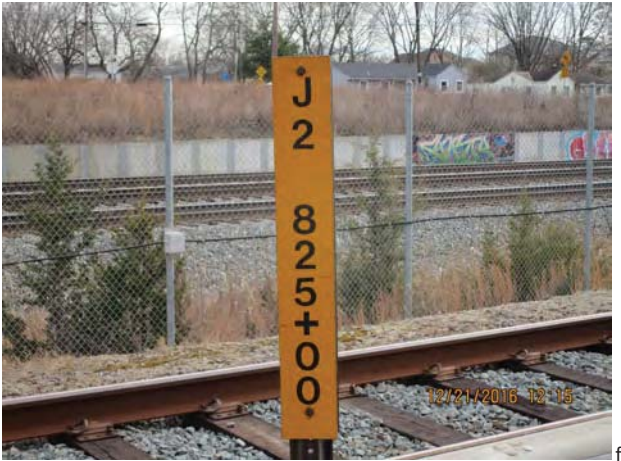
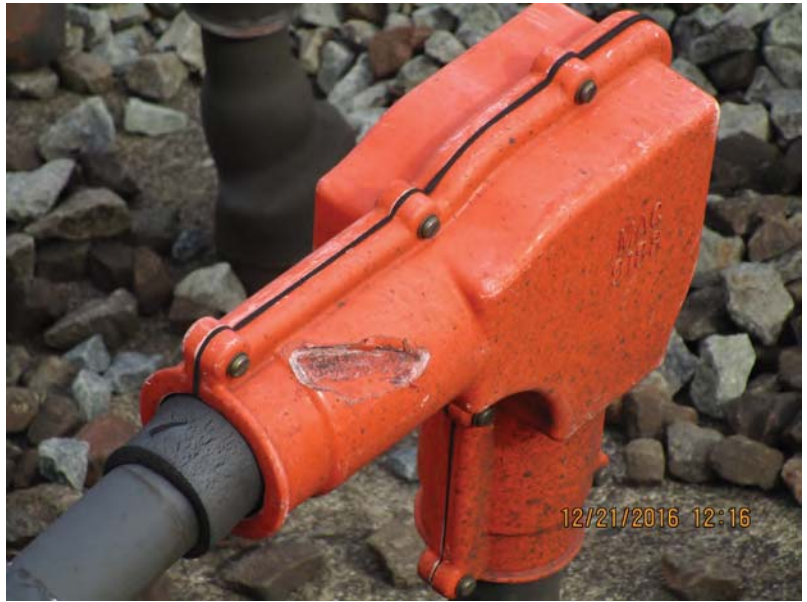
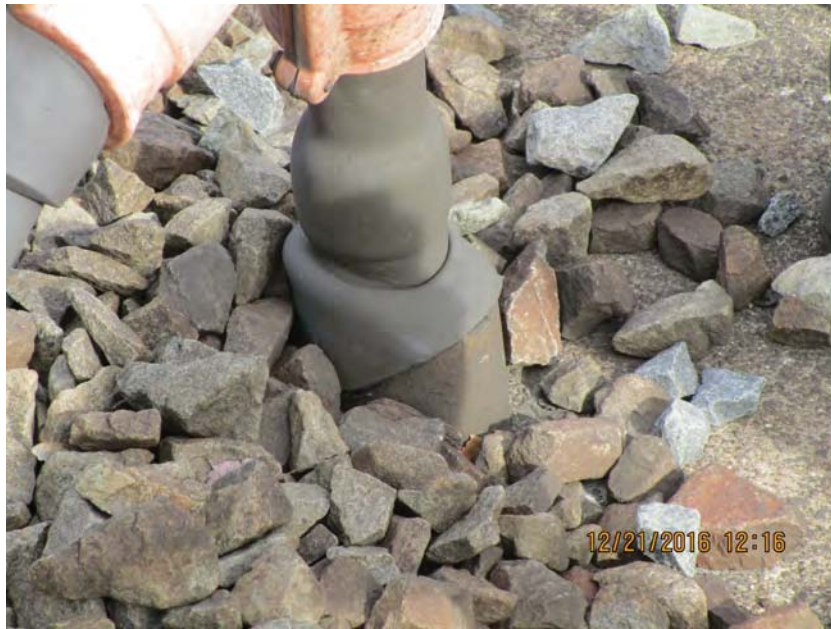
FIGURE 6 - BROKEN ORANGE BOOT, f EAT SF RfNK NEEDS REPLACEMENT ON STUB-UP TRANSITION FROM CONDUIT TO f ORANGE BOOT f

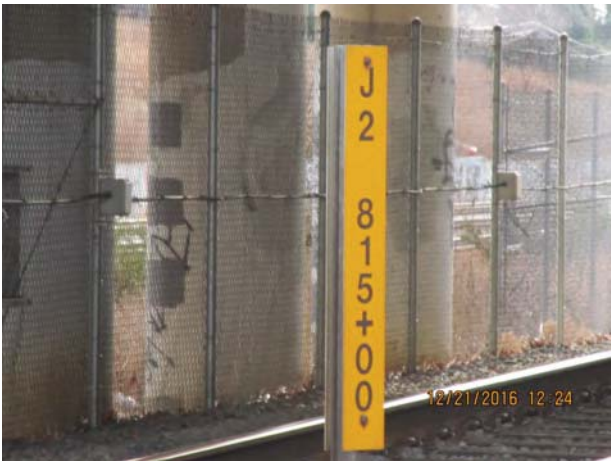
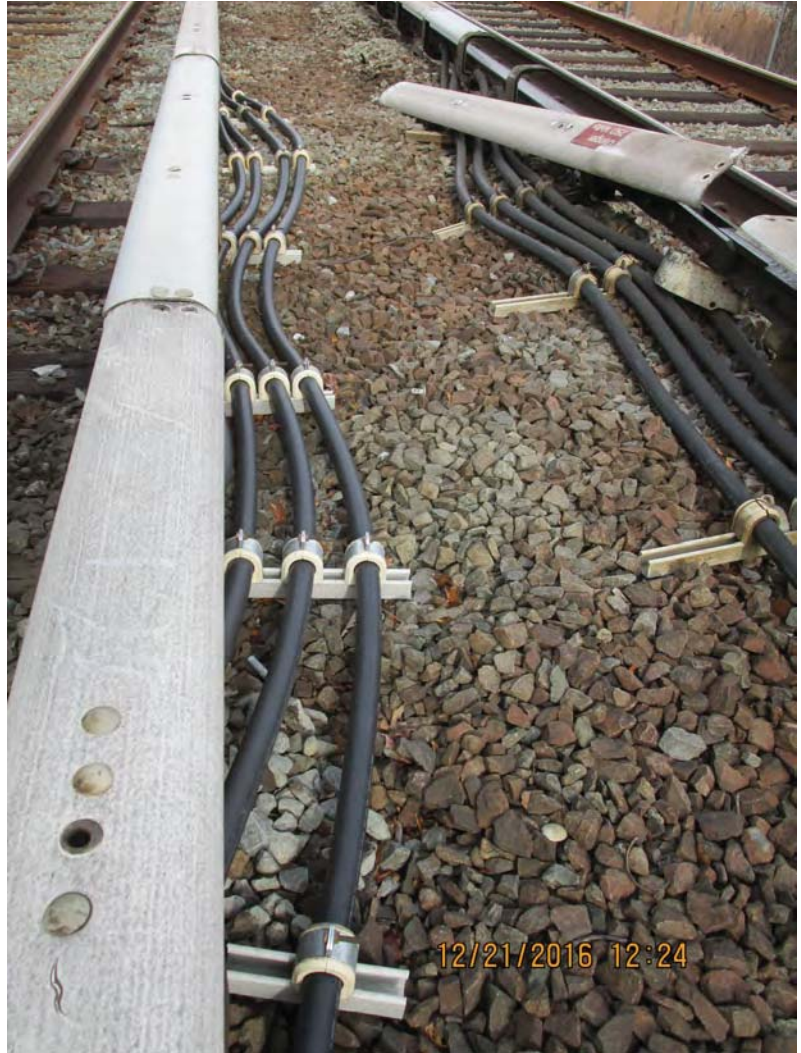
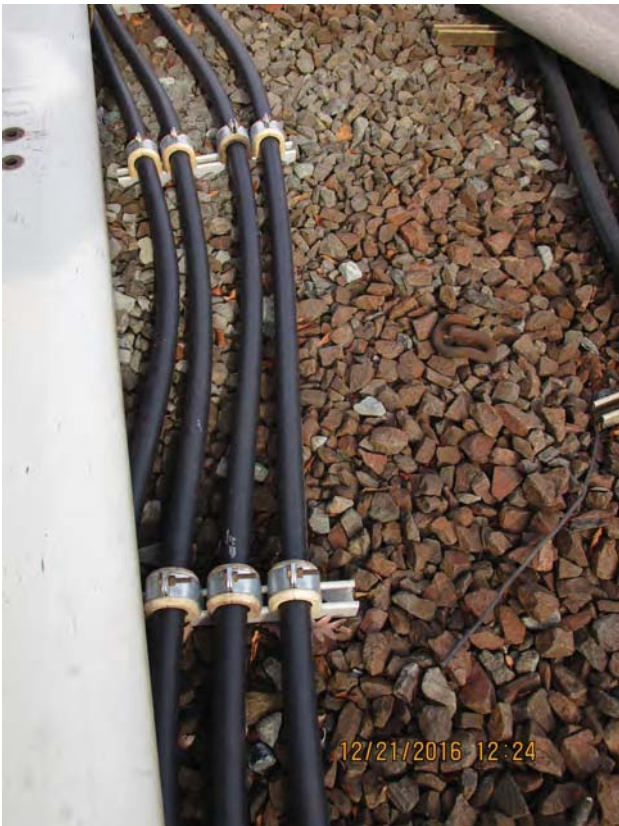
f
FIGURE 7 - CABLES LAYING ON DECK (BALLAST), 3RD RAFL COVERBOARD FALLEN OFF f

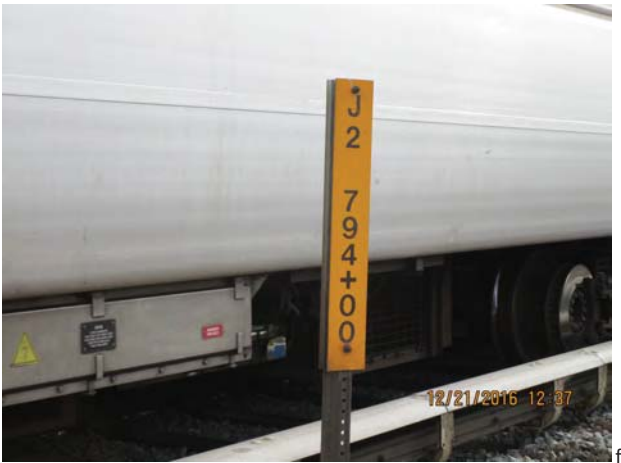
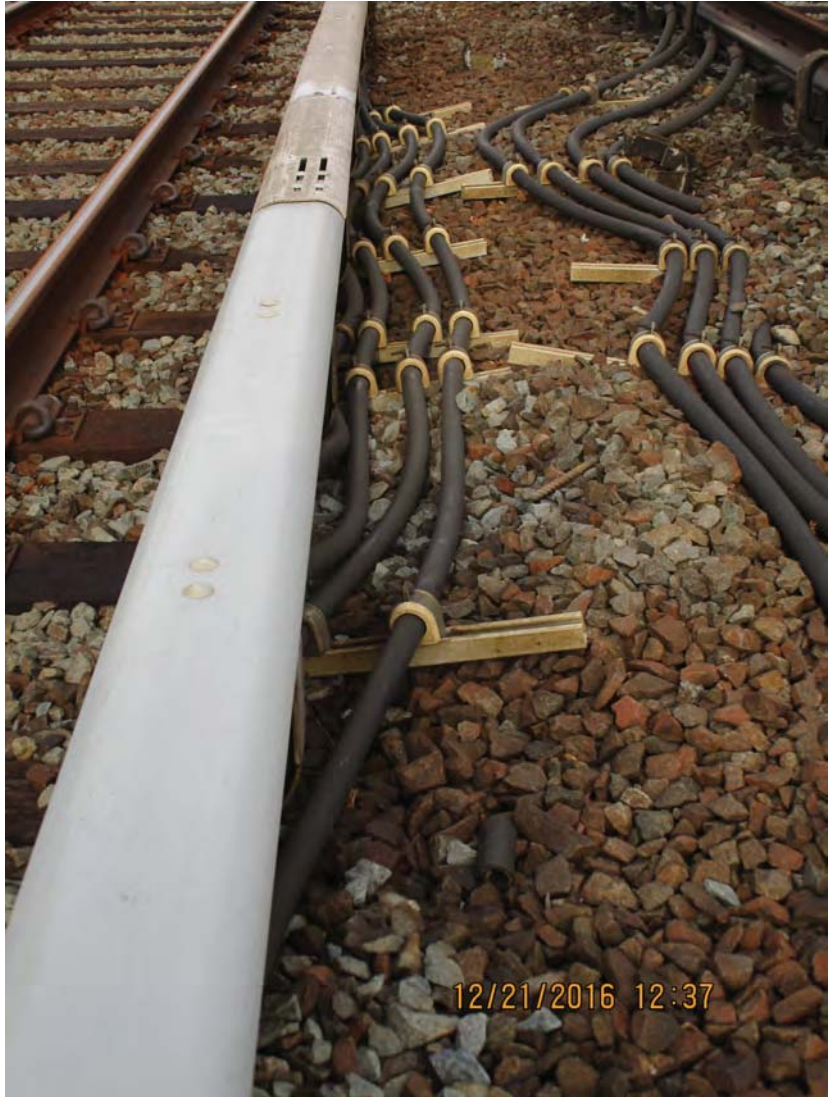
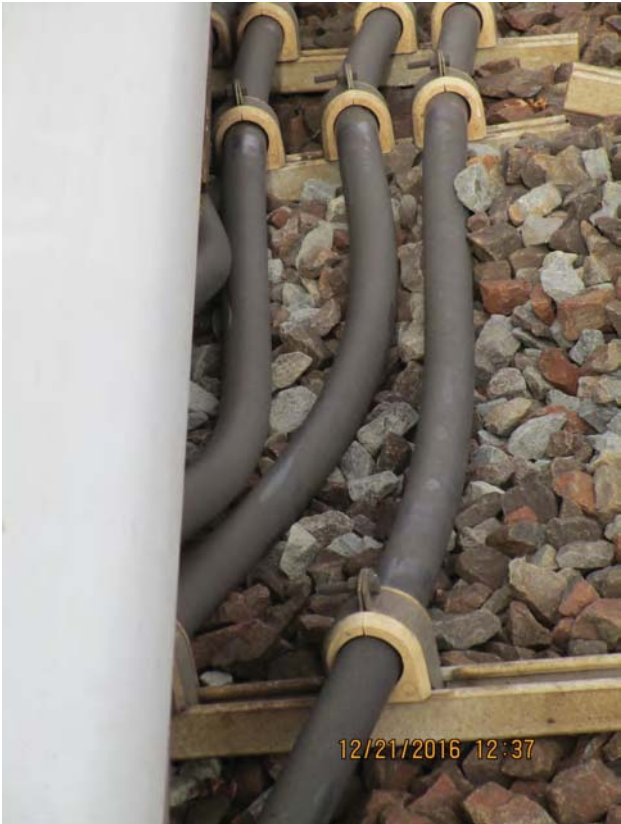
FIGURE 8 - CABLES LAYING ON DECK, RECOMMEND BALLAST TO TAMPED, f REGULATED, AND SPREAD EVENLY IN AREA f

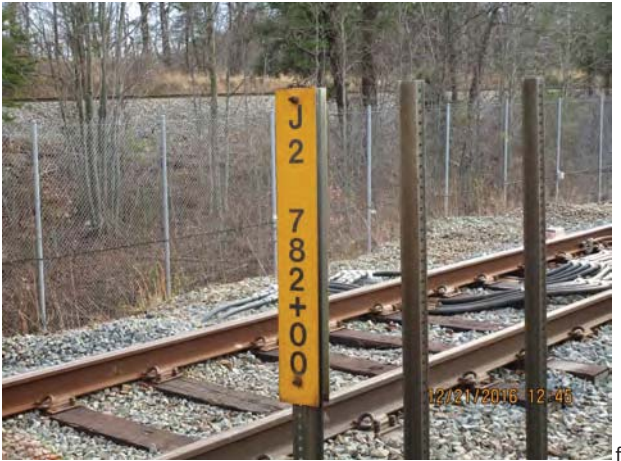
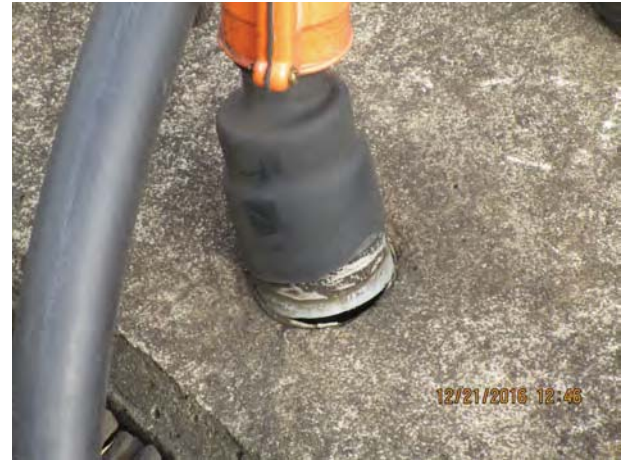
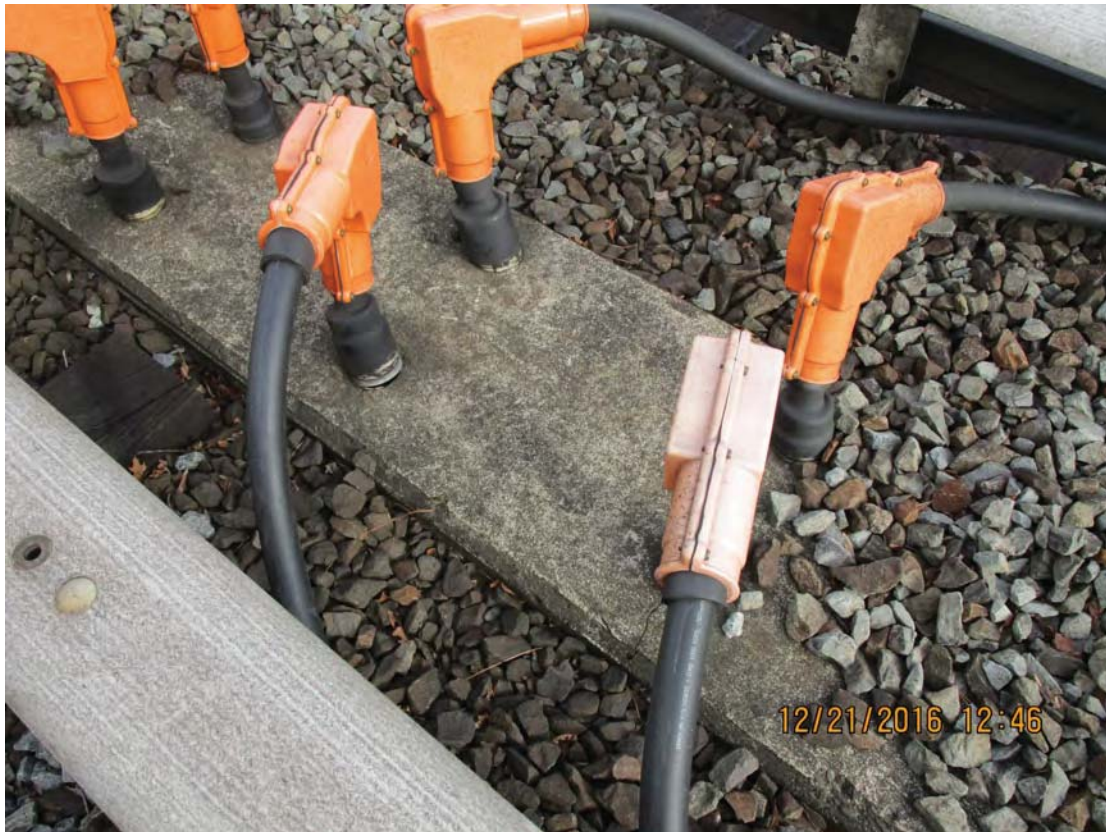
FIGURE 9 - OZ BUSHING COMPROMISED ON STUB-UP AND NEEDS REPLACEMENT f

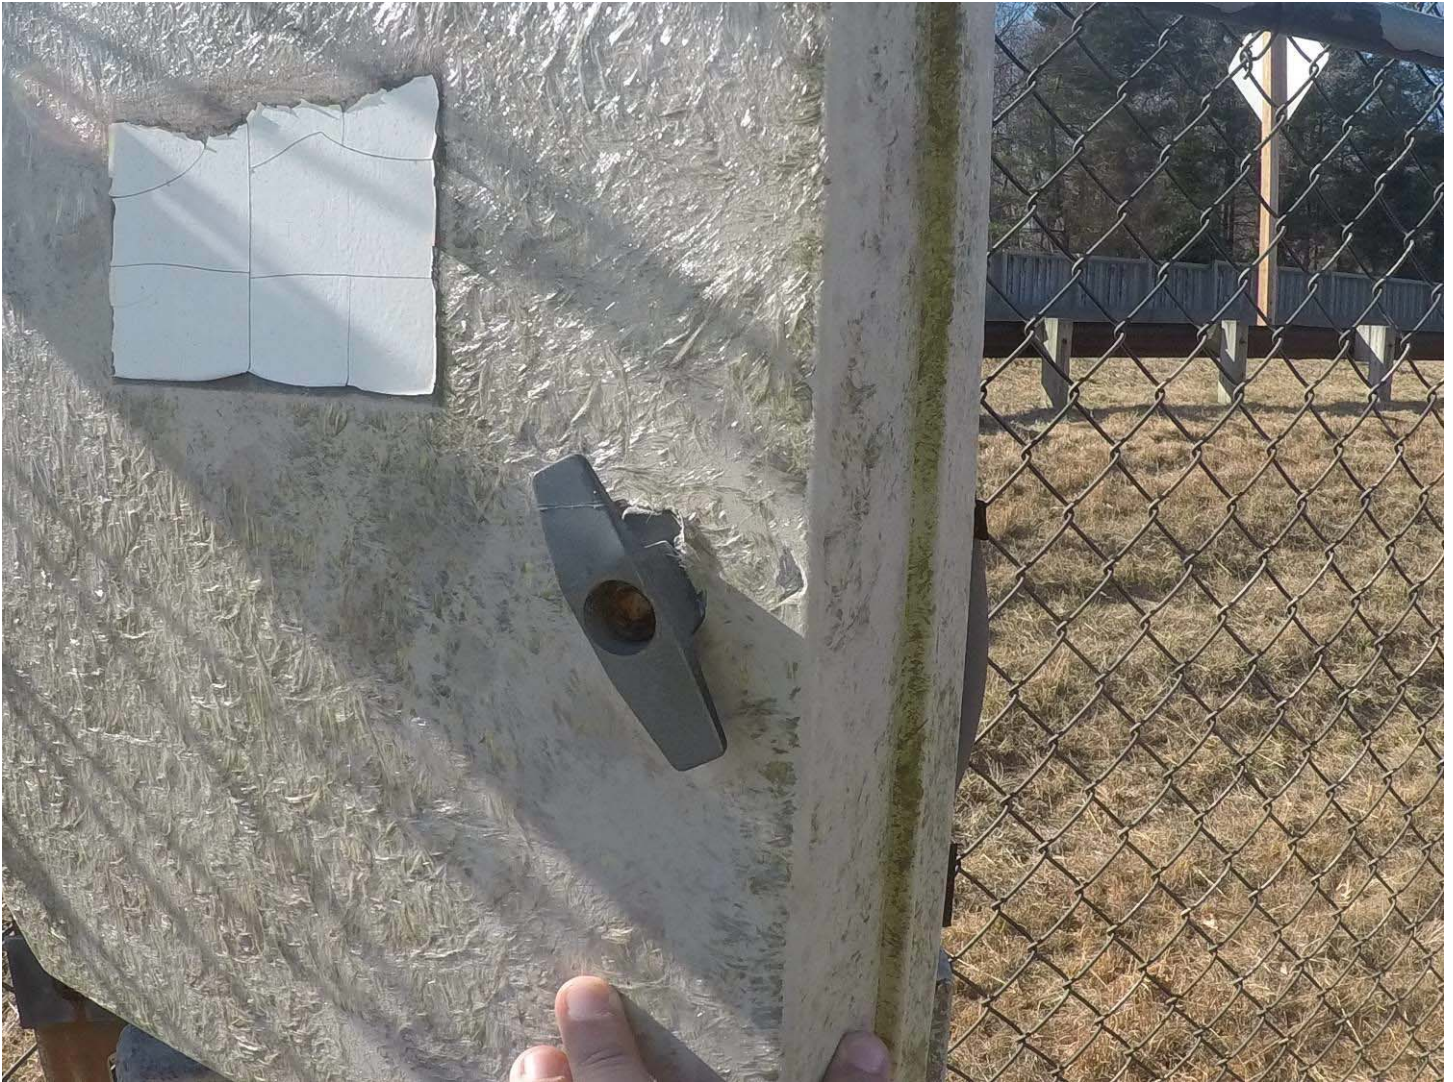
ETS Box with Broken Door Latch at K1 451+50

Remedial Action	<ol style="list-style-type: none"> WMATA must replace or repair the ETS door at K1 451+50. WMATA should elevate the ATC cables off the ballast or implement a similar solution in order to preserve the insulation of these cables.
-----------------	---

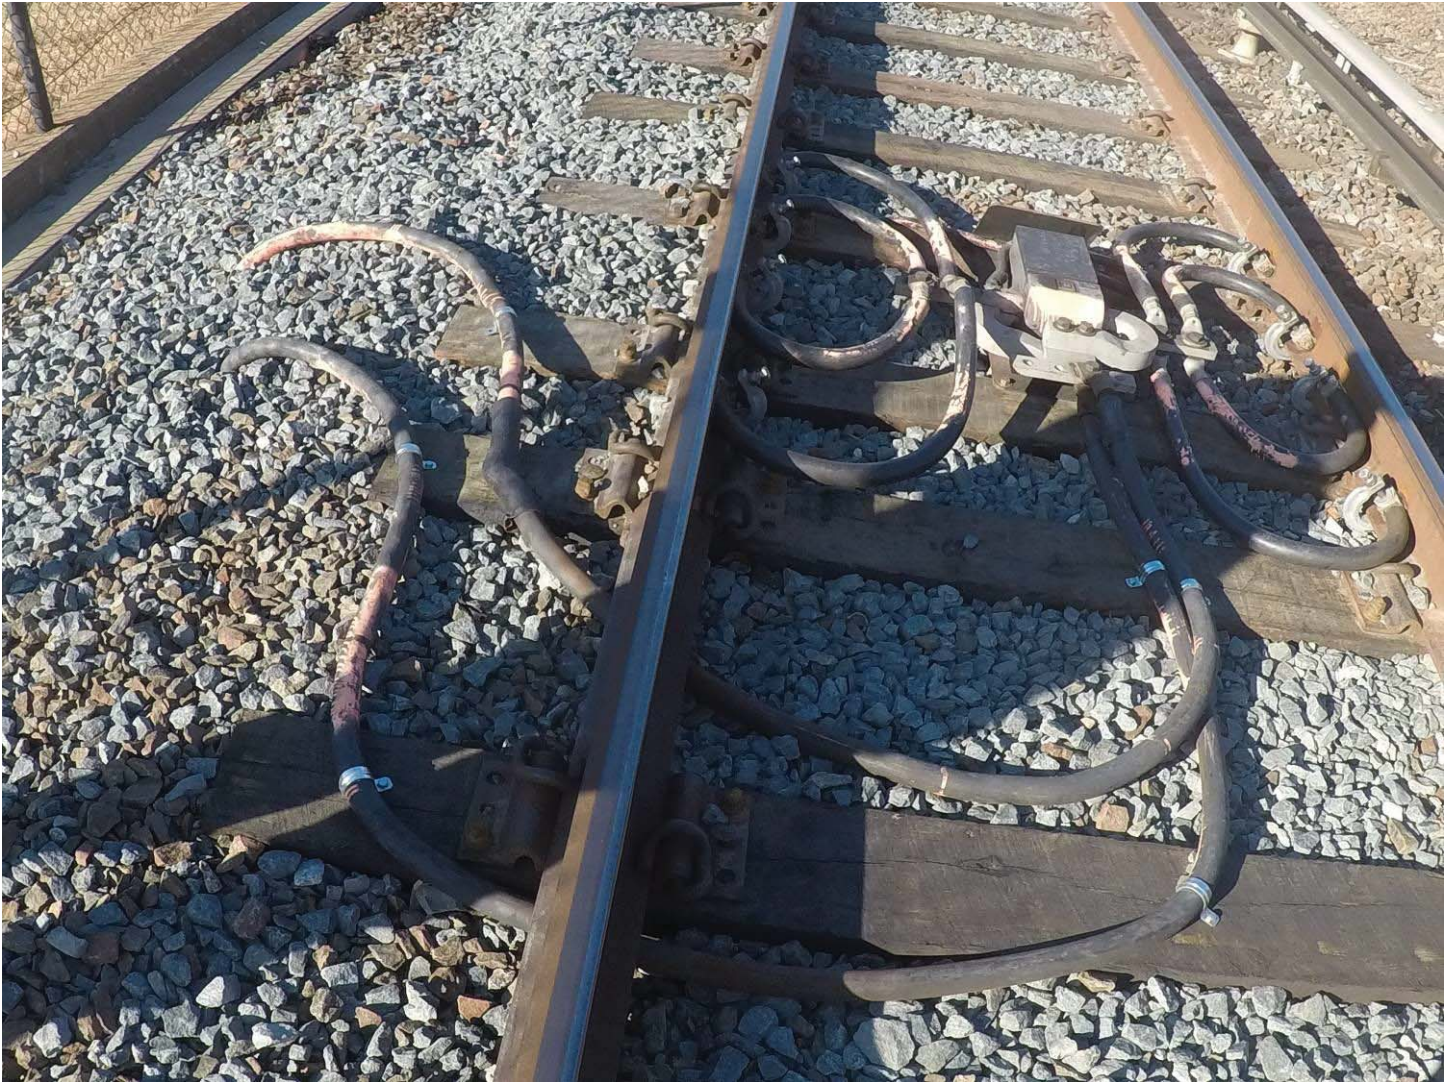
Cables in contact with ballast

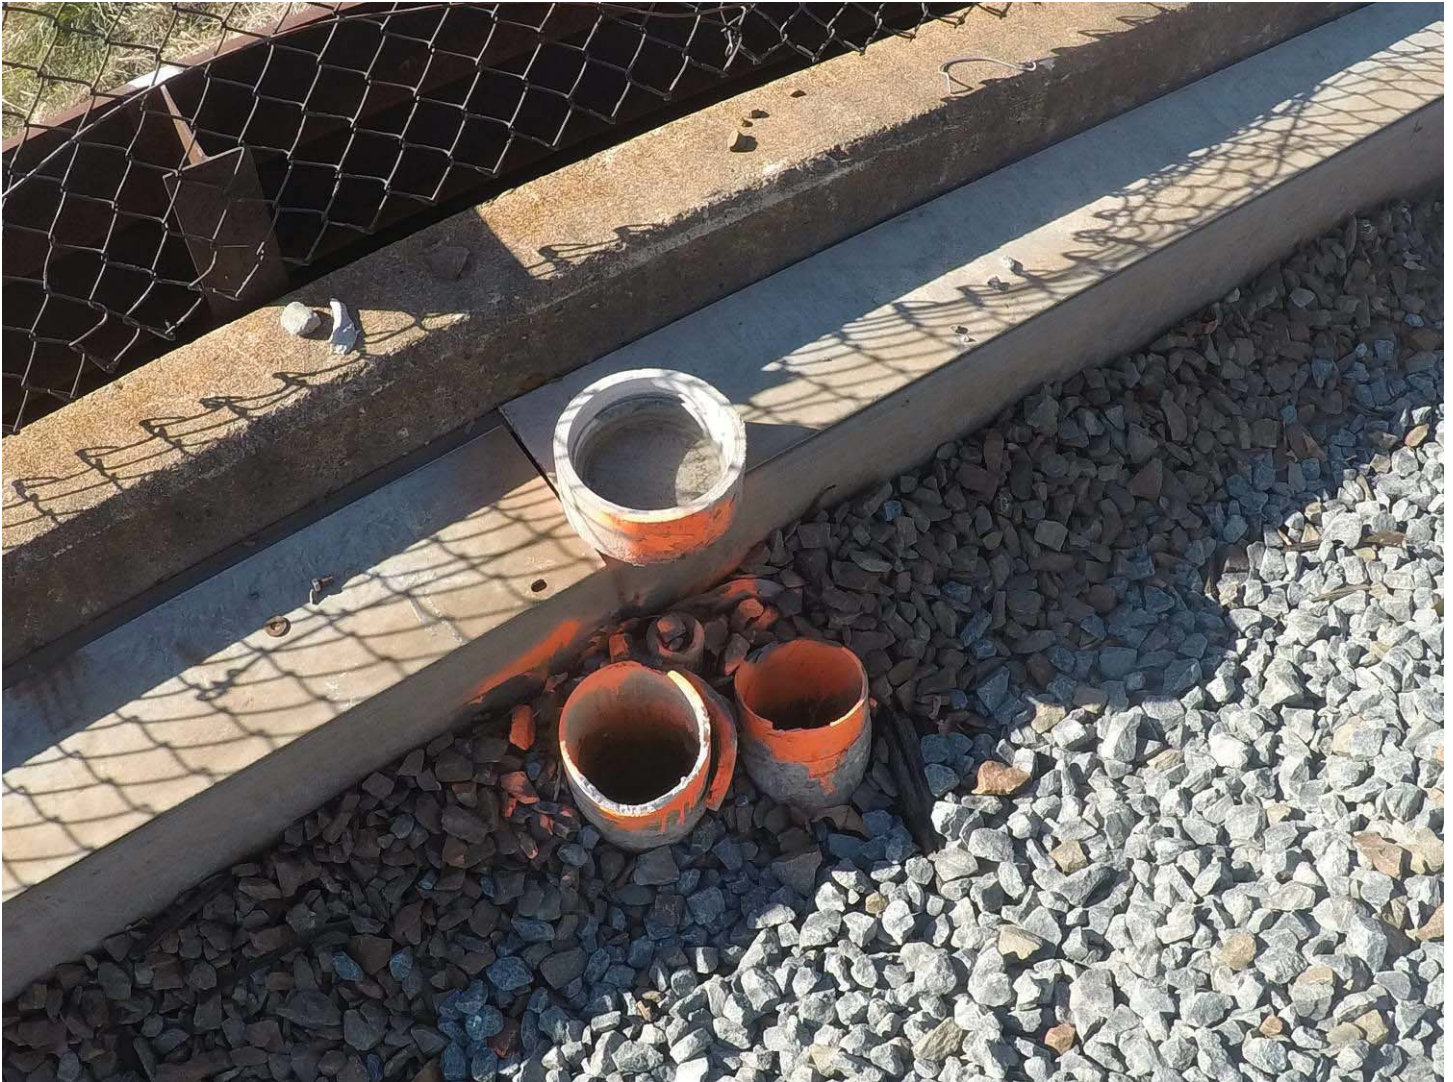
Damage to drainage access, marked for repair
