Form FTA-IR-1

United States Department of Transportation Federal Transit Administration

Inspection Date	YYYY	MM	DD	Deport Number	20161101-WMATA-AD-1					
inspection Date	2016	11	01	Report Number						
Rail Agency Name	Washington Authority	Metropolitan	Area Transit	Rail Agency Department	RTRA	Sub- Dep				
Rail Agency Department	Name			Email	Office Phon	e	Ν	Mobile Phone		
Contact Information										
Inspection Location		Carmen Turner Facility 3500 Pennsy Drive, Landover MD

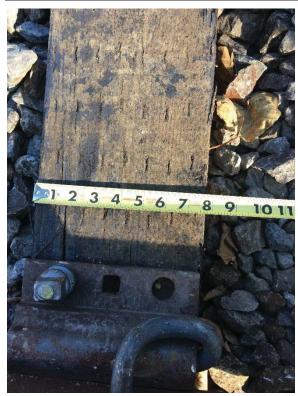
7 ¾" wide tie

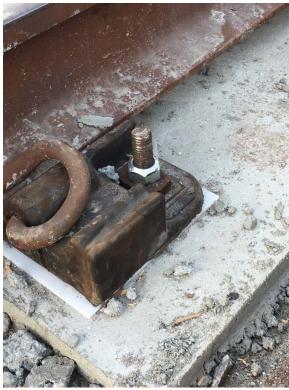
New nut style with more beveled edge

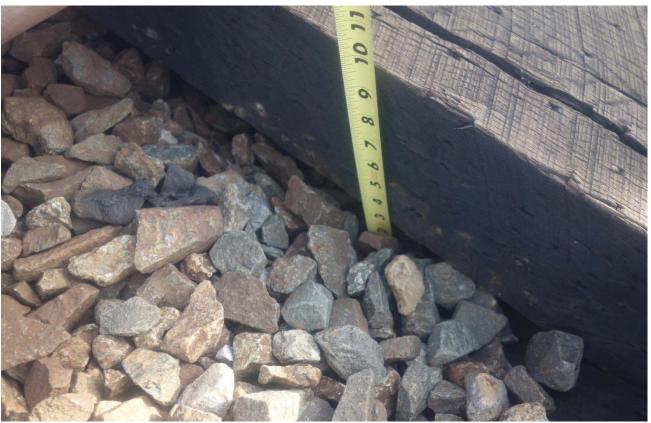
Low Crib Ballast at B2 138+00

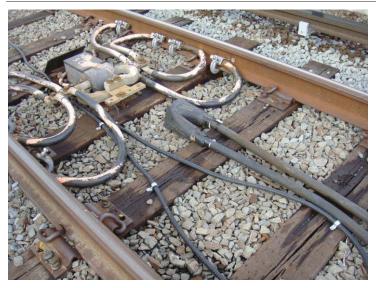
Figure 1 - K1 CM673+80 - Cross Bond not connected

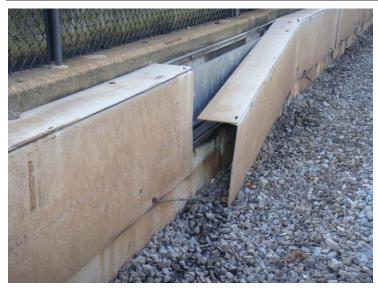
Figure 3 - K1 CM754+00 Cable Trough Cover Dislodged

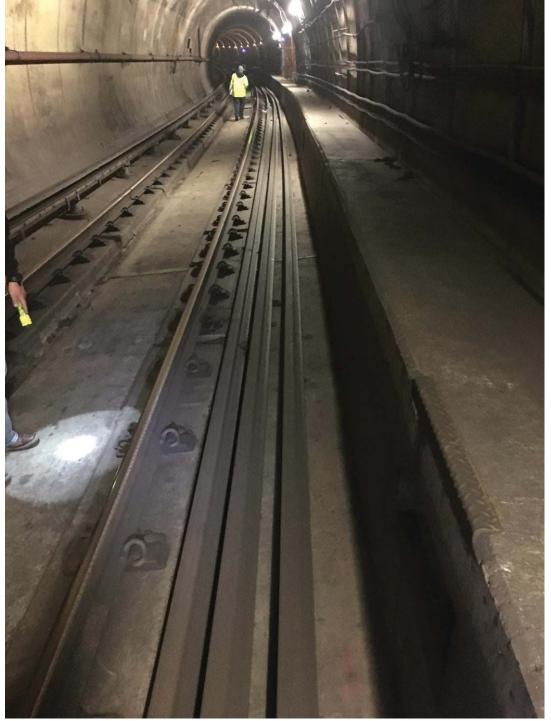
CWR Pieces encumbering access to Safety Walk from the ROW

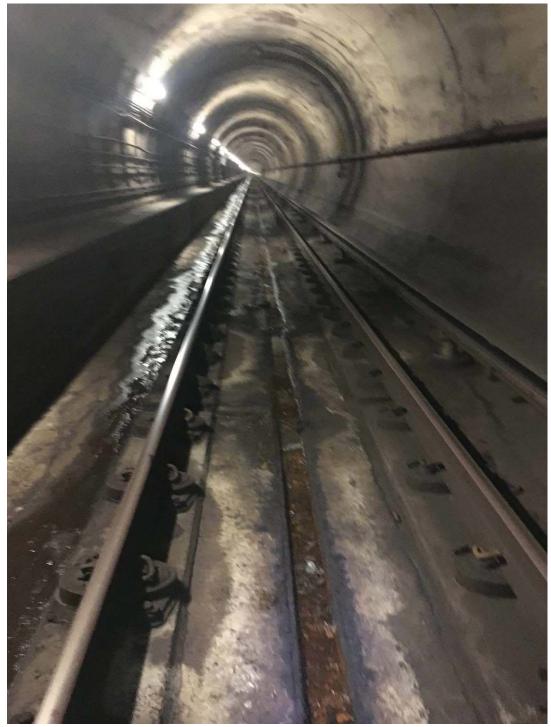
Standing Water due to clogged drains E1 196+00

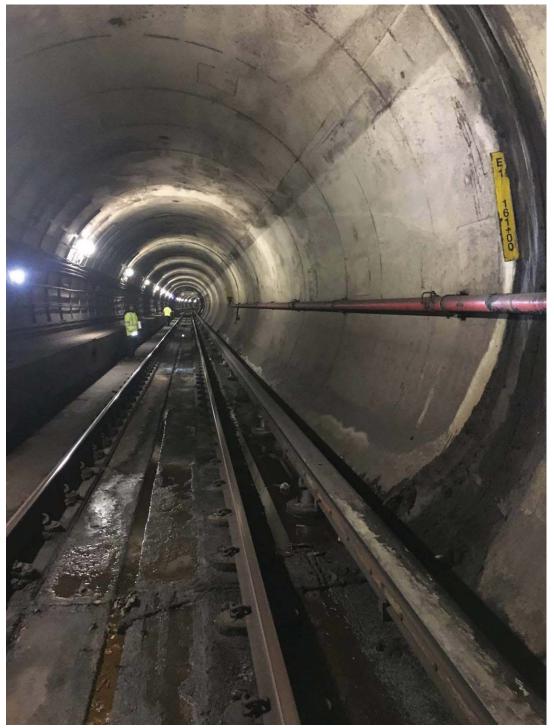
Curve starting at 161+00

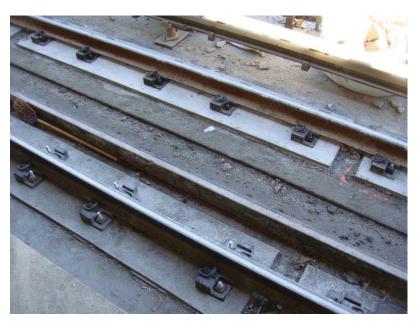
Figure 1 - New Grout Pads at B04

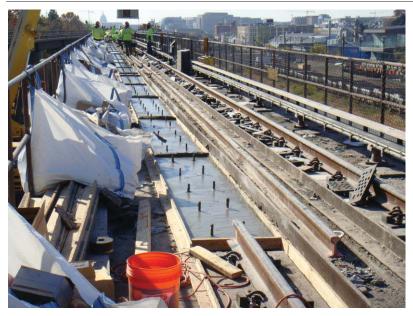
Figure 2 - New Grout Pads being poured east of B04

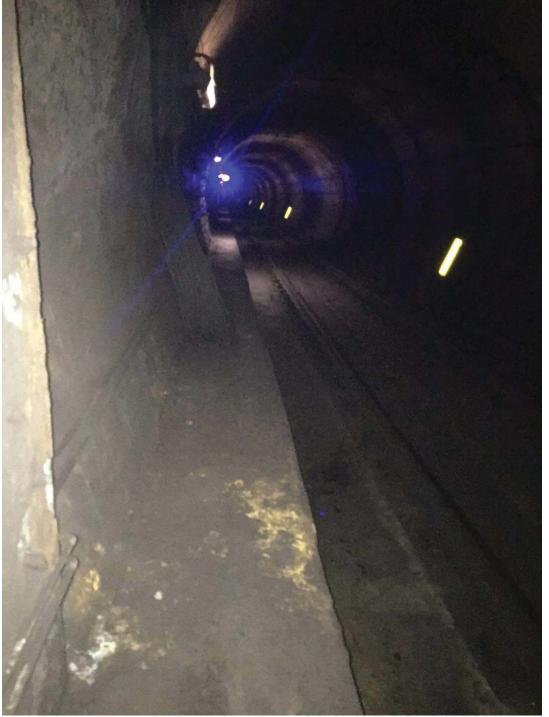
Bundle of cables stored on safety walk at D1 198+00

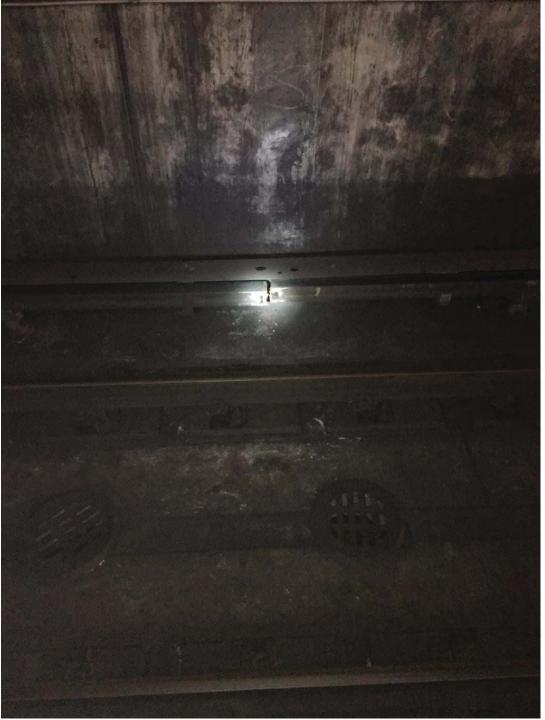
Rail Break noted just outside the Potomac Ave. station

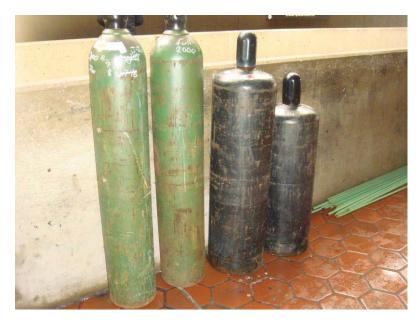
Figure 1 - Un-secured Oxygen CGC alongside Un-secured Acetylene CGC

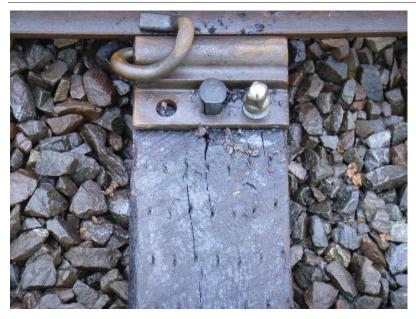
Figure 2 - K1 CM417+40 - 7 1/2" Crosstie

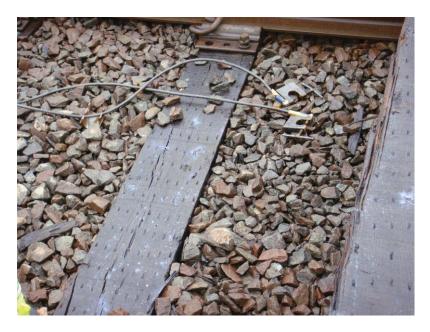
Concerns:									Recomm	ended Fir	nding?			No	
Description	•		unt stra	p at the	e east	end of t	he work a	rea was not o	connected.	Remedia	l Action R	equire	d?		No	
		· ·		'		nit #203 as requi		Iobile Comm	and and the	Recommended Re-inspection? No					No

Figure 3 - Shunt Strap not attached at East End of the Work Zone

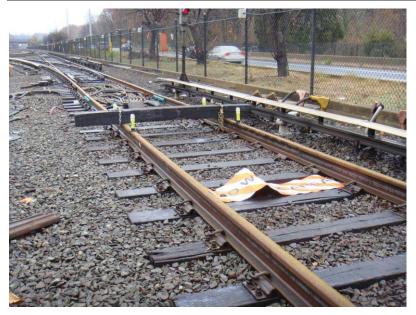
Figure 3 - RWP Work Zone Set-up - East End of Work Zone

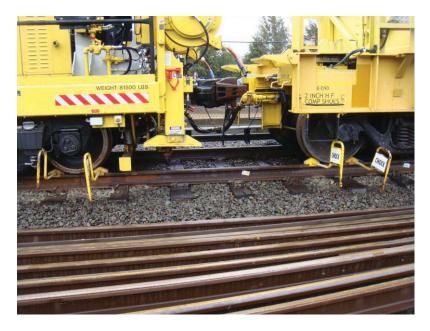
Figure 4 - Roadway Maintenance Machines - properly chocked

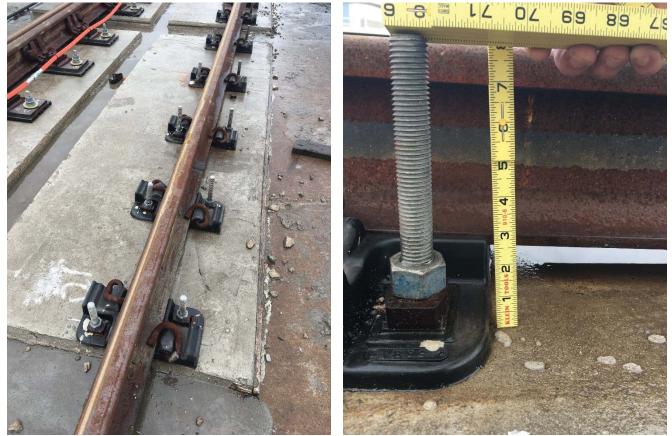
High Studs found at C1 361+00

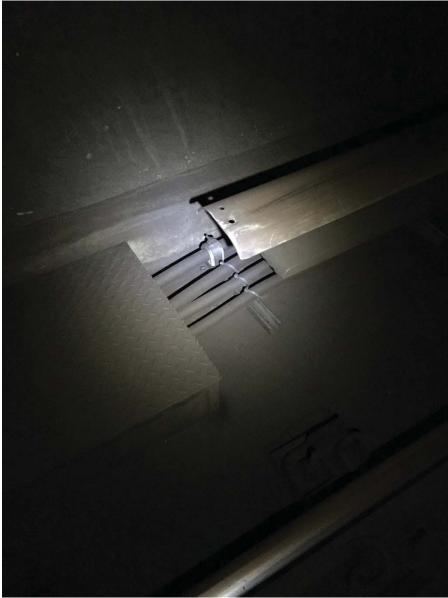
Expansion Cables improperly secured to fiberglass strut
