Inspection Form

United States Department of Transportation
Federal Transit Administration

Inspection Date	YYYY	MM	DD	Report Number	20160404-WMATA-JMC-1		
	2016	04	04				
Rail Agency Name	Washington Metropolitan Area Transit Authority			Rail Agency Department	Rail Transportation	Sub-Department	Shady Grove Subdivision
Rail Agency Department Contact Information	Name		Email		Office Phone		Mobile Phone
	[REDACTED]		[REDACTED]		[REDACTED]		[REDACTED]
Inspection Location	WMATA Grosvenor-Strathmore Station, 10300 Rockville Pike, Bethesda, MD 20852

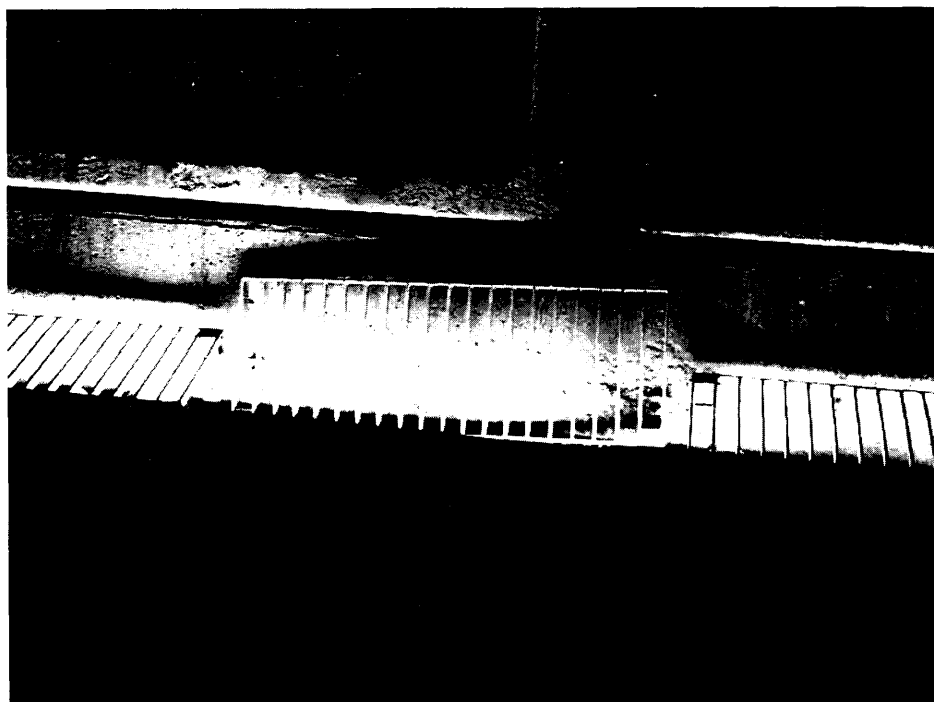
Main Track Center
Drain - 90% blocked
by mud.

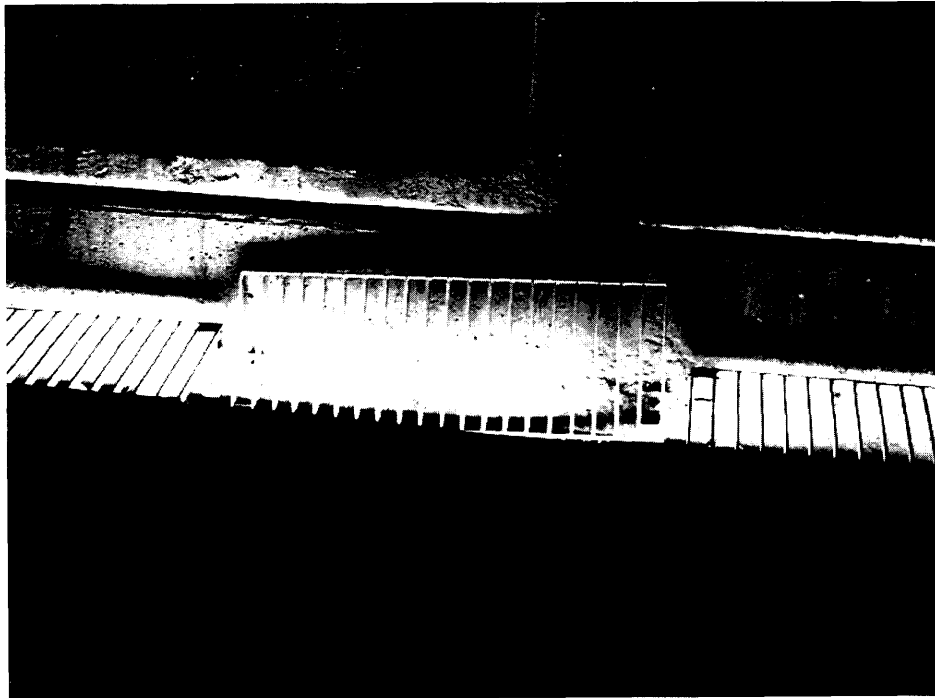
Main Track Center
Drain - 90% blocked
by mud.

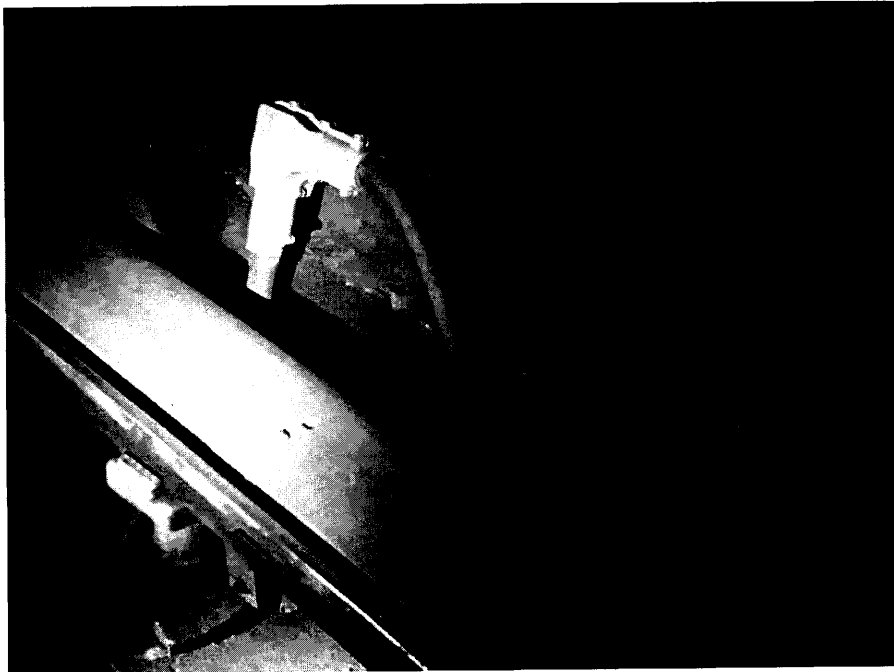
New Boot and Cable at B1 CM 562+00

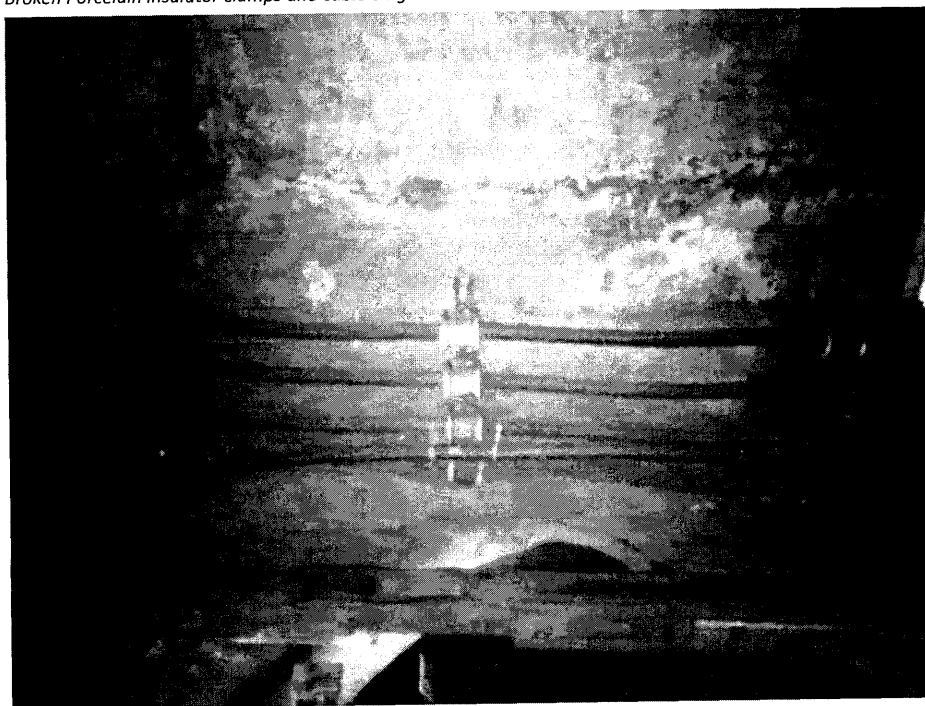
Broken Porcelain insulator clamps and cable on ground at B2 CM 516+00

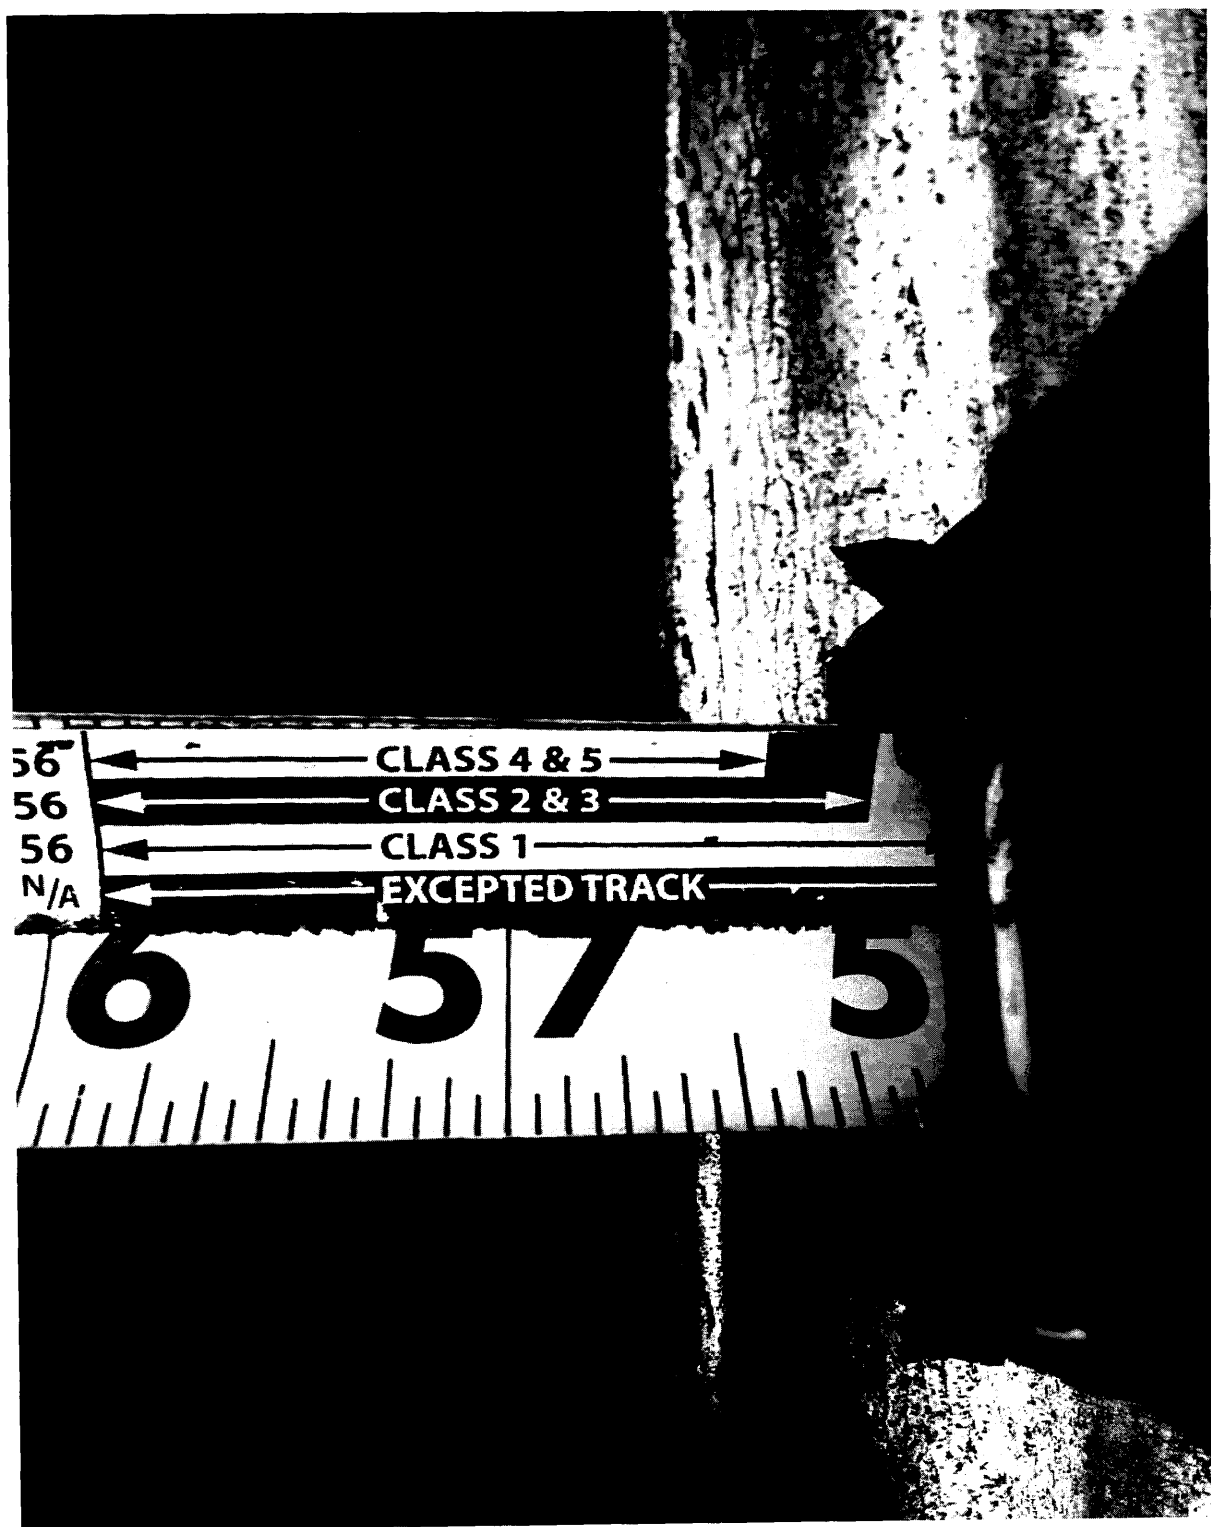
Bullet point one, 57-1/4 inch static gage measurement.

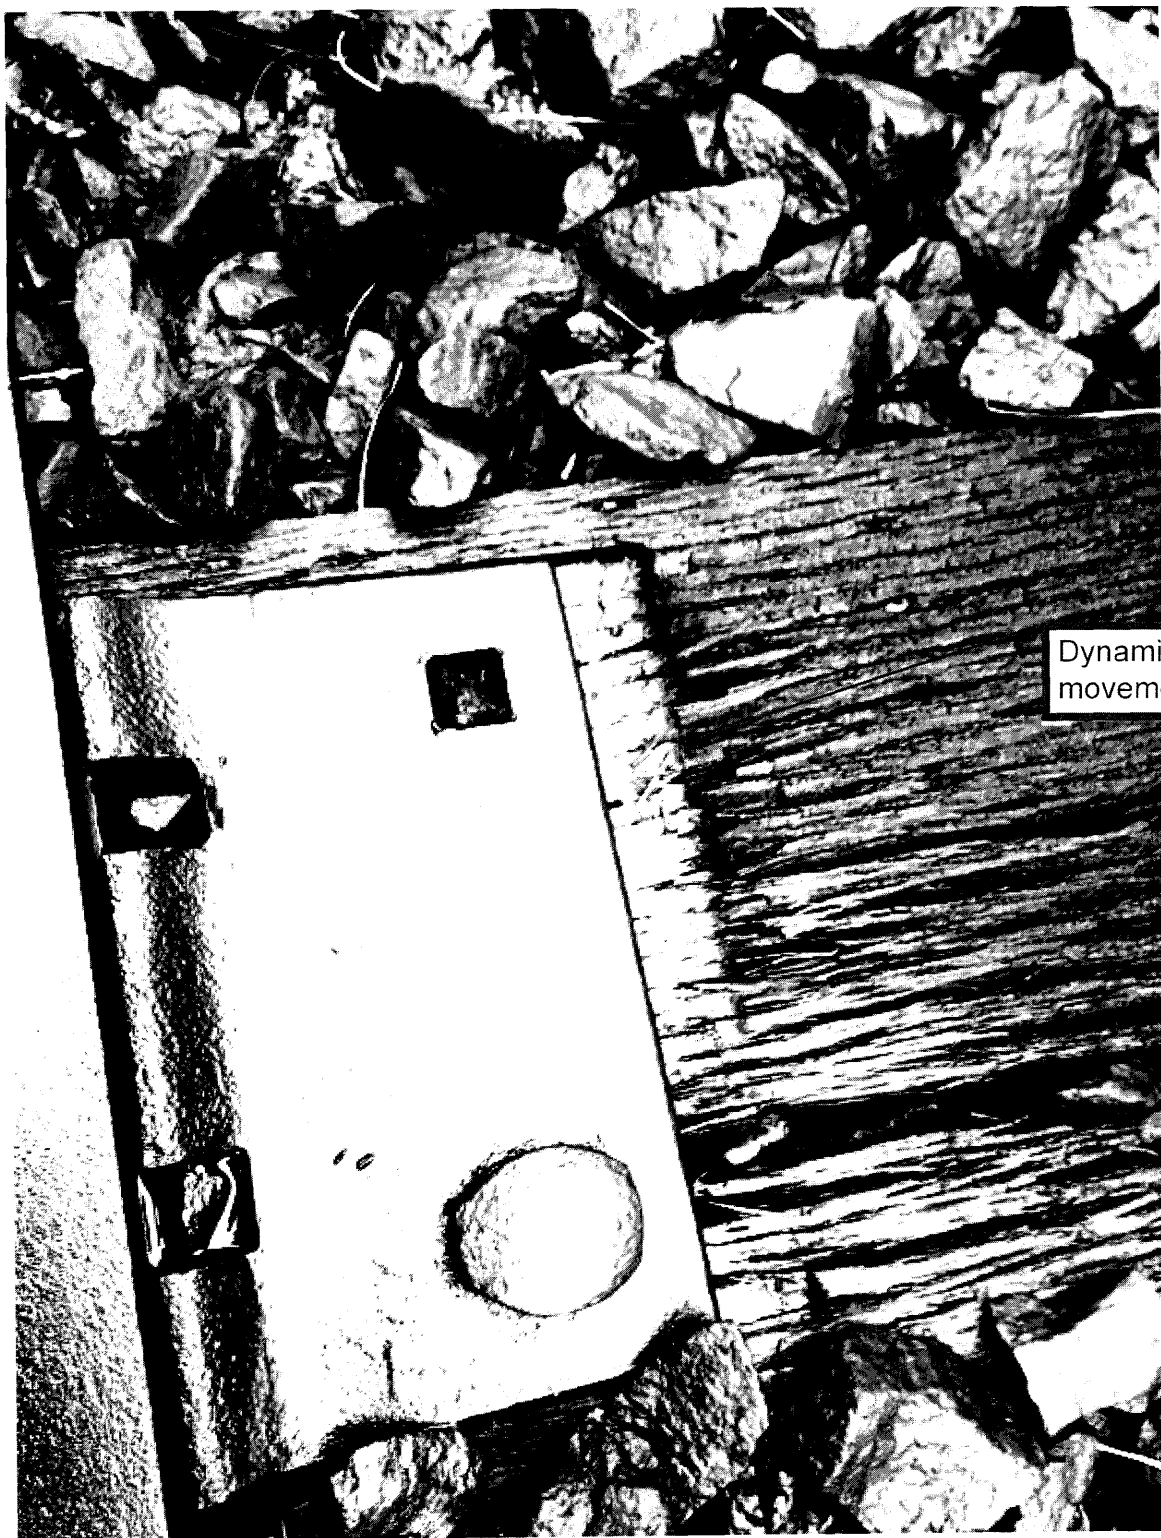
Bullet point one, dynamic plate movement marks.

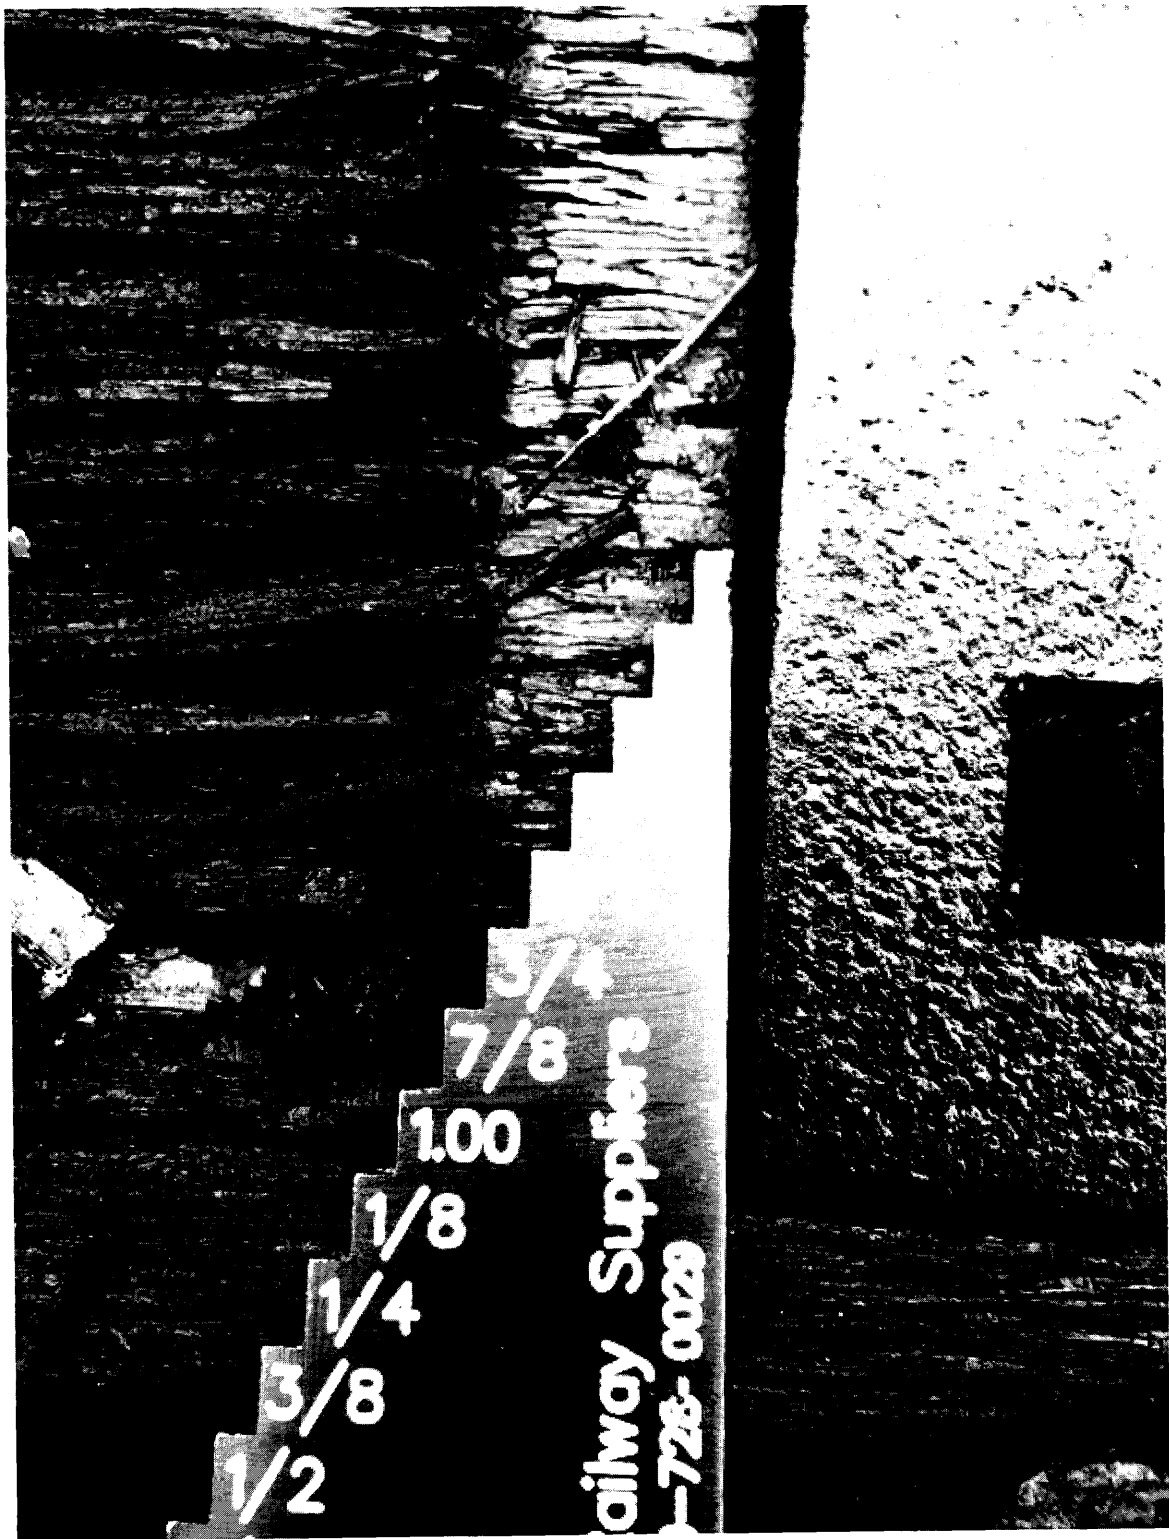
Bullet point one, 15/16 inch dynamic measurement high rail.

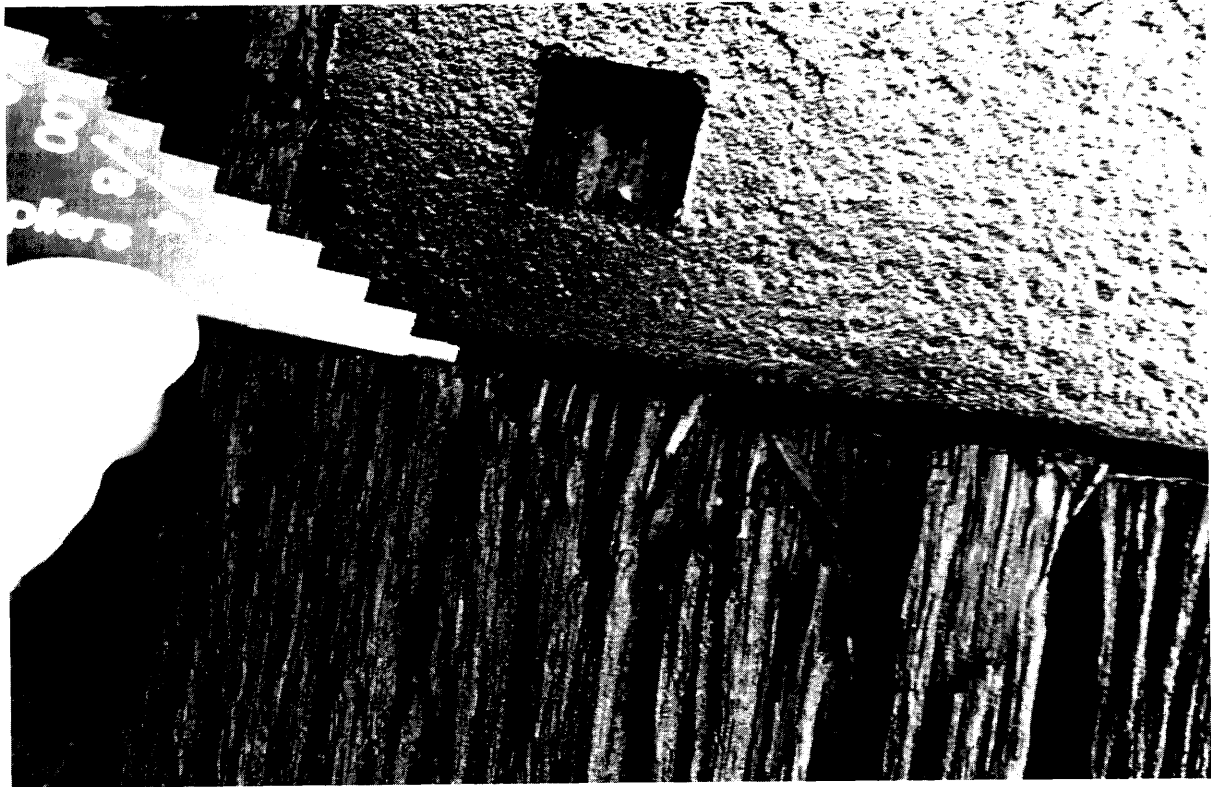
Bullet point one, 1/8 inch dynamic plate movement low side.

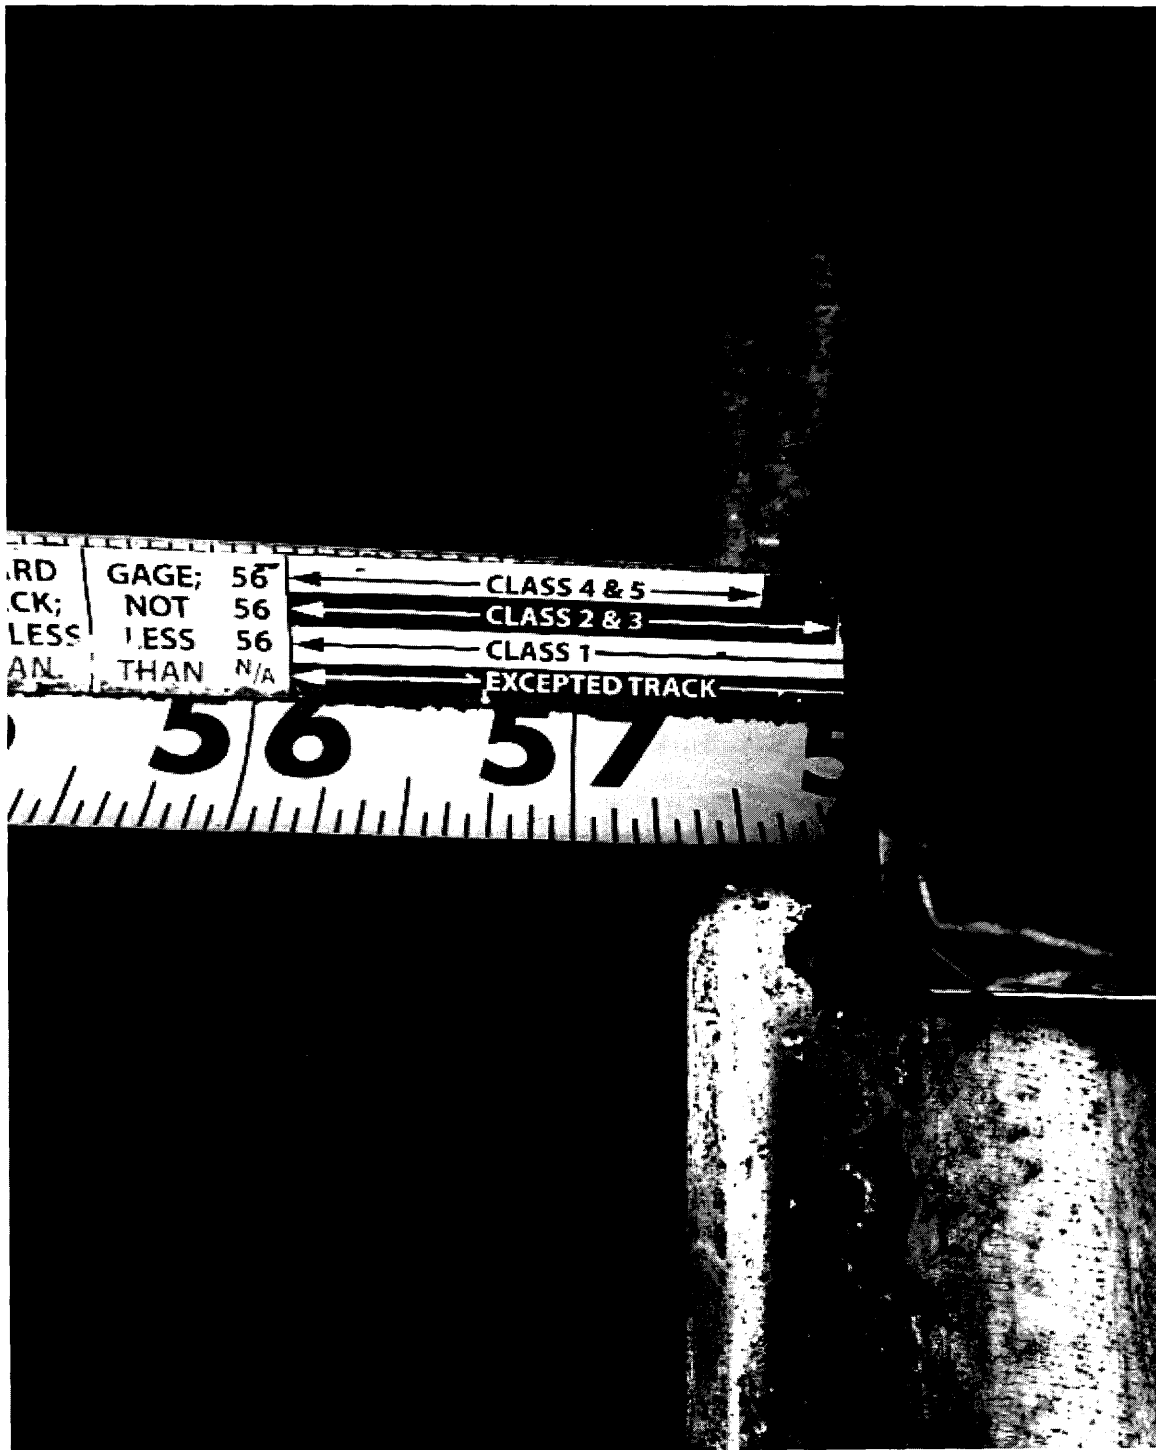
Bullet point two, 57-1/4 inch static gage.

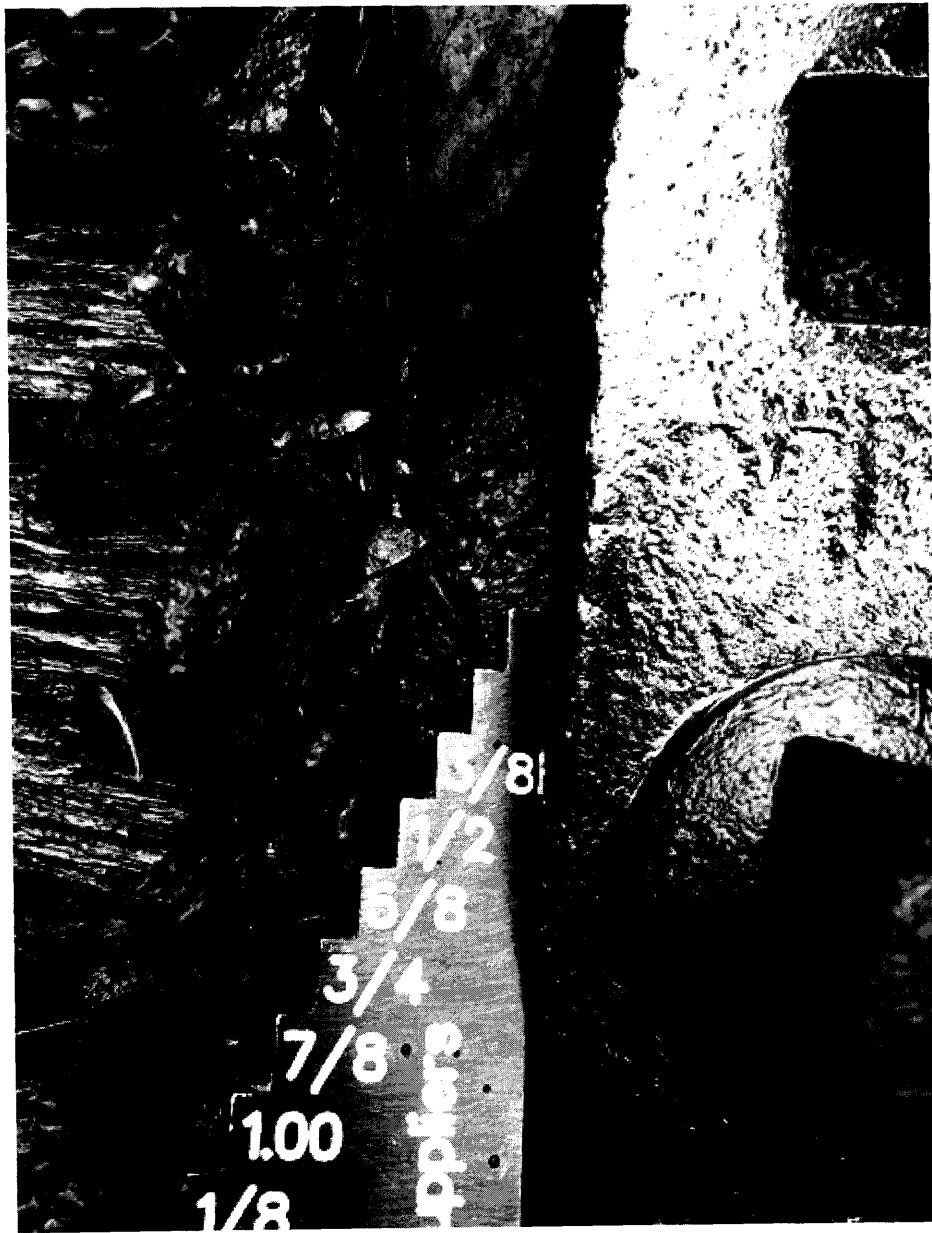
Bullet point two, 5/8 inch dynamic plate movement.

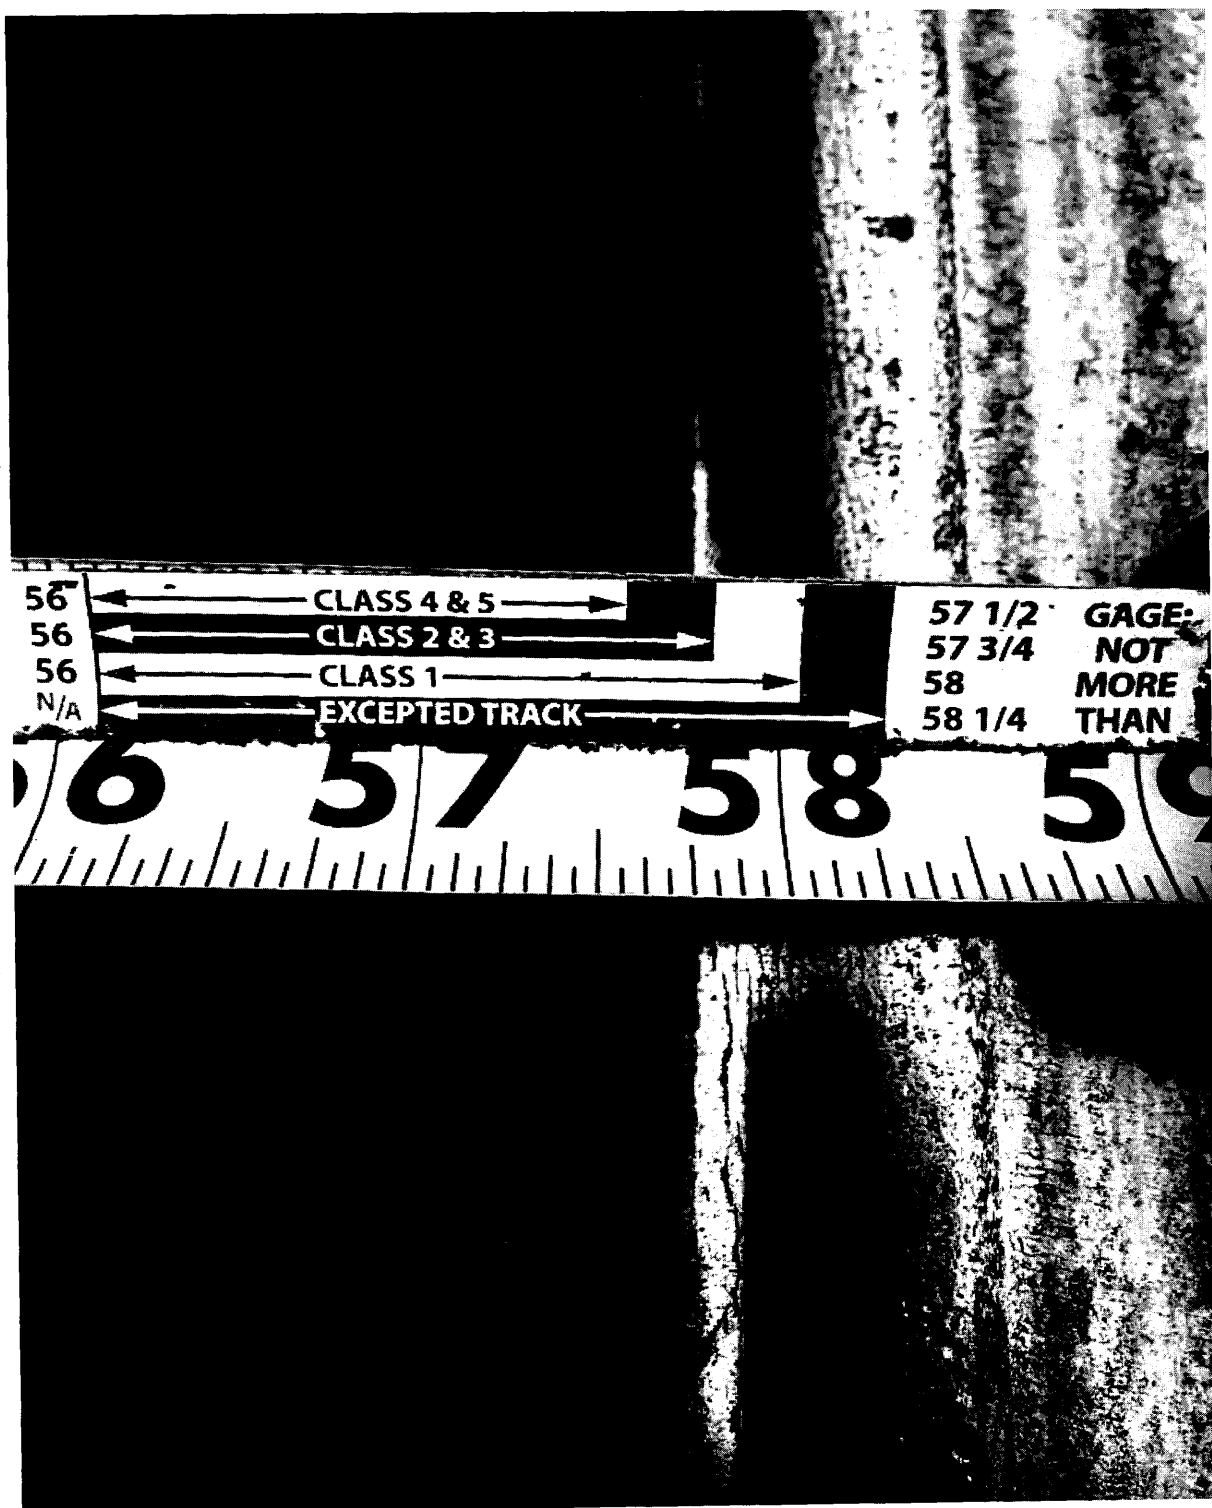
Bullet point three, 57-3/4 inch static gage.

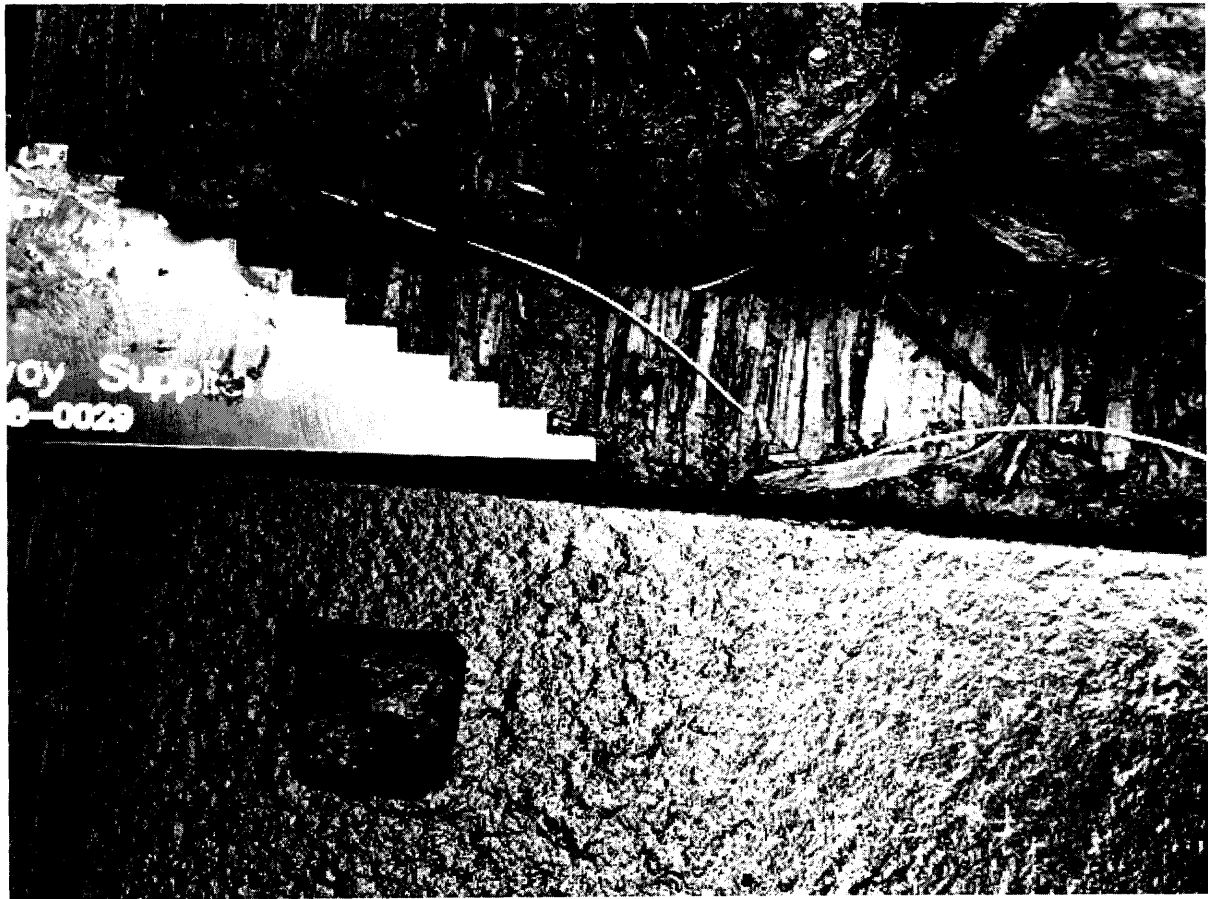
Bullet point three, one inch dynamic plate movement high side.

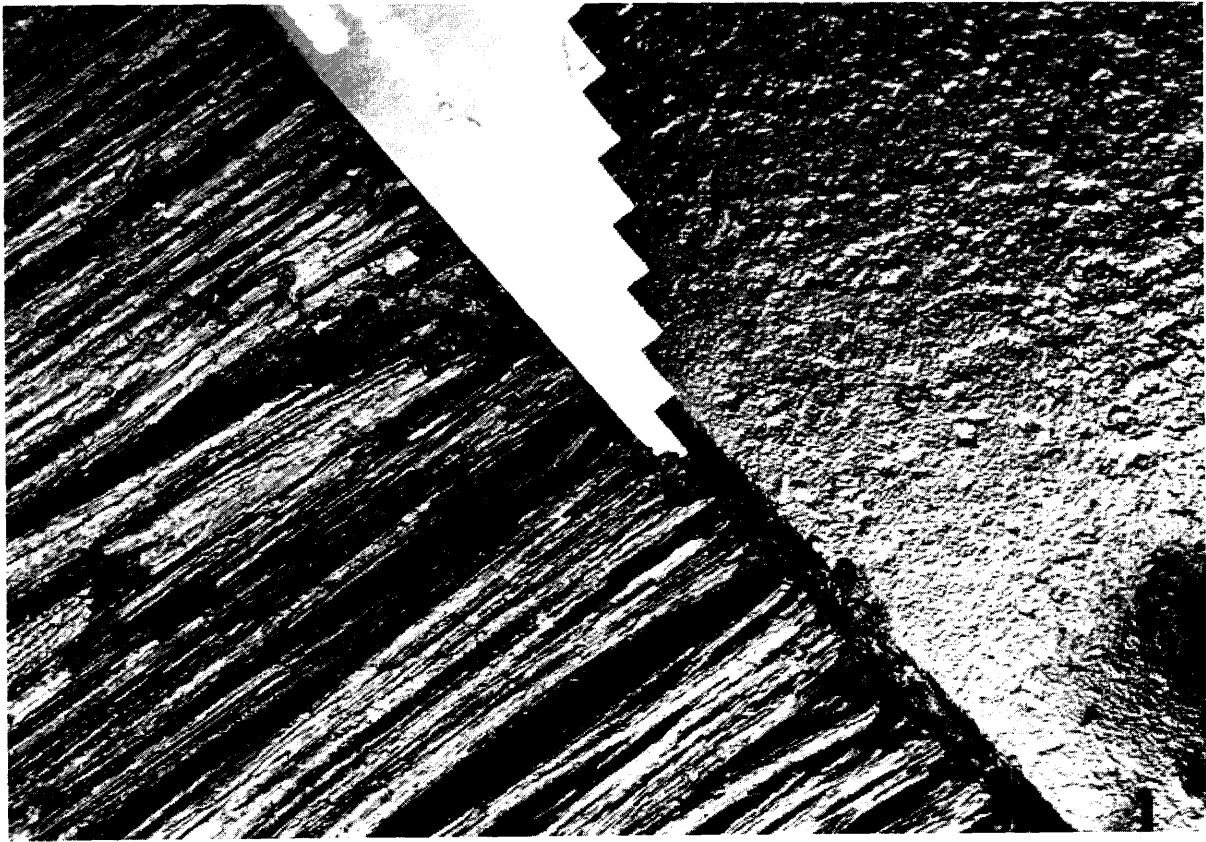
Bullet point three, 1/8 inch dynamic plate movement low side.

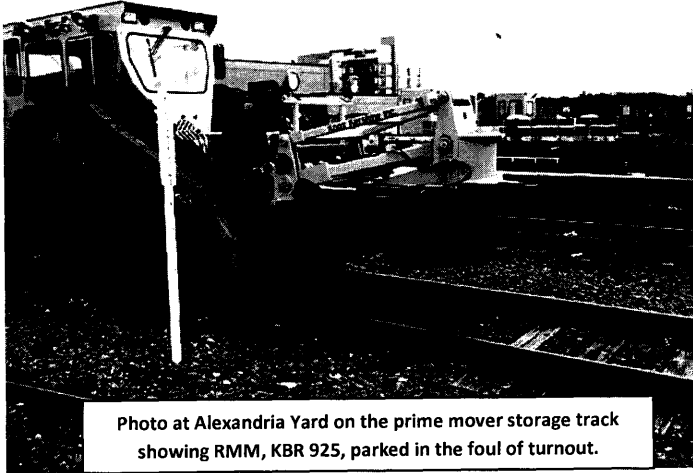
Photo at Alexandria Yard on the prime mover storage track showing RMM, KBR 925, parked in the foul of turnout.

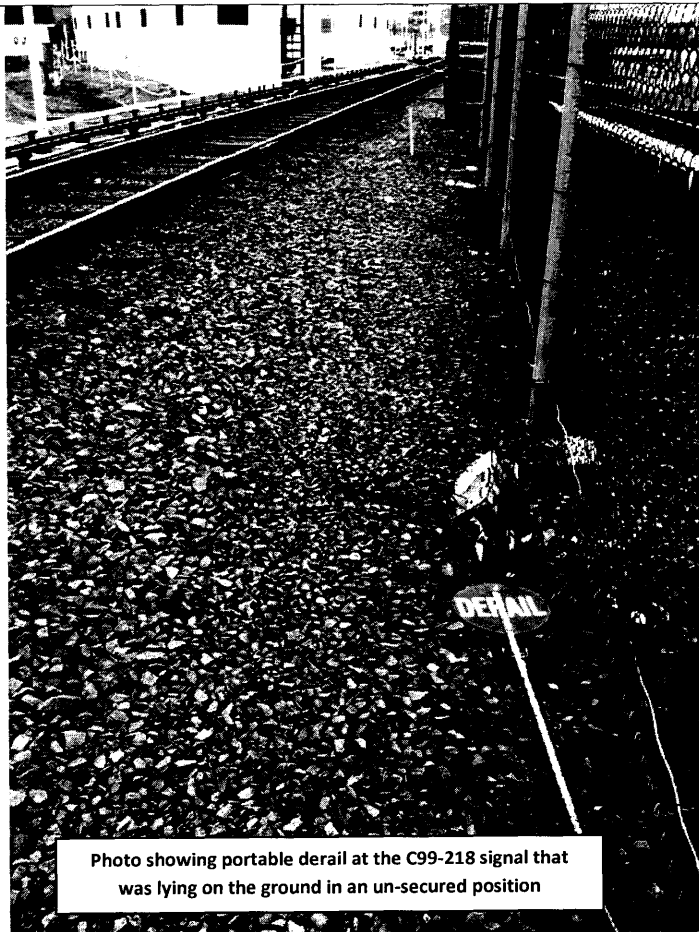
Photo showing portable derail at the C99-218 signal that was lying on the ground in an un-secured position

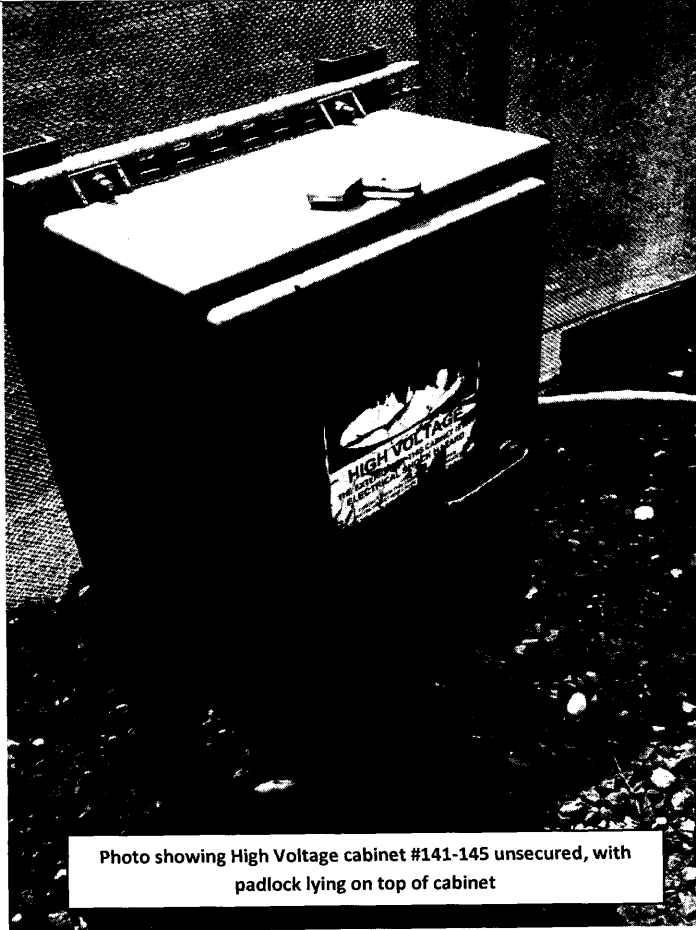
Photo showing High Voltage cabinet #141-145 unsecured, with
padlock lying on top of cabinet

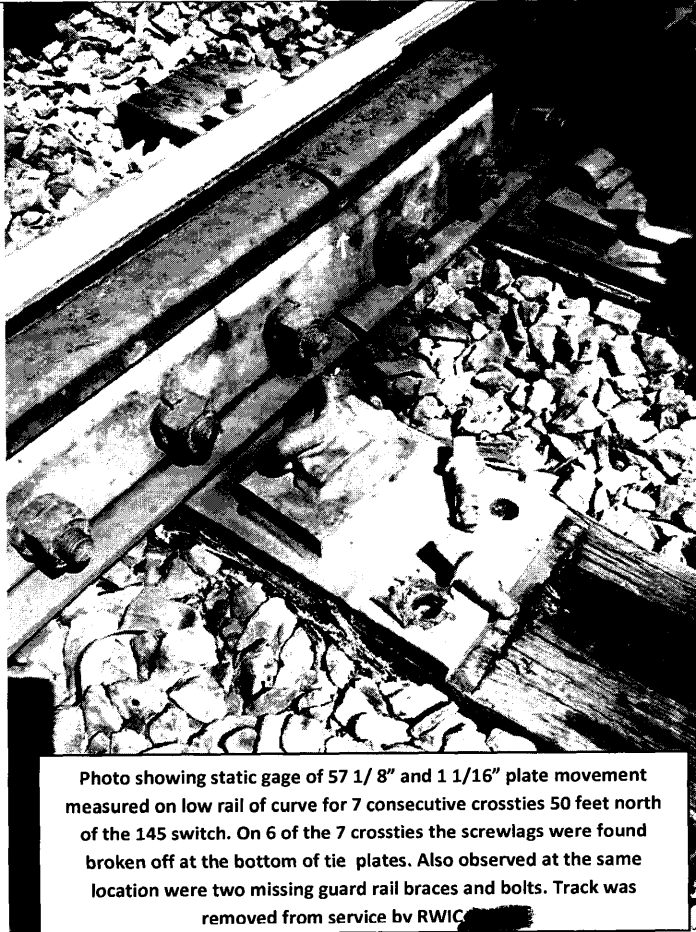
Photo showing static gage of 57 1/8" and 1 1/16" plate movement measured on low rail of curve for 7 consecutive crossties 50 feet north of the 145 switch. On 6 of the 7 crossties the screwlags were found broken off at the bottom of tie plates. Also observed at the same location were two missing guard rail braces and bolts. Track was removed from service by RWIC [REDACTED]

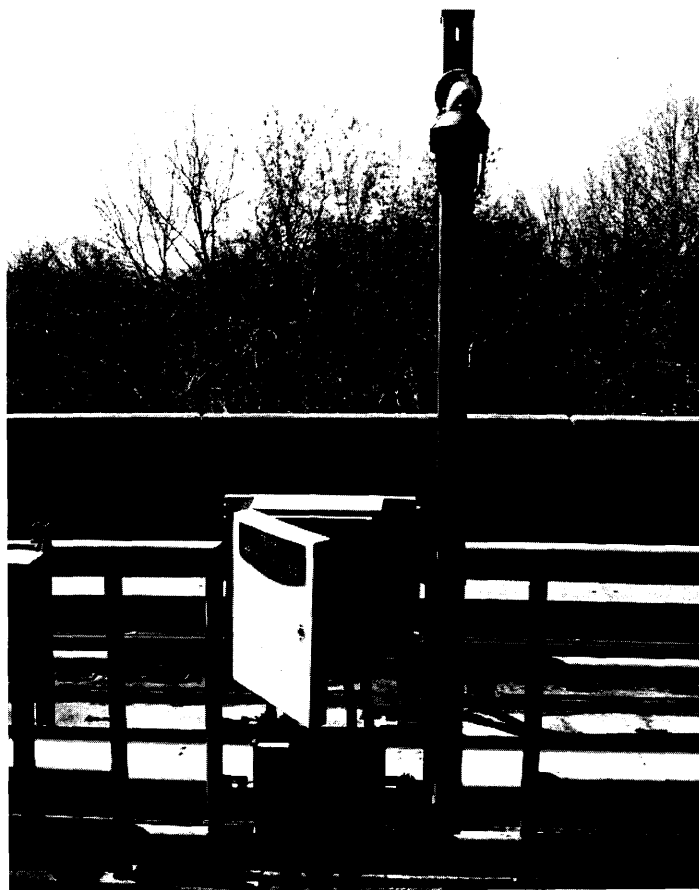
Photo showing broken latch on open cabinet door #ETSF159

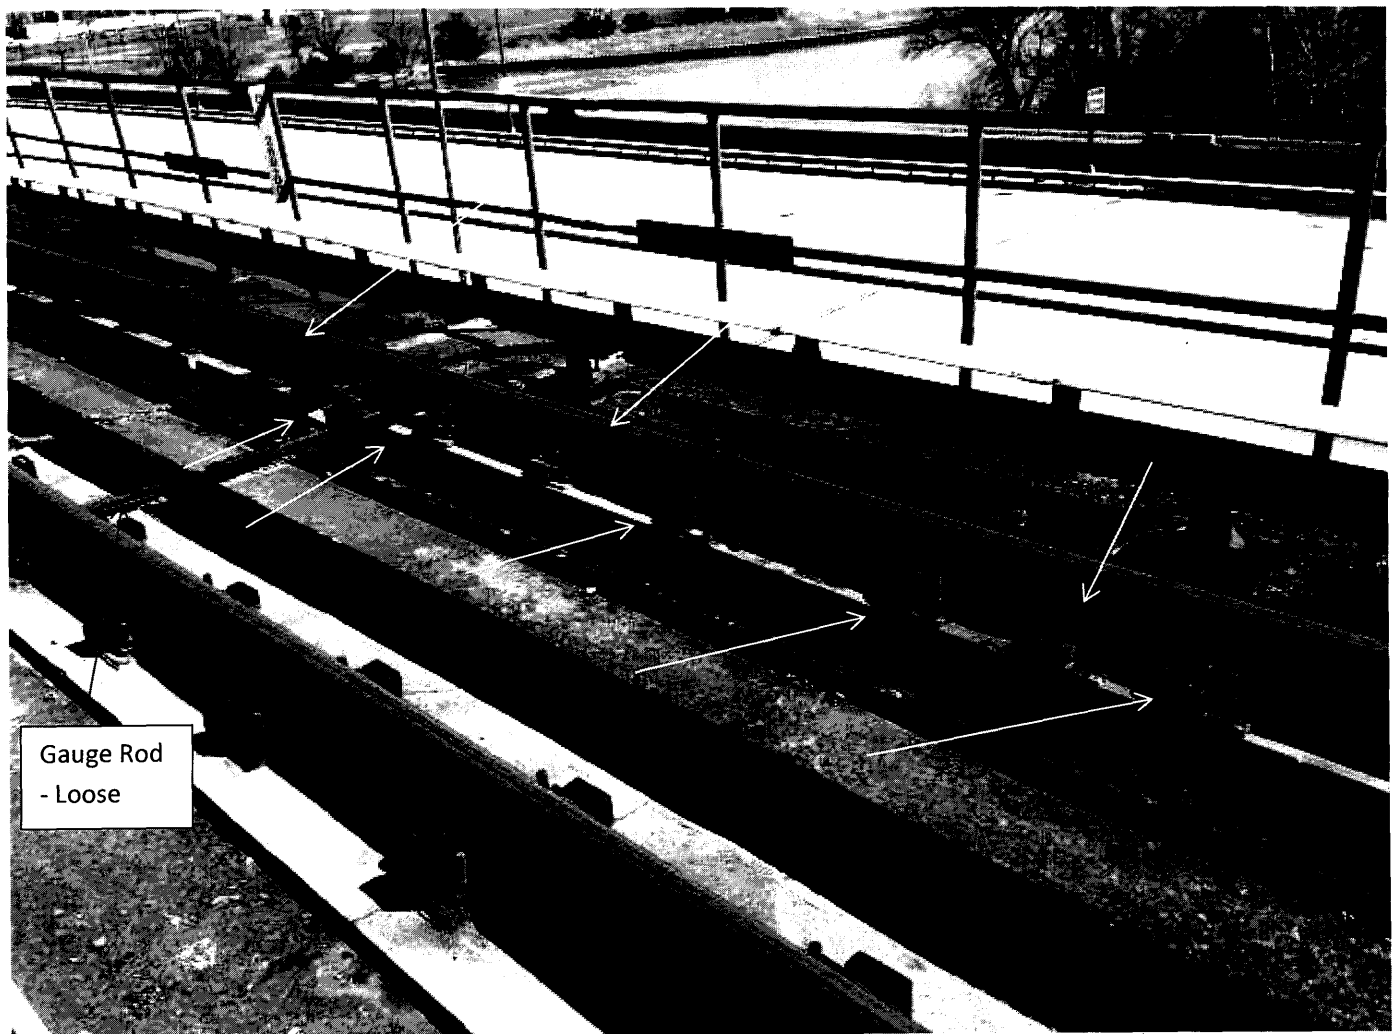
DF Fastener defect at D&G Ariel.

CM269+00 on Right rail 8 consecutive defective fasteners with 244" between effective fasteners.

This location was slow ordered to 15 miles per hour.

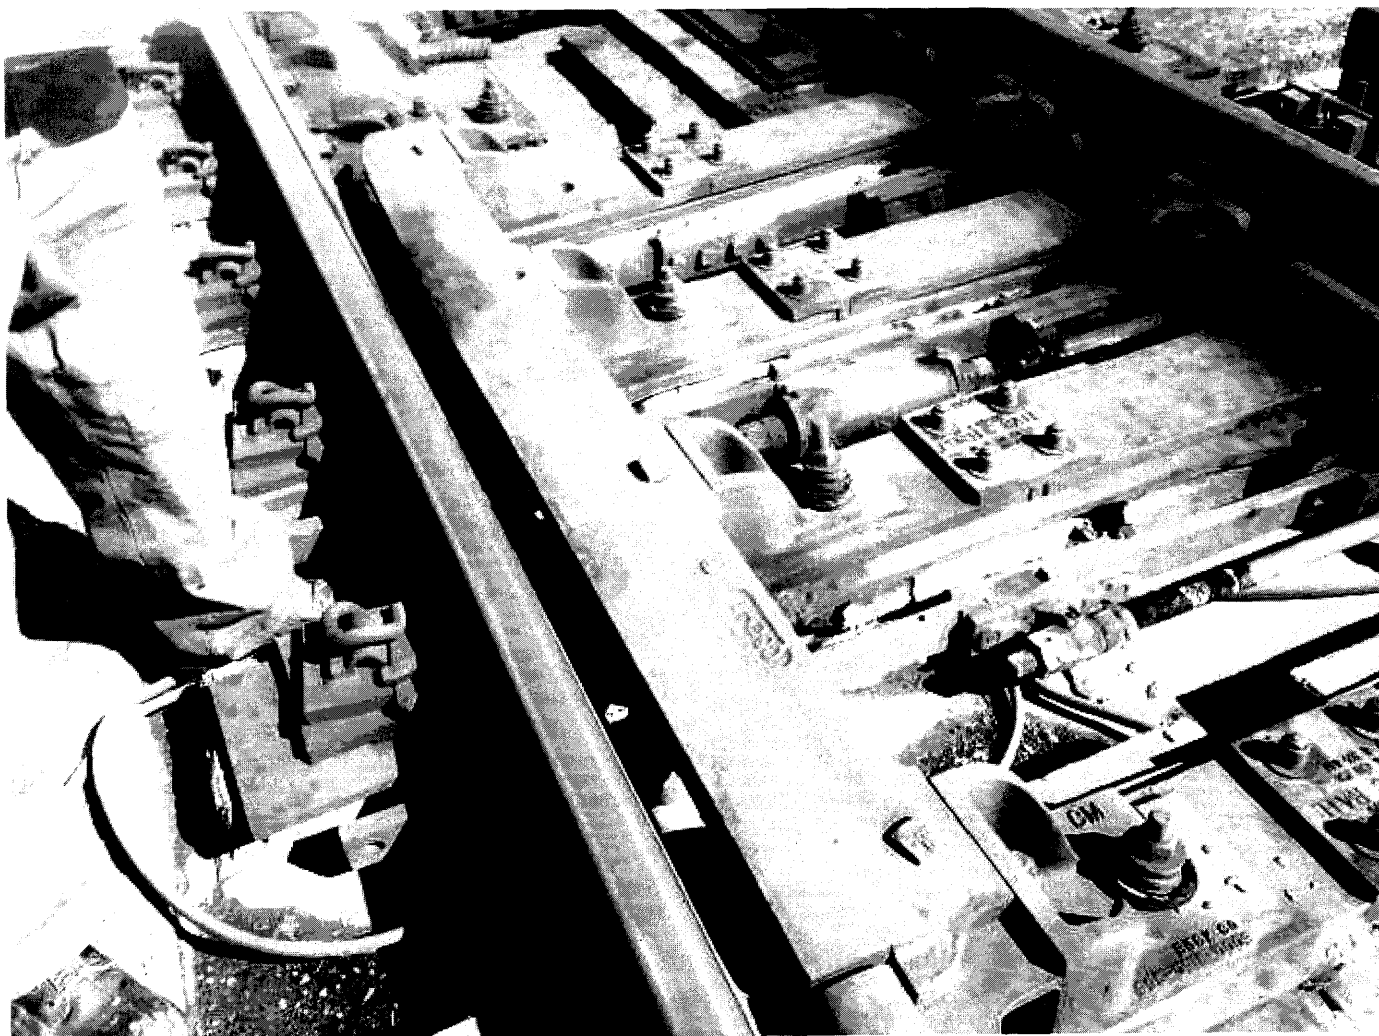
House Top Guardrail with bolts installed upside-down.

When installed this way, bolts appear to be performing correctly, but are hiding when the nuts get loose and ultimately fall off as in picture. Additionally, cotter pins can not be installed this way to prevent nuts from backing off.
