Inspection Form

United States Department of Transportation
Federal Transit Administration

Inspection Date	YYYY	MM	DD	Report Number	20160404-WMATA-JMC-1		
	2016	04	04				
Rail Agency Name	Washington Metropolitan Area Transit Authority			Rail Agency Department	Rail Transportation	Sub-Department	Shady Grove Subdivision
Rail Agency Department Contact Information	Name		Email		Office Phone		Mobile Phone
	[REDACTED]		[REDACTED]		[REDACTED]		[REDACTED]
Inspection Location	WMATA Grosvenor-Strathmore Station, 10300 Rockville Pike, Bethesda, MD 20852

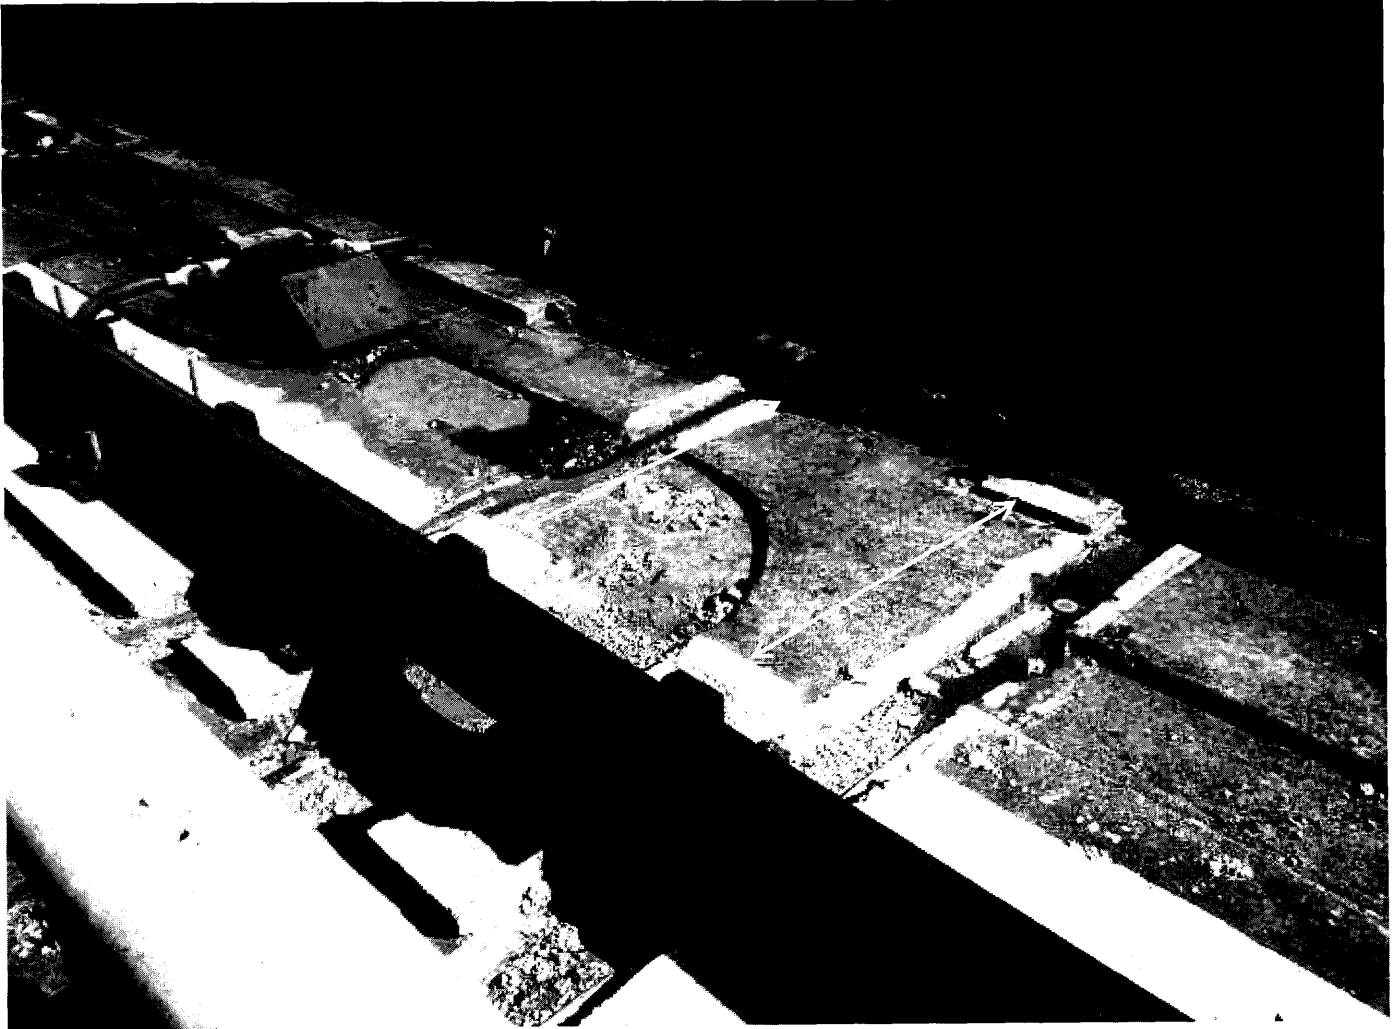
Two consecutively opposed defective fasteners.
