Inspection Form

United States Department of Transportation
Federal Transit Administration

Inspection Date	YYYY	MM	DD	Report Number	20160804-WMATA-TW-1		
	2016	08	04				
Rail Agency Name	Washington Metropolitan Area Transit Authority			Rail Agency Department	RTTO	Sub- Department	
Rail Agency Department Contact Information	Name		Email		Office Phone		Mobile Phone
	[REDACTED]		[REDACTED]		[REDACTED]		
Inspection Location	Surge #6 Takoma and Silver Spring Station Platforms

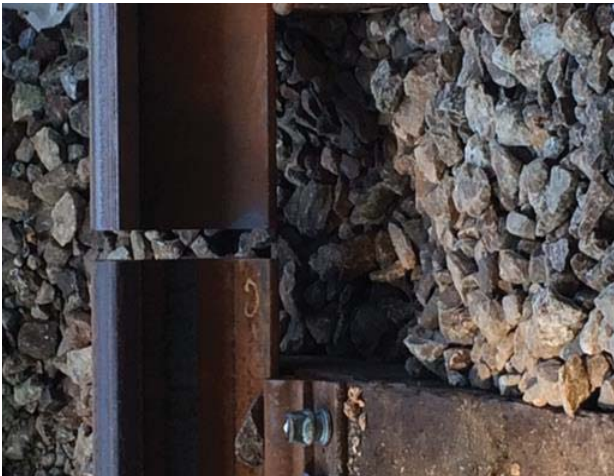
New 39' rail sections requiring weld in 4 locations.

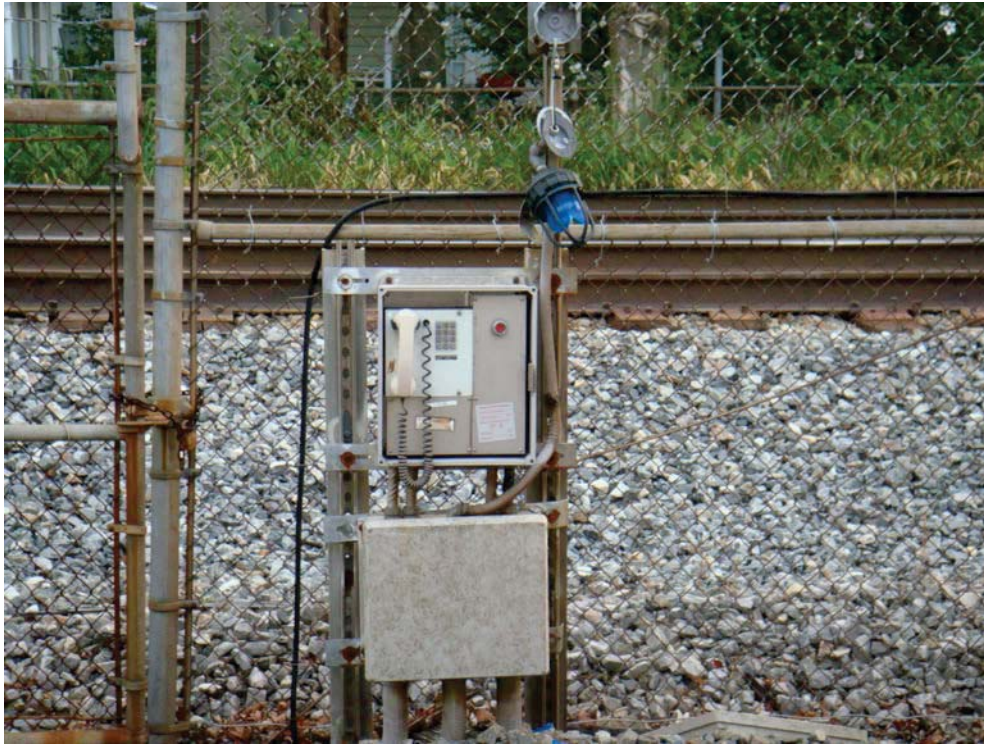
Inspection Activity #	3	Inspection Subject	Communications (ETS) Observations					Activity Code	COMM	GEN	OBS
Job Briefing Employee Name/Title	Unit #6198			Accompanied Inspector?		Out Brief Conducted		Time		Outside Shift	
Related Reports				Related CAPS / Findings							
Related Rules, SOPs, Standards, or Other	Ref		Rule or SOP		Standard		Other / Title		Checklist Reference		
Inspection Location	Main Track	Yard	Station	OCC	RTA Facility	FTA Office	Track Type	At-grade	Tunnel	Elevated	N/A
	X							X			
Line(s)	A-Line	Track Number	#1 with visual on #2	Chain Marker and/or Station(s)	From			To			
					A1 CM 798+00			A1 CM 718+00			
Vehicles	Head Car Number		Number of Cars		Equipment						
Description	General Observations: (These ETS Boxes should be repaired) <ul style="list-style-type: none"> A1 CM 769+50 – ETS box has no door A2 CM 769+50 – ETS box has no door A2 CM 747+00 – ETS box has no door or blue light ETS Box 202 – ETS box has no light (broken) A2 CM 723+20 – ETS box has no door on cable box of comm box 							Number of Defects		5

Figure 1 - A2 CM747+00 - ETS Box with no door and broken light

Recommended Finding?		No	
								Remedial Action Required?		Yes	
								Recommended Reinspection?		Yes	
Remedial Action	WMATA should repair the listed boxes due to fire life safety concerns: <ol style="list-style-type: none"> A1 CM 769+50 – ETS box has no door A2 CM 769+50 – ETS box has no door A2 CM 747+00 – ETS box has no door or blue light ETS Box 202 – ETS box has no light (broken) A2 CM 723+20 – ETS box has no door on cable box of comm box

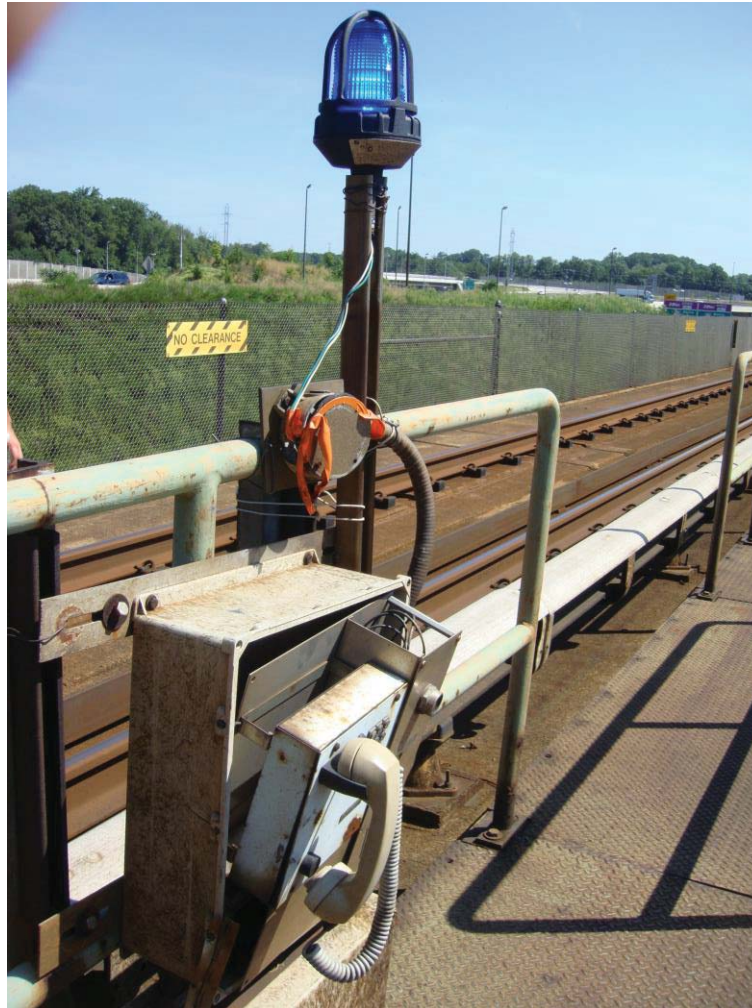
Recommended Finding?		No		
							Remedial Action Required?		Yes		
							Recommended Reinspection?		Yes		
Remedial Action	<p>WMATA should repair the following ETS boxes:</p> <ol style="list-style-type: none"> K2 CM630+00 – No door on the enclosure K1 CM630+00 – No door on the enclosure K2 CM623+00 – No door, broken blue light fixture K1 CM623+00 – No door K1 CM616+40 – ETS Box – No door

Figure 1 - ETS Box in state of poor repair

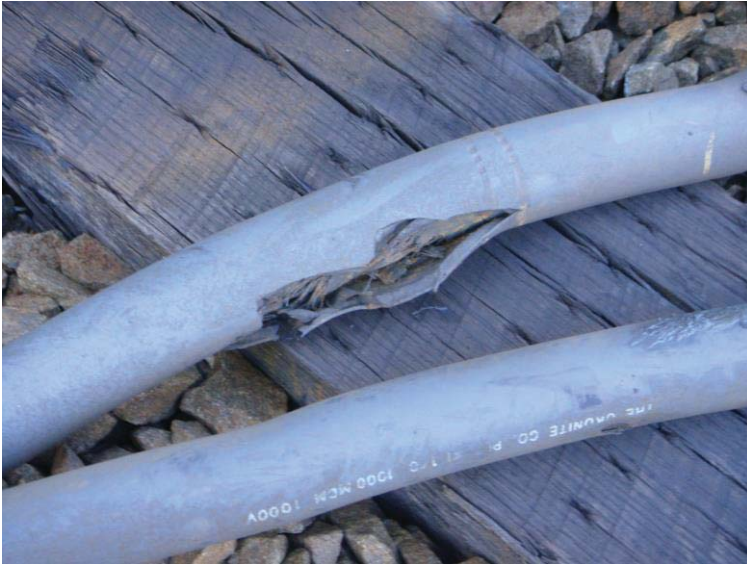
Figure 1 - Track 1 to Track 2 Cross Bond Cable at K1 CM547+55 (Item Noted by Unit #626)

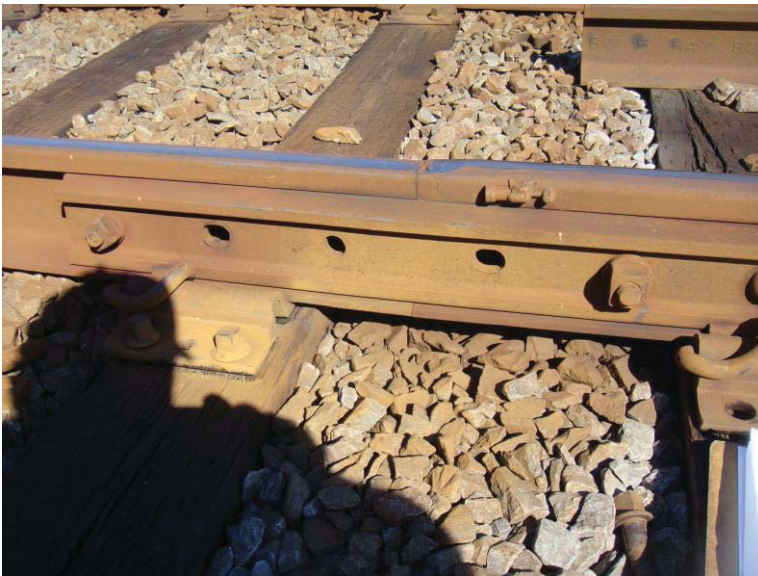
Figure 2 - Missing Bolt at K1 CM604+90

<ul style="list-style-type: none"> Track Drains – notes were made to re-seat manhole locations that were not properly seated. K08 Interlocking <ul style="list-style-type: none"> Track Unit #626 performed a physical inspection of K08 Interlocking to include four switches, diamond and frogs. Crossties were also checked. The ties were in good shape. A few were noted for replacement during the upcoming surge. <p>Note 1: FWSO did not take any exceptions to this section of track related to the track system. Note 2: FWSO made note that no other departments were participating in pre-surge inspection activities. This participation would enhance the efficiency of the surge efforts.</p>		
Remedial Action	WMATA should replace the broken bolt and C-bonds at K1 CM604+90.

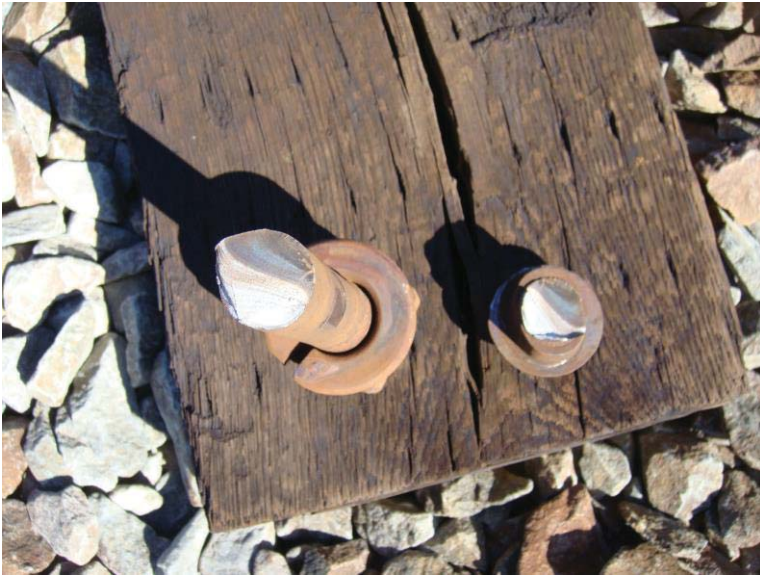
Figure 3 - Broken Bolt from K1 CM604+90

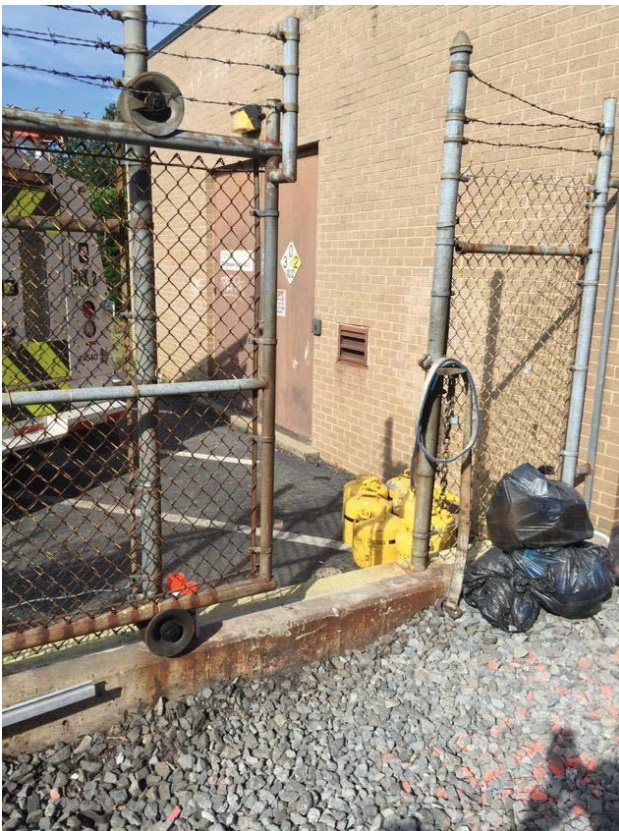
Photo 1 - Open and unmanned wayside gate.

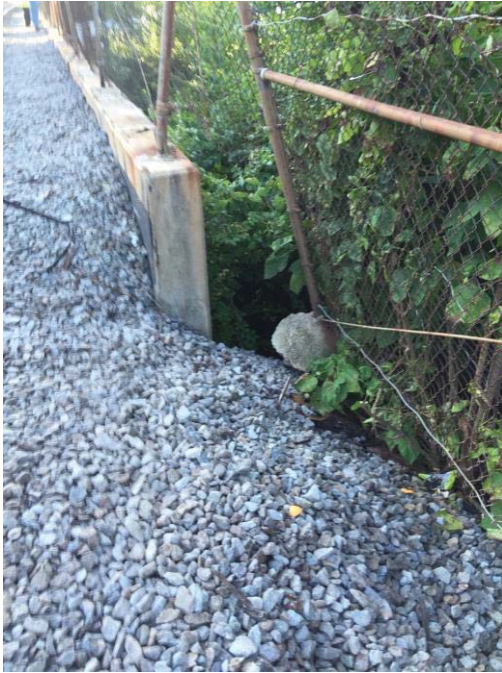
Photo 2 A1-771+00 – Severe soil erosion around wayside
Fence post at bridge abutment

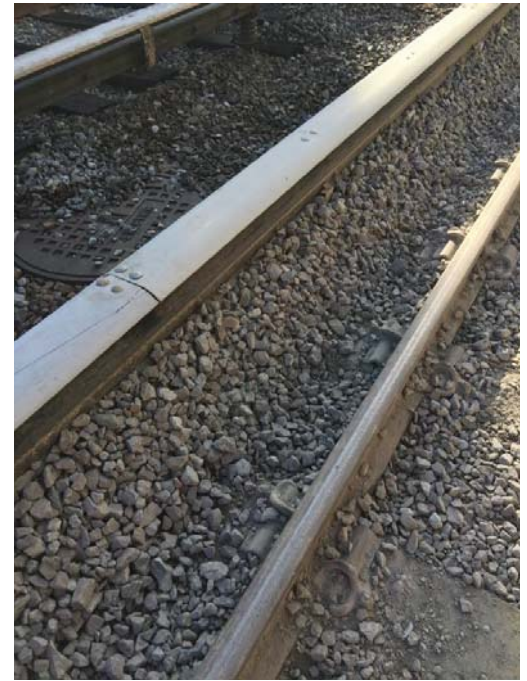
<p>issue is under review by WMATA engineering for manufacturing quality issues)</p> <ul style="list-style-type: none">• Extensive third rail work (insulator and cover board replacement) to be completed before Surge conclusion• Rubber seals around 1000 mcm cable and 4" conduit has been replaced with new seals.• A1-771+00 – Severe soil erosion around wayside fence post at bridge abutment. Complete fence post exposed (See photo 2)• Excessive amount of ballast lodged under and against third rail. Must be removed prior to revenue start-up. Ballast work and regulating was underway. (See Photo 3)		
Remedial Action	<ul style="list-style-type: none">• WMATA to mitigate severe soil erosion around wayside fence post at bridge abutment - A1-771+00.• WMATA to remove excessive amount of ballast lodged under and against third rail; must be removed prior to revenue start-up.

Photo 3 - Excessive ballast under third
and rail and against Third Rail

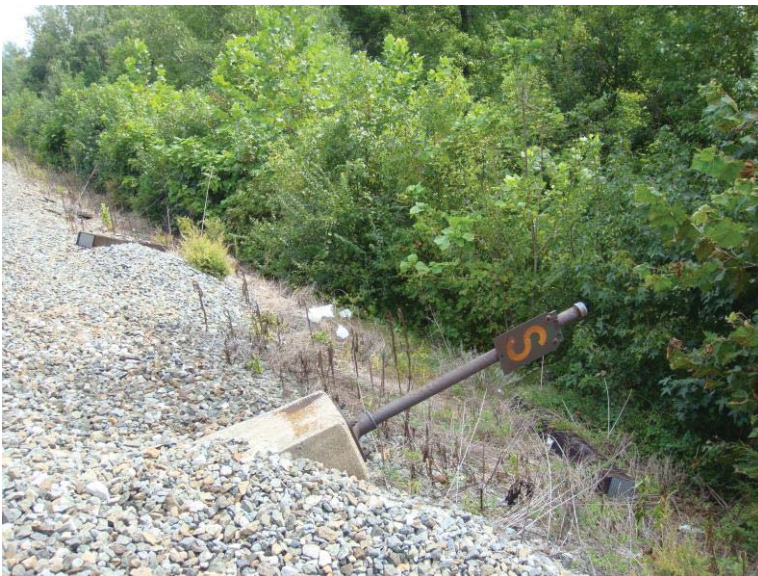
<ul style="list-style-type: none"> At D1 CM569+50 the Station Marker (S) sign was knocked over on its side. Prior to a return to ATC control this should be repaired. (Photo) In the vicinity of D1 CM567+00 there is a need for ballast. The shoulder ballast appears to be in need of servicing as well. 		
Remedial Action	<p>WMATA should repair the following items:</p> <ol style="list-style-type: none"> On the aerial structure from D1 CM548+00 to D1 CM558+00 there were five (5) locations where the distance between effective fasteners was greater than 120". As per TRST 1000 table 7-1 this condition is a Black Condition. The Track Supervisor used his discretion to implement a 10mph speed restriction through this area through the use of speed couplers. The track in this section is on an ascending grade and was tangent. There were no signs of rail movement and periodic gage measurements indicated that the track was within WMATA specifications. The ERT team responded to this area to make temporary repairs until emergency rights are implemented for repairs this evening. Noted four (4) gage rods with deteriorated ties in the vicinity of the block house on track #1 at New Carrollton. The ties were painted orange which indicates that they should be replaced during upcoming work activities. The insulator assembly at the end approach located at D1 CM525+00 was compromised and non-effective. Per TRST 1000, table 13-6 this is a RED condition. Track Unit 641 noted the condition.

Figure 1 - Toppled Station Marker Sign at D1 CM569+50

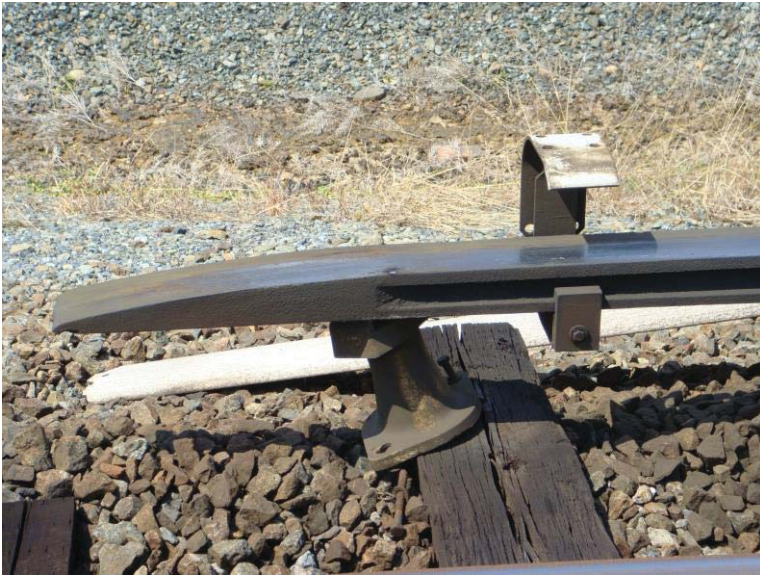
Figure 2 - Unsupported End Approach at D1 CM525+90

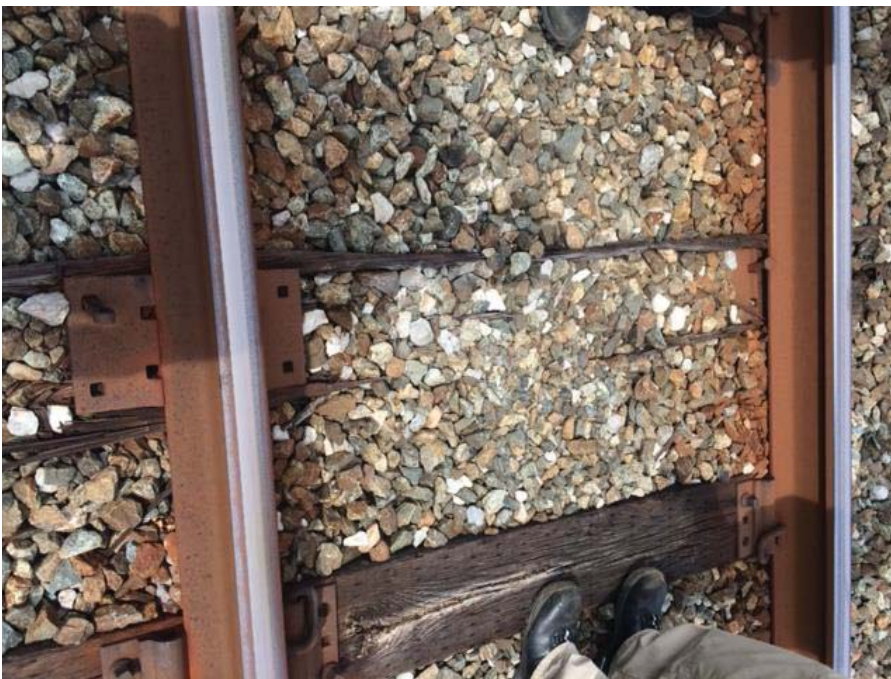
Figure 3 – Deteriorated tie conditions at approx. D1 CM580+00

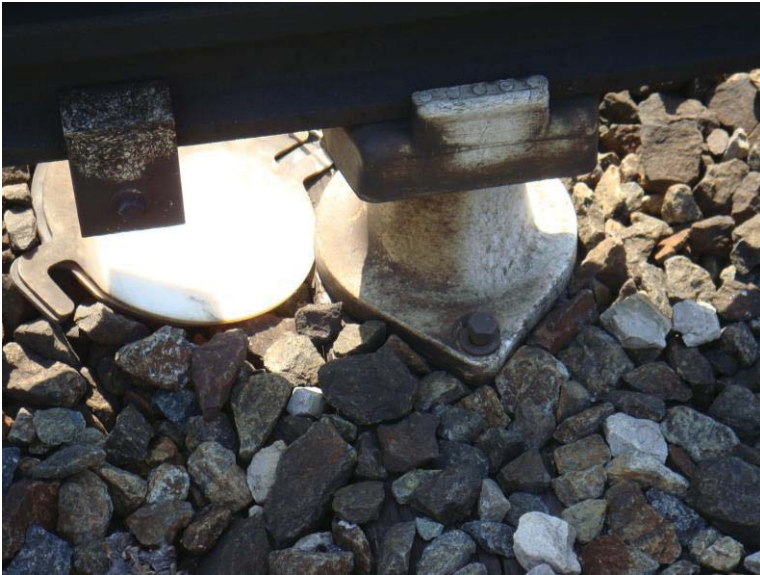
Figure 1 - Loose insulator anchors with dislodged shims

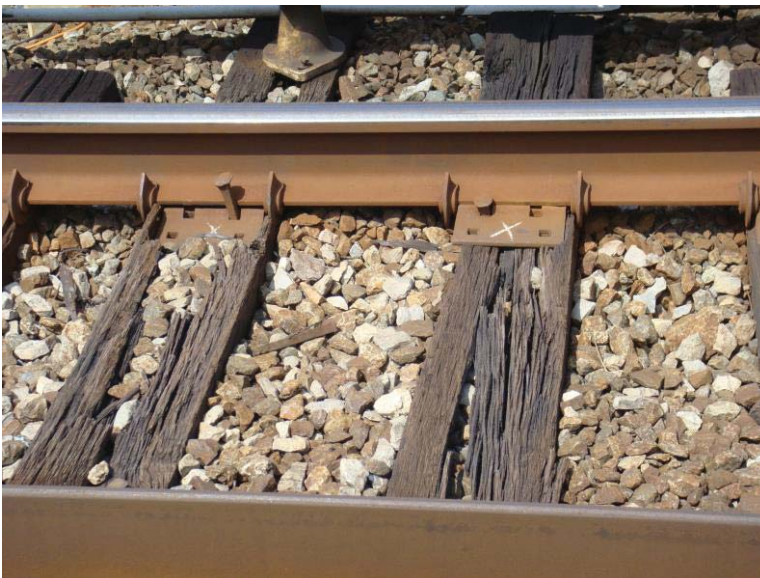
<ul style="list-style-type: none"> Cross Tie conditions varied in the at-grade portion of the walk. Ties ranged from 25% replacement to 50% replacement due to past efforts, passes, through the area. 		
Remedial Action	<p>WMATA should correct the items noted below:</p> <ol style="list-style-type: none"> At D2 CM516+00 – Right rail end approach has 16 feet between insulators leaving the joint un-supported. At D2 CM523+50 – There are three ties in a row that are not secured due to deteriorated condition. From D2 CM531+00 to approximately D2 CM546+40 the 3rd rail insulator bolts are loose and a number of shims have dislodged. At D2 CM540+00 there are deteriorated crossties with evidence of lateral movement along with a vertical deflection of 5/16" under load. A 10mph speed restriction was put in place until ERT team made repairs. From D2 CM546+54 through D2 CM565+80 there are numerous deteriorated fasteners. Noted conditions were: <ul style="list-style-type: none"> Worn serated washers Worn stud bolts Missing stud bolts Double nuts on stud bolts Track pumping <p>Note: At 547+55 there were six (6) fasteners in a row (17' 4" between effective fasteners). This was indicative of the conditions found across the elevated span.</p>

Figure 2 - Deteriorated ties at transition from direct fixation to ballasted track
