Inspection Form

Form FTA-IR-1

United States Department of Transportation
Federal Transit Administration

Inspection Date	YYYY	MM	DD	Report Number	20170201-WMATA-CB-1		
	2017	02	01				
Rail Agency Name	Washington Metropolitan Area Transit Authority			Rail Agency Department	TRST	Sub- Department	TKIN
Rail Agency Department Contact Information	Name			Email		Office Phone	
	[REDACTED]			[REDACTED]		[REDACTED]	
	[REDACTED]			[REDACTED]		[REDACTED]	
	[REDACTED]			[REDACTED]		[REDACTED]	
	[REDACTED]			[REDACTED]		[REDACTED]	
	[REDACTED]			[REDACTED]		[REDACTED]	
Inspection Location	Rockville (A14) to Twinbrook (A13) on the A Line, Track 2

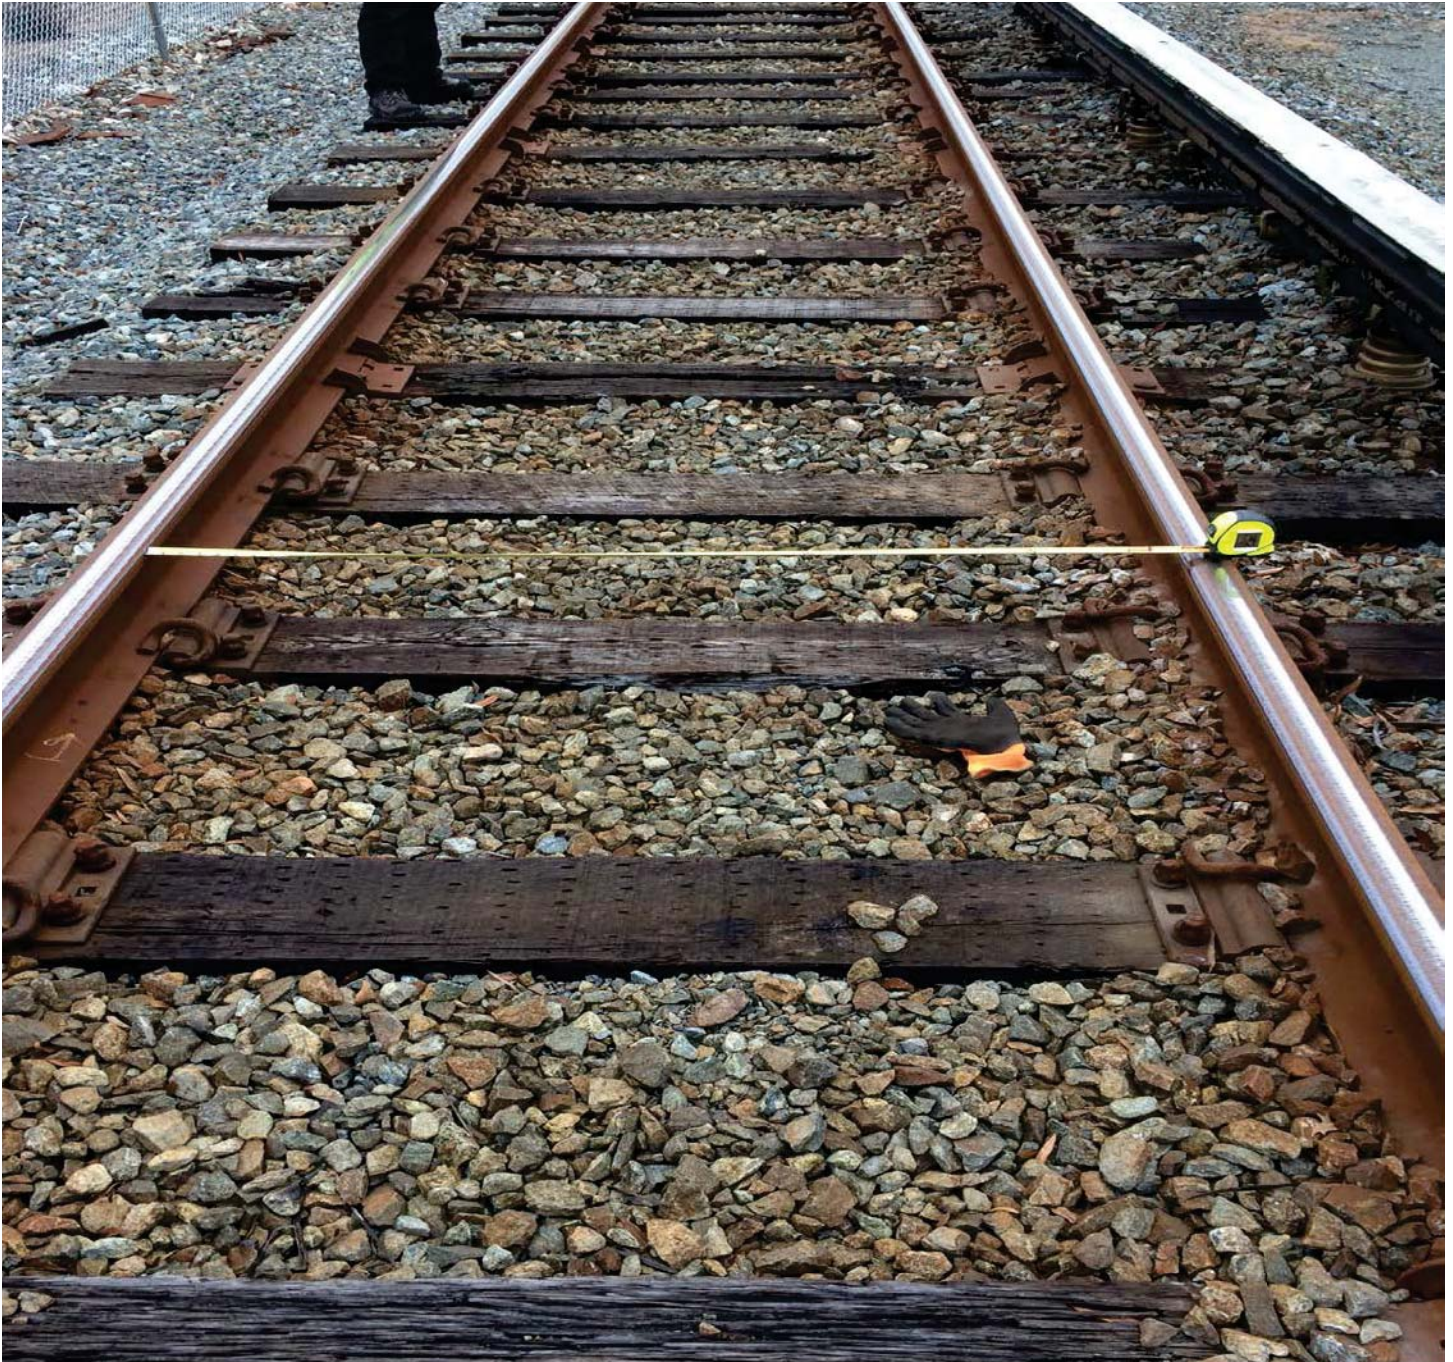
Tight Gauge at CM A2 798+55.

Recommended Finding?		No		
								Remedial Action Required?		Yes		
								Recommended Reinspection?		Yes		
Remedial Action	<ul style="list-style-type: none"> WMATA must verify that the November 29, 2016 TGV loaded tight gauge deviations at CM A2 712+71 and CM A2 798+55 have been properly remediated. WMATA must remove concentrated loads under the base of the rail.

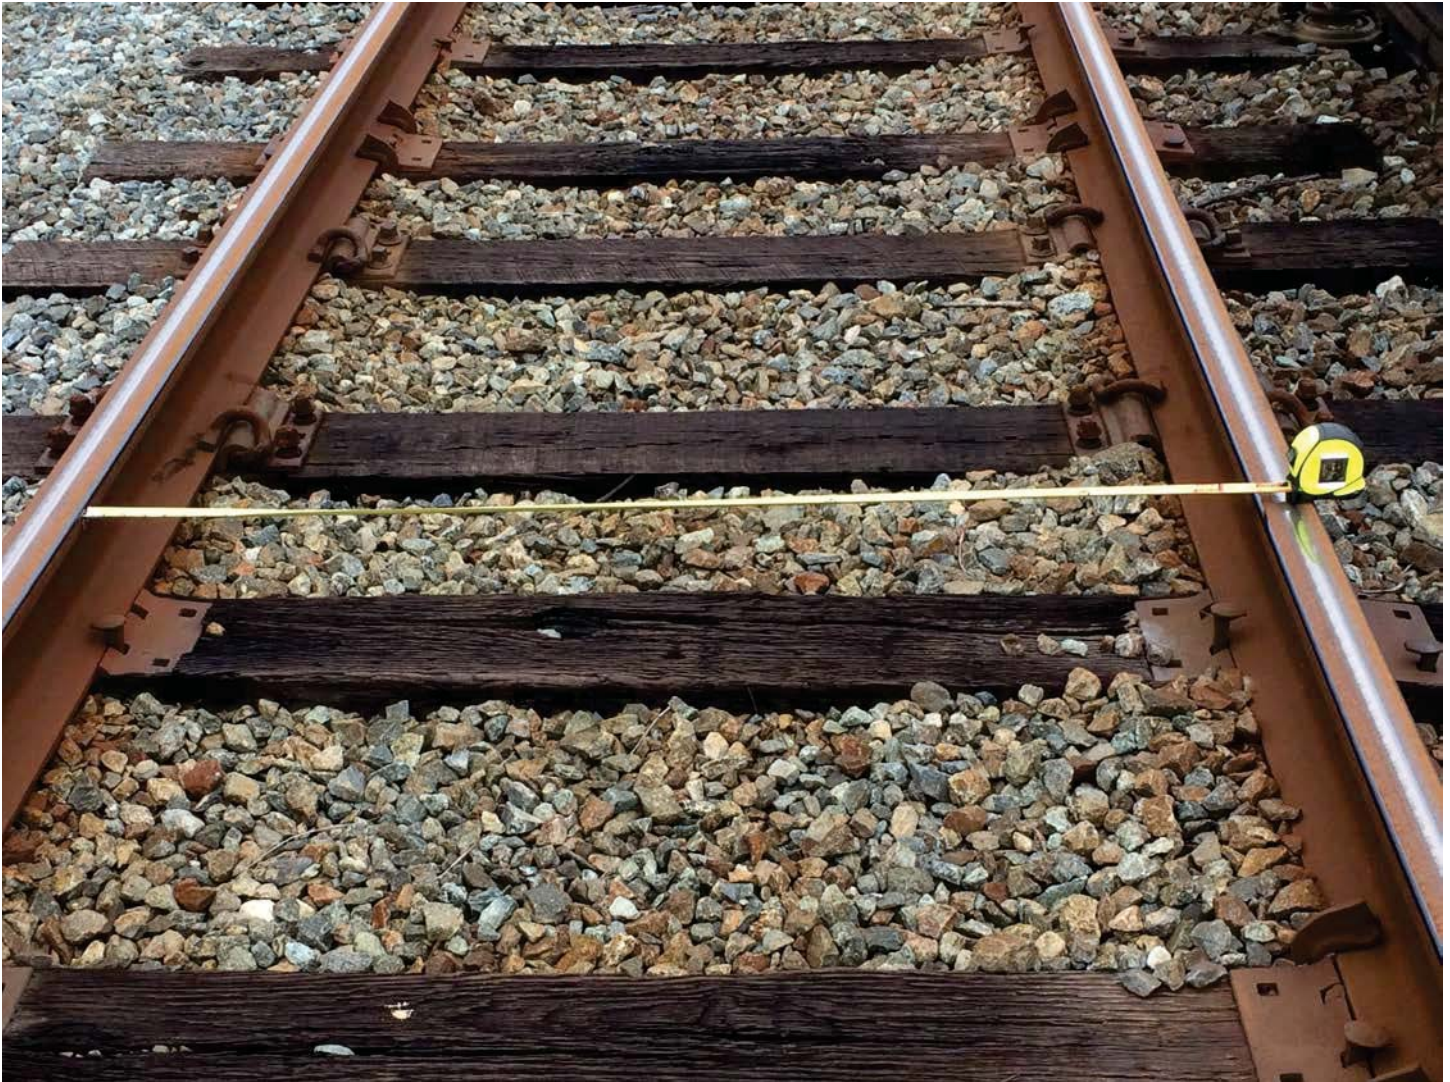
Tight Gauge at CM A2 712+71.

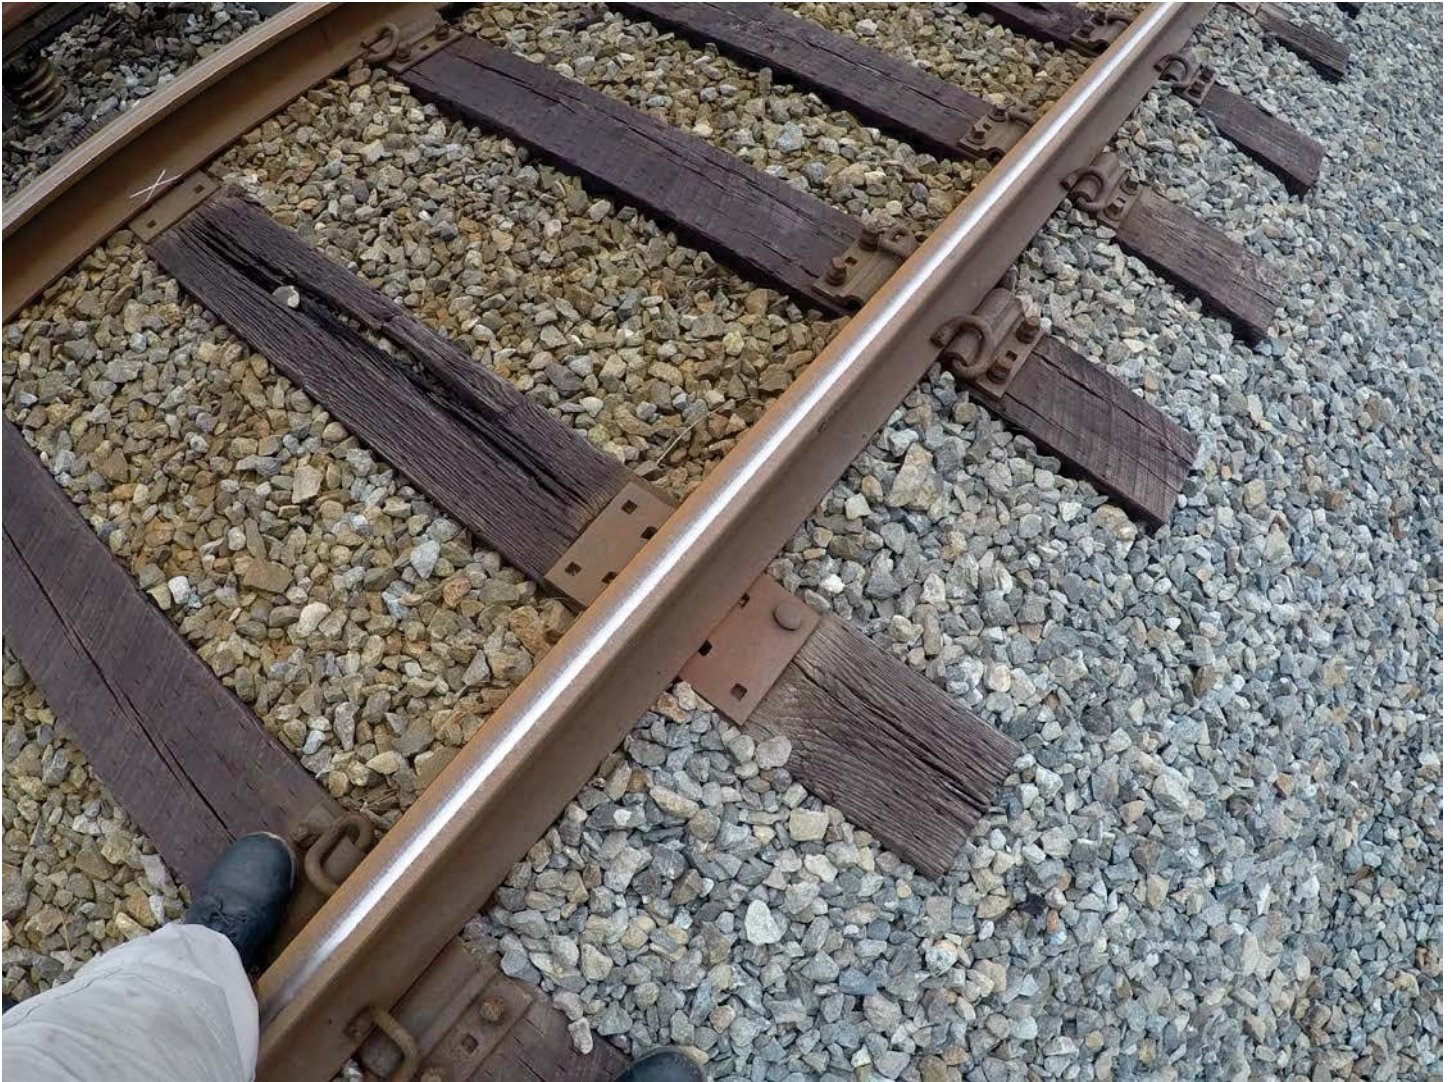
Numerous concentrated loads under base of rail due to spike heads and plate shoulders—similar to the photo above—between Stations A14 and A13 on track A2.

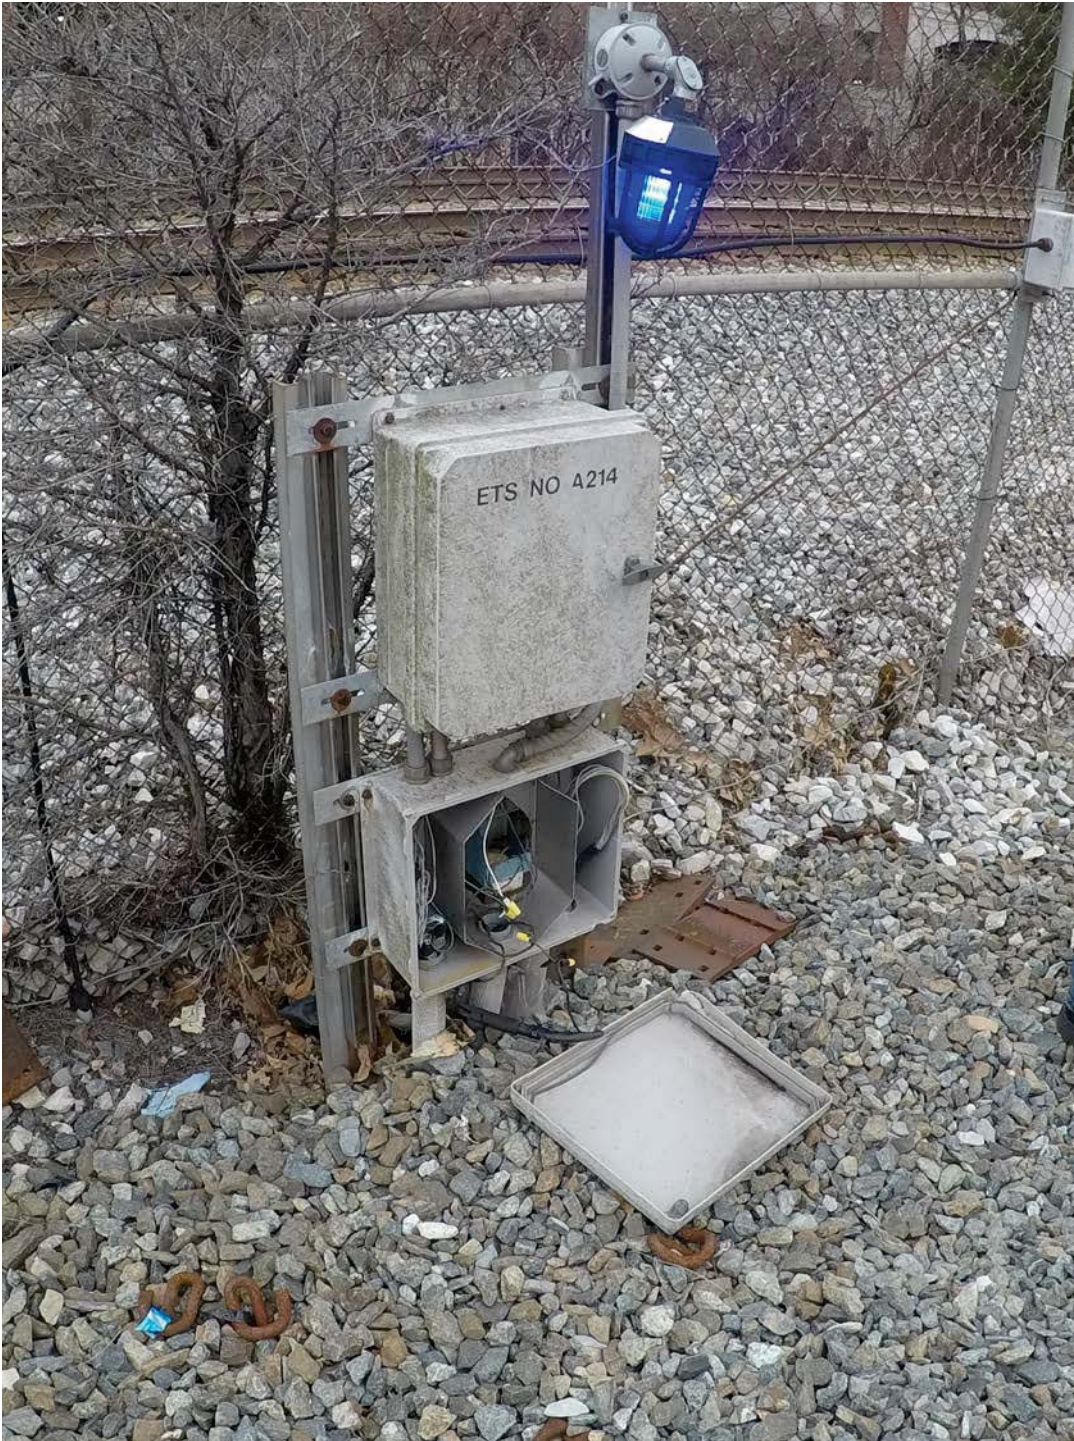
ETS box cover off at CM A2 777+15.

| | <ul style="list-style-type: none">• WMATA must ensure the 3rd rail is firmly and securely seated in all insulator assemblies and re-secure anchor arms.• WMATA must repair and/or replace damaged ETS doors at CM A2 708+00.• WMATA must repair and/or replace damaged ETS doors at CM A2 777+15. |

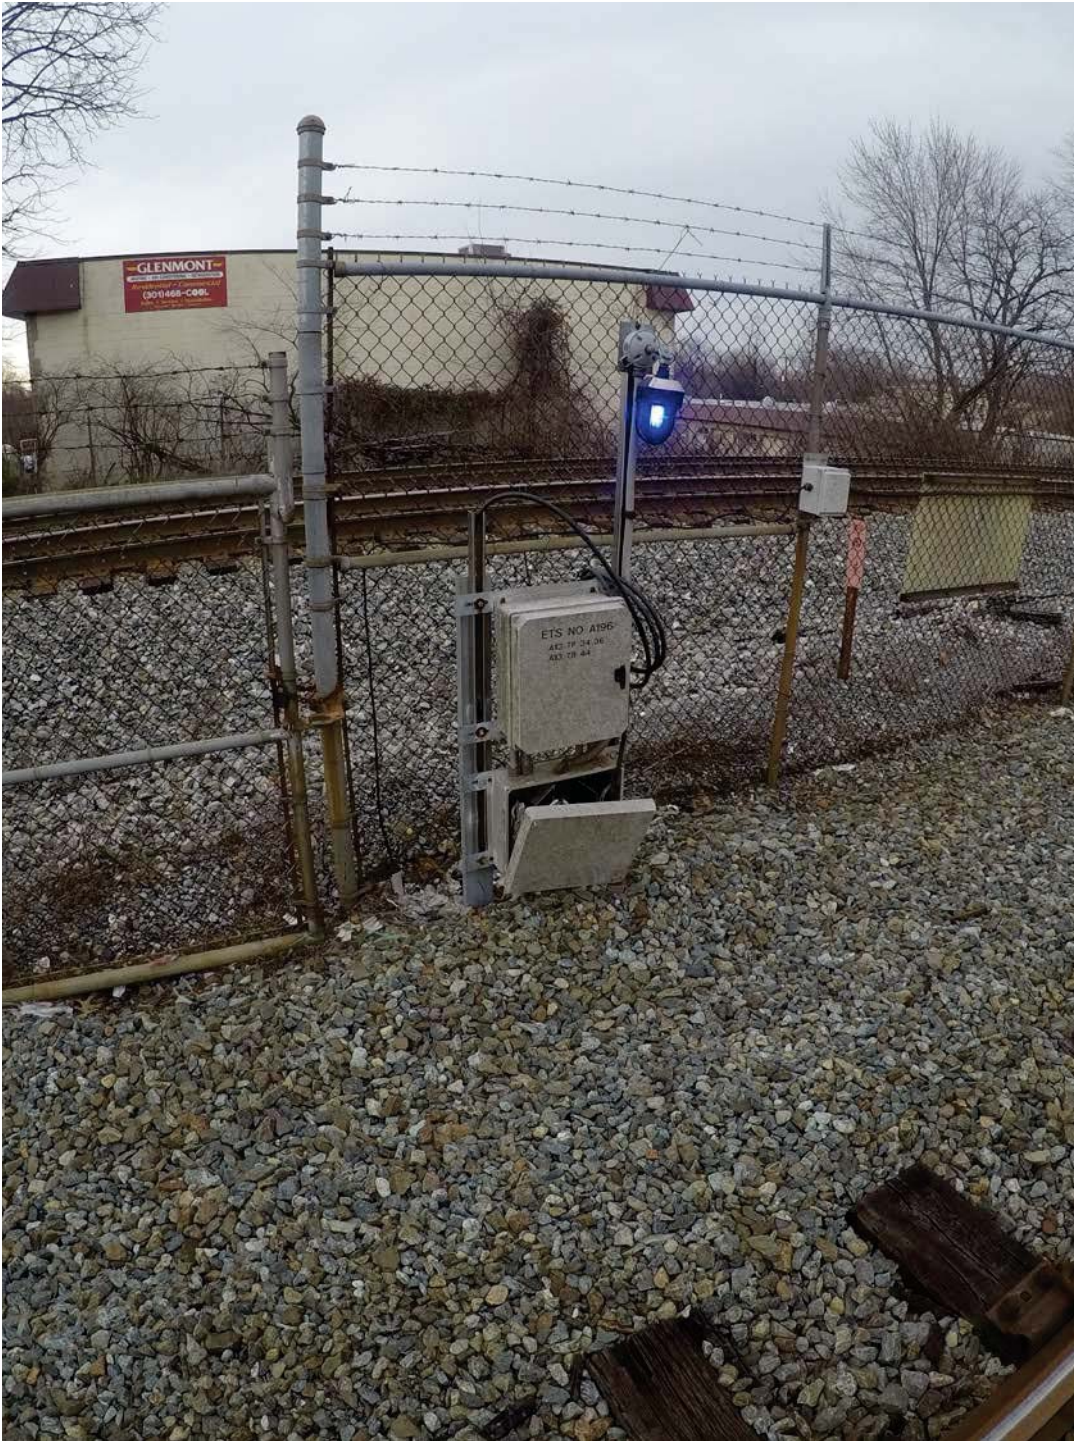
ETS box cover off at CM A2 708+00.

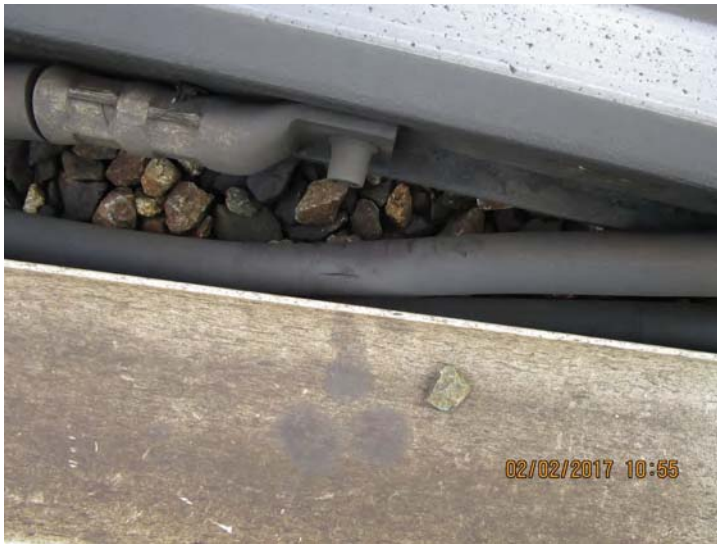
FIGURE 1 - TRK 2 CM 913+00 – DAMAGED CABLE

Remedial Action	<ul style="list-style-type: none">• TRK 2 CM 913+00 – Replace damaged cable.• TRK 2 CM 893+00 – Replace damaged cable and ensure enough clearance between newly installed cable and insulator.• TRK 2 CM 879+00 – Replace heat shrink and OZ Gedney bushing on the duct line transition (feeder cable stub-up)• TRK 2 CM 879+00 – Replace cable with temporary repair.• TRK 2 CM 868+00 – Replace nicked cables.• TRK 2 CM 868+00 – Install nut/bolt permanent installation on fiberglass standoffs instead of zip ties.• TRK 2 CM 858+00 – Replace 3rd rail porcelain insulator.• TRK 2 CM 848+00 – Provide enough clearance between cables and coverboard bracket and replace any damaged cables.• TRK 2 CM 838+00 – Replace damaged cables.• TRK 2 CM 828+00 – Install permanent nut/bolt assembly on fiberglass standoffs.• TRK 2 CM 828+00 – Unbury cables from the ballast.

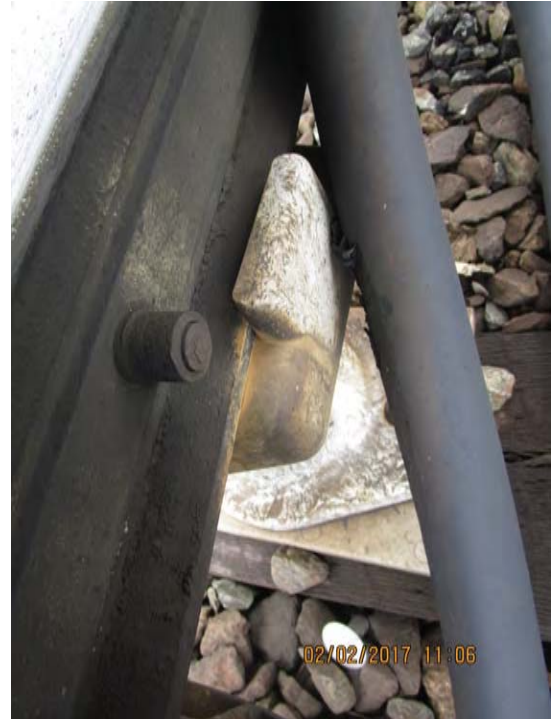
FIGURE 2 - TRK 2 CM 893+00 – DAMAGED CABLE
AND PROVIDE CLEARANCE WITH INSULATOR

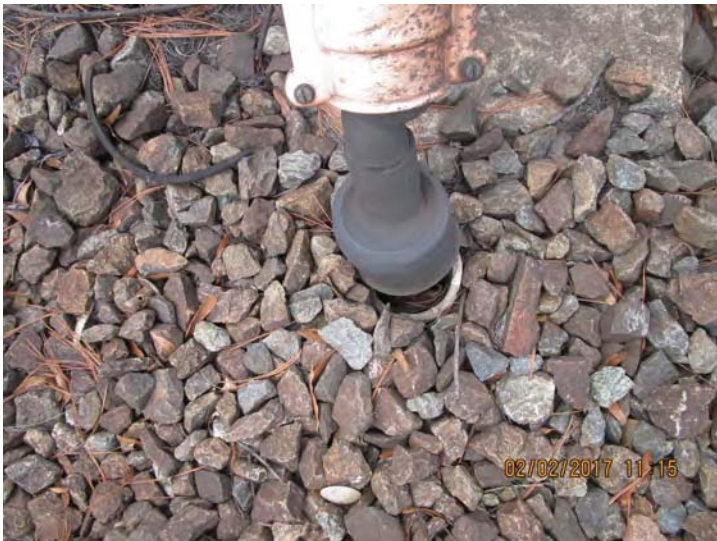
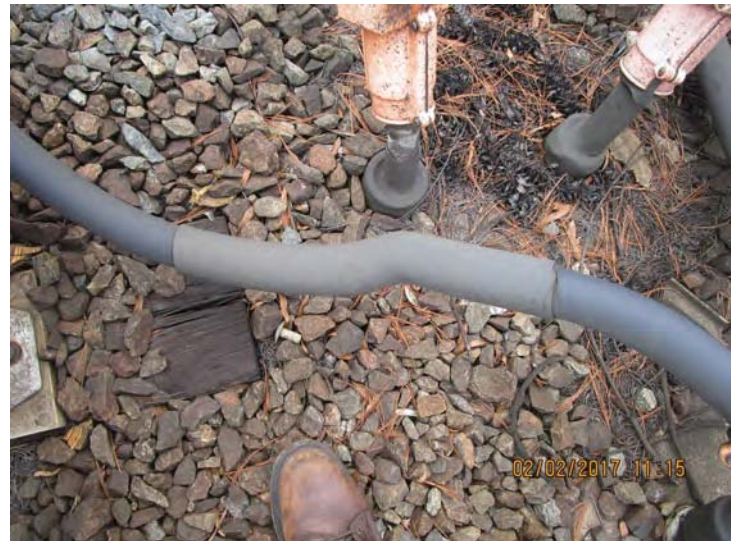
FIGURE 3 - TRK 2 CM 879+00 – HEAT SHRINK AND OZ GEDNEY BUSHING ON DUCT LINE TRANSITION COMPROMISED;
TEMPORARY REPAIRED CABLE NEEDS REPLACEMENT

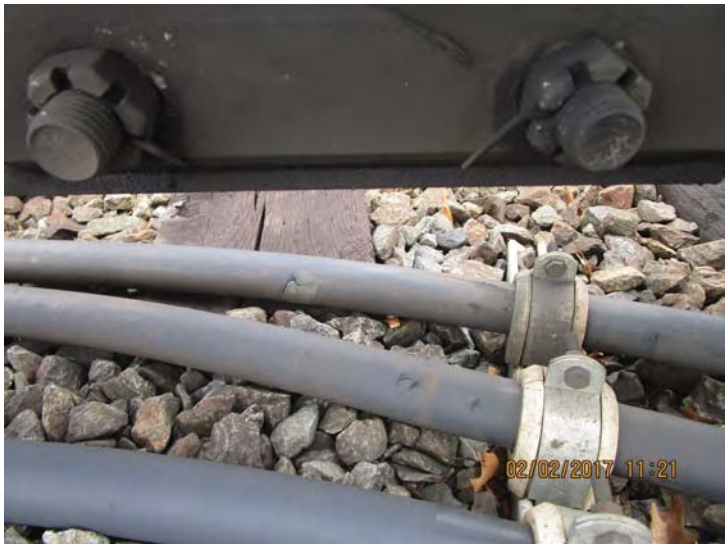
FIGURE 4 - TRK 2 CM 868+00 – DAMAGED CABLES AND TEMPORARY INSTALL OF STANDOFFS WITH ZIP TIES

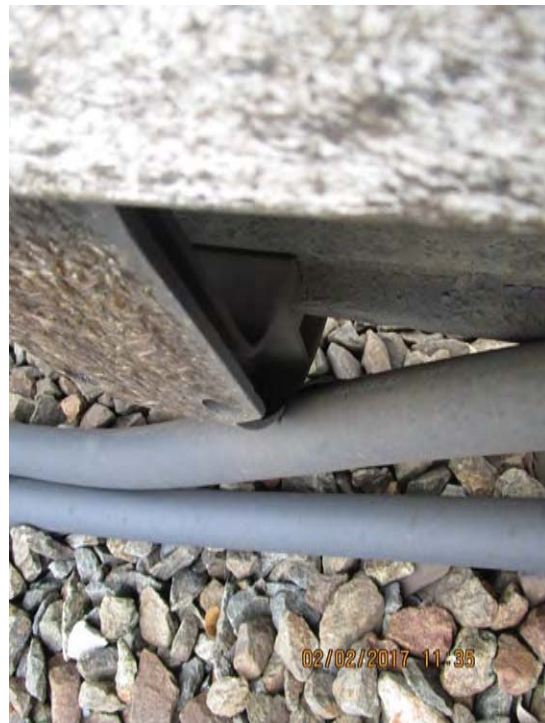
FIGURE 6 - TRK 2 CM 848+00 – CABLES TOO CLOSE TO 3RD RAIL COVERBOARD BRACKET

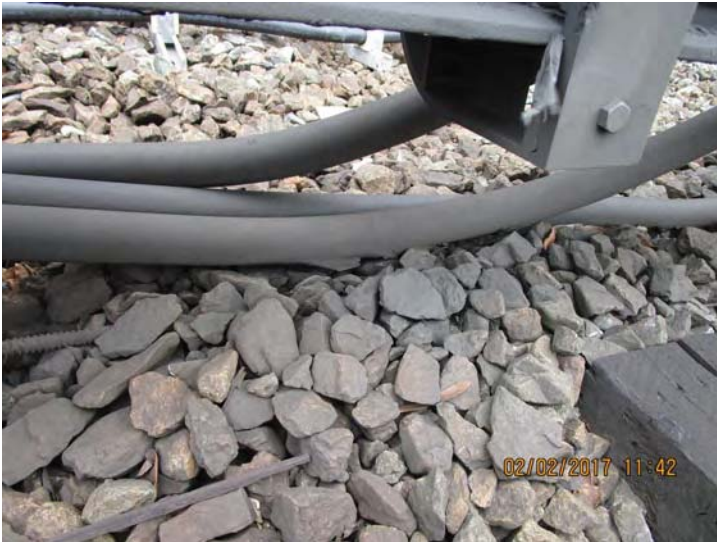
FIGURE 7 - TRK 2 CM 838+00 – DAMAGED CABLES

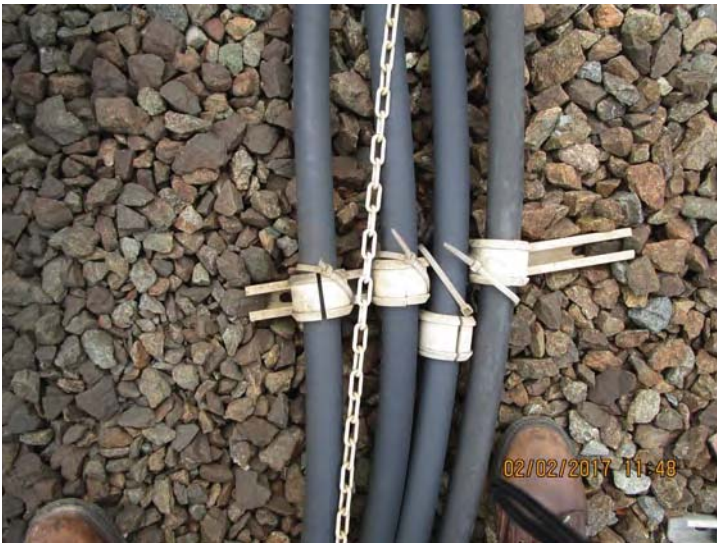
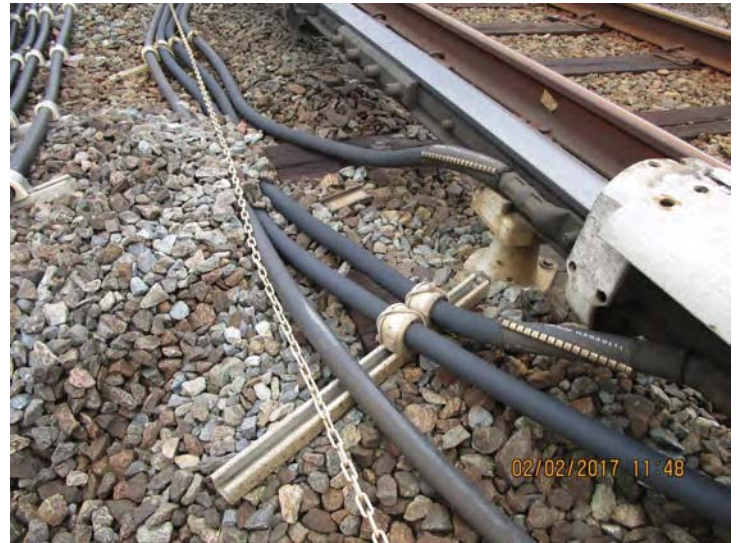
FIGURE 8 - TRK 2 CM 828+00 – TEMPORARY INSTALL OF ZIP TIES FOR FIBERGLASS CABLE STANDOFFS AND BURIED CABLES

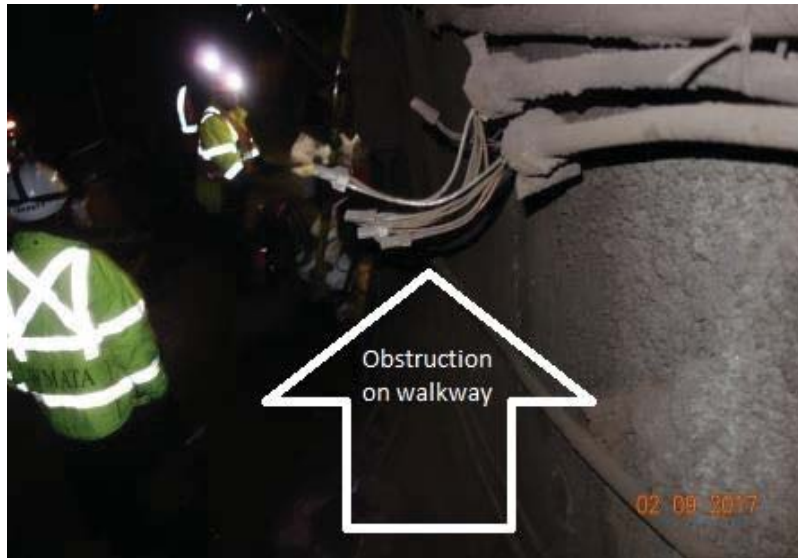
Live exposed wires with wire caps serving as protection, note condition of wires suggesting an on-going condition.

Recommended Finding?		Yes						
							Remedial Action Required?		Yes						
							Recommended Reinspection?		Yes						
Remedial Action	<ul style="list-style-type: none"> Between CM 466+00 and 467+00, WMATA must repair loose unsecure wires. Between CM 466+00 and 467+00, WMATA must repair the exposed wires and cables.

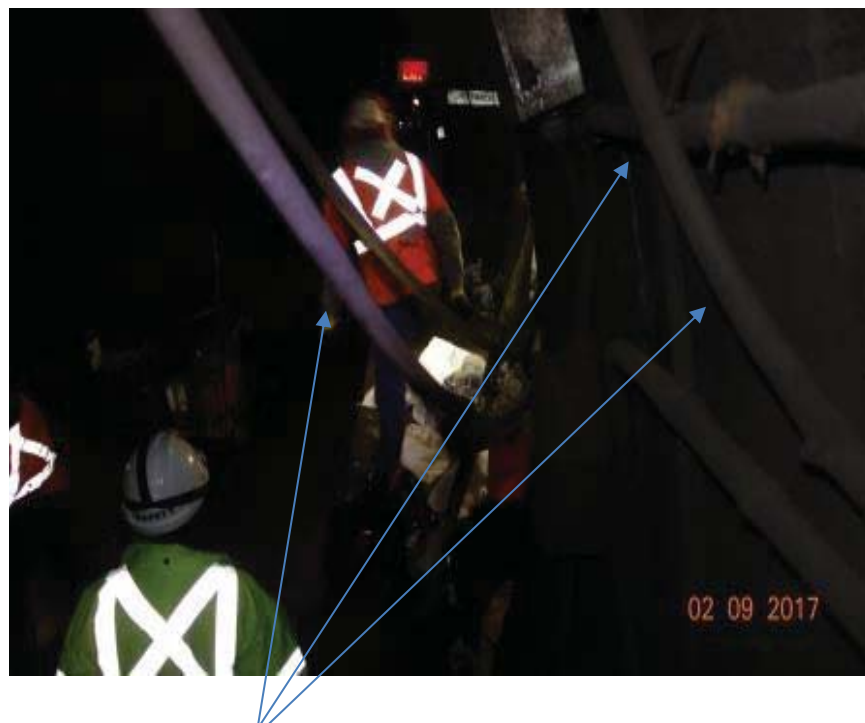
Dangling electrical cables hindering walkway, individuals using the walkway must physically move the cables to get through.

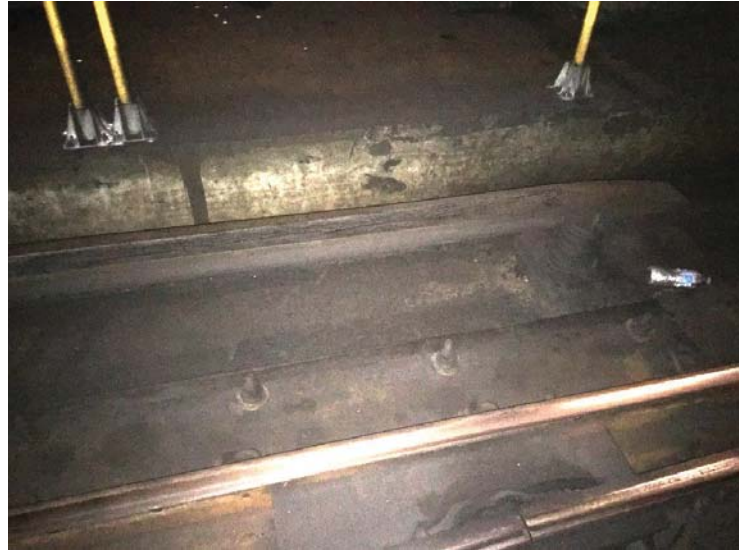
FIGURE 2 - TRK 1 CM 222+00 – 3RD RAIL END APPROACH CORRODED

Remedial Action	<ul style="list-style-type: none">• TRK 1 CM 194+00 – Mitigate water intrusion in tunnel• TRK 1 CM 222+00 – Replace 3rd rail end approach• TRK 1 CM 235+00 – Replace cables that have temporary repairs• TRK 1 CM 236+00 – Replace cable with temporary repair• TRK 1 CM 246+00 – Replace 3rd rail end approach• TRK 1 CM 261+00 – Replace cable with temporary repair• TRK 1 CM 261+00 – Install missing Kindorf straps

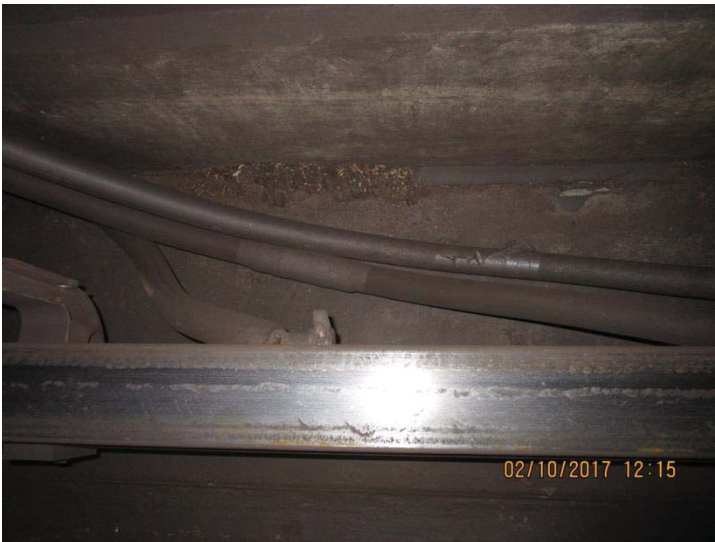
FIGURE 1 - TRK 1 CM 194+00 – WATER INTRUSION

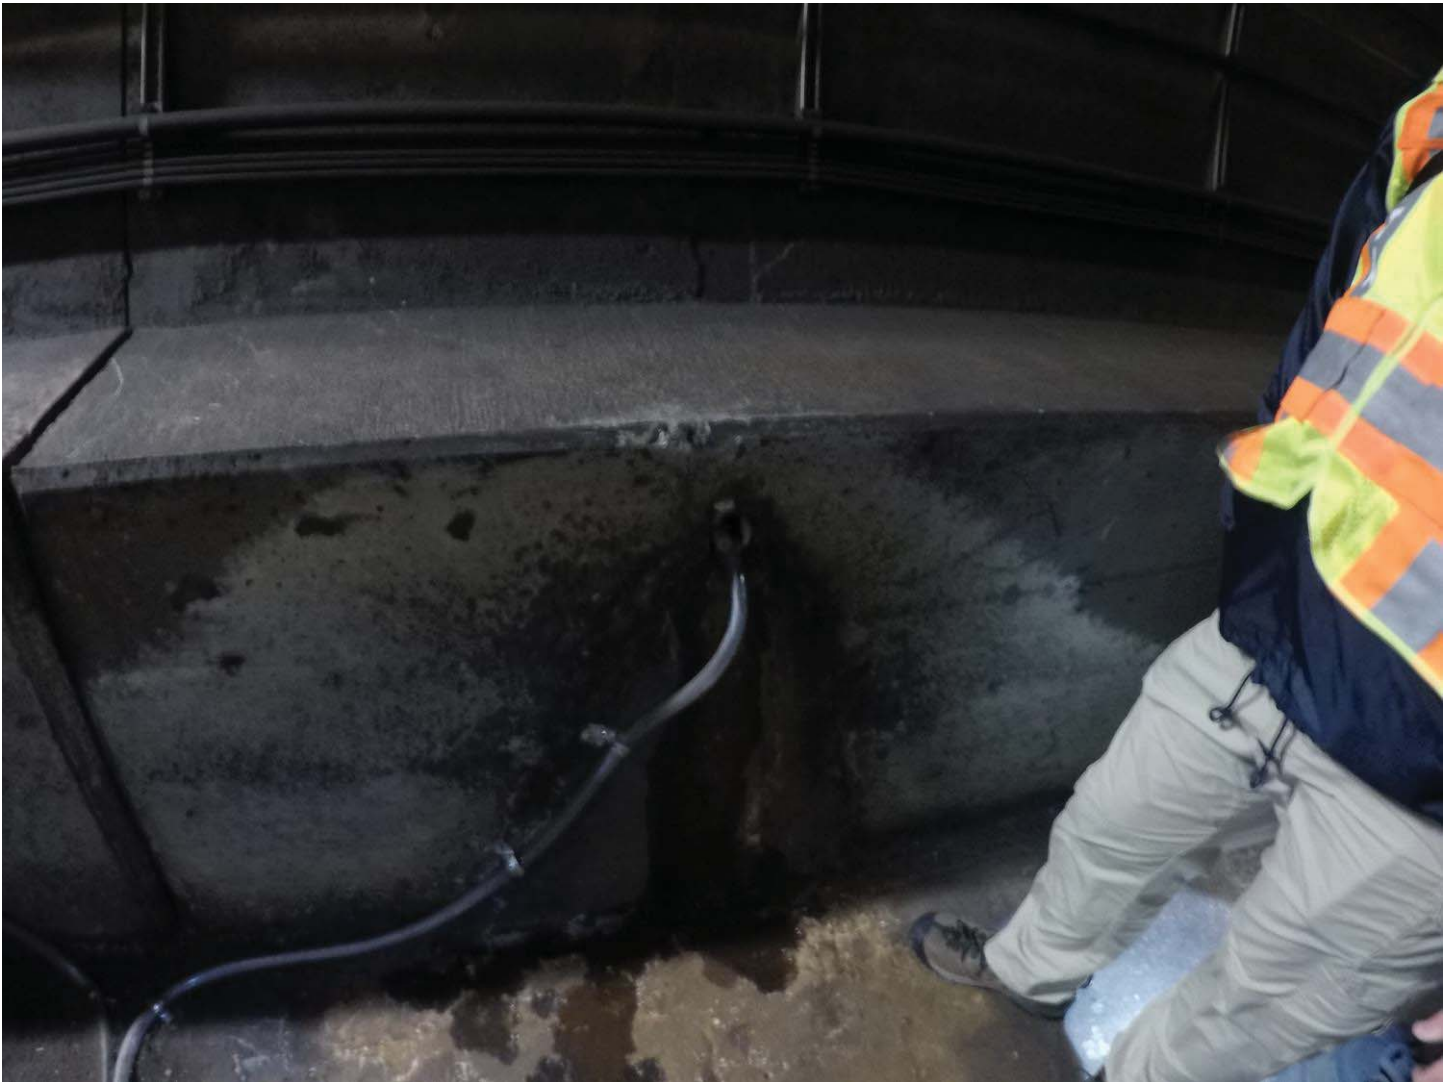
Hosing used to direct water flow

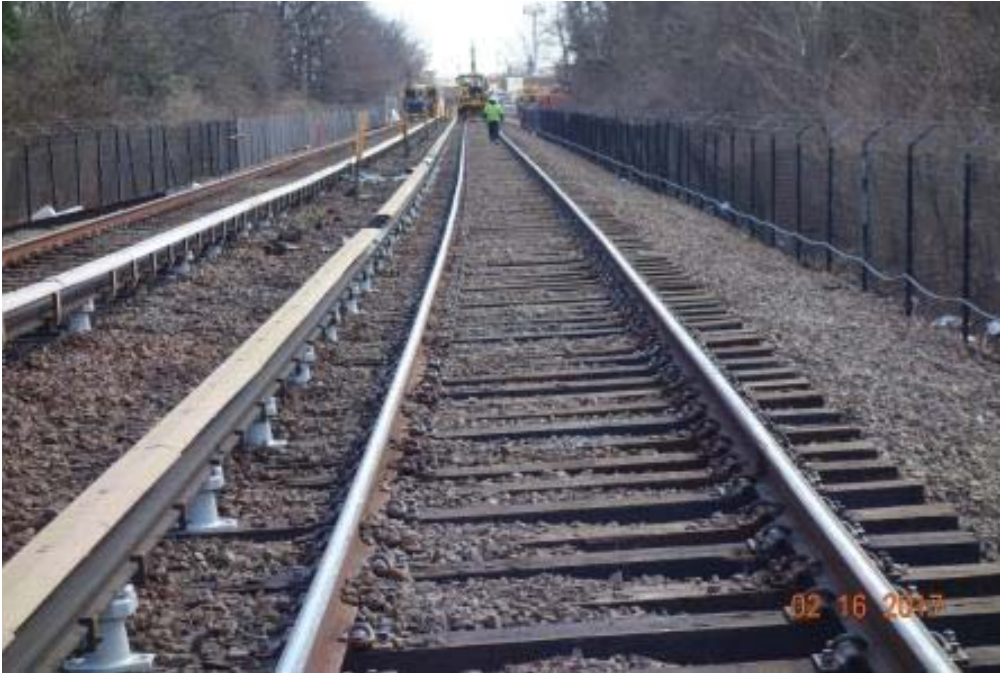
Recently replaced ties in surge area

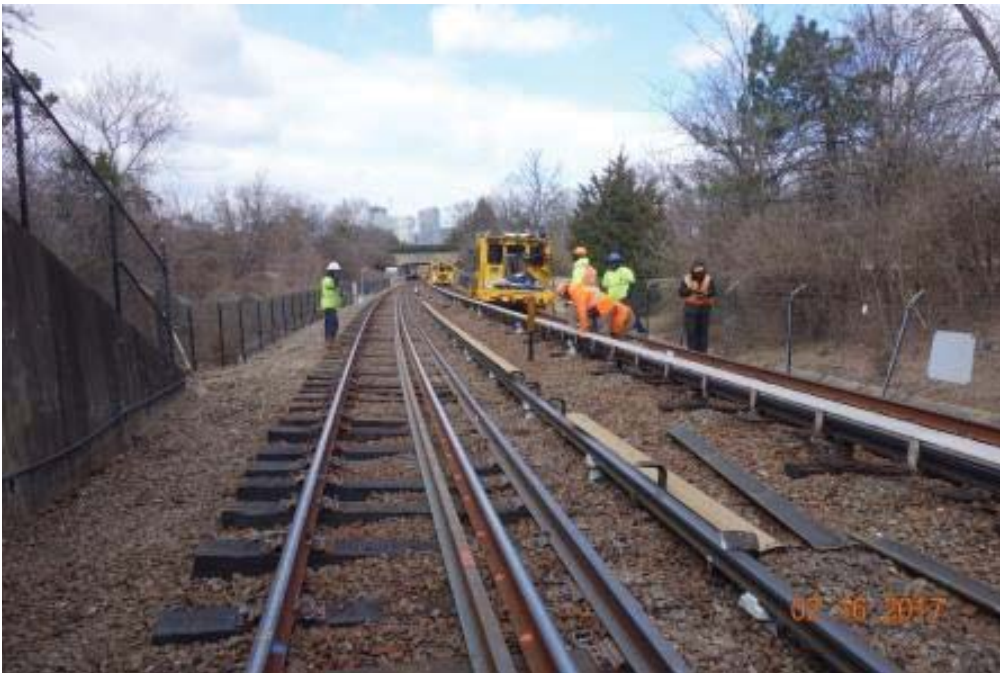
Tie crew replacing ties in surge area

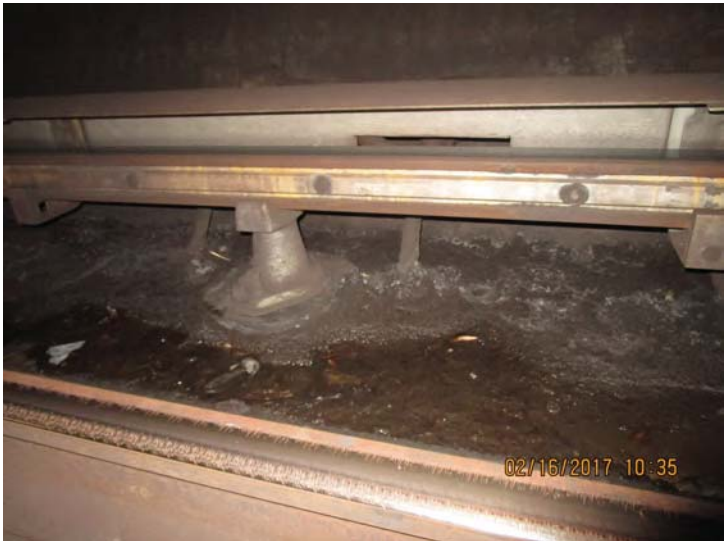
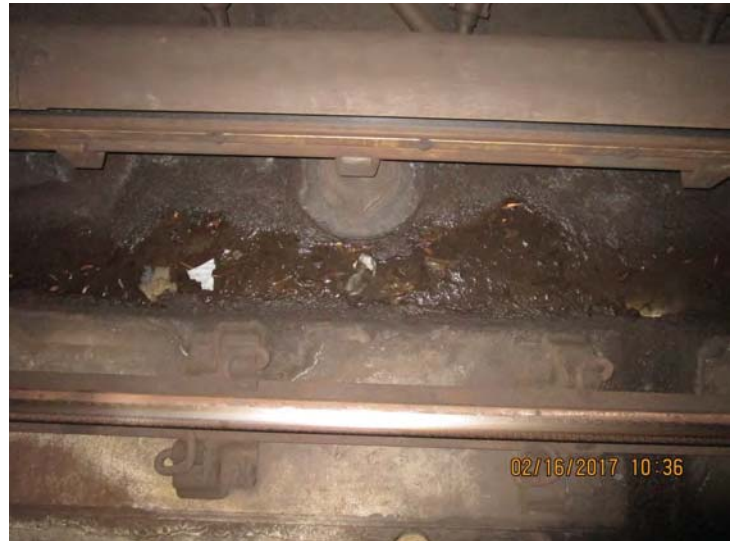
FIGURE 1 - TRK 1 CM 106+00 – WATER INTRUSION SURROUNDING CABLES

Remedial Action	<ul style="list-style-type: none">• TRK 1 CM 106+00 – Mitigate water intrusion, megger cables to ensure cables have not been compromised and if so, then replace those cables• TRK 1 CM 063+00 – Reattach Kindorf channel to the tunnel wall per Engineering Modification Instruction (EMI)• TRK 1 CM 023+00 – Replace heat shrink on conduit stub-up

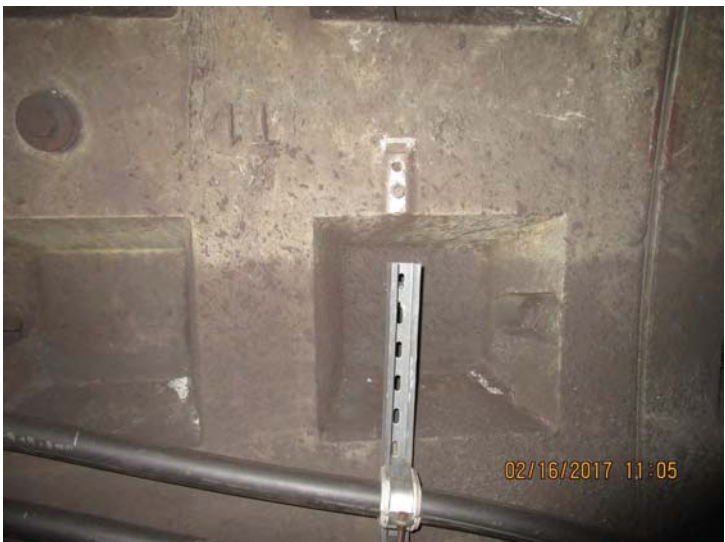
FIGURE 2 - TRK 1 CM 063+00 – KINDORF CHANNEL NEEDS REATTACHMENT TO TUNNEL WALL

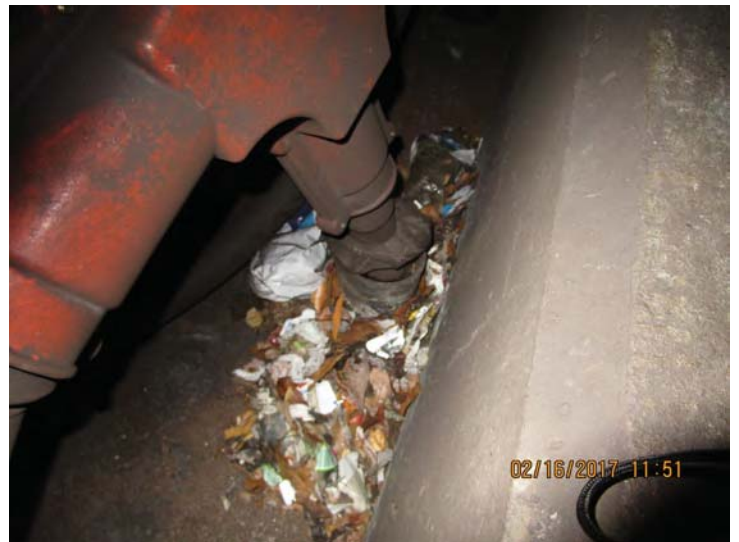
FIGURE 3 - TRK 1 CM 023+00 – HEAT SHRINK NEEDS REPLACEMENT ON STUB-UP AND TRASH SURROUNDING CABLE

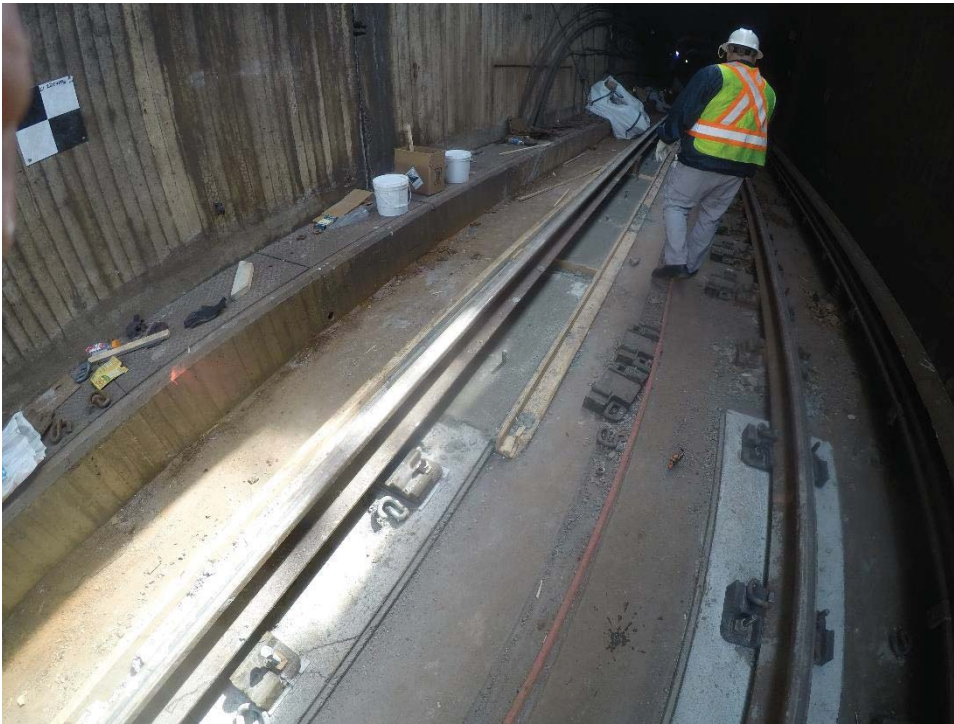
Grout Pad Renewal in Progress

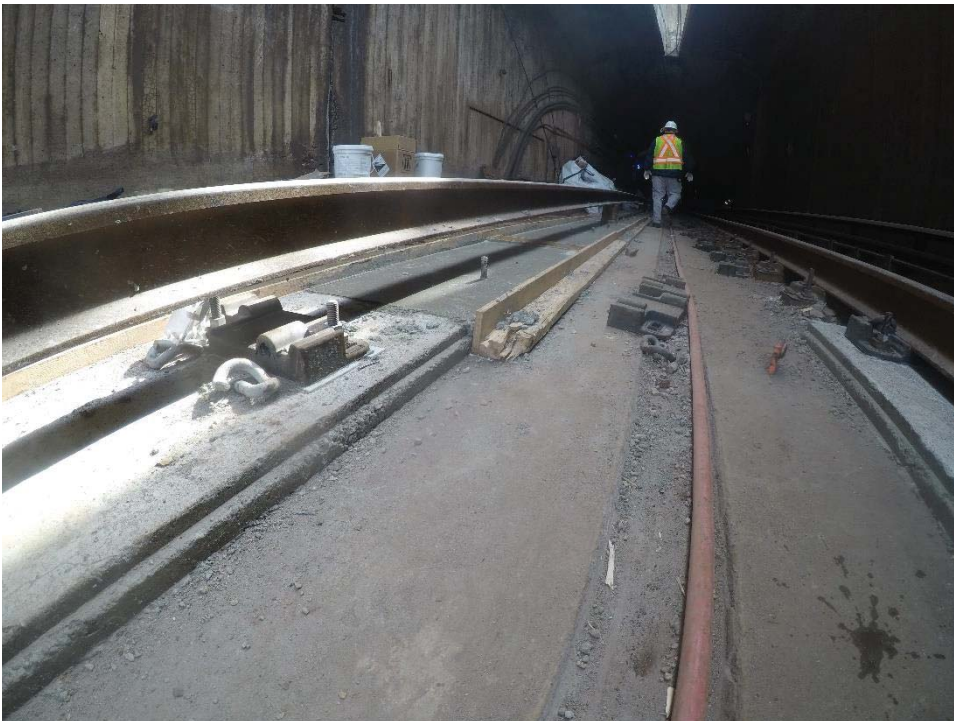
Elevated Rail during grout pad renewal

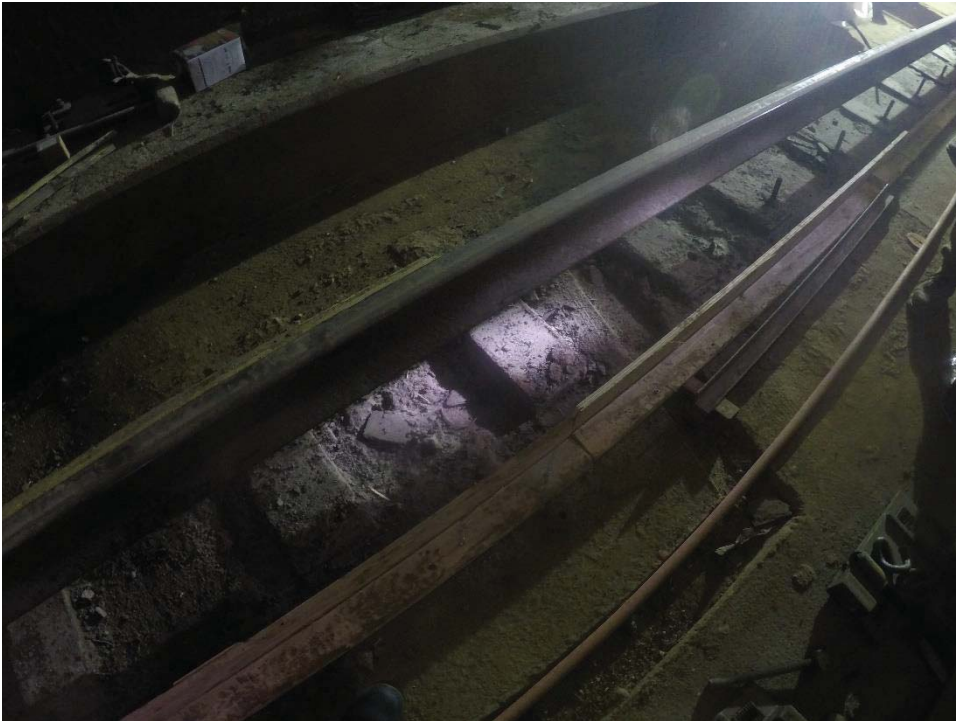
Old Grout Pads in the process of being jackhammered out

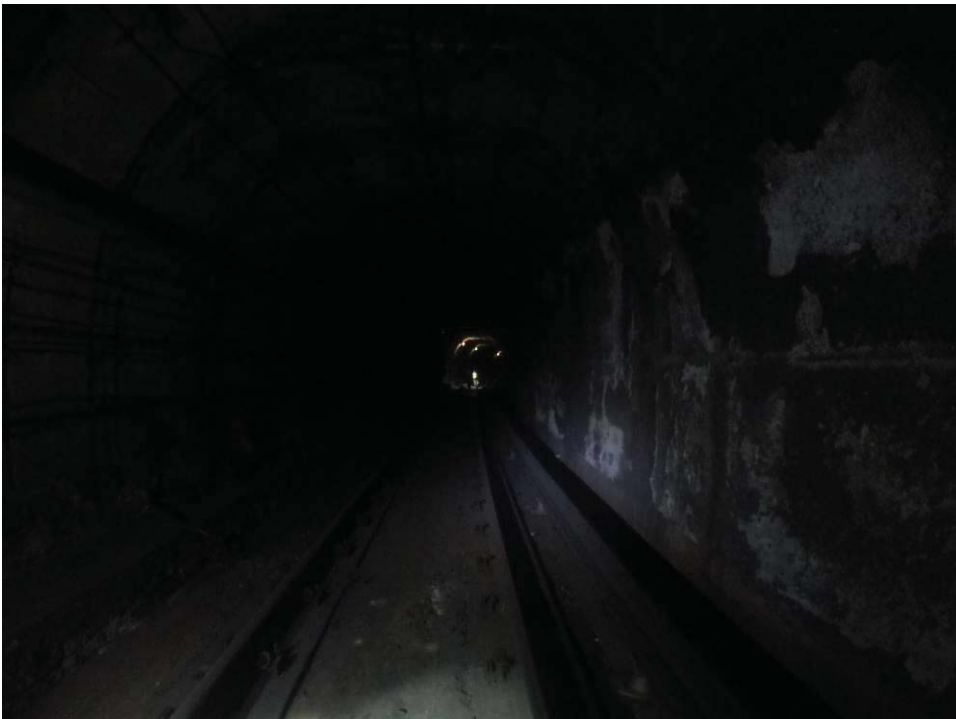
Lighting in Tunnel in surge area

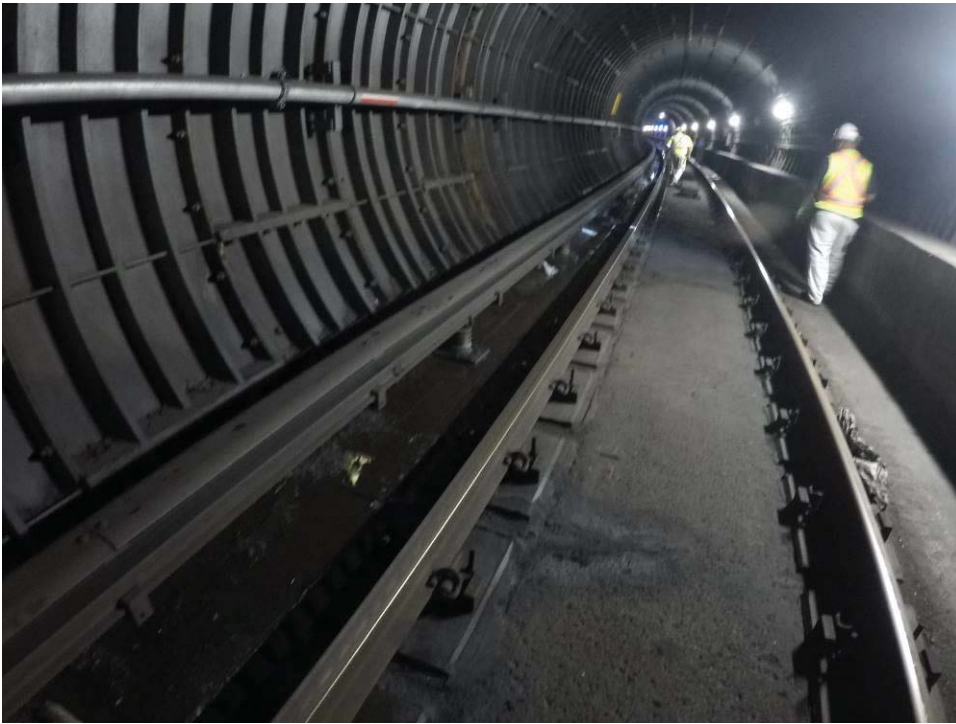
Standing Water underneath third rail at D1 74+30
