Inspection Form

Form FTA-IR-1

United States Department of Transportation
Federal Transit Administration

Inspection Date	YYYY	MM	DD	Report Number	20170201-WMATA-CB-1		
	2017	02	01				
Rail Agency Name	Washington Metropolitan Area Transit Authority			Rail Agency Department	TRST	Sub- Department	TKIN
Rail Agency Department Contact Information	Name			Email		Office Phone	
	[REDACTED]			[REDACTED]		[REDACTED]	
	[REDACTED]			[REDACTED]		[REDACTED]	
	[REDACTED]			[REDACTED]		[REDACTED]	
	[REDACTED]			[REDACTED]		[REDACTED]	
	[REDACTED]			[REDACTED]		[REDACTED]	
Inspection Location	Rockville (A14) to Twinbrook (A13) on the A Line, Track 2

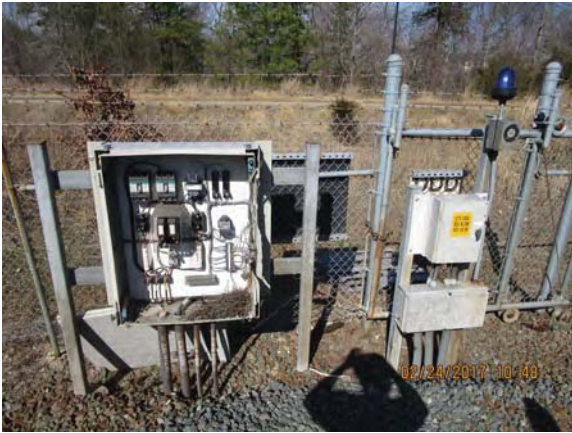
FIGURE 1 - TRK 2 CM 850+00 – TRACKSIDE HEATER PANEL DOOR MISSING

Remedial Action	<ul style="list-style-type: none">• TRK 2 CM 850+00 – Replace door to trackside heater panel• TRK 2 CM 827+00 – Replace running rail jumper cables (2)• TRK 2 CM 826+00 – Repair conduit stub-up• TRK 2 CM 782+00 – Repair conduit stub-up and replace running rail jumper cables (2)• TRK 2 CM 731+00 – Repair conduit/OZ Gedney Bushing• TRK 2 CM 705+00 – Replace and adjust 3rd rail post insulator

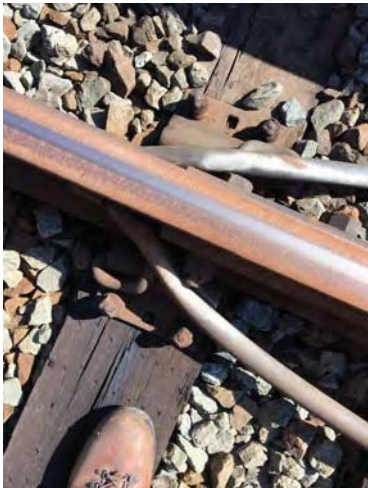
FIGURE 2 - TRK 2 CM 827+00 – RUNNING RAIL JUMPER CABLES WORN

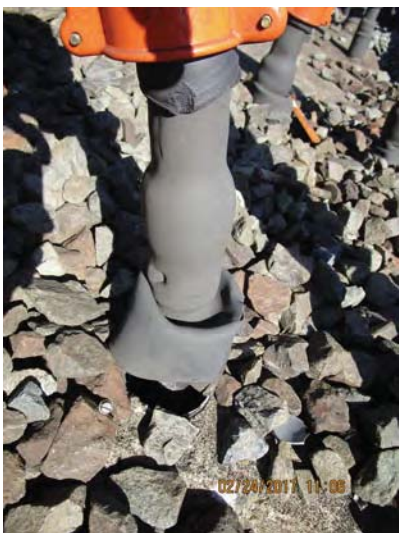
FIGURE 3 - TRK 2 CM 826+00 – CONDUIT STUB-UP AND
HEAT SHRINK COMPROMISED

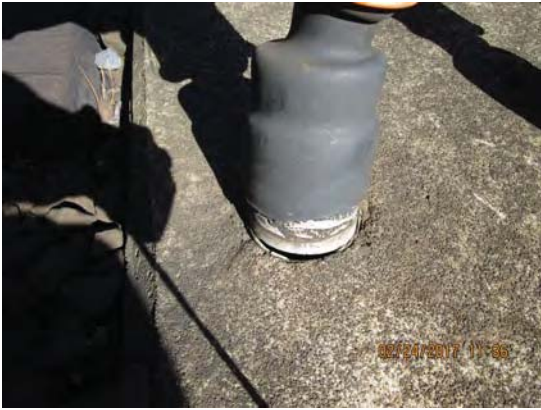
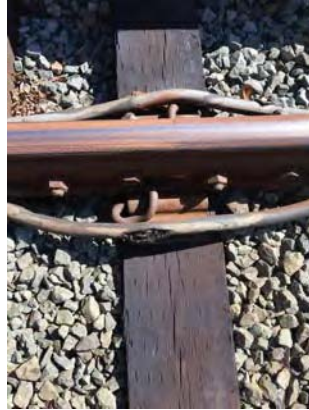
FIGURE 4 - TRK 2 CM 782+00 – CONDUIT STUB-UP BROKEN AND RUNNING RAIL JUMPER CABLES BADLY WORN

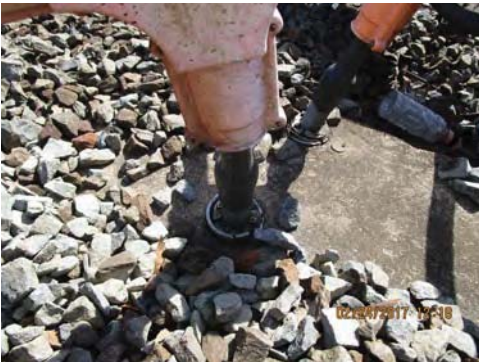
FIGURE 5 - TRK 2 CM 731+00 – CONDUIT/OZ GEDNEY BUSHING BROKEN

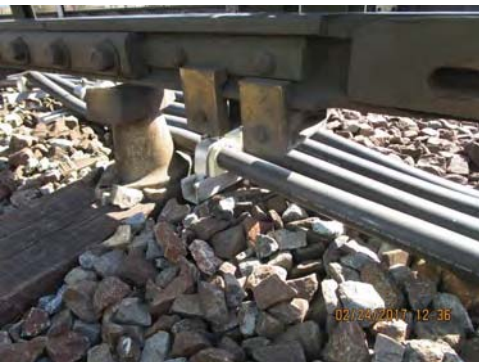
FIGURE 6 - TRK 2 CM 705+00 – 3RD RAIL INSULATOR NOT SUPPORTING 3RD RAIL

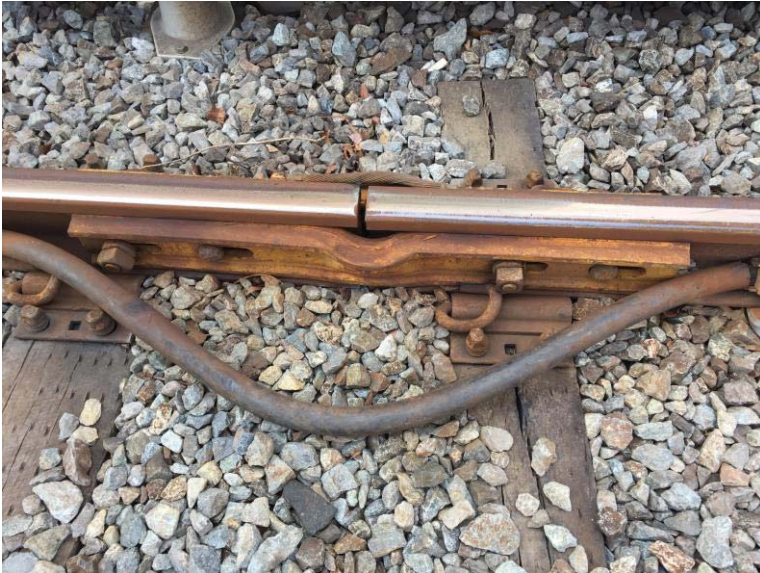
Welding strap bars being used as angle bars

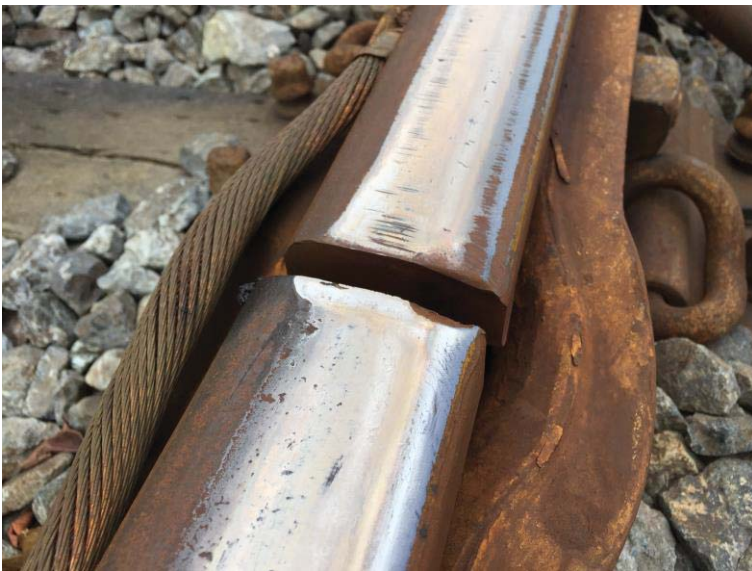
Welding straps allowing a 1/8 gage side mismatch. A wheel flange could possibly pick this mismatch allowing the wheel climb onto the rail and cause the railcar to derail.

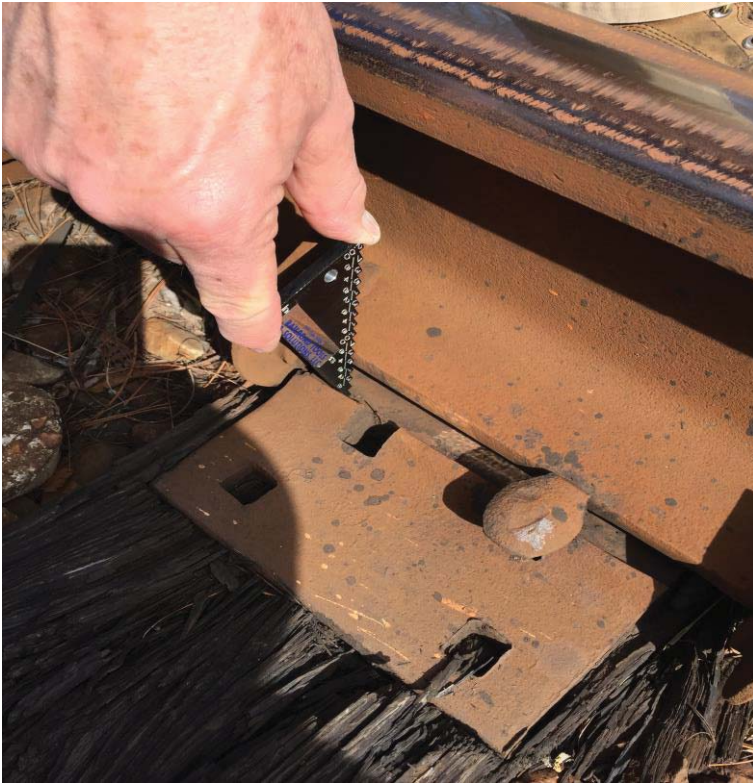
Rail not properly seated in rail plates permitting 1-inch dynamic vertical deflection under load.

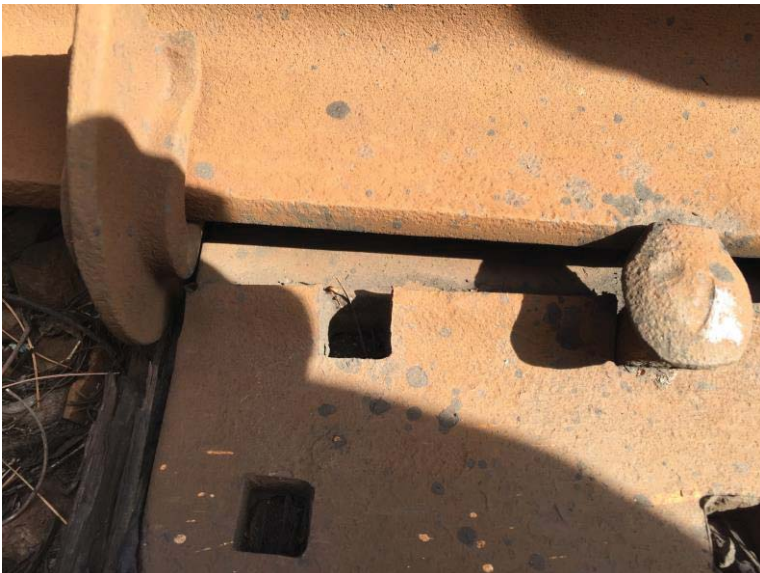
3/4 -inch gap between base of rail and rail plate

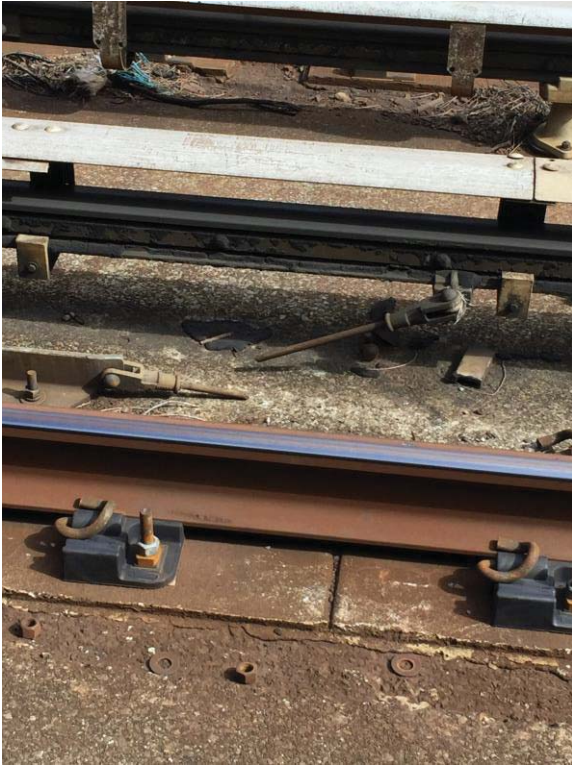
Broken third rail support cable.

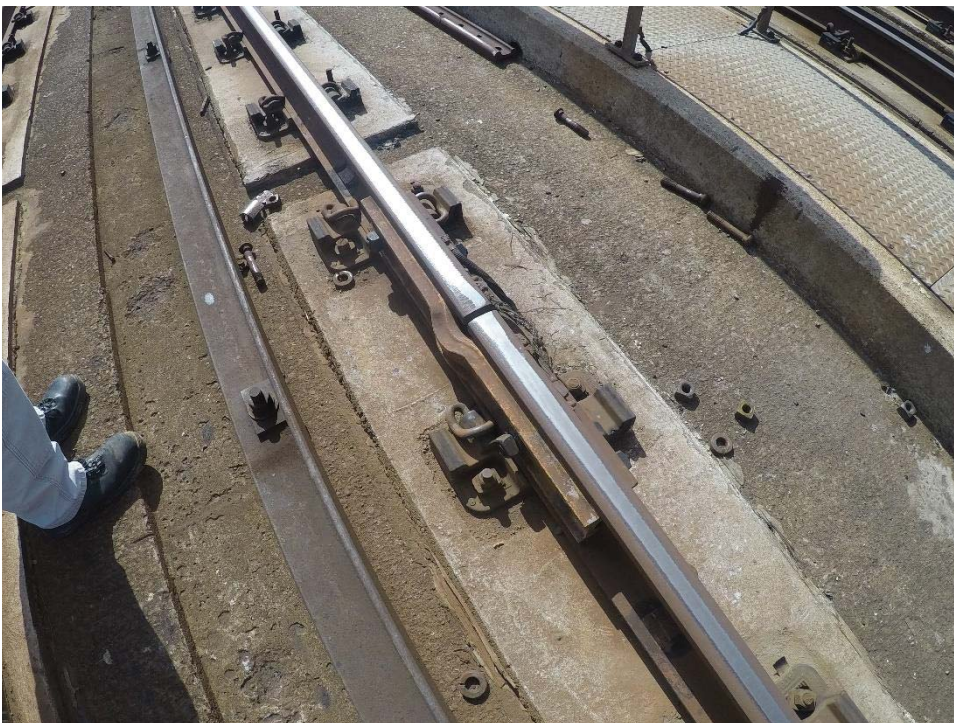
Joint Bar mismatch at A2 517+20

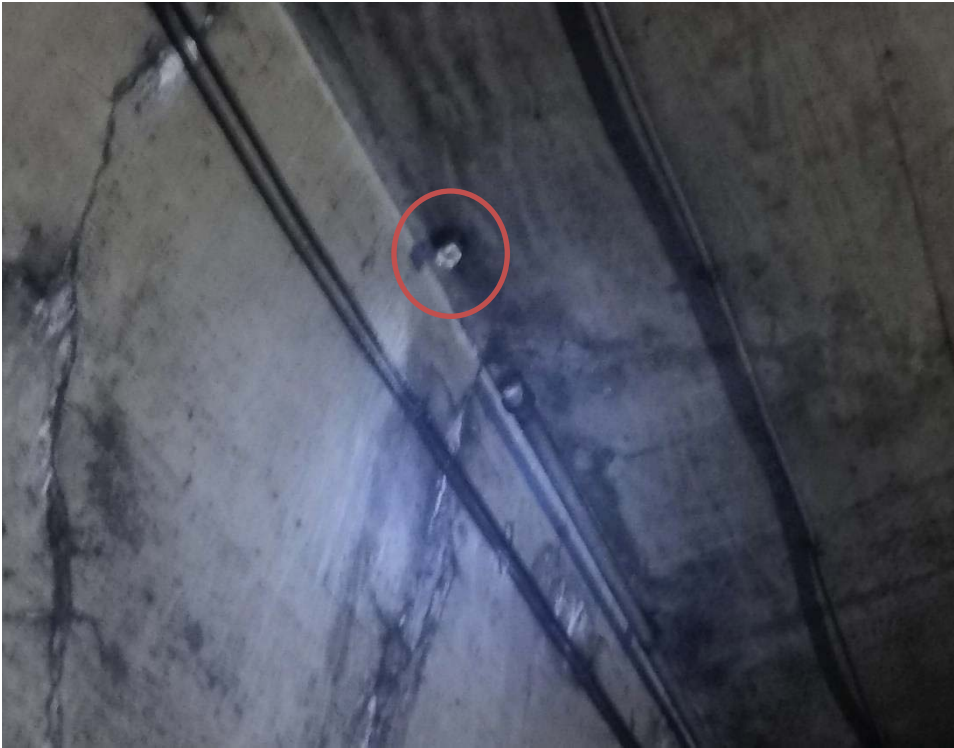
Broken Pipe at A2 451+00

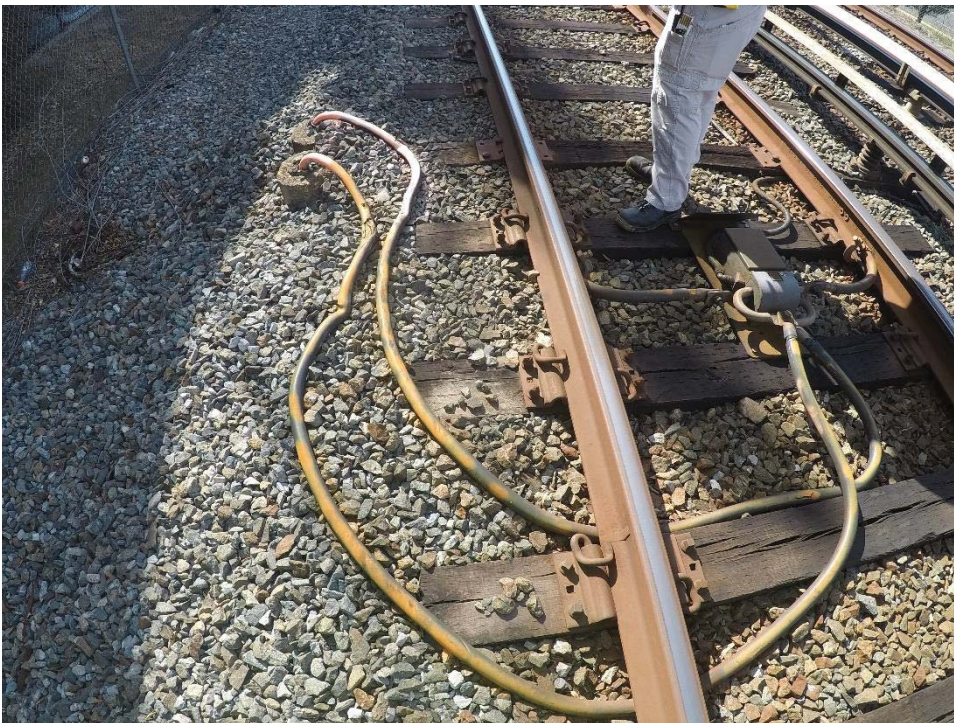
Deteriorating insulation on negative return cables at A2 551+40
