Inspection Form

Form FTA-IR-1

Inspection Date	YYYY	MM	DD	Report Number	20170301-WMATA-WP-1		
	2017	03	01				
Rail Agency Name	Washington Metropolitan Area Transit Authority			Rail Agency Department	TRST	Sub- Department	Maintenance
Rail Agency Department Contact Information	Name		Email		Office Phone		Mobile Phone
	[REDACTED]		[REDACTED]		[REDACTED]		[REDACTED]
	[REDACTED]		[REDACTED]		[REDACTED]		[REDACTED]
	[REDACTED]		[REDACTED]		[REDACTED]		[REDACTED]
Inspection Location	A-Line, track 1, between Bethesda Station and Grosvenor-Strathmore

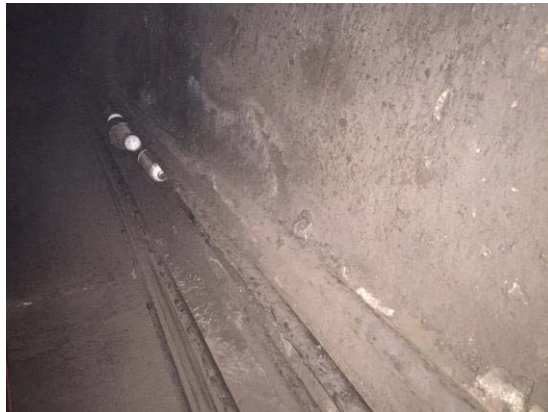
Conduit that became unattached from the wall and lying on the walkway

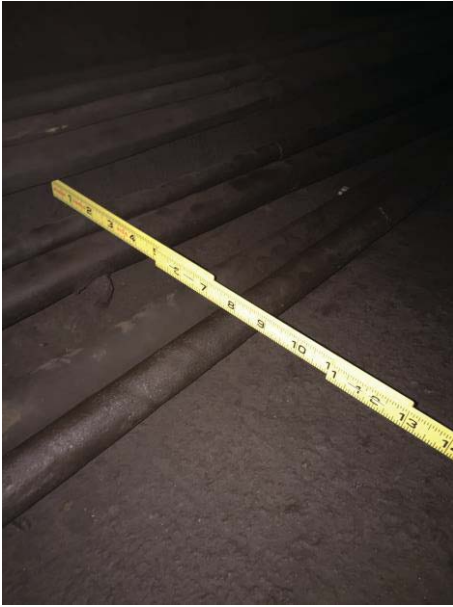
Unsecure conduit from the wall on the walking occupying 8-1/2 of the 24-inch walkway, leaving only 15-1/2 inches of useable walkway in the event of a train evacuation of passengers.

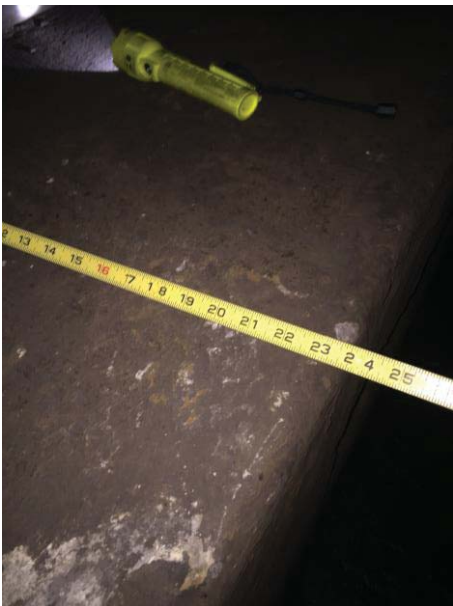
Walkway measurement

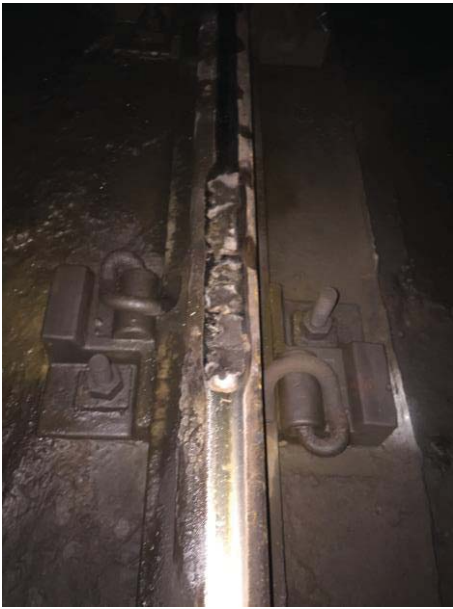
Damaged running surface of rail.

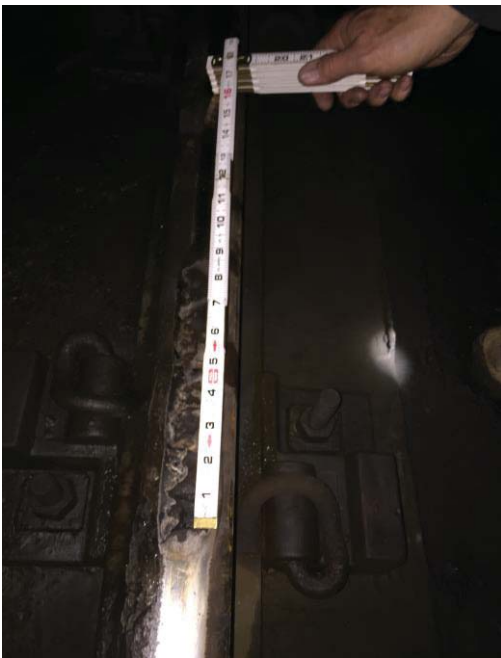
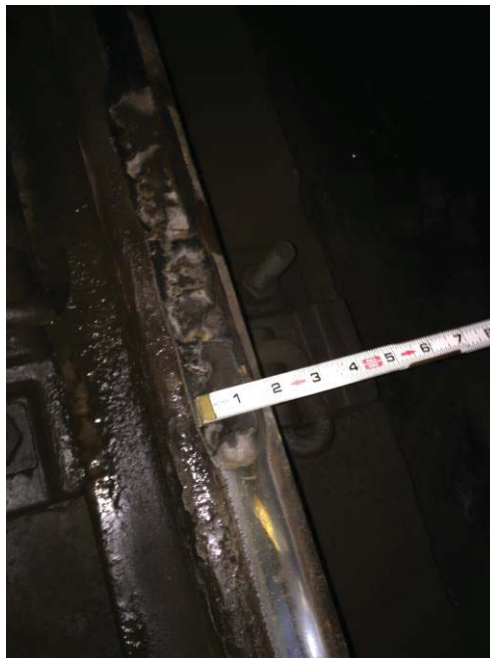
Defect measurements.

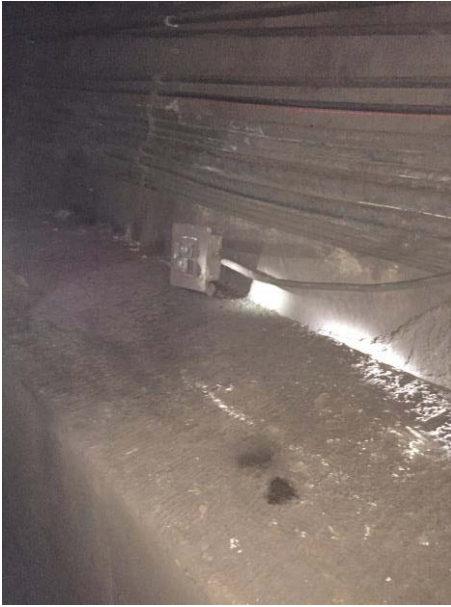
110-volt electrical box unsecured from the wall and on the walkway

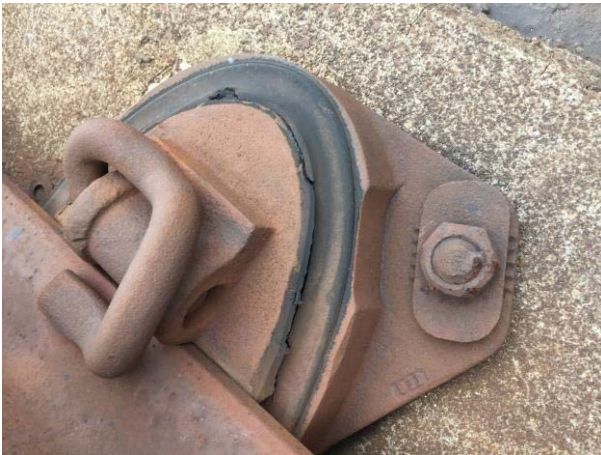
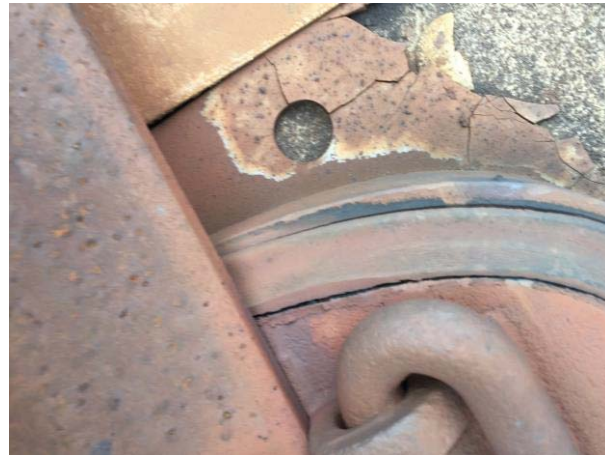
Broken and cracked egg fasteners. 360 degree cracks, not secure to the fastener and allowing rails to float, which threatens track geometry.

<ul style="list-style-type: none">• At CM 510+98 at the portal, the ETS box has no cover.• Between CM 541 and 546 on the Grosvenor aerial structure—both tracks—the egg shape fasteners are failing. This condition is allowing the rail to float in an unsecure manor, which threatens track geometry. Due to the distance between non-defective supporting fasteners, this defect is a black condition.• At CM 547+30 next to the third rail power cables, there are five defective ties in-a-row. Due to the distance between non defective ties and holding spikes, this defect is a red condition.		
Remedial Action	<ul style="list-style-type: none">• Between CM 402+00 and CM 413+ 00, the relay rail must be collected, and the mud and debris must be cleared away.• At CM 442+30, the arching insulator must be replaced.• At CM 451+60, the leaking valve must be repaired or replaced.• Between CM 467+00 and 468+00, the wires obstructing the walkway must be re-secured to the wall.• At CM 482+00, the 110-volt electrical box must be re-secured to the wall.• Between CM 487+00 and the vent shaft, the wires obstructing the walkway must be re-secured to the wall.• At CM 497+00 on the left and right rail, the fasteners must be tightened or replaced.• At CM 497+00 left rail, the rail head defect must be repaired.• At CM 510+98 at the portal, the ETS box cover must be replaced.• Between CM 541 and 546 on the Grosvenor aerial structure—both tracks—WMATA must assess the condition of the egg shape fastener on the aerial structure. Until that time, WMATA must apply a speed restriction and gage rods must be installed to protect gage.• At CM 547+30 next to the third rail power cables, WMATA must replace the five defective ties in-a-row.

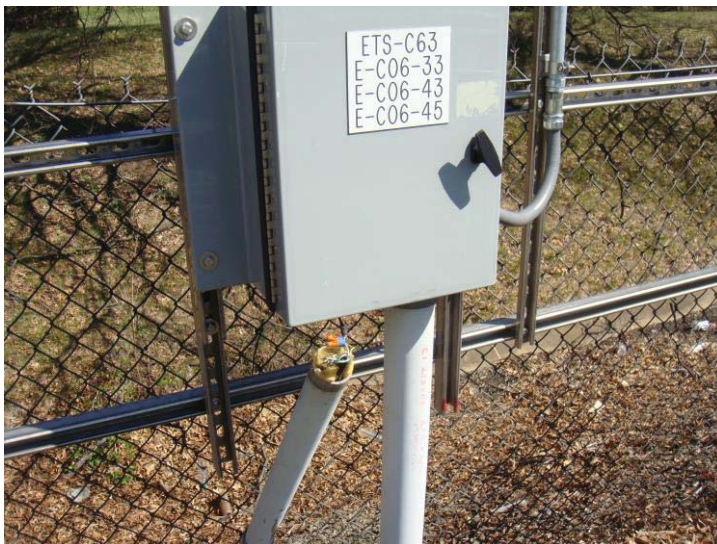
Figure 1 - C63 - Broken Conduit

Recommended Reinspection?		No		
Remedial Action	<ul style="list-style-type: none">WMATA must repair ETS box number C-51.WMATA must repair ETS box number C-63.

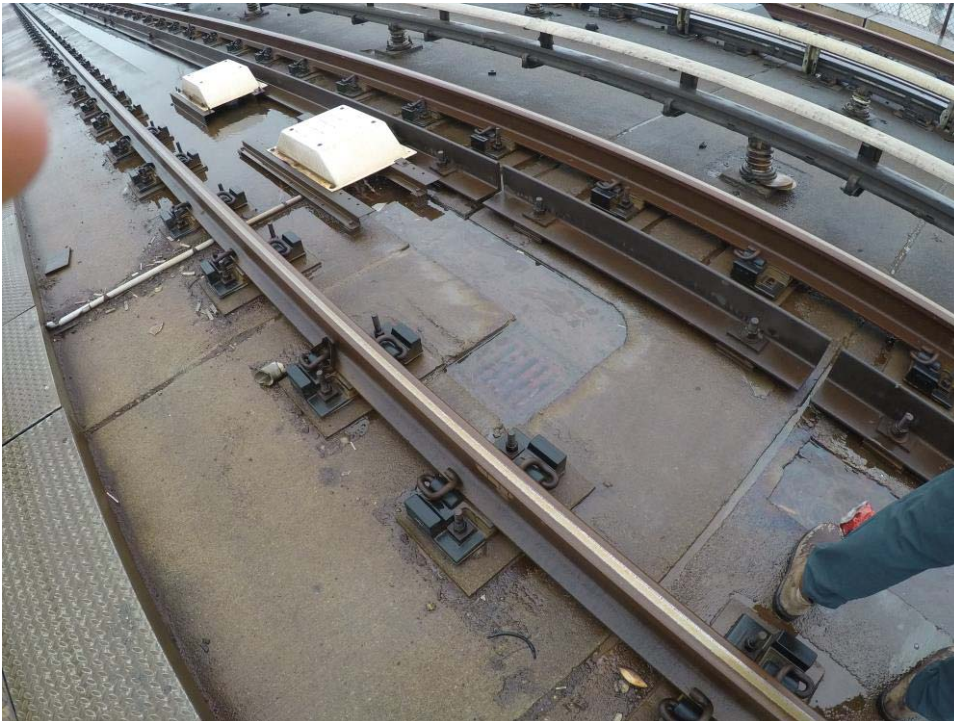
Clogged Drain at C1 603+00

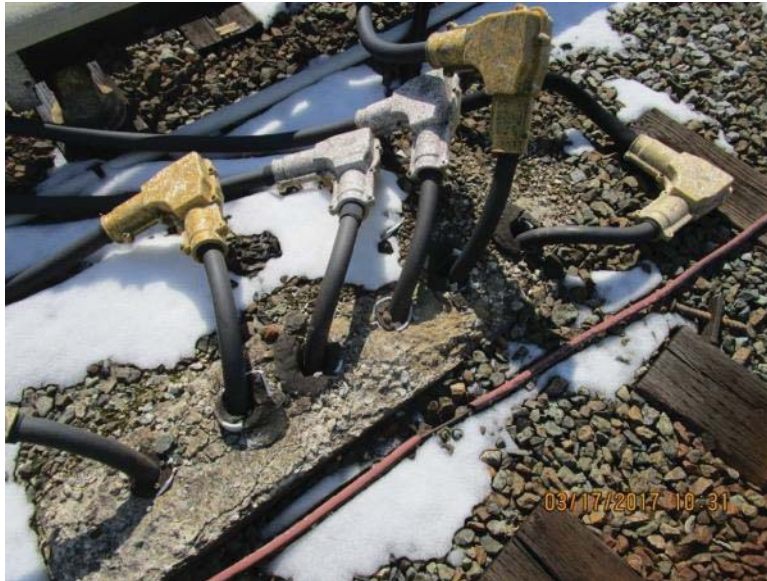
FIGURE 1 - YCR (YARD CONTACT RAIL) 81 – CONDUIT STUB-UPS BROKEN

Remedial Action	<ul style="list-style-type: none">• YCR 81 – Replace conduit stub-ups• YCR 81 – Replace OZ Gedney bushings• YCR 16 – Replace missing heat shrink on conduit stub-ups• YCR 25 – Replace heat shrink on conduit stub-ups

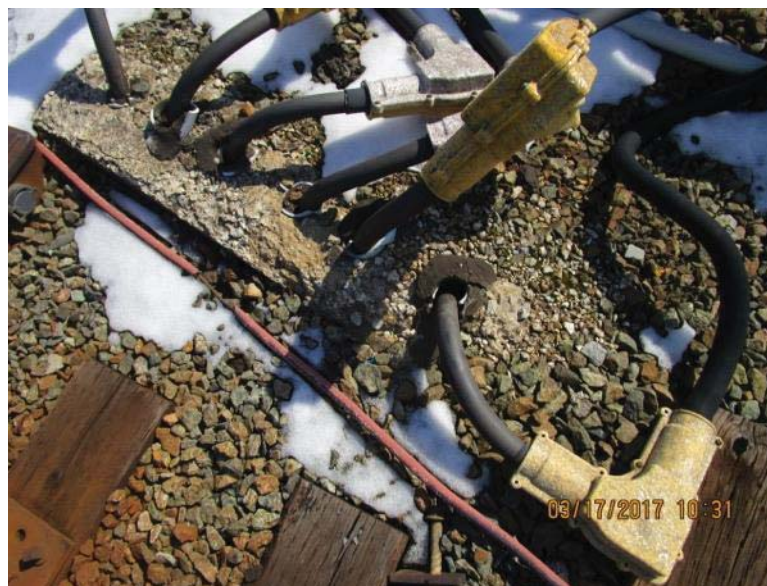
FIGURE 2 - YCR (YARD CONTACT RAIL) 81 – OZ GEDNEY BUSHINGS COMPROMISED

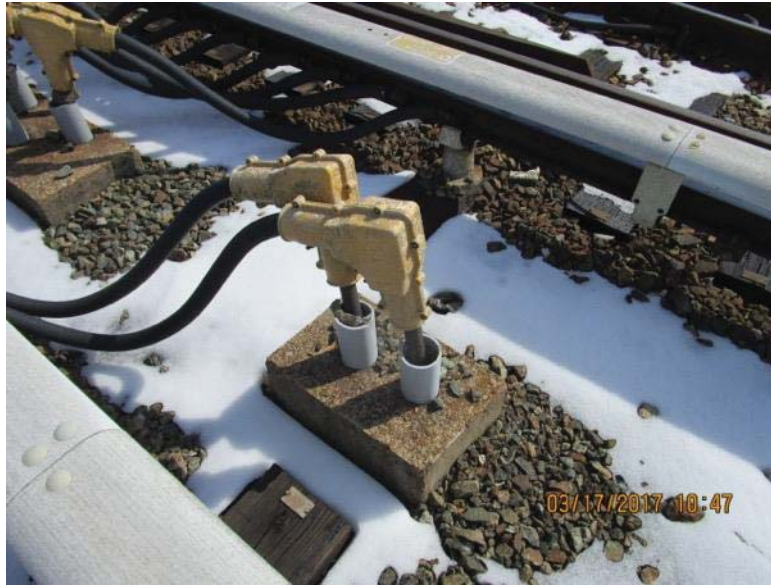
FIGURE 3 - YCR (YARD CONTACT RAIL) 16 – MISSING HEAT SHRINK ON CONDUIT STUB-UPS

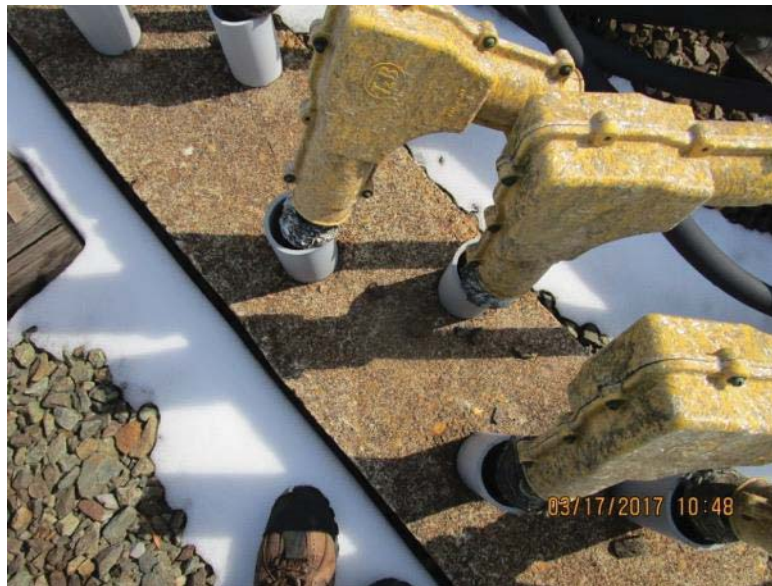
FIGURE 4 - YCR (YARD CONTACT RAIL) 25 – HEAT SHRINK COMPROMISED ON CONDUIT STUB-UPS

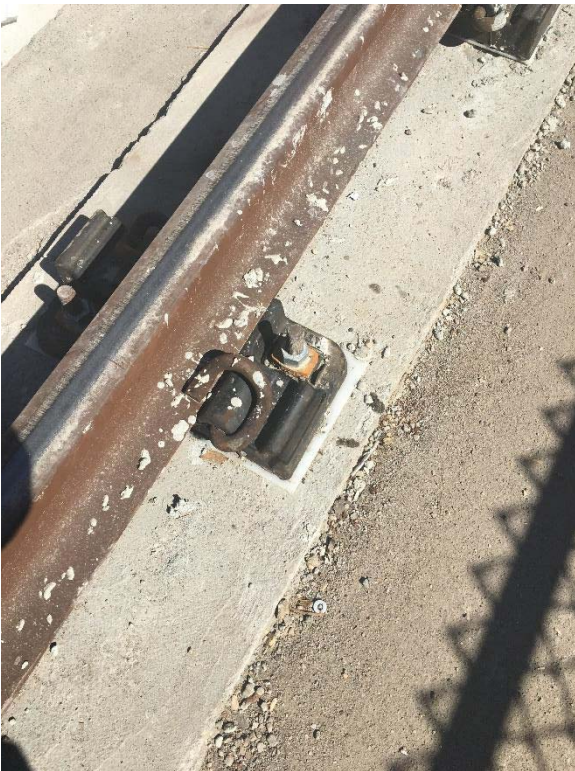
Overdriven Clip observed and reported to TRST Quality Officer

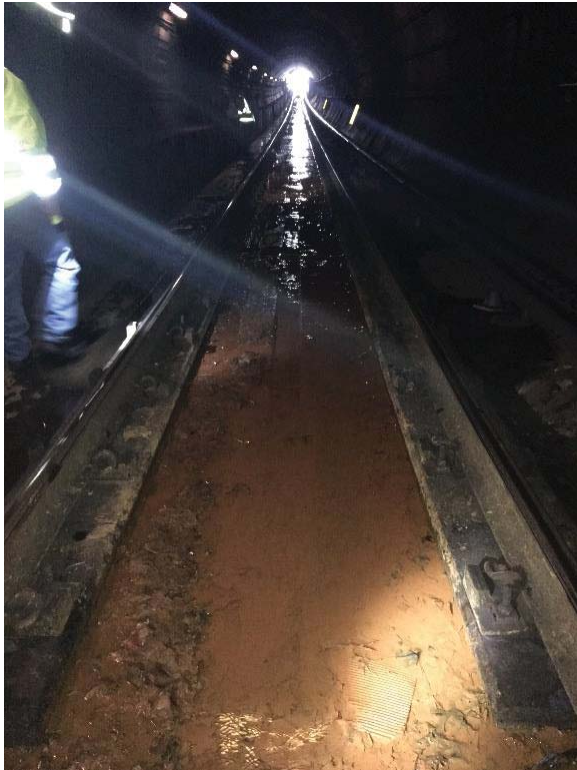
Poor drainage at D2 226+50.

Other Notable Observations: <ul style="list-style-type: none">• D2 230+50 – Clog under ATC impedance bond.• D1 226+70 – Clog under marker coil		
Remedial Action	To achieve compliance with WMATA's requirements: <ul style="list-style-type: none">• WMATA must install correct joint bar at D1 270+10.• WMATA must replace defective fasteners at D2 231+50.• WMATA must replace defective fasteners at D2 265+75.• WMATA must elevate cables at D2 262+00.

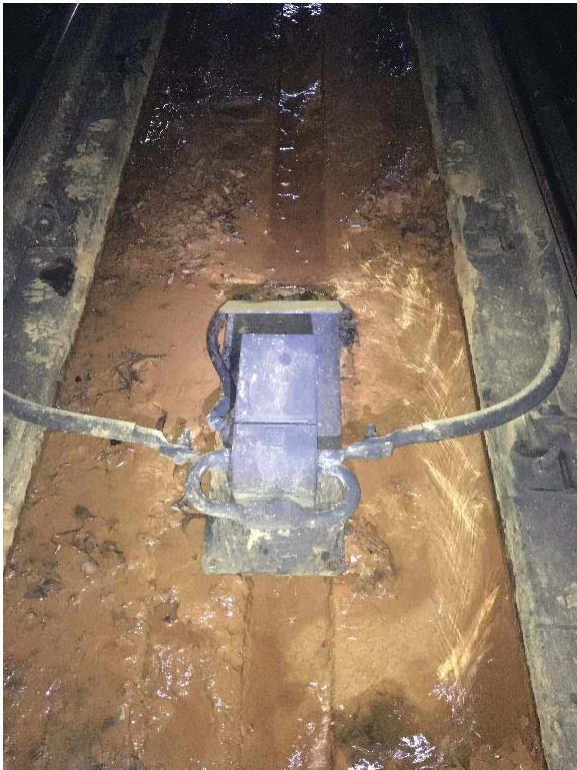
Clog under impedance bond at D2 230+50.

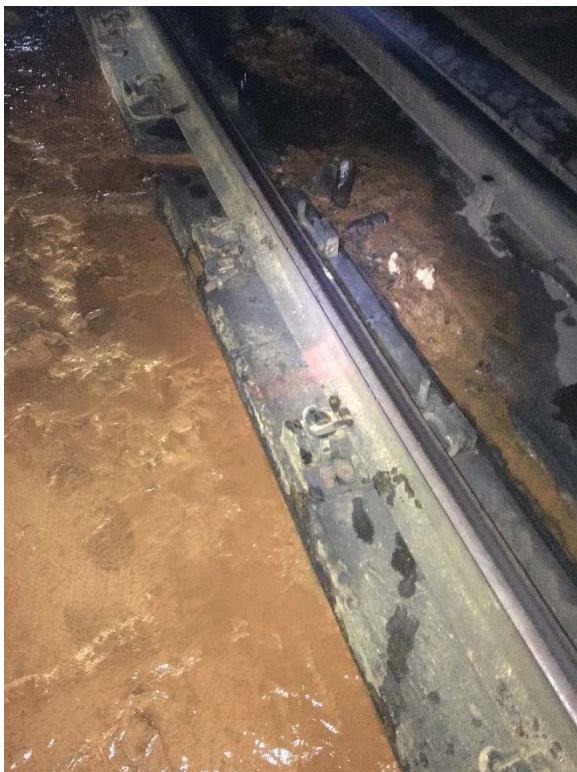
Defective fasteners at D2 231+50.

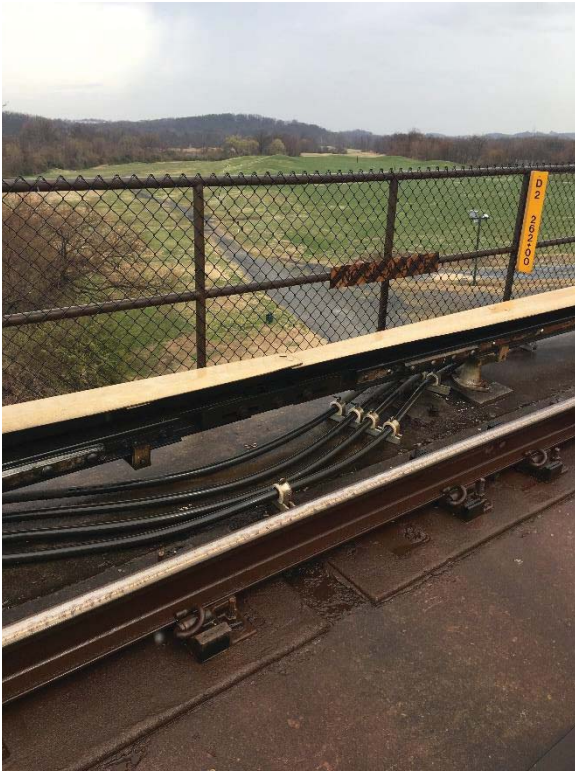
Cables on deck of aerial structure at D2 262+00.

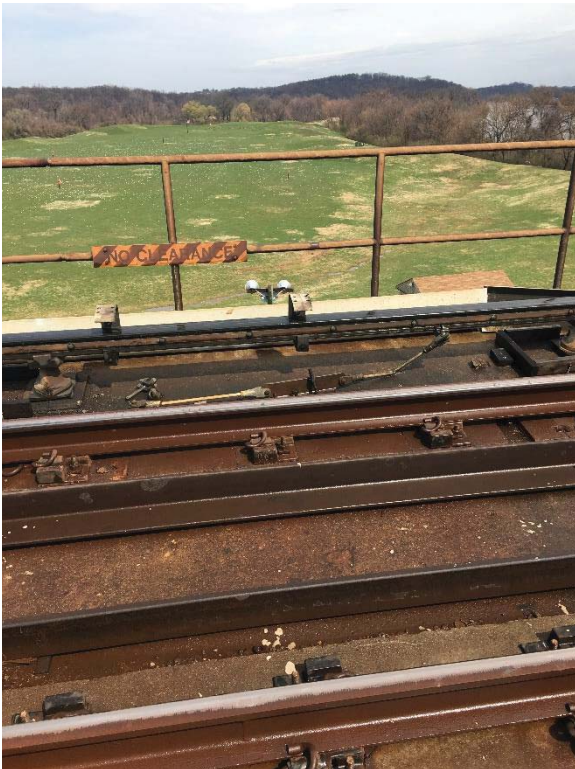
Broken third rail anchor at D2 266+20.

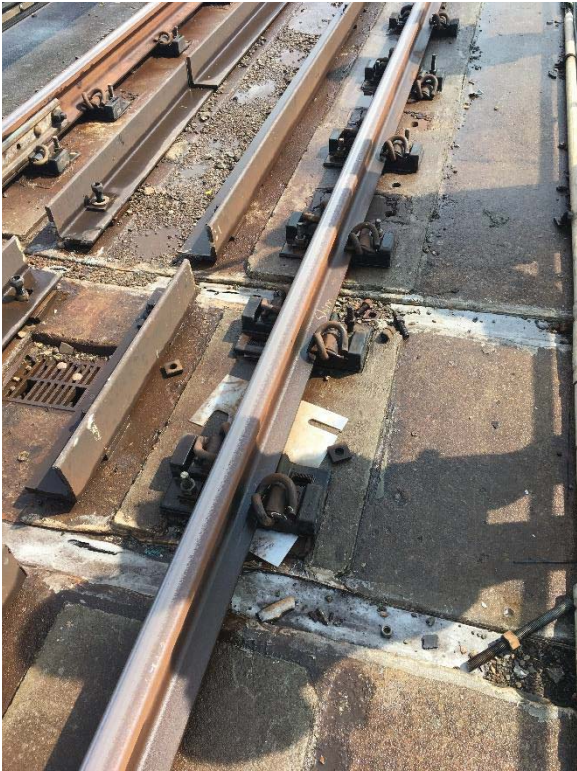
Defective fasteners at D2 265+75.

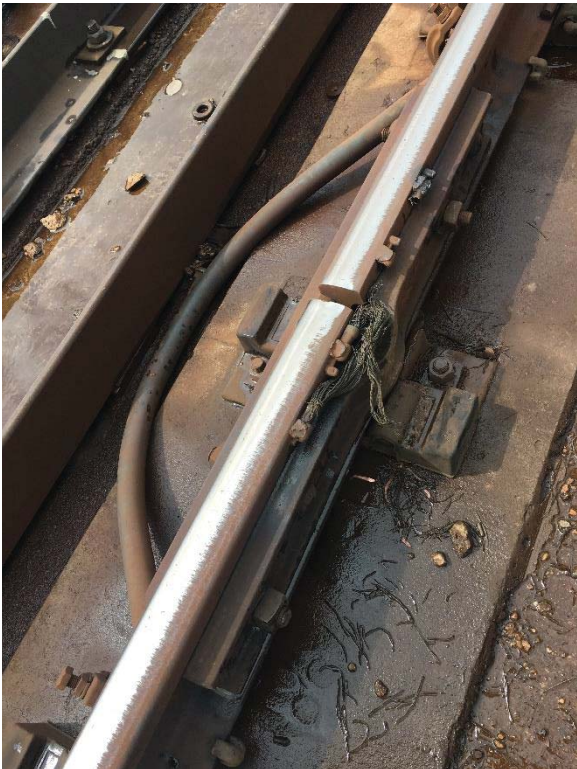
Joint bar mismatch at D1 270+10.

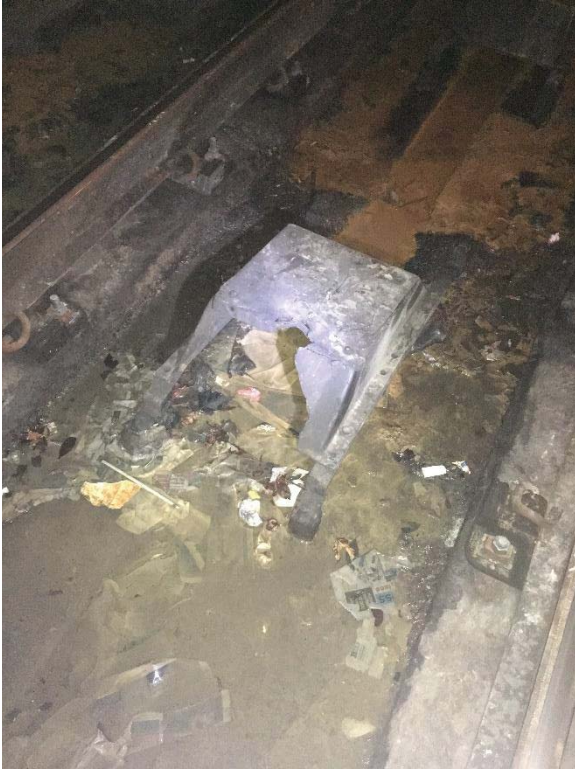
Clog under marker coil at D1 226+70

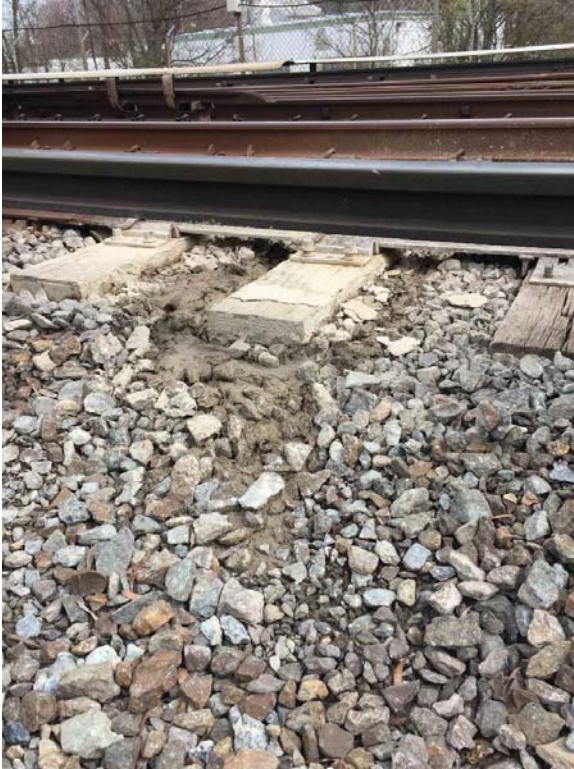
Foul ballast CM 351+10 static condition

- WMATA must tighten switch point protector bolts at B2 351+10, switch 3B.
- WMATA must tighten transit clip switch rod bolts at B2 351+10, switch 3B.
- WMATA must replace ballast and stabilize track geometry between B2 351+10 and 353+50.
- WMATA must tighten guard rail bolts at B2 351+10, switch 3B.
- WMATA must replace missing end approach cover board at B2 354+00.

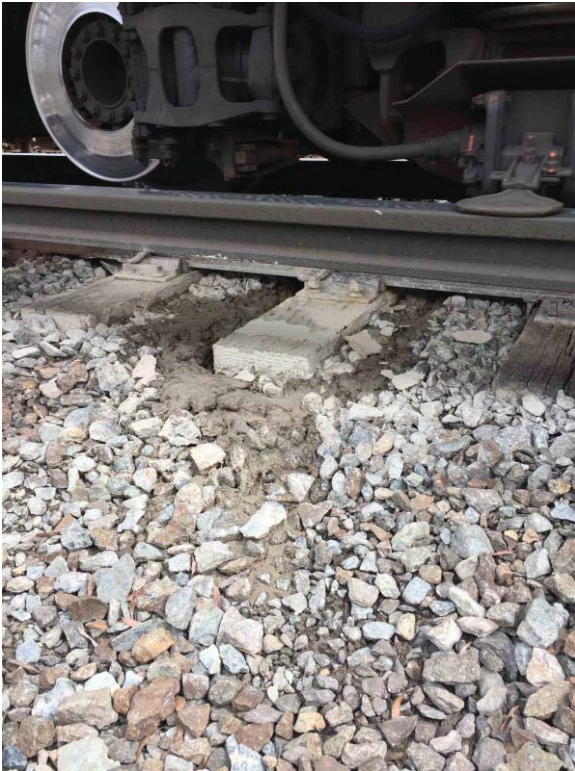
Foul ballast CM 351+10 dynamic condition

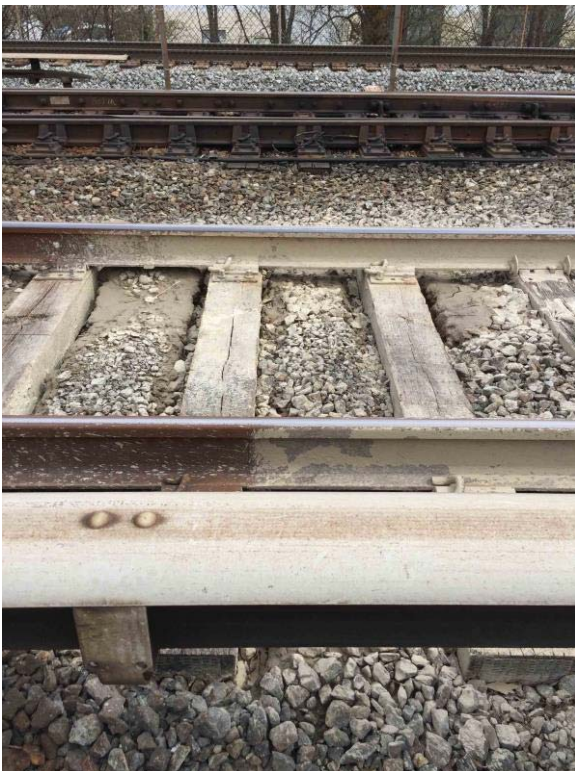
Foul ballast CM 351+50

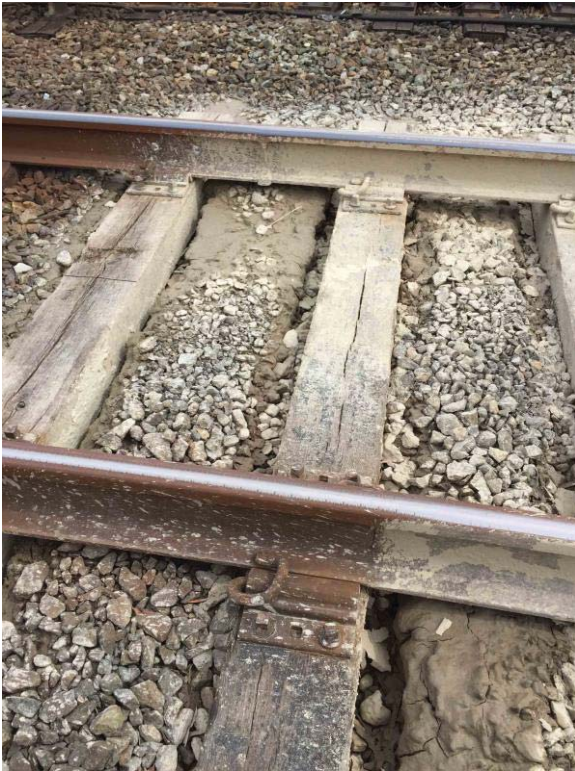
Foul ballast CM 351+50

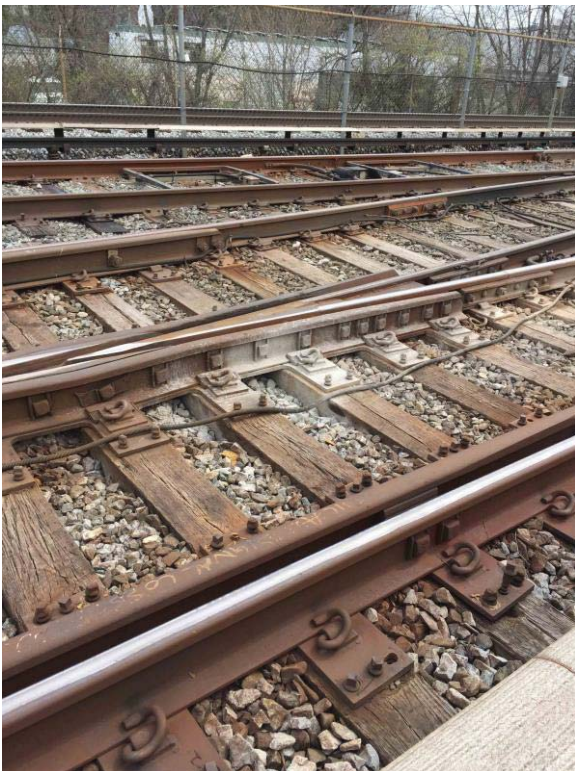
Caption 5: Foul ballast and loose bolt condition

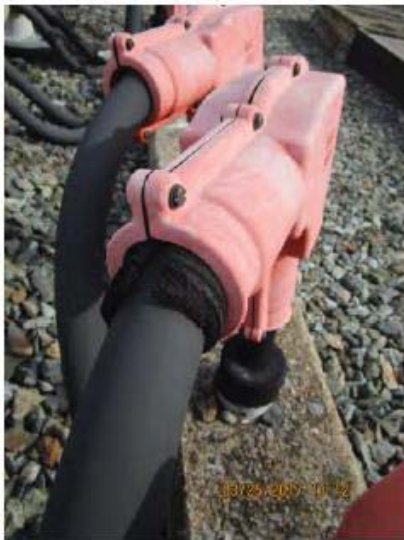
FIGURE 1 - YCR 63 – NEOPRENE SLEEVE
COMPROMISED ON ORANGE BOOT

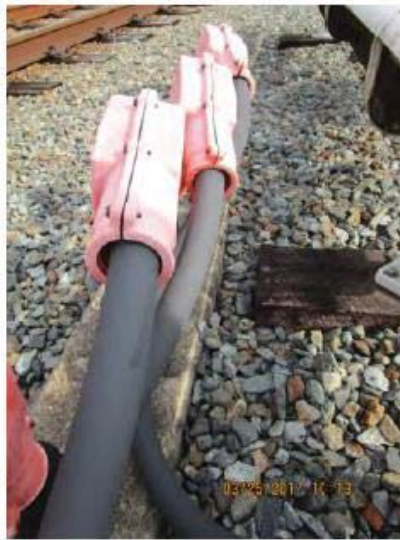
FIGURE 2 - YCR 62 – NEOPRENE SLEEVE
COMPROMISED ON ORANGE BOOT

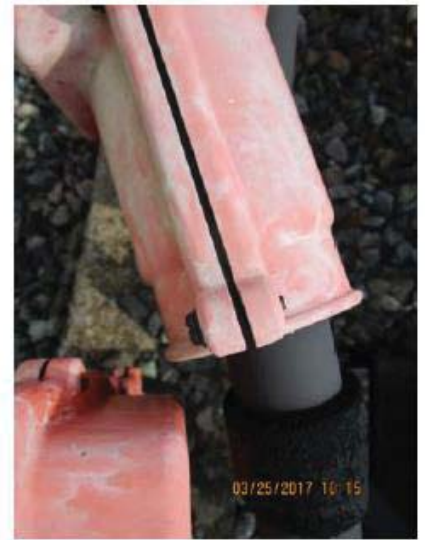
FIGURE 3 - YCR 64 – NEOPRENE SLEEVE
COMPROMISED ON ORANGE BOOT

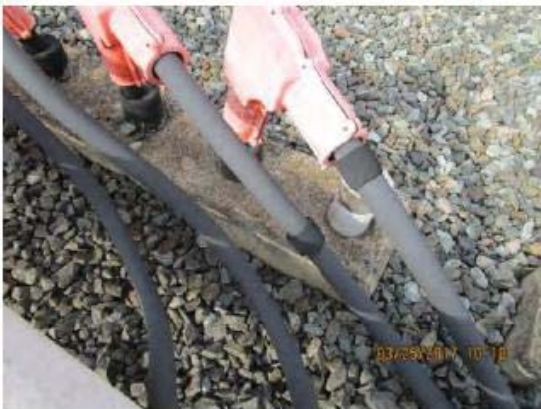
FIGURE 4 - YCR 77 – NEOPRENE SLEEVE
COMPROMISED ON ORANGE BOOT

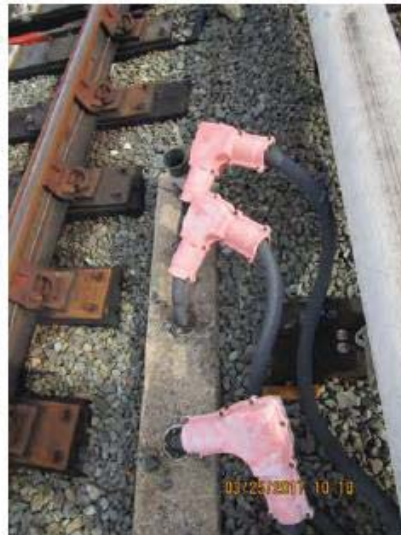
FIGURE 5 - YCR 77 – HEAT SHRINK COMPROMISED
ON CONDUIT STUB-UP

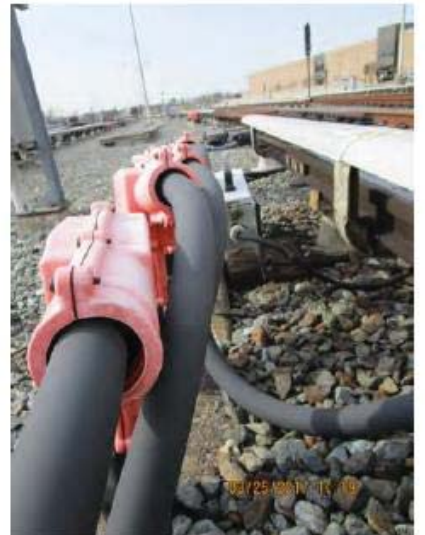
FIGURE 6 - YCR 76 – NEOPRENE SLEEVE
COMPROMISED ON ORANGE BOOT

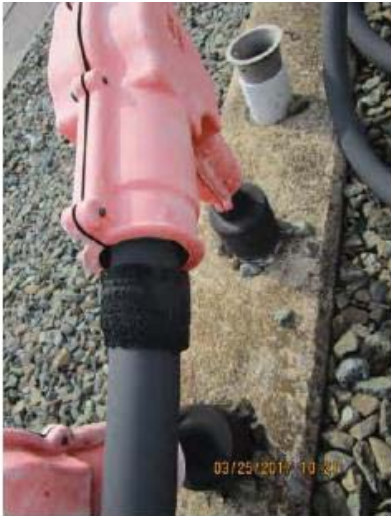
FIGURE 7 - YCR 78 – NEOPRENE SLEEVE
COMPROMISED ON ORANGE BOOT

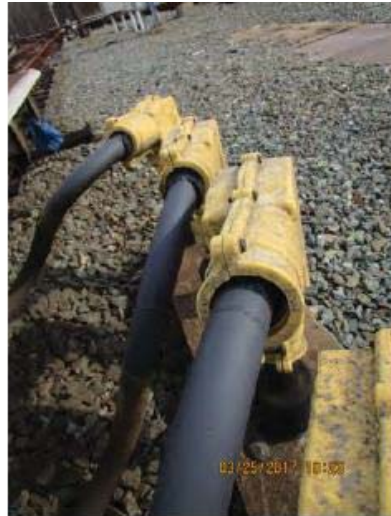
FIGURE 8 - YCR 82 – NEOPRENE SLEEVE
COMPROMISED ON ORANGE BOOT

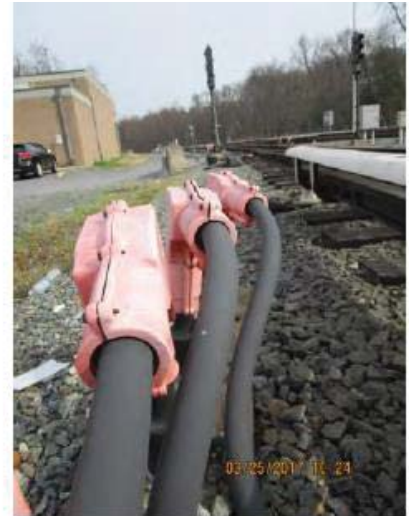
FIGURE 9 - YCR 75 – NEOPRENE SLEEVE
COMPROMISED ON ORANGE BOOT

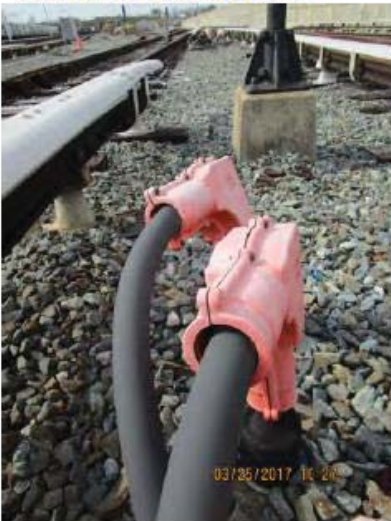
FIGURE 10 - YCR 61 – NEOPRENE SLEEVE
COMPROMISED ON ORANGE BOOT

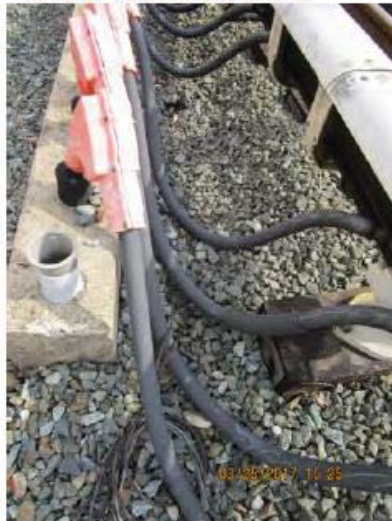
FIGURE 11 - YCR 61 – CABLE WITH TEMPORARY
REPAIR

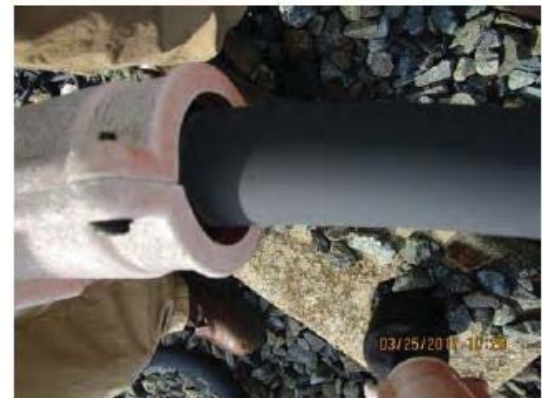
FIGURE 12 - YCR 124 – NEOPRENE SLEEVE
COMPROMISED ON ORANGE BOOT

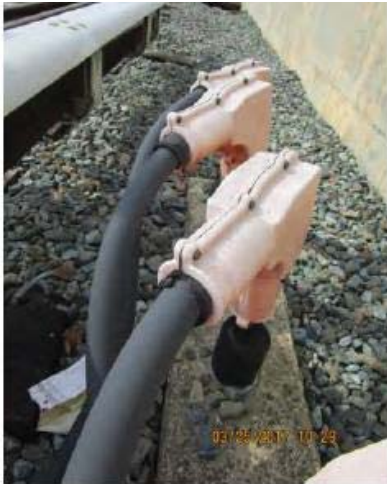
FIGURE 13 - YCR 123 – NEOPRENE SLEEVE
COMPROMISED ON ORANGE BOOT

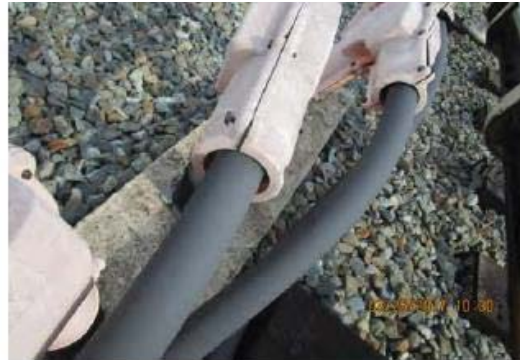
FIGURE 14 - YCR 59 – NEOPRENE SLEEVE
COMPROMISED ON ORANGE BOOT

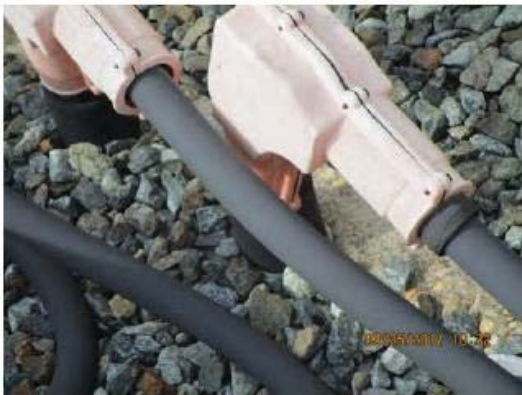
FIGURE 15 - YCR 58 – NEOPRENE SLEEVE
COMPROMISED ON ORANGE BOOT

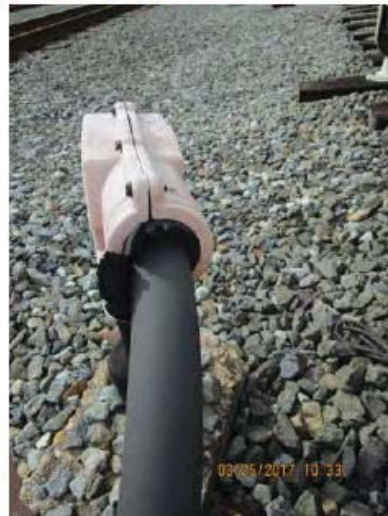
FIGURE 16 - YCR 60 – NEOPRENE SLEEVE
COMPROMISED ON ORANGE BOOT

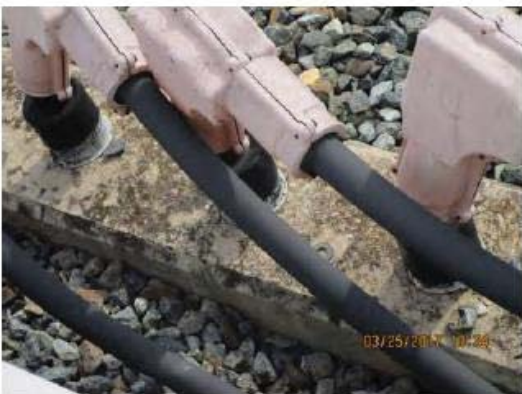
FIGURE 17 - YCR 60 – HEAT SHRINK COMPROMISED
ON CONDUIT STUB-UP

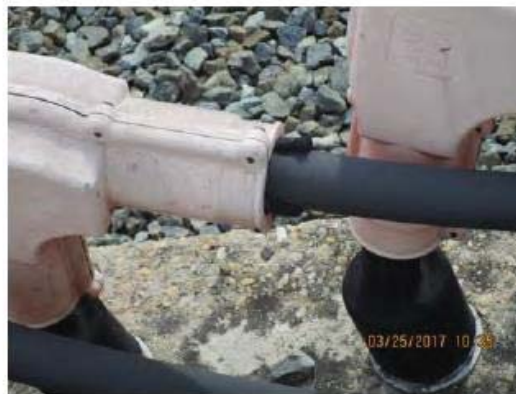
FIGURE 18 - YCR 144 – NEOPRENE SLEEVE
COMPROMISED ON ORANGE BOOT

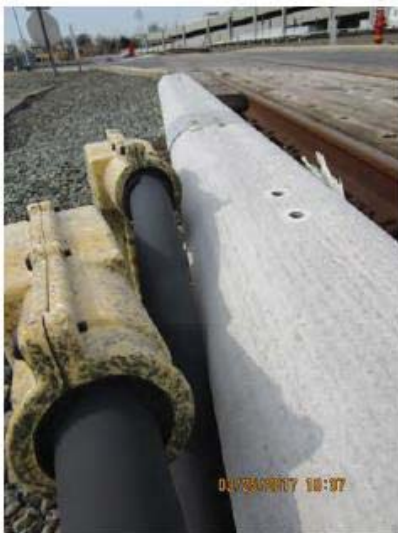
FIGURE 19 - YCR 138 – CABLES AND "BLOW DRYERS" TOO CLOSE TO 3RD RAIL

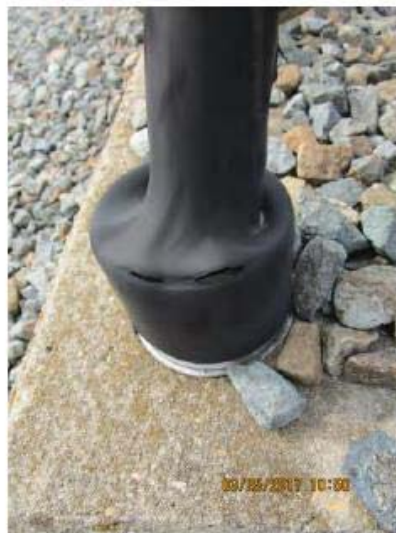
FIGURE 20 - YCR 35 – HEAT SHRINK COMPROMISED ON CONDUIT STUB-UP

<ul style="list-style-type: none">• YCR 36 – Cables lying on the ballast.• YCR 35 – Cables lying on the ballast.• YCR 37 – Cables lying on the ballast.• YCR 122 – Cables lying on the ballast.• YCR 34 – Cables lying on the ballast.• YCR 32 – Cables lying on the ballast.• YCR 31 – Cables lying on the ballast. <p>FWSO will follow up to confirm the conclusion of the work once the cable issues have been corrected.</p>		
Remedial Action	<p>To achieve compliance with WMATA's requirements, WMATA must:</p> <ul style="list-style-type: none">• YCR 63 – Replace with new orange boots. Installing new orange boots requires a new neoprene sleeve to be installed.• YCR 62 – Replace with new orange boots.• YCR 64 - Replace with new orange boots.• YCR 77 – Replace with new orange boots.• YCR 77 – Replace heat shrink on conduit stub-ups.• YCR 76 - Replace with new orange boots.• YCR 78 - Replace with new orange boots.• YCR 82 - Replace with new orange boots.• YCR 75 - Replace with new orange boots.• YCR 61 - Replace with new orange boots.• YCR 61 – Replace cable with temporary repair with new cable.• YCR 124 - Replace with new orange boots.• YCR 123 - Replace with new orange boots.• YCR 59 - Replace with new orange boots.• YCR 58 – Replace with new orange boots.• YCR 60 – Replace with new orange boots.• YCR 60 - Replace heat shrink on conduit stub-ups.• YCR 144 – Replace with new orange boots.• YCR 38 – Move 3rd rail cables and boots farther away from the 3rd rail.• YCR 35 – Replace heat shrink on conduit stub-ups.• YCR 35 – Replace vertical portion of cable going into orange boot with a longer length cable such that the boot has enough slack to stand vertically upwards.• YCR 37 – Replace with new orange boots.

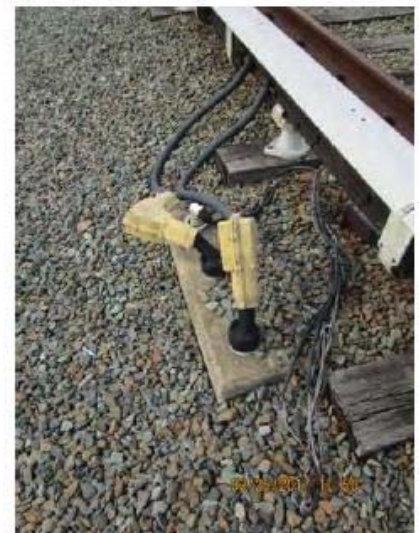
FIGURE 21 - YCR 35 –VERTICAL PORTION OF CABLE COMING THROUGH POWER DUCT BANK INTO "BLOW DRYER" TOO SHORT

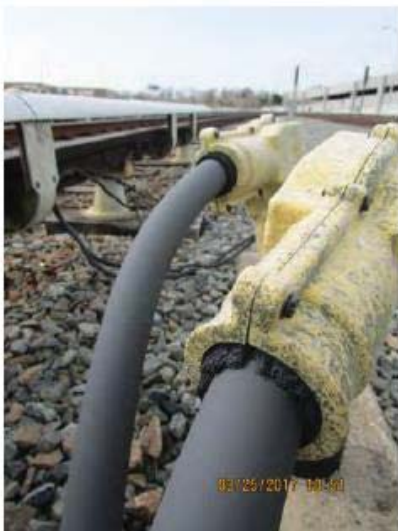
FIGURE 22 - YCR 37 – NEOPRENE SLEEVE COMPROMISED ON ORANGE BOOT

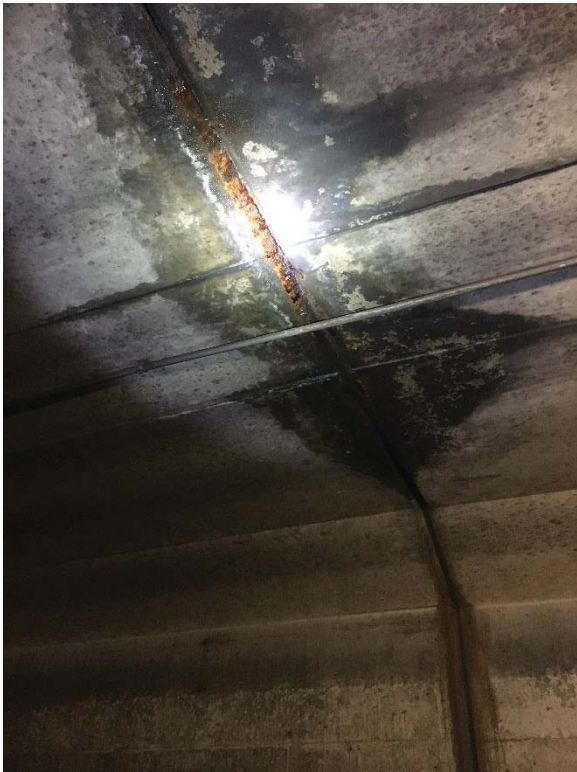
Leak in tunnel ceiling at C2 233+90.

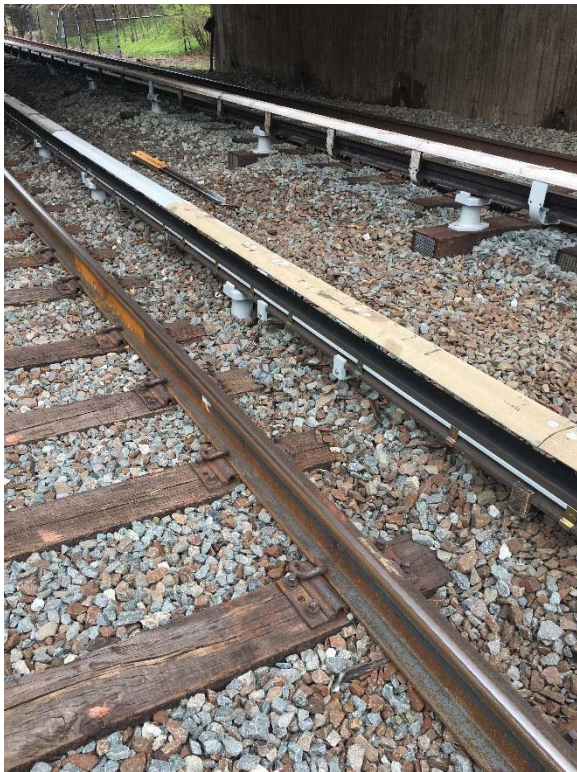
Ballast piled up against third rail between C2 195+40 and C2 207+00.

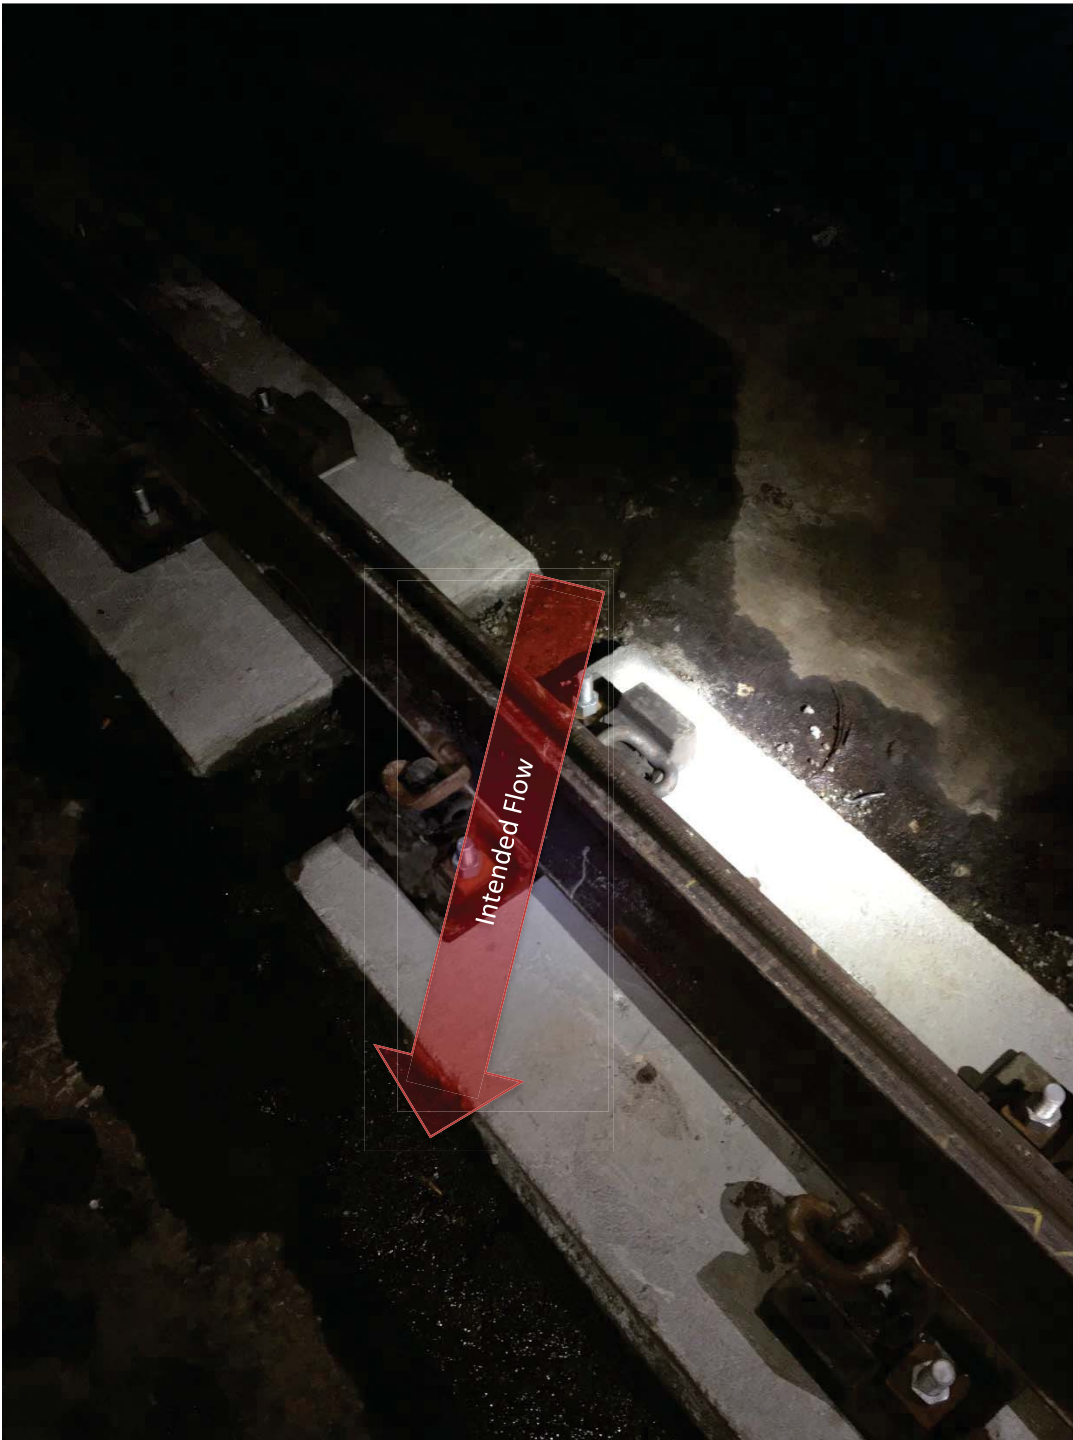
Grout pad obstructing drain at C2 162+60.

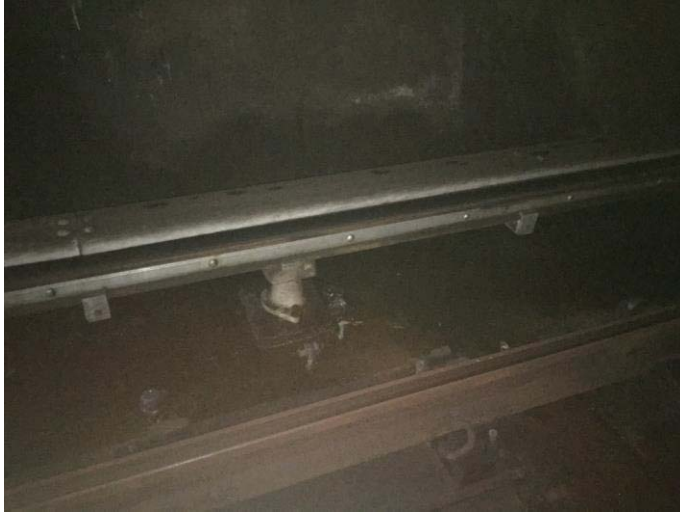
FIGURE 1 - TRK 1 CM 135+00 – STANDING WATER WAS OBSERVED IN THE TUNNEL

Recommended Reinspection?	Yes
Remedial Action	<p>To achieve compliance with WMATA's requirements:</p> <ul style="list-style-type: none">• WMATA must mitigate water intrusion at TRK 1 CM 135+00.• WMATA must mitigate water intrusion at TRK 1 CM 146+00.• WMATA must clean out catch basin approaches at TRK 1 CM 154+00 to CM 156+00.• WMATA must replace existing orange boots with new orange boots at TRK 1 CM 195+00.• WMATA must install OZ Gedney bushings at TRK 1 CM 195+00.• WMATA must install heat shrink on conduit stub-ups at TRK 1 CM 195+00.• WMATA must replace heat shrink on conduit stub-up at TRK 1 CM 198+00.

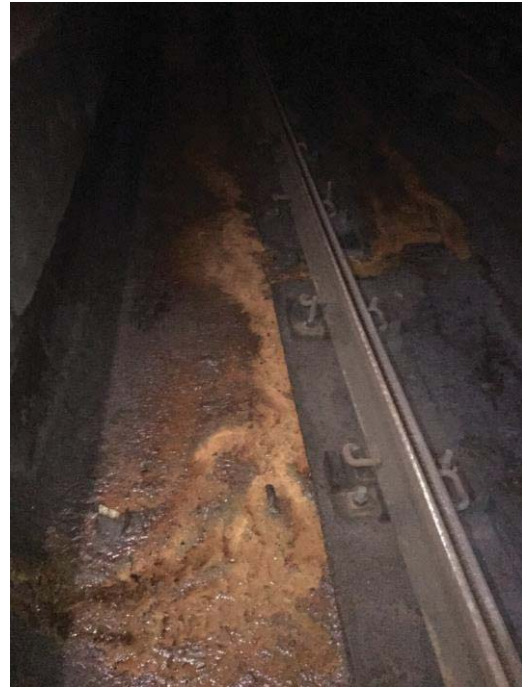
FIGURE 2 - TRK 1 CM 146+00 – STANDING WATER WAS OBSERVED IN THE TUNNEL

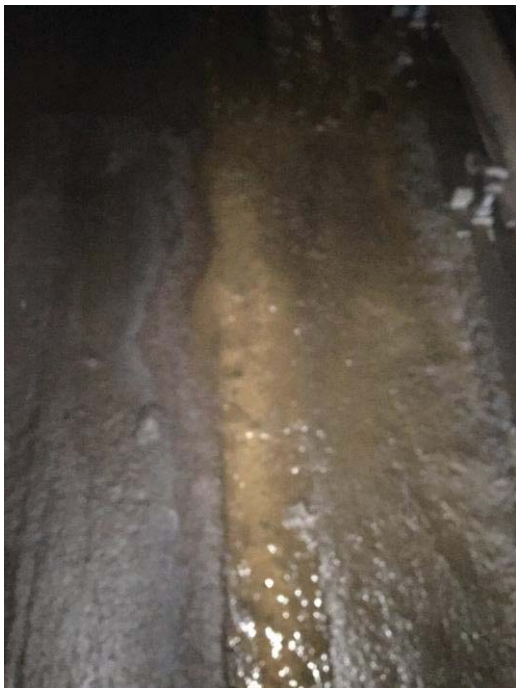
FIGURE 3 - TRK 1 CM 194+00 TO CM 196+00 - EXISTING DRAINAGE DITCHES IN TUNNEL ARE FULL OF MUD AND DEBRIS.

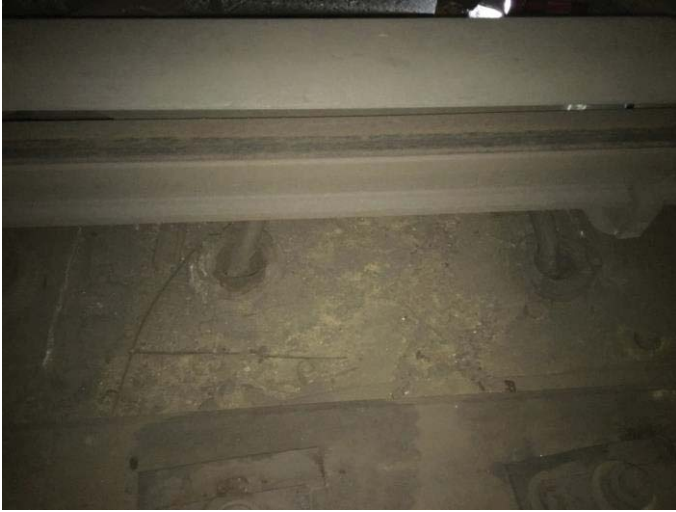
FIGURE 5 - TRK 1 CM 195+00 – MISSING OZ GEDNEY BUSHINGS AND
HEAT SHRINK ON CONDUIT STUB-UPS
