Inspection Form

Form FTA-IR-1

Inspection Date	YYYY	MM	DD	Report Number	20170905-WMATA-AG-1		
	2017	09	05				
Rail Agency Name	Washington Metropolitan Area Transit Authority			Rail Agency Department	TRST	Sub- Department	TKIN
Rail Agency Department Contact Information	Name		Email		Office Phone		Mobile Phone
	[REDACTED]		[REDACTED]		[REDACTED]		[REDACTED]
	[REDACTED]		[REDACTED]		[REDACTED]		[REDACTED]
	[REDACTED]		[REDACTED]		[REDACTED]		[REDACTED]
Inspection Location	N-Line, Track 2, Wiehle-Reston East (N06) to Spring Hill (N04)

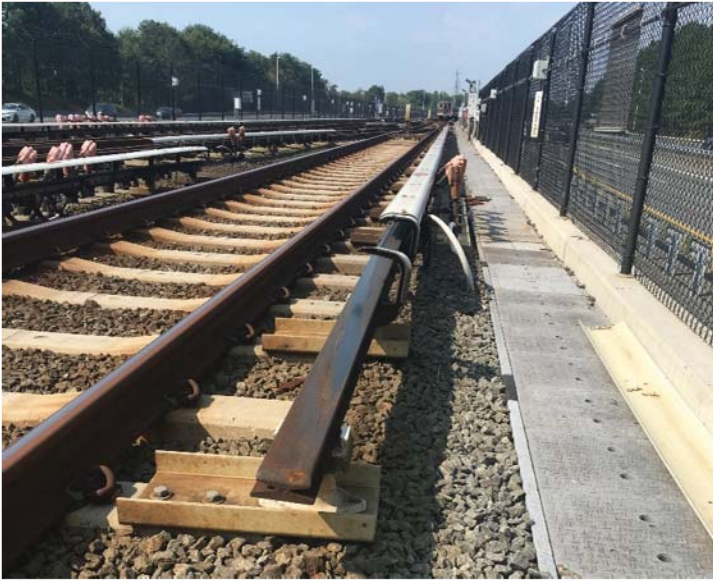
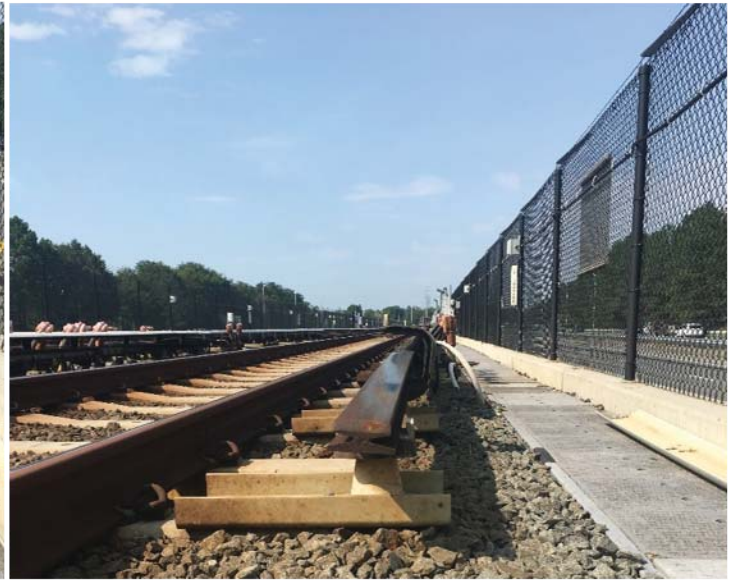
Description	<p>FWSO Inspectors observed WMATA employees and contractors perform a track inspection on track 2 of the N-Line between Wiehle-Reston East (N06) and Spring Hill (N04). Inspectors also inspected track conditions and followed up on previously-issued remedial actions.</p> <p>The following non-color-coded defects were observed:</p> <ul style="list-style-type: none"> TRST 1000 Manual, 13.3.14: End approach cover board was missing at N2 1006+70. TRST 1000 Manual, 13.3.6: There was evidence of collector shoes striking the nose of the end approach at N2 1006+70. There were multiple collector shoes laying on the ballast nearby. The end approach also appeared to be misaligned with the insulator, creating an uneven wear pattern. (See figures 1 and 2 below.) TRST 1000 Manual, 13.3.4: The third rail anchor arm was broken at N2 838+50. <p>Other Notable Observations:</p> <ul style="list-style-type: none"> There was evidence of track pumping at N1 800+40. Inspectors were not inspecting this track, so the vertical deflection could not be measured. There was a crane situated beneath the aerial structure at N2 788+00 which has the potential to foul the roadway when in use. (See figure 3 below.) 	Number of Defects	3

Figures 1 and 2: Missing cover board, evidence of collector shoes striking the nose of the end approach, and misaligned end approach at N2 1006+70.

Remedial Action	<p>To achieve compliance with WMATA's requirements:</p> <ul style="list-style-type: none"> WMATA must replace the cover board at N2 1006+70. WMATA must adjust the end approach at N2 1006+70. WMATA must repair the third rail anchor at N2 838+50.
------------------------	---

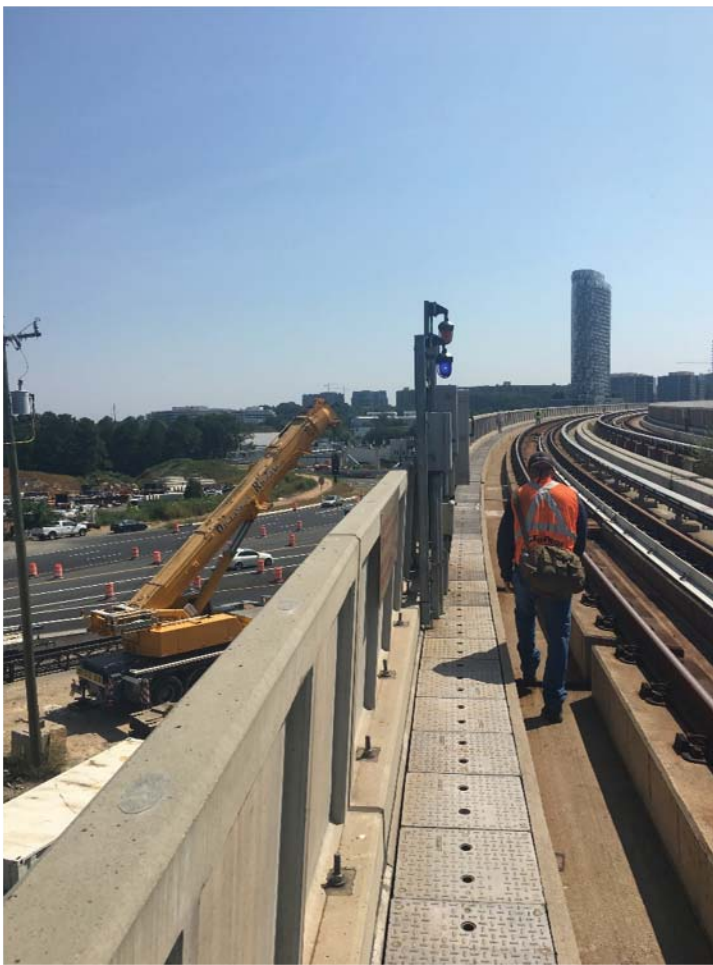
Figure 3: Crane beneath aerial structure at N2 778+00.

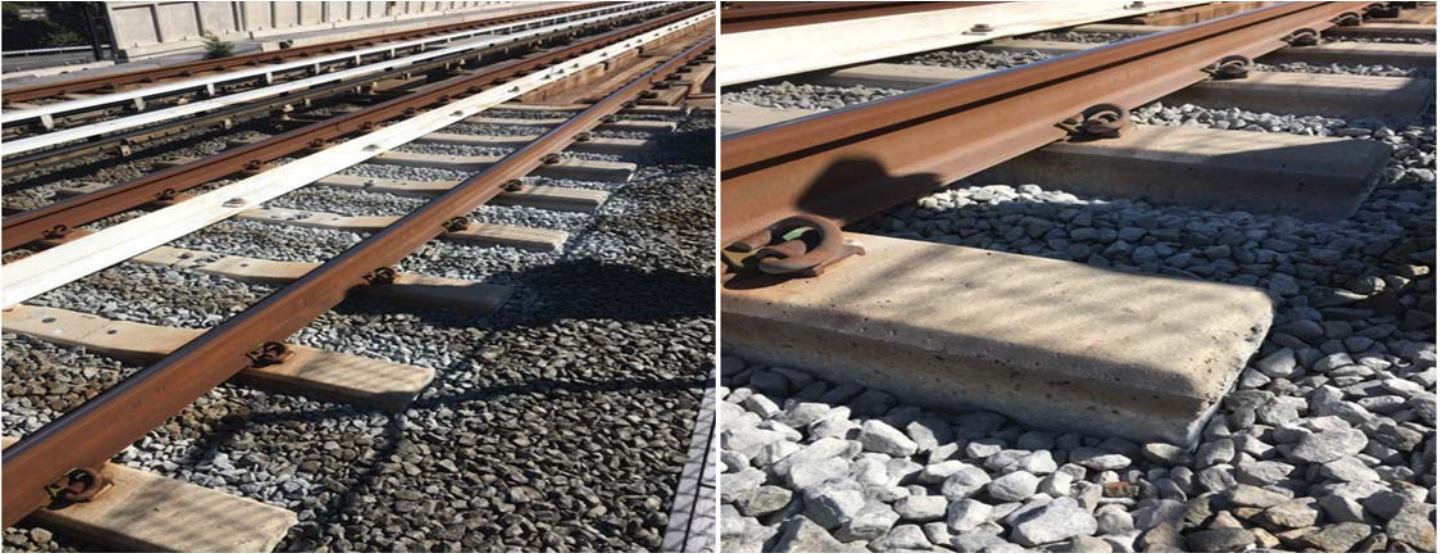
Figures 1 & 2: Churned ballast at the location with a 1 ½" uniform profile deviation. Ballast indents on the sides of the concrete crossties indicate the amount of dynamic movement under loaded operations.

Recommended Finding?		Yes	
											Remedial Action Required?		Yes	
											Recommended Reinspection?		Yes	
Remedial Action	<p>To achieve compliance with WMATA's requirements:</p> <ul style="list-style-type: none"> WMATA must repair the uniform profile deviation at N1 800+40.

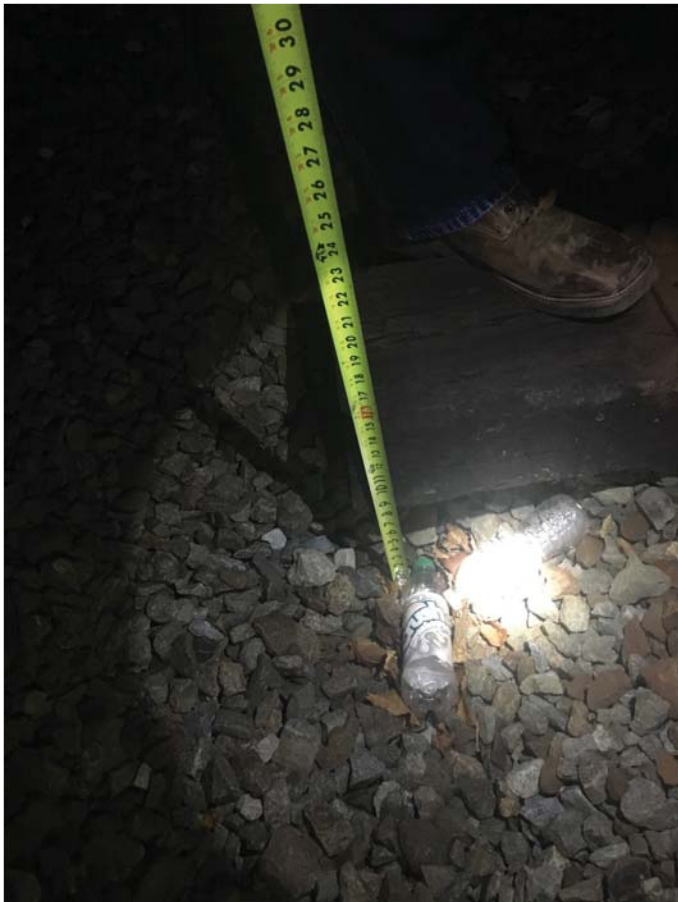
Figure 1: Low ballast condition at right rail tie end at C2 411+50. Ballast 8 inches below tie end.

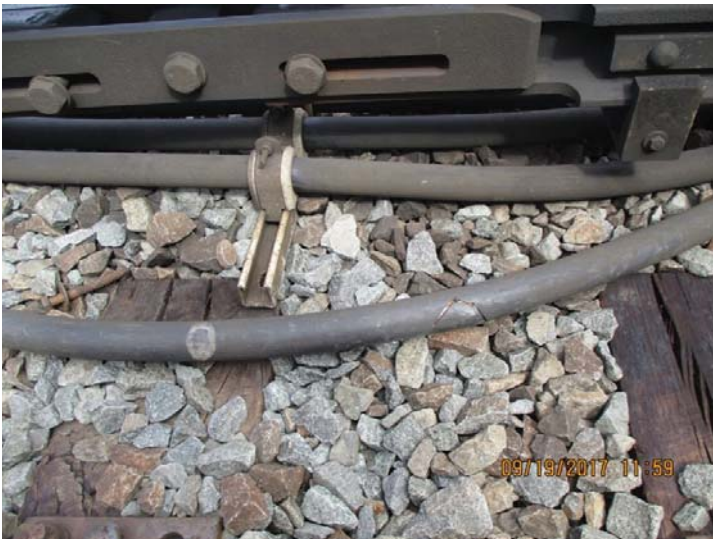
Figure 1: J1 607+00 - Expansion cable damaged and on gauge side of the third rail.

Remedial Action	<p>To achieve compliance with WMATA's requirements:</p> <ul style="list-style-type: none">• WMATA must replace expansion cable and install cables per EMI at J1 607+00.• WMATA must replace missing cover board at J1 536+00.• WMATA must replace missing cover board at J1 566+60.• WMATA must replace missing cover board at J1 627+00.

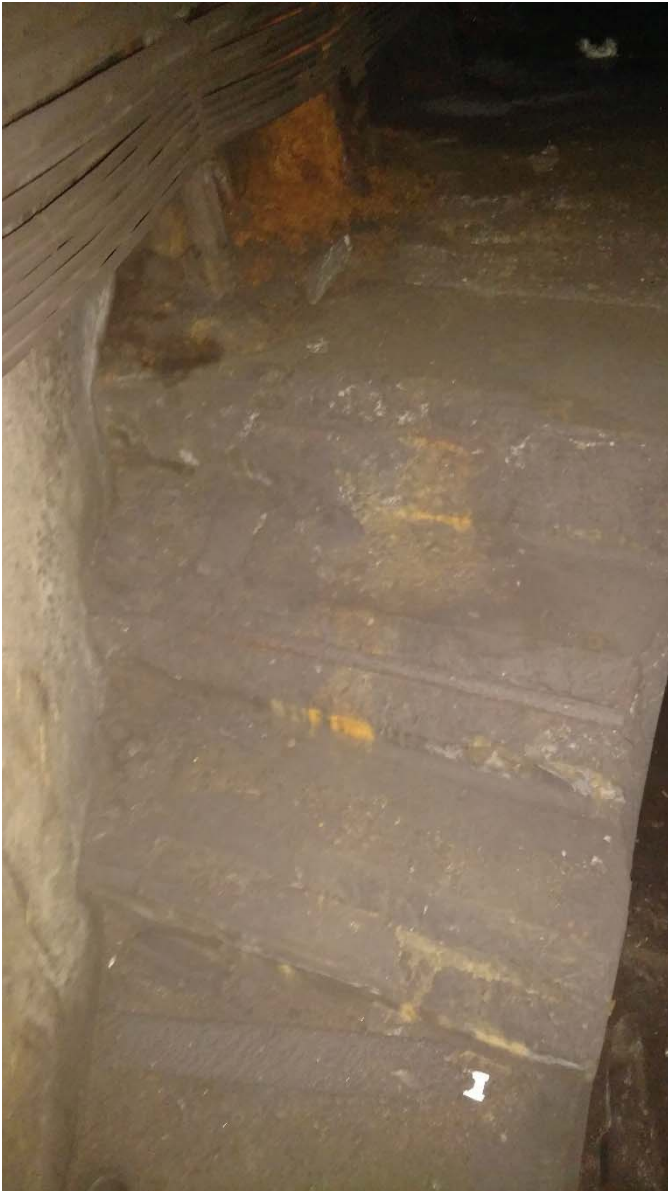
Figure 1: Safety Walk Stairs. Note exposed rebar, crumbled step and displaced step edge.

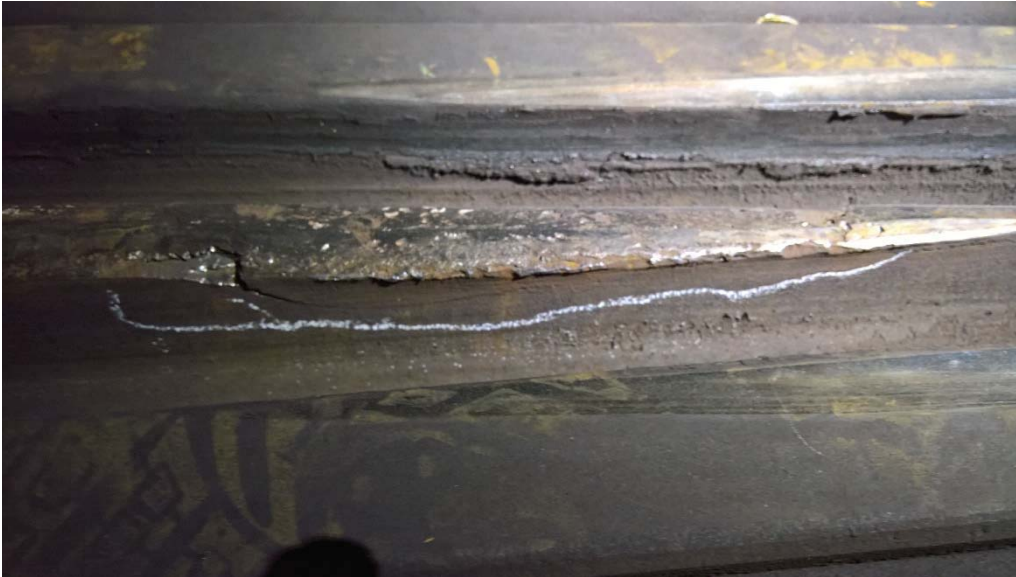
Figure 1: Cracked frog point at switch #3.

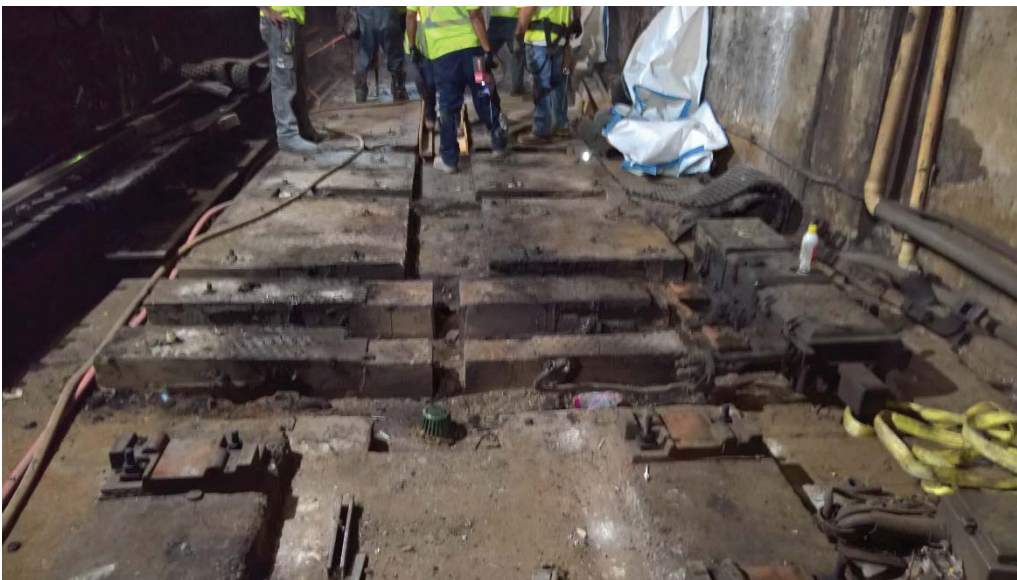
Figure 3: Switch components removed from switch #3.

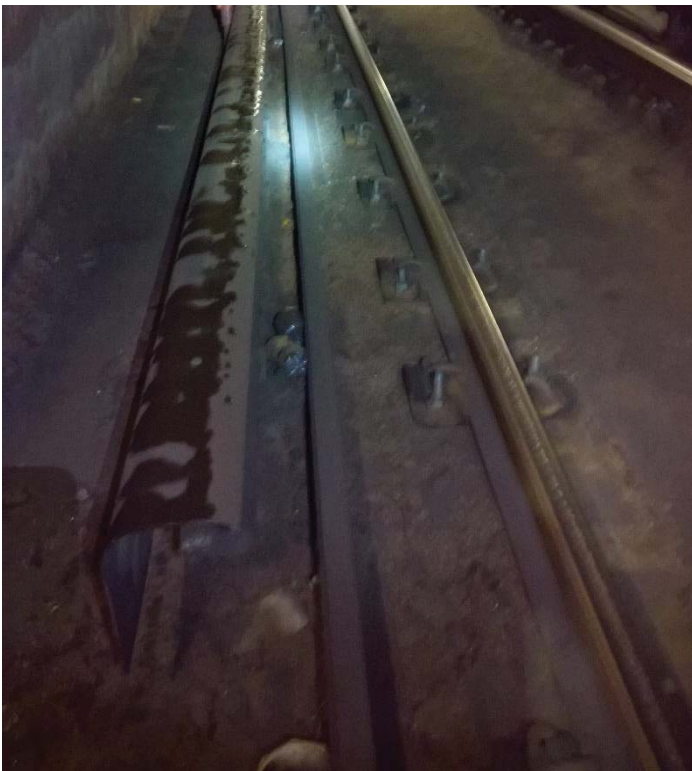
Figure 1: Relay rail stored between running rail and third rail between D2 43+06 and 43+60.

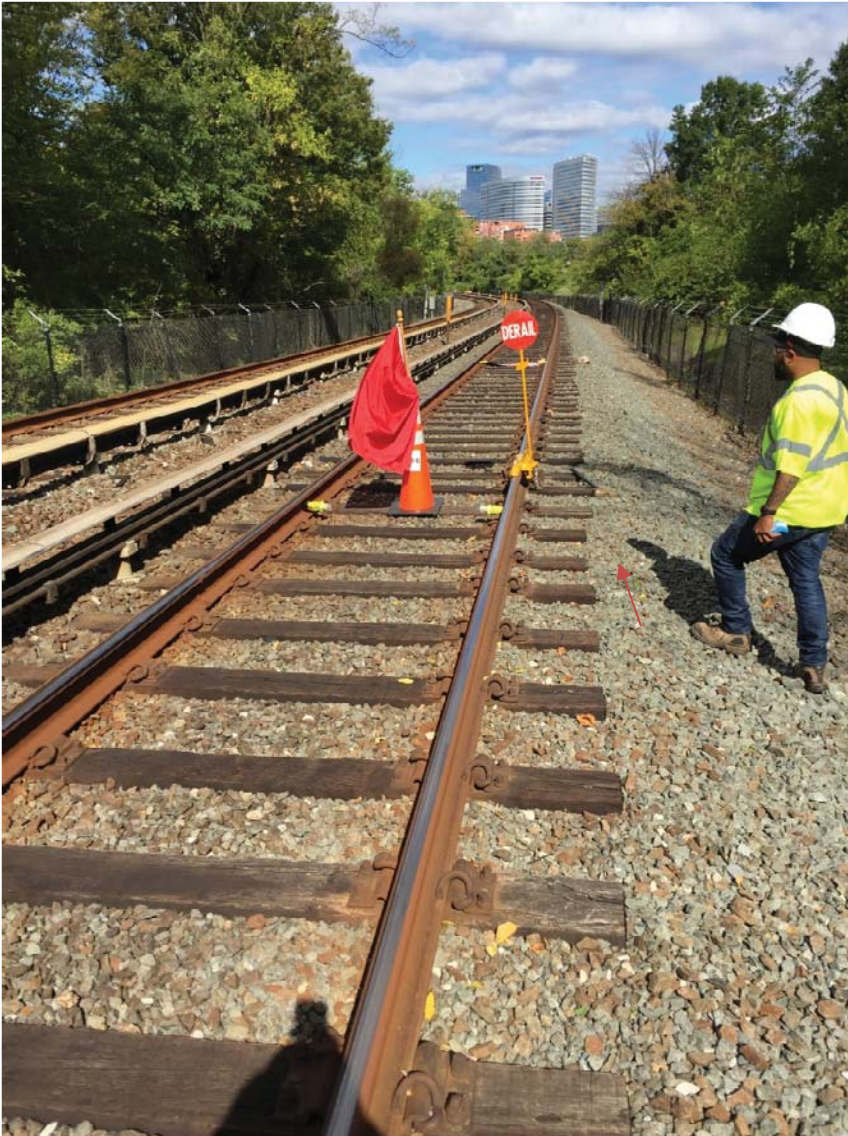
Figure 1: Derail installed improperly at C1 185+00.
