# FTA Standards Development Program: Transit Bus Operator Temporary Barrier to Reduce COVID-19 Exposure

PREPARED BY  
Center for Urban Transportation Research  
Virginia Tech Transportation Institute

FTA Report No. 0224

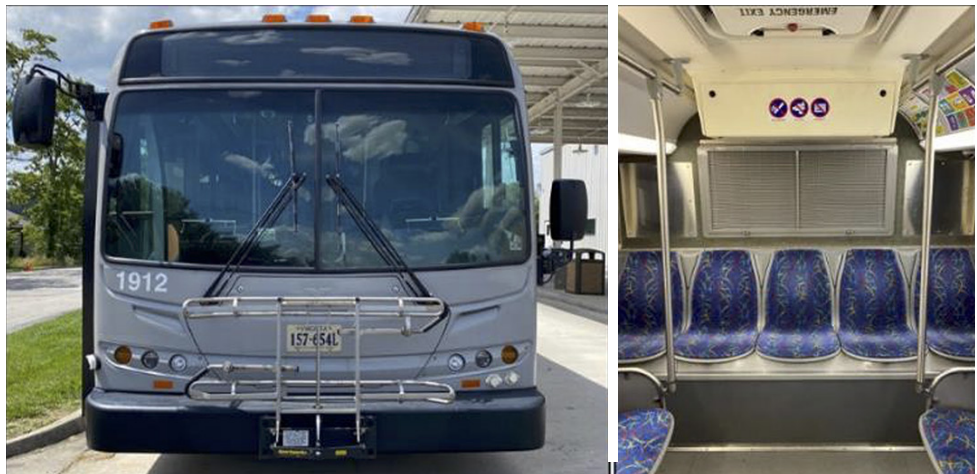
**Figure 2-1** *BT New Flyer 40-ft bus (bus A) configured with rear HVAC exhaust*

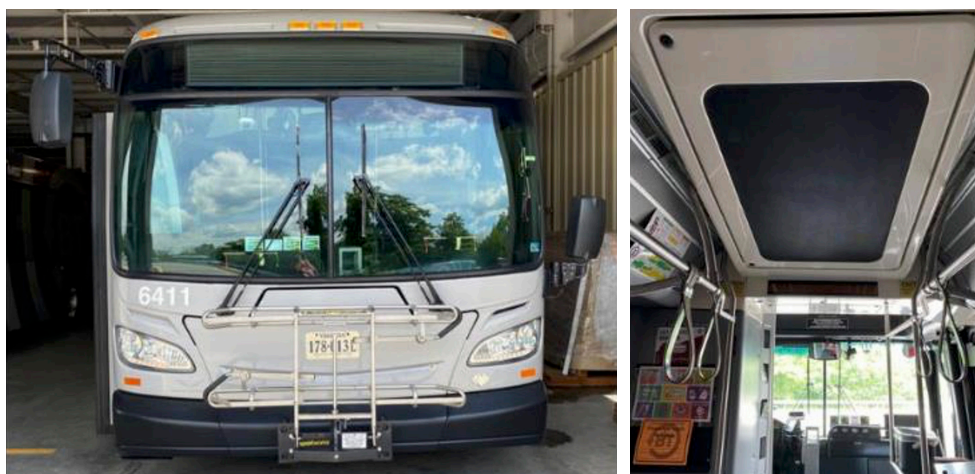
**Figure 2-2** BT New Flyer 40-ft bus (bus B) configured with forward roof HVAC exhaust

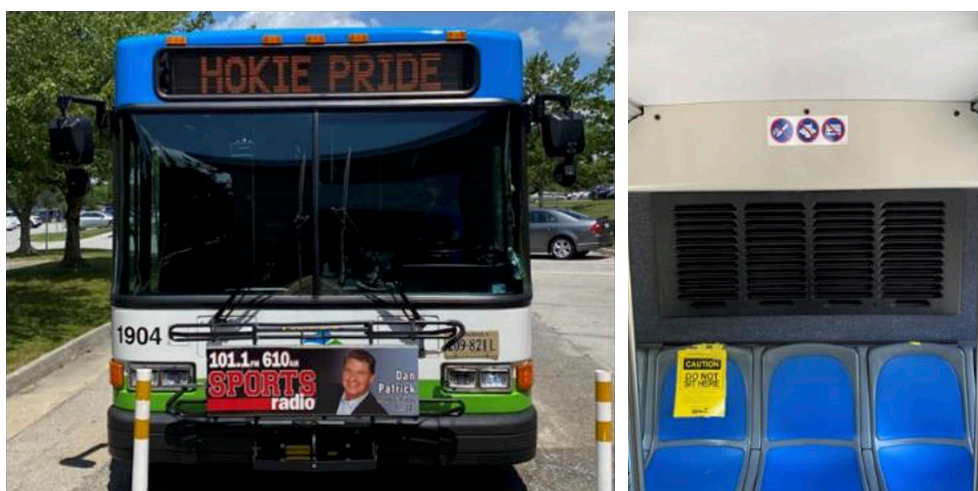
**Figure 2-3** VM Gillig 35-ft bus (bus C) configured with rear HVAC exhaust

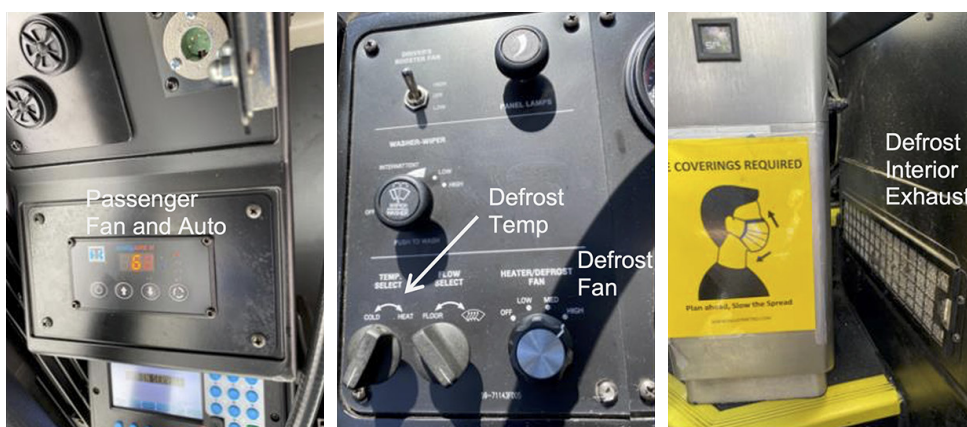
**Figure 2-6** Bus C equipped with passenger interior air recirculation (left) and driver defrost interior air recirculation (middle) only; source of exhaust for driver defrost air located on dash panel wall and in front of fare box (right)

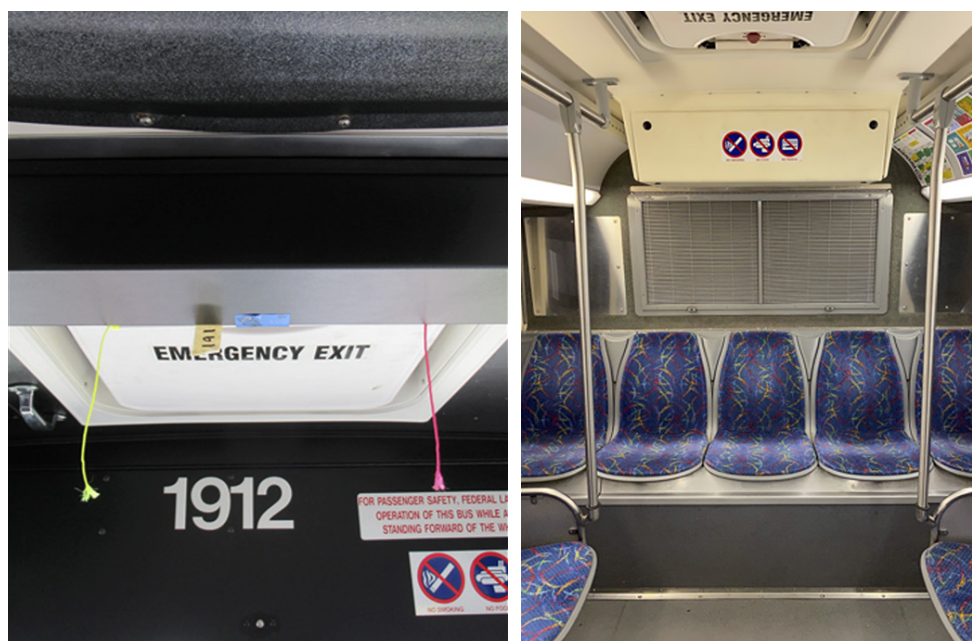
**Figure 2-7** Bus A roof hatches located near bus operator workstation (left) and rear bench (right)

Both Buses A and B have front roof hatches located above the aisle and between the entry door and the bus operator workstation. Both buses also have rear roof hatches above the rear-wall bench seat, as shown in Figure 2-7 and Figure 2-8. The rear roof hatch in bus C is like buses A and B in relative location on the bus body; however, the front roof hatch in bus C is located significantly farther rearward compared to buses A and B, near the front axle in the ADA section, as shown in Figure 2-9.

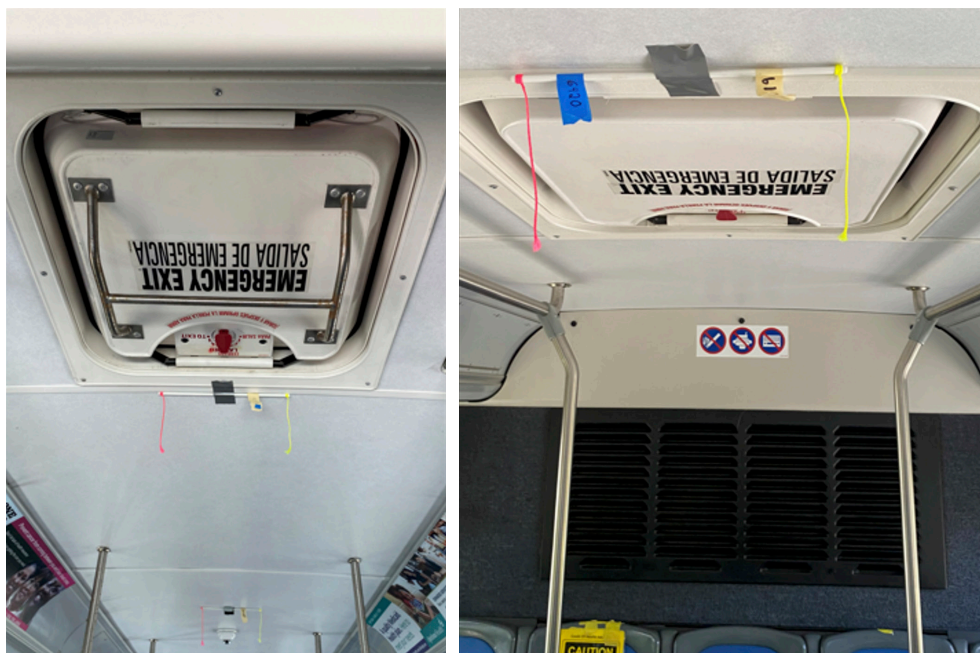
**Figure 2-9** Bus C roof hatches located near front axle (left) and rear bench (right)

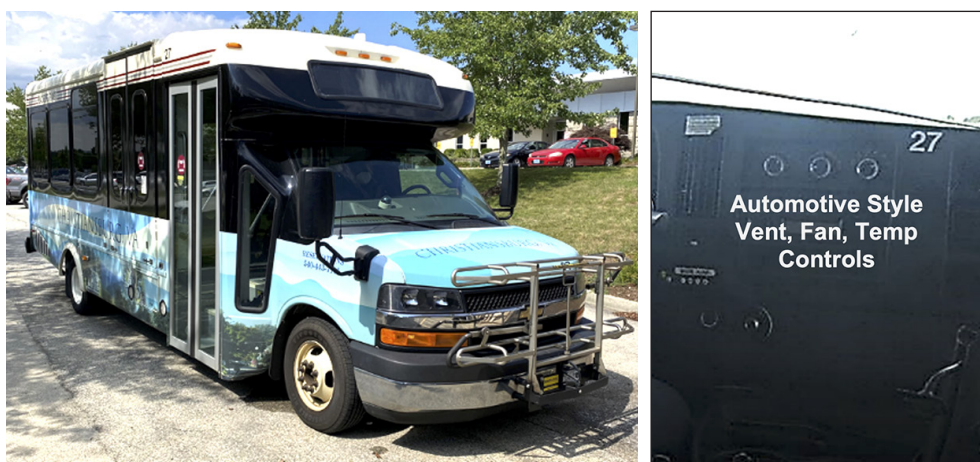
**Figure 2-10** BT BoC bus configured with cut-away van driver HVAC and separate roof-mounted rear passenger interior HVAC system

Limited testing was performed with a Body on Chassis (BoC) bus at the request of BT. BT requested that VTTI test the effects of exterior air impacts on the direction of air flow inside the bus and near the bus operator. This bus was equipped with a passenger air HVAC on the body and traditional Chevrolet cut-away van HVAC fresh air driver defrost controls, as shown in Figure 2-10.

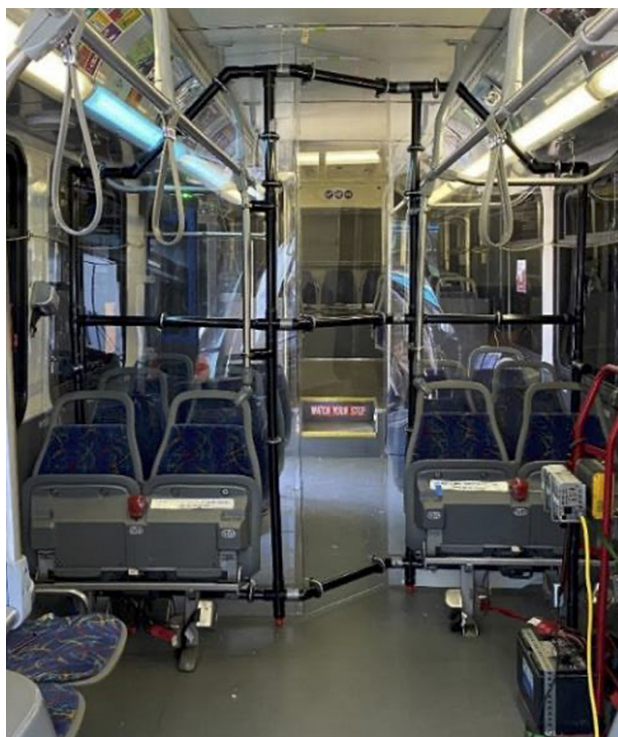
**Figure 2-11** Rear exhaust HVAC configuration (bus A) prototype temporary barrier with 3-in. ceiling gap on curb side (left) and 1-in. ceiling gap on street side (right)

The temporary barrier installed for testing on Bus A, which has the rear exhaust HVAC configuration, is shown in Figure 2-11. The original temporary barrier installed for testing on bus B, which has the central roof-mounted exhaust HVAC configuration, is shown in Figure 2-12. The modified temporary barrier in bus B was made to extend the barrier below and in front of the roof-mounted exhaust with semi-rigid transparent vinyl. The modified temporary barrier is shown in Figure 2-13.

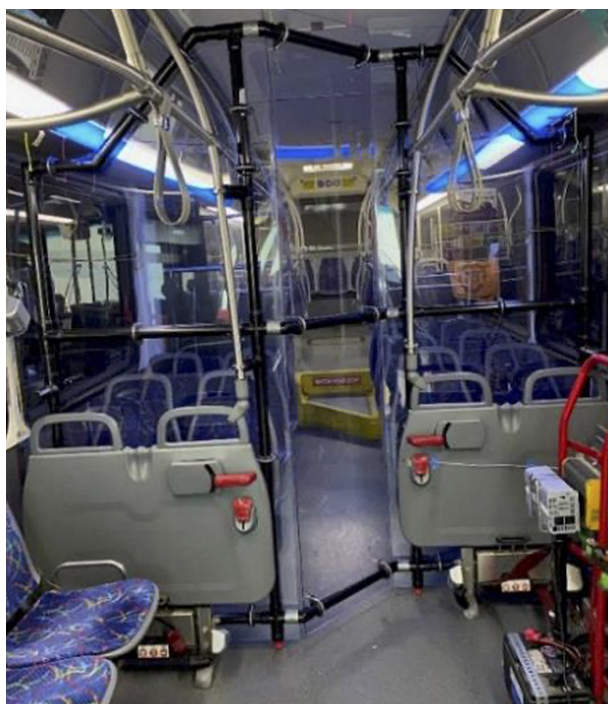
**Figure 2-12** Roof exhaust HVAC configuration (bus B) prototype temporary barrier, original with 3-in. ceiling gap on curb side (left) and 1-in. ceiling gap on street side (right)

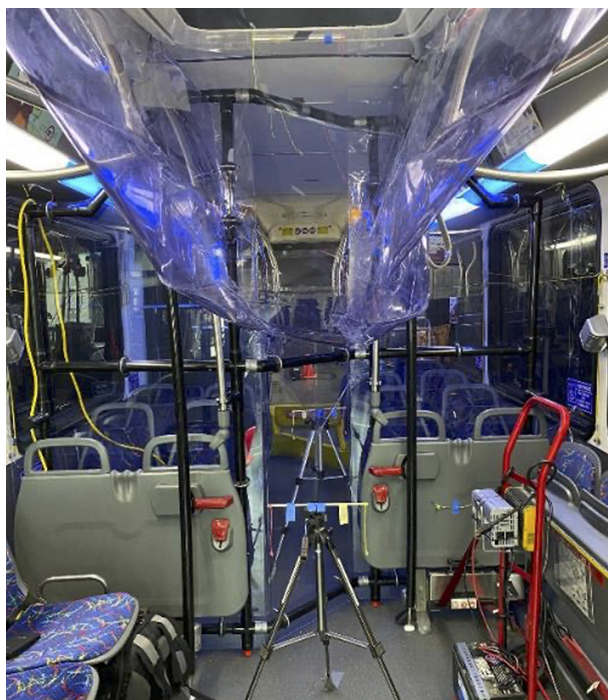
**Figure 2-13** Roof exhaust HVAC configuration (bus B) prototype temporary barrier, modified with hood surrounding roof exhaust

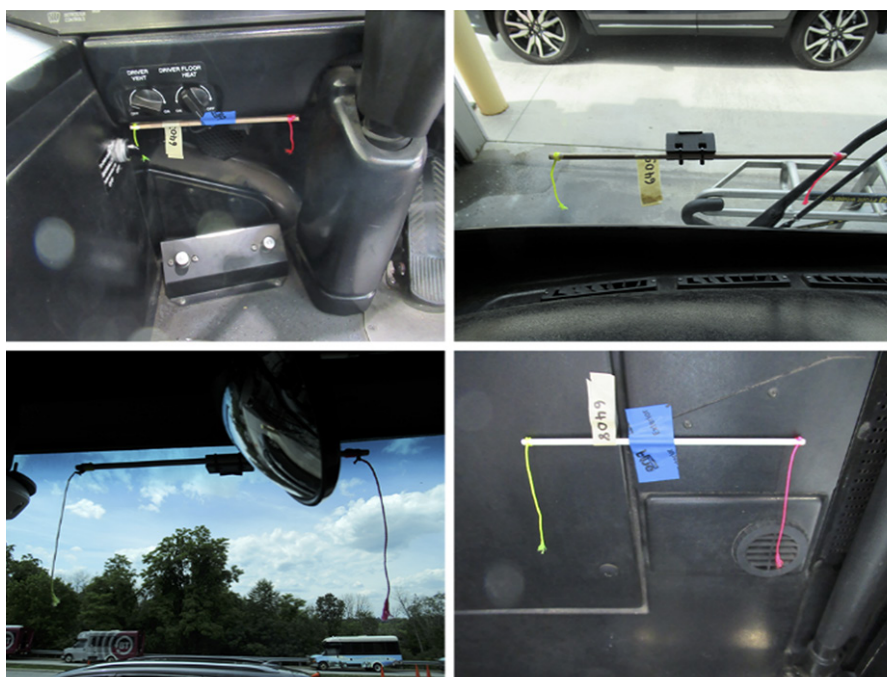
**Figure 2-14** Telltale locations near dedicated ducts from driver defrost on bus B—above pedals near steering column (upper left), lower windshield near defrost ducts (upper right), upper windshield (lower left), entry door duct (lower right)

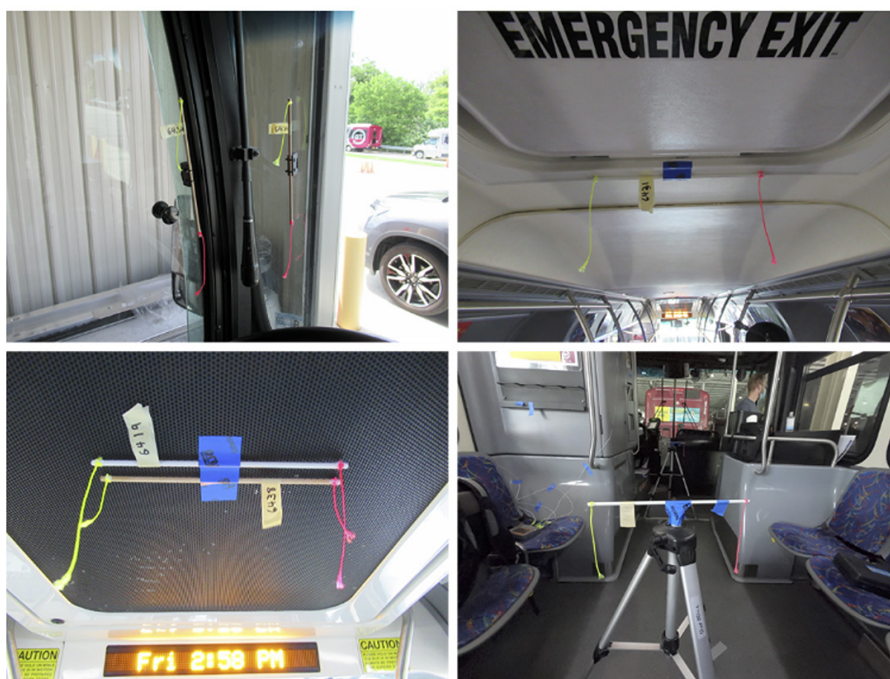
**Figure 2-17** Other selected telltale locations on bus B—driver window glass and A-Pillar windshield (upper left), rear roof hatch (upper right), passenger HVAC roof-mounted exhaust (lower left), floor tripods (lower right)

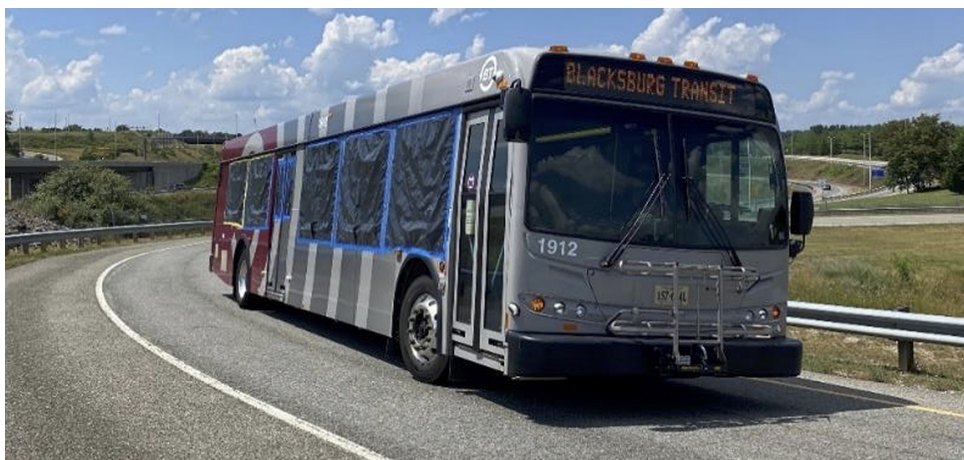
**Figure 2-21** BT (bus A) during air flow testing on VSR Highway section

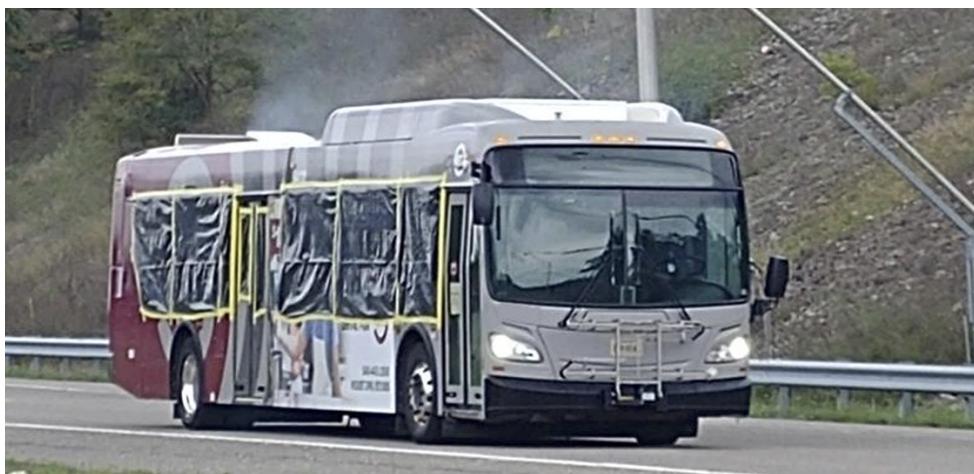
**Figure 2-22** BT (bus B) during air flow testing on VSR Highway section; fog visible exiting bus rear roof hatch

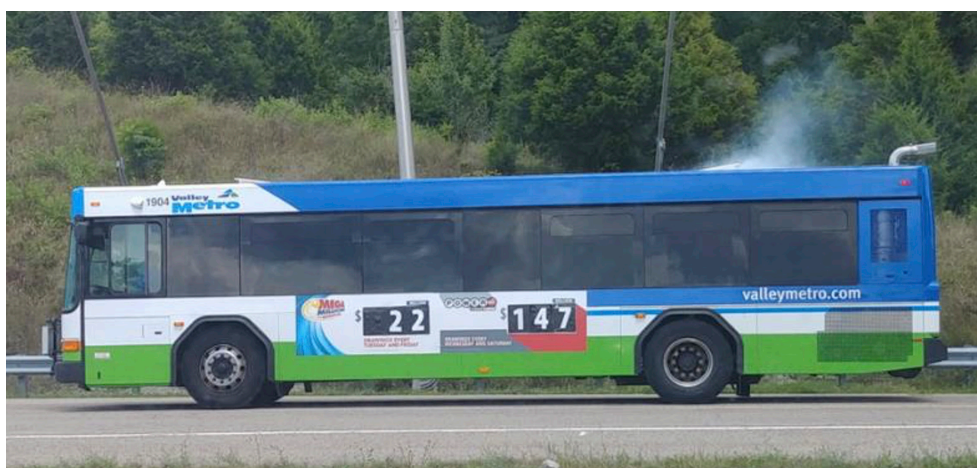
**Figure 2-23** VM (bus C) during air flow testing on VSR Highway section; fog visible exiting bus rear roof hatch

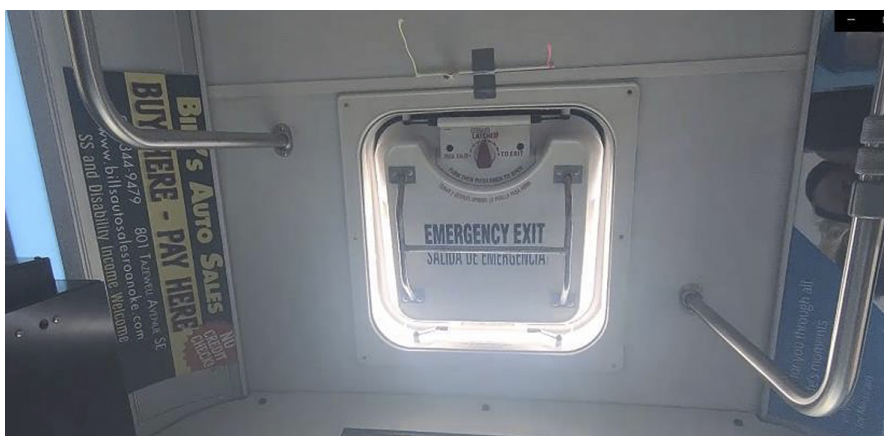
**Observation A3:** Roof hatches located behind the bus operator workstation near the front axle can scoop or pull air into the bus, increasing the dilution of interior air (see Figure 3-3) without drawing air forward near the bus operator workstation.

**Figure 3-3** Bus C, open front roof hatch near front axle, telltales blowing rearward due to air entering

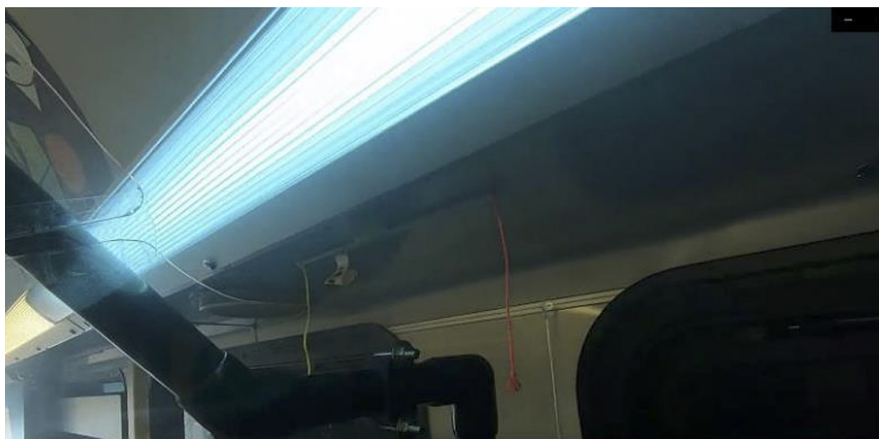
**Observation B1:** A positive pressure differential can be produced at the front of the bus when a temporary barrier is implemented on a bus equipped with a rear exhaust HVAC, causing the air to flow from front to back when the driver window is closed. This pressure differential was observed both with driver defrost air only (see Figure 3-5) and passenger air only (see Figure 3-6).

**Figure 3-5** Bus A, fog flowing from front to back on curb side of bus with driver defrost air only

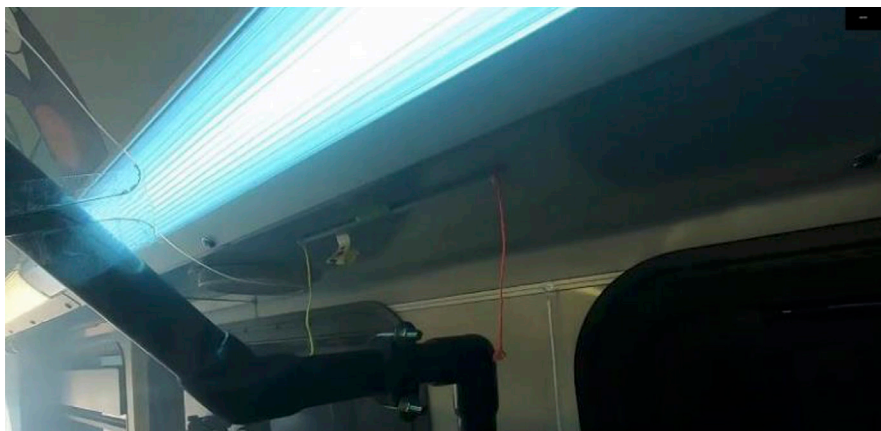
**Figure 3-6** *Bus A, fog flowing from front to back on curb side of bus with passenger air only*

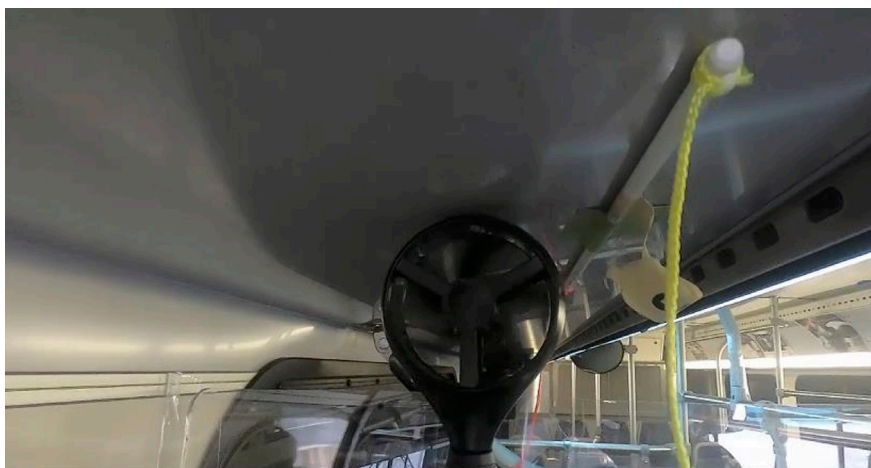
**Observation B2:** The direction of air flow from front to back on the bus is measurable with an anemometer, as shown in Figure 3-7. Fog positioned rear of the barrier approaches the barrier at low pressures forward and is maintained or sent rearward near the openings on a temporary barrier that is implemented on a bus equipped with HVAC rear exhaust, as seen in Figure 3-8.

**Figure 3-7** *Bus A, anemometer demonstration while bus idling with driver defrost and passenger air both on high with driver window and roof hatches closed*

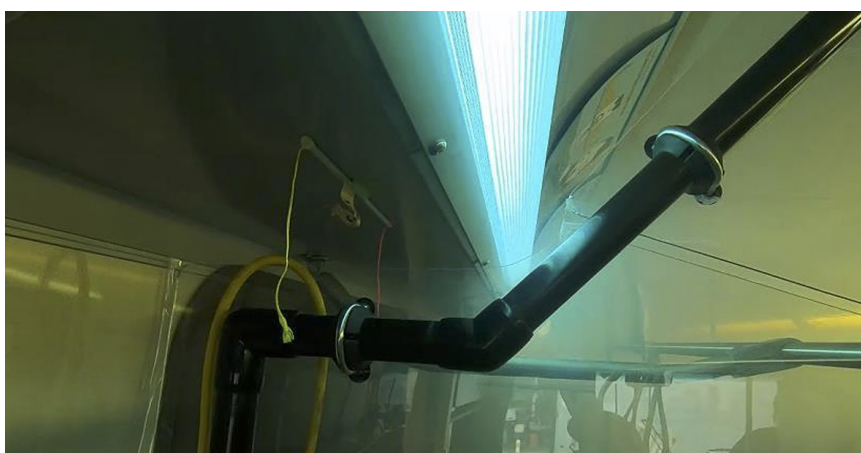
**Figure 3-8** *Bus A, air shearing fog on back side while bus idling with driver defrost on high with driver window and roof hatches closed*

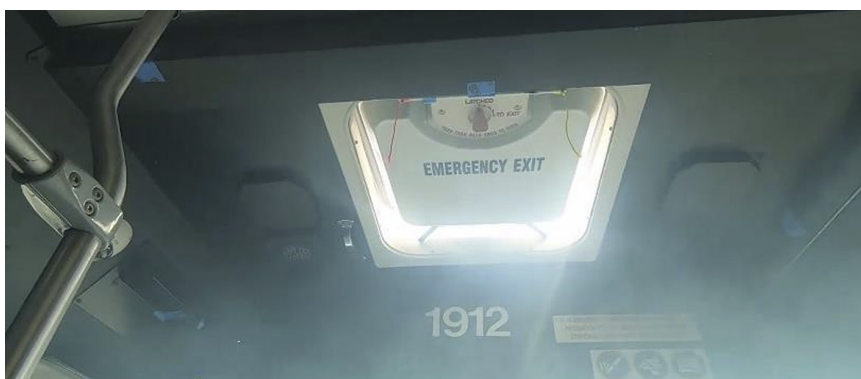
**Observation C1:** Roof hatches located forward of the axle and next to the bus operator workstation tend to pull air out, which can lead to increased bus operator exposure from air moving from the rear to the front. This is presumably because the hatch is near the leading top edge of the roof, which at high velocities will overcome pressures inside the bus, as demonstrated in Figure 3-9.

**Figure 3-9** *Bus A, open front hatch next to bus operator workstation*

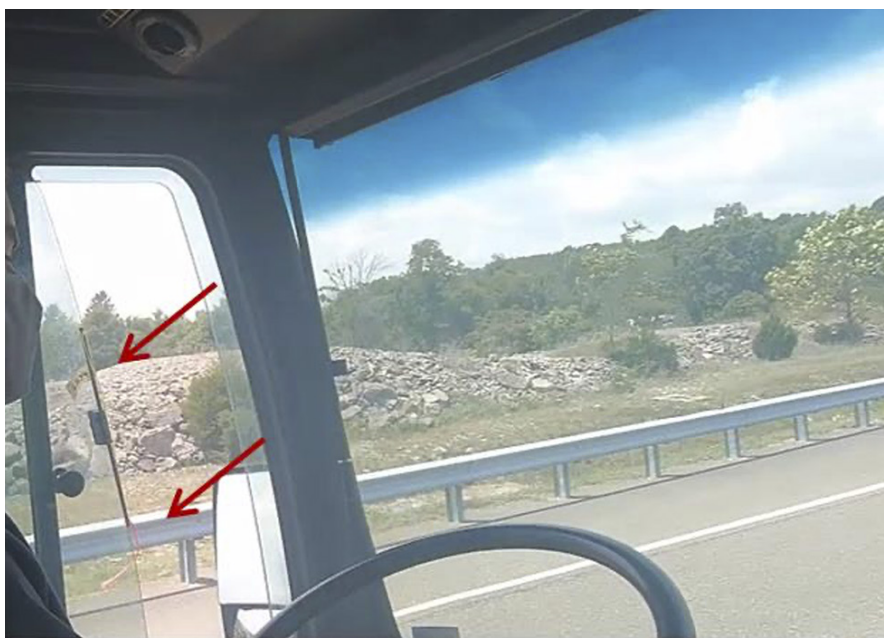
**Observation C3:** When the driver window is open, the air is pulled primarily out of the bus to varying degrees based on the bus make and body configuration. Occasionally, during a turning maneuver or when a gust of wind blows against the street side of the bus, the air may briefly enter the driver window, blowing the telltales toward the bus operator. Otherwise, the telltales attached to the bus operator window remain still or are pulled out of the driver window as seen in Figure 3-11.

**Figure 3-11** *Bus B, driver window open and hatches closed, telltales pulled out of window*

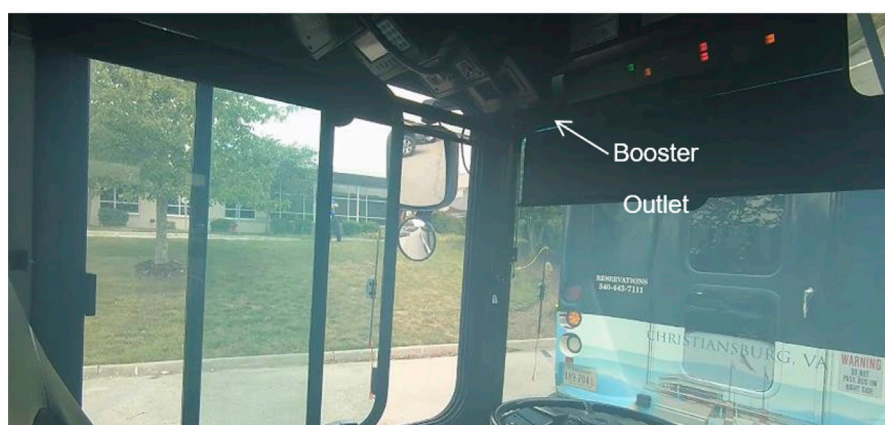
**Observation C4:** The booster fan above the bus operator workstation is designed to assist in cooling and heating the bus operator by accelerating the air flow from the back of the bus. However, this feature increases the bus operator's exposure to air from the back of the bus. This was clearly observed while bus C was idling at 0 mph and only the driver defrost air was on, including the booster fan. It is worth noting that the driver window was also open. The fog machine was positioned in the back of the bus and the passenger air was off. However, as seen in Figure 3-12, fog was pulled forward above the bus operator workstation, without any assistance from the passenger air fans, through the overhead ducts in the passenger area.

**Figure 3-12** Bus C, fog being pulled forward above bus operator workstation with booster fan active
