**An Evaluation of the Cleveland HealthLine Mechanical Guide Wheel**

**Report Number: FTA- FL- 26-7110.2011.2**

**March 2011**

13. ABSTRACT Vehicles on the Cleveland HealthLine Bus Rapid Transit (BRT) system are equipped with a mechanical docking arm and guide wheel to assist with precision docking at the stations. This report documents the evaluation of the guide wheel in 4 areas: how close to the platform the vehicles were able to dock; how fast the vehicles were able to dock; how much money was spent on damages related to docking; and how well the guide wheels are regarded by the HealthLine drivers. The evaluation compared the performance of the HealthLine to the EmX BRT in Eugene, Oregon. The EmX uses the same model vehicle as the HealthLine but does not come equipped with a docking arm and guide wheel.

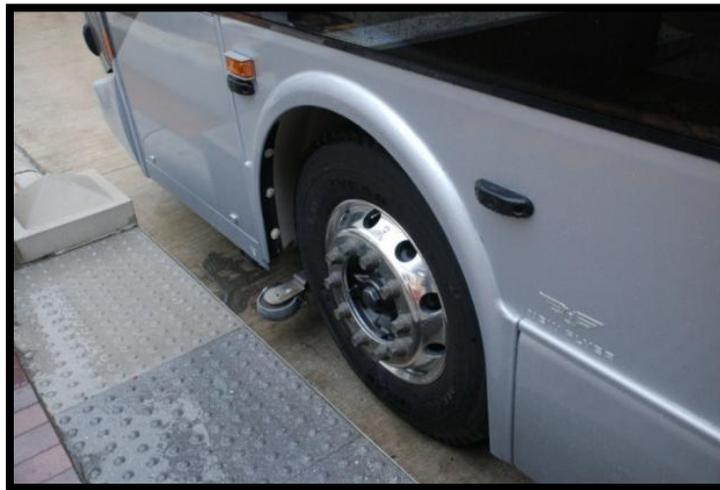
Figure 1 - Mechanical Guide Wheel

The HealthLine BRT uses three tools for precision docking, the primary one being the mechanical guide wheel/docking arm (Figure 1). The other two tools are a painted blue guide stripe on the pavement (Figure 2) and a docking assist system (Figure 3). The blue guide stripe helps the driver to align the vehicle as he/she approaches the station. The docking assist system (DAS) consists of 2 ultrasonic sensors, 1 system controller, and an audible warning device. As the driver approaches the station, the DAS will emit four successive beeps when contact with the platform is imminent. It is important to note that the painted guide stripe and DAS are not required for proper operation of the mechanical guide wheel. They were added as an extra assist to the guide wheel.

GCRTA equips each of their HealthLine rapid transit vehicles (RTVs) with two mechanical guide wheels mounted on each side of the front axle (see Figure 1). The purpose of the guide wheels is to get the RTV as close to the edge of the station platform as possible and thereby simulate the experience of passenger rail docking. As the HealthLine RTV approaches a station, the driver angles the vehicle toward the platform until the guide wheel makes contact. When properly aligned, the side of the vehicle is nearly flush with the platform edge leaving only a small gap in between.

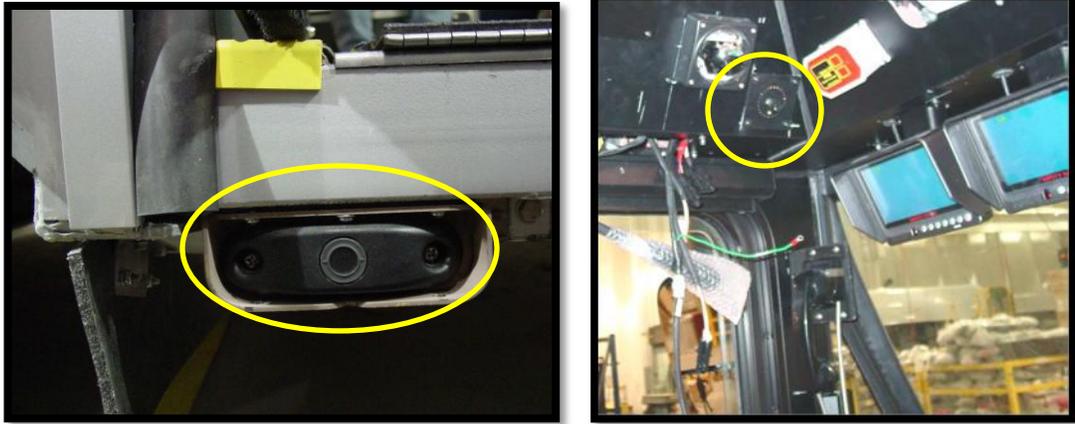
Figure 3 - Docking Assist System

GCRTA reports that it costs about \$3,700 to equip each HealthLine RTV with two docking arms. Additionally, each RTV is equipped with a Docking Assist System (DAS) that consists of 2 sensors, 1 system controller, and an audible warning device. GCRTA reports that the unit cost of the DAS is \$216 for each sensor, \$647 for the controller, and around \$150 for the speaker. However, they report that the DAS is an optional feature. If the entire package were installed on a RTV, the total costs would be \$4,929.

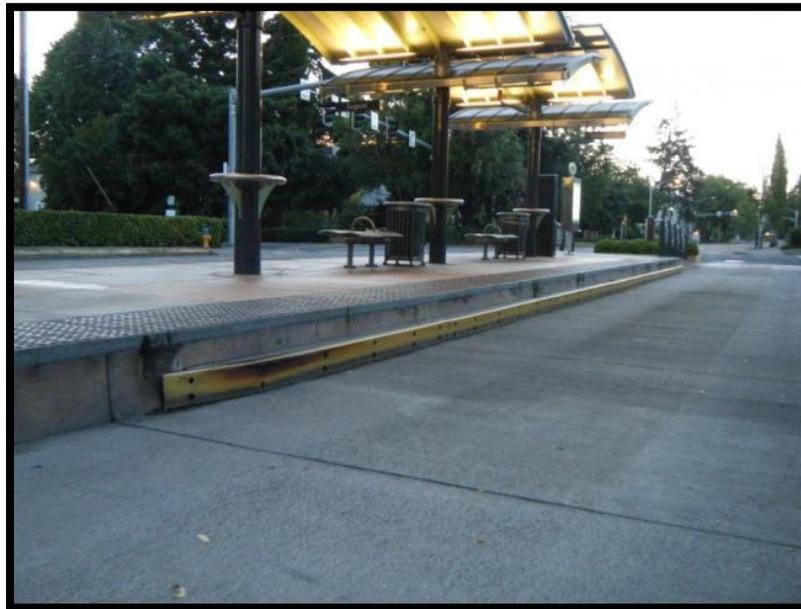
Figure 4 - Yellow Guide Strip

In Eugene, all EmX station platforms are outfitted with a yellow, polyethylene guide strip that sticks out 5 ½ inches from the base to prevent the RTV from hitting it (see Figure 4). This is not a precision docking device per se. Unlike the HealthLine's mechanical guide wheel which is supposed to make contact with the curb, the EmX guide strip is not meant for contact by the RTV. It is there simply to prevent damage to the station platform and RTV should contact occur.

observed gap was 4 inches at the 6<sup>th</sup> Street Station and 4 ½ inches at the 9<sup>th</sup> Street Station. The minimum observed gap for the EmX was 6 ½ inches at the Hilyard Station and 7 ¼ inches at the Dad’s Gate Station. That the EmX RTVs would be farther away even at their best, is not surprising given that the yellow guide strips at the EmX stations stick out 5 ½ inches from the platform.

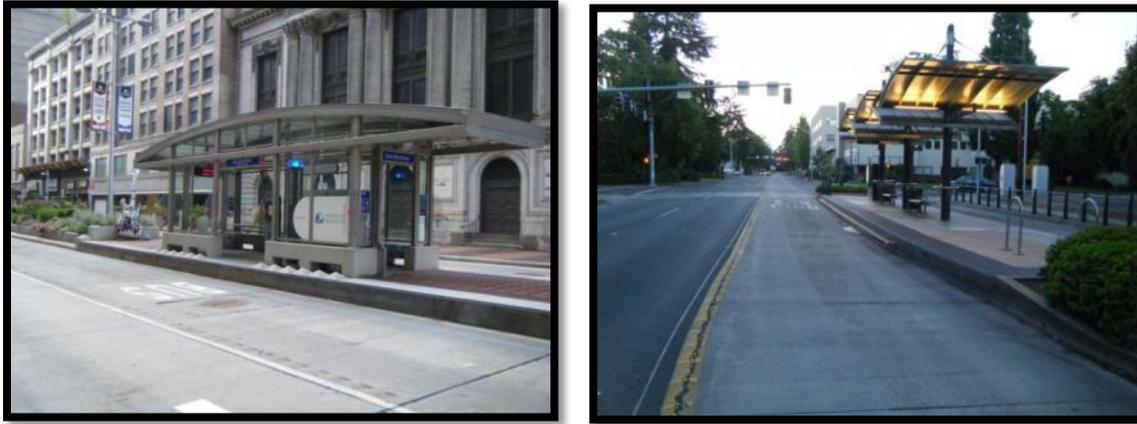
Figure 5 - 9th St. Station (westbound) & Hilyard St. Station (westbound)

In order to have comparable results, it was important to identify stations in Cleveland and Eugene that had similar design characteristics and roadway geometry and to collect the data in a manner that was as consistent as possible. In a conference call between NBRTI, GCRTA, and Lane Transit District, several candidate stations were discussed. As-built drawings were later exchanged and compared. It was determined that the westbound side of East 9<sup>th</sup> Street Station in Cleveland was comparable to the westbound side of Hilyard Station in Eugene. It was determined also that eastbound side of East 6<sup>th</sup> Street Station in Cleveland was comparable to the westbound side of Dad's Gate Station in Eugene. These stations are illustrated in Figures 5 and 6 below. All of these stations are for left-side boarding. There were no comparable stations for right-sided boarding.

The results show that on average there was not much difference in the vehicle-to-station gap when comparing docking at the HealthLine’s 9<sup>th</sup> Street Station to the EmX’s Hilyard Station. On average, the RTVs of both systems docked at about 8 to 8 ½ inches from the platform. However, there was more of a difference when comparing docking at the HealthLine’s 6<sup>th</sup> Street Station to the EmX’s Dad’s Gate Station. The RTVs at the 6<sup>th</sup> Street Station were almost 4 inches closer on average compared to the RTVs at Dad’s Gate Station.

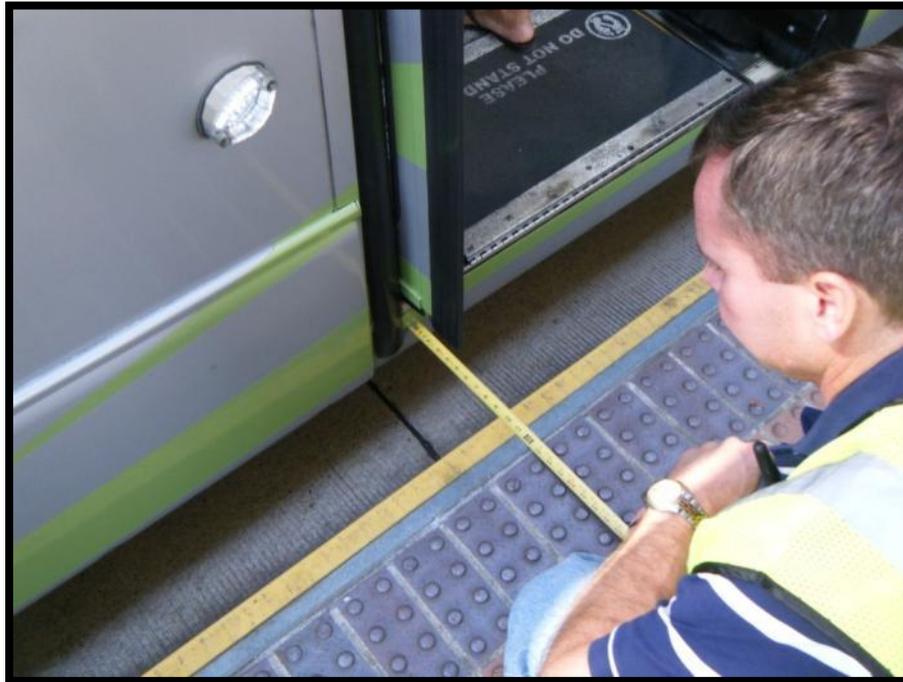
Figure 7 - Precision Docking Measurement

For measuring the gap between the RTV and the station platform, measurements were taken at the second door on the left side of the vehicle, at the forward most side of the doorway (see Figure 7). In the figure, the front of the vehicle is towards the left. The reason why the second door was chosen is because the HealthLine and EmX BRTs both use articulated vehicles, and the second door is located aft of the articulation point. It was agreed by NBRTI, GCRTA, and Lane Transit District staff that the true test of precision docking would be how close the second door came to the platform.

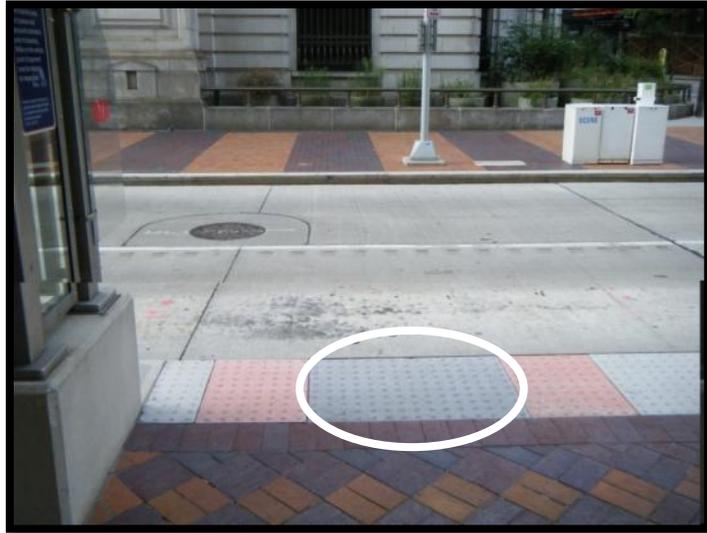
Figure 8 - Grey Colored Brick Paver at 9th St. Station (Cleveland)

Both the HealthLine and EmX stations incorporate features that show the driver where to stop. At the HealthLine 9<sup>th</sup> Street Station, the drivers stopped once he/she was personally aligned with the grey colored brick paver on the opposite side of the platform (see Figure 8). At the 6<sup>th</sup> Street Station, drivers stopped once they were personally aligned with a marker post just past the platform (see Figure 9).

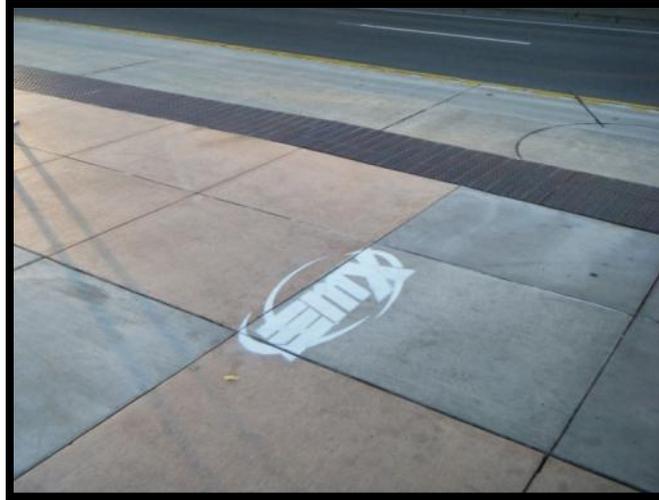
Figure 10 - EmX Marker (Eugene)

In Eugene, the EmX drivers stop their vehicle once they are personally aligned with an EmX logo that is painted on the station platform (see Figure 10).

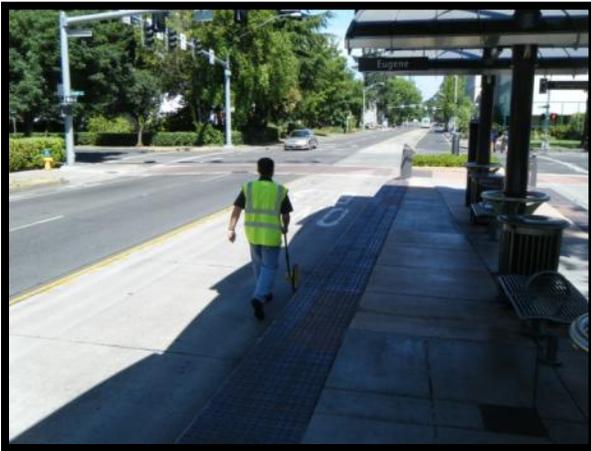
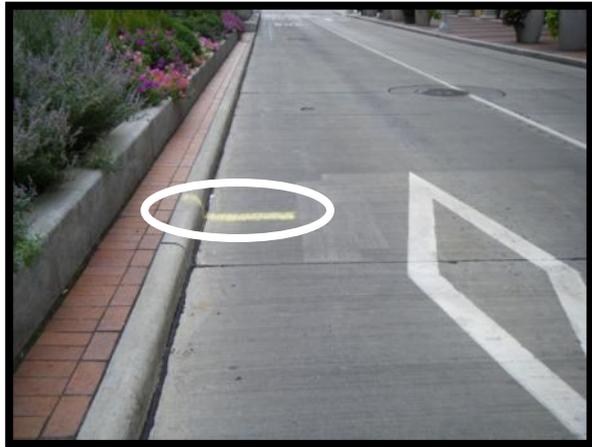
Figure 11 - Measuring and Marking 120 feet

For measuring the amount of time it took the RTVs to dock, NBRTI staff identified a location 120 feet out from where the RTV regularly stopped, marked it, and timed how long it took the vehicle to cross that point and come to a complete stop. The reason why 120 feet was chosen was because that is twice the length of the RTV used by GCRTA and Lane Transit District. For the purpose of this evaluation, the vehicle was considered to be in “docking phase” once it was within 120 feet of its stopping point at the station.

From these stopping points, 120 feet was measured using a distance wheel, and the spot was marked with chalk (see Figure 11).

During data collection, the person collecting the data would stand at a vantage point with a stopwatch. When the RTV's front bumper crossed over the chalk, he would start the clock. When the RTV came to a complete stop, he would stop the clock and enter the elapsed time on a tracking sheet. For data collection on the HealthLine, the observer would discard the time if he observed that the guide wheel did not make contact with the platform. The reason for this decision is that we were attempting to gather data on "precision docking". If a driver was not making an effort to dock with the guide wheel, the time recorded would not be reflective of the true time it takes to precision dock.
