## Transit Track Worker Safety Protection Demonstration Project

FTA Report No. 0046  
Federal Transit Administration

Mark Willer  
Bombardier Transportation

| 13. ABSTRACT<br>This report describes the demonstration of an innovative system to reduce the hazards of working in the track environment. It describes the deployment of the system, provides a summary of developments to further enhance the system for transit agencies and railroads, describes the testing of the system, and summarizes user feedback. | | | |

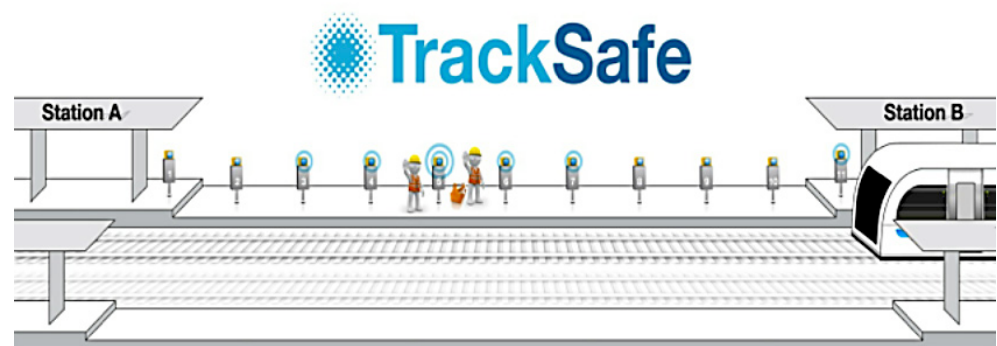
**Figure 2-1**  
*TrackSafe concept*

Roadway workers are equipped with an RFID tag, typically embedded in a wristband, which they use to “tag in” at a unit at their point of entry to track level. No other equipment is required for the roadway workers, allowing them to carry necessary work equipment and enhance their safety with minimal effort.

As the roadway work crew proceeds at track level, they tag in at various check points. This creates an Alert Warning Zone (AWZ) by automatically illuminating LED lights that warn train operators of the location of roadway workers as the train approaches the AWZ. The AWZ is configurable so that varying combinations of maximum train approach speed, stopping distance, and time for track workers to reach a place of safety can be accommodated.

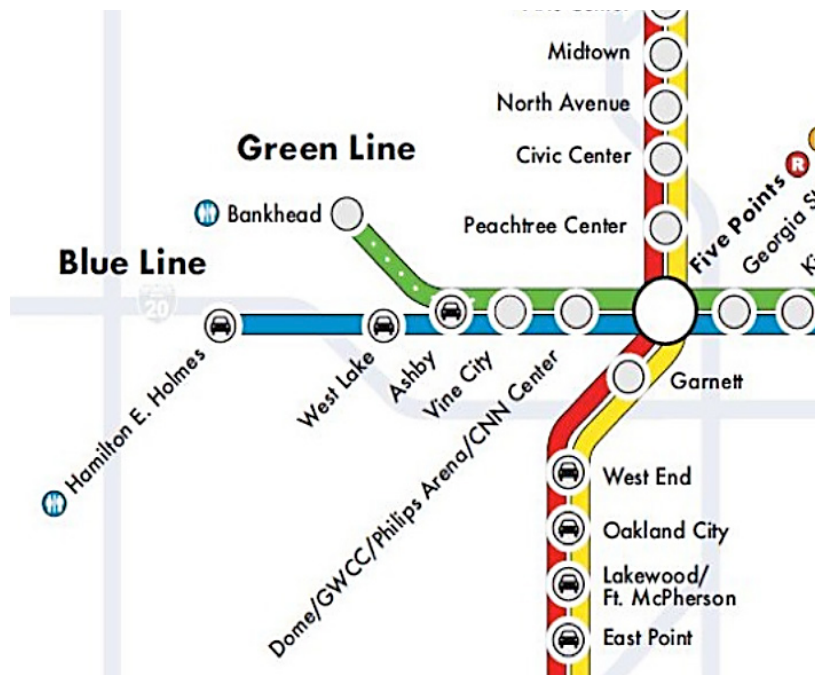
**Figure 3-1**  
MARTA rail map

In consultation with MARTA and FTA, the section of track selected for the demonstration was between Ashby Station and Bankhead Station on MARTA's Green Line. This section which is approximately 1.5 miles in length and features:

- 1,500 feet of tunnel in a tight curve
- Changes in gradient
- Road and rail bridges over the track
- A bridge featuring limited clearance that carries the MARTA track over a creek

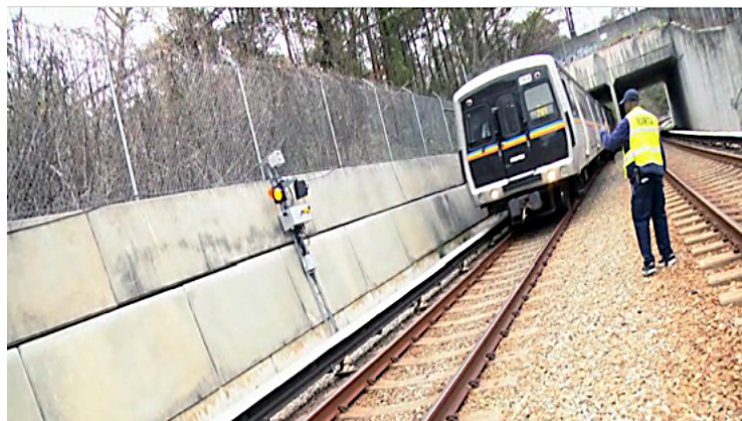
**Figure 3-2**  
*Track Level Unit (TLU)*

The system was deployed and commissioned over two weekends of “track time.” Figure 3-2 shows the TrackSafe equipment mounted to a wall.

TLUs provide track workers with an interface to communicate their location with the rest of the system. This is enabled through the workers swiping their tags at the TLUs. They communicate with the server to send event-based information and receive commands from the server to turn on lights or horns based on their location in the AWZ.

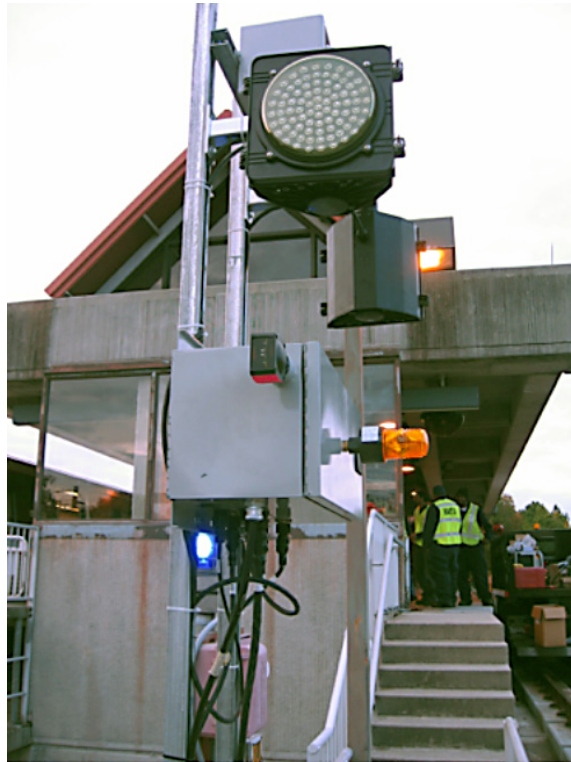
**Figure 3-4**

*Bankhead Station  
installation*

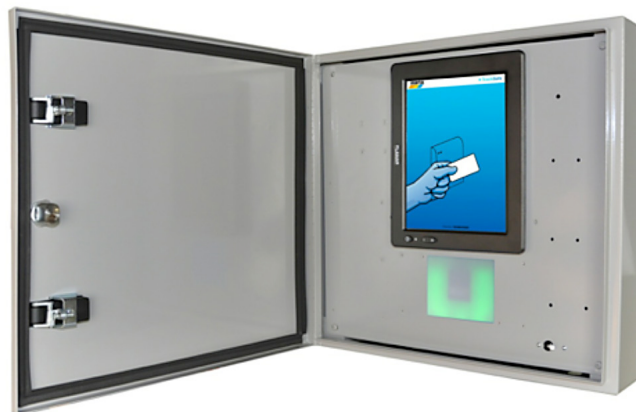
**Figure 5-2**

*Station Level  
Unit (SLU)*

SLUs are used by workers to check in and check out. The testing conducted on SLUs is discussed below. Challenges were experienced with the SLUs during initial testing. These challenges were due to the changing architecture of the server. Once the server architecture was updated, these challenges were resolved and the results from final testing are provided above.
