Bus Safety Study: A Report to Congress

FTA Report No. 0051
Federal Transit Administration

Center for Urban Transportation Research
University of South Florida

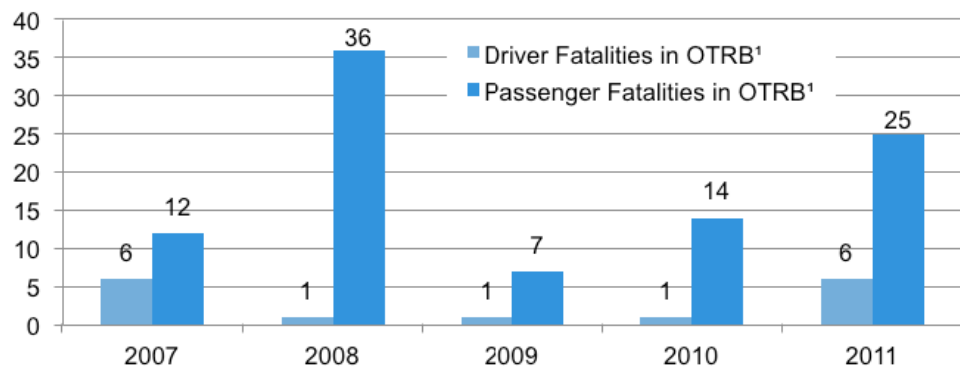
Figure 1

OTRB Driver and Passenger Fatalities on High Speed Roadways²

¹Data from National Highway Traffic Safety Administration's (NHTSA) Fatality Analysis Reporting System (FARS) database for years specified. NTD was used to exclude those fatalities that occurred on OTRBs while in public transit service.

²High speed roadway defined as location where speed limit is greater than 45 mph.

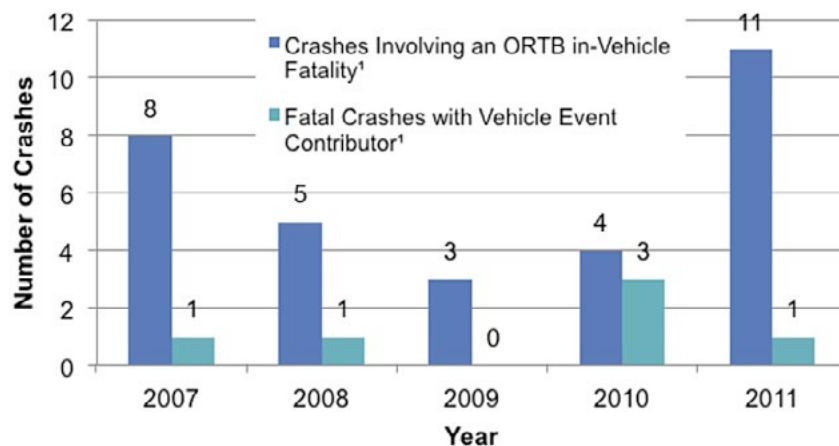
Figure 2

OTRB Crashes and Vehicle Events on High Speed Roadways²

¹Data from NHTSA's Fatality Analysis Reporting System (FARS) database for years specified. NTD was used to exclude those fatalities that occurred on OTRBs while in public transit service.

²High speed roadway defined as location where speed limit is greater than 45 mph.

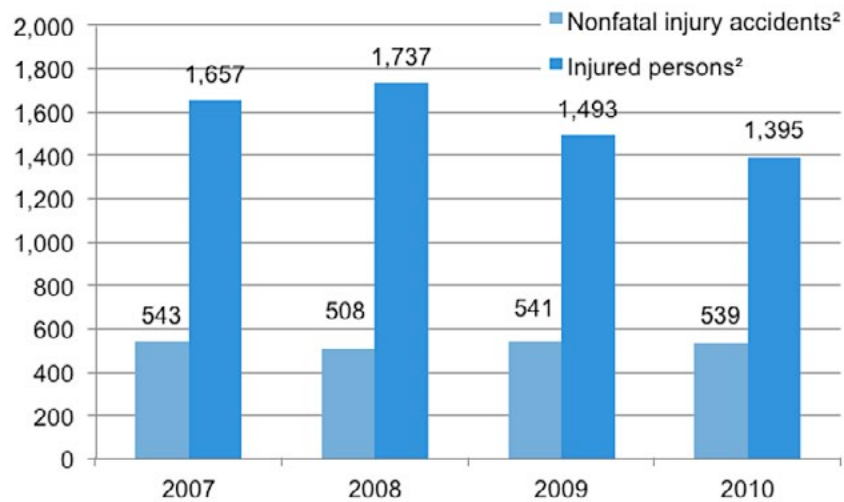
significant variation in the number of persons injured in those events, from a high of 1,737 injured persons in 2008 to 1,395 injured persons in 2010. The data suggest randomness of events and resultant injuries, not attributable to any noticeable trends.

Figure 3
*OTRB Carrier¹
Reported Total Non-
Fatal Injury Accidents
and Injured Persons*

¹OTRB/motorcoach carriers only; does not include vehicles operated by transit agencies.

²Motor Carrier Management Information System (MCMIS) summary data as cited in NTSB's *Report on Curbside Motorcoach Safety*; includes all persons injured in or outside a vehicle at the scene of the crash who were transported to a medical facility for immediate medical attention.

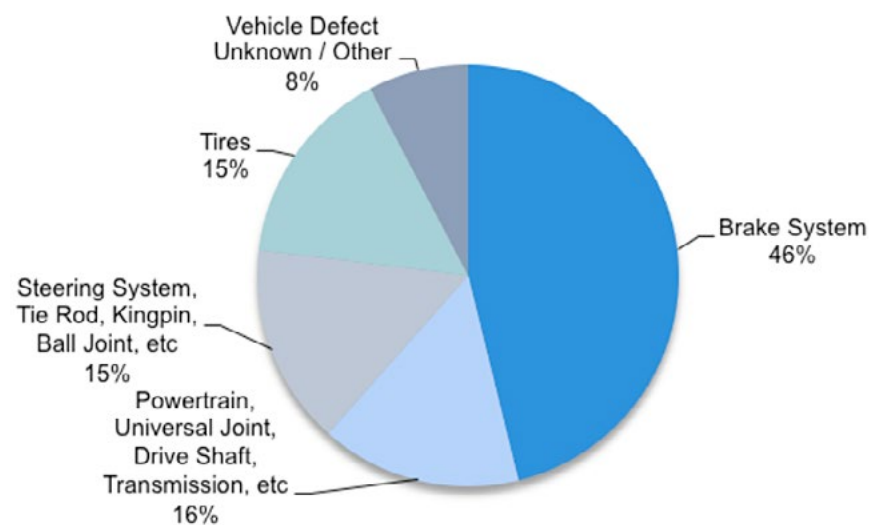
Figure 4
*GES Sample of OTRB
Crashes with Vehicle-
Related/Contributing
Factors¹*

¹From NHTSA's General Estimates System (2007-2011); includes only OTRB crashes.

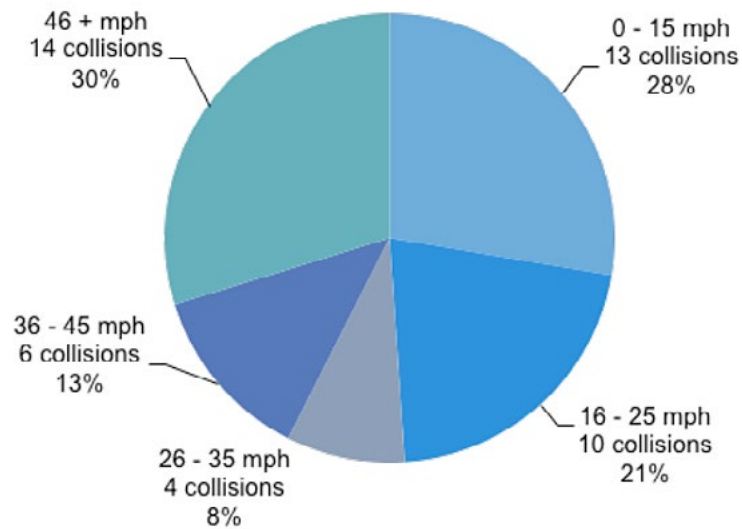
Figure 6 shows the speeds at which the collisions occurred. Whereas all of these 48 collisions occurred on the highway corridors sampled for this study, only 14 occurred at speeds of greater than 45 miles per hour. Thirteen collisions occurred at speeds of 15 miles per hour or less, or when the vehicle was stopped in traffic. These data indicate that the majority of the collisions within these highway corridors did not occur at normal highway speeds. One reason for this could be that transit buses are typically operating service within these corridors during peak periods when traffic congestion is higher than during other times of the day.

Figure 6
NTD Motorbus
Collision Speed
Information Totals
for Transit Systems
Included in the Study,
2008–2012¹

¹Data from NTD for years specified; includes directly-operated and purchased motorbus services, for collisions on identified corridors for this study. Speeds listed are estimated. One collision did not have estimated speed information in its reports.

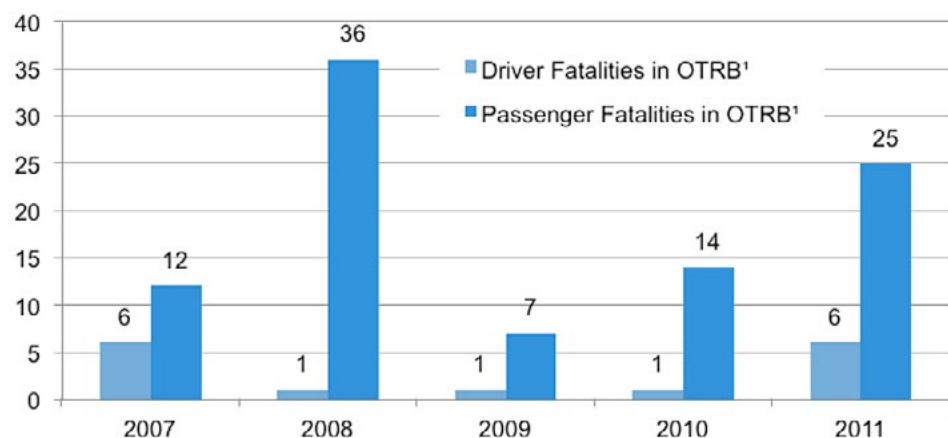
Figure 1-1
*OTRB Driver and
Passenger Fatalities on
High Speed Roadways²*

¹Data from NHTSA's Fatality Analysis Reporting System (FARS) database for years specified. NTD was used to exclude those fatalities that occurred on OTRBs while in public transit service.

²High speed roadway defined as location where speed limit is greater than 45 mph.

Figure I-1 identifies the driver and passenger fatalities that occurred while OTRBs were operating on high-speed roadways. Figure I-2 illustrates the number of crashes and vehicle events for OTRB that correspond to the fatalities in Figure I-1. These do not include any OTRB crashes that occurred while in public transit service.

During the study period, fatalities peaked in 2008, in large part due to a single crash involving 17 fatalities, which accounted for nearly half of the total OTRB for the entire year.⁷ In 2007, driver fatalities represented one third of the total for the year (driver fatalities typically represent a much smaller proportion of total fatalities than in 2007). In 2011, 11 crashes resulted in fatalities, with one crash resulting in 15 of the 31 total fatalities that year. Crashes with vehicle-related factors or vehicle contributing causes were present in four of the five years in the study period. Vehicle contributing causes reached their maximum both in proportion of total crashes and in count in 2010. The Vehicle-Related and Contributing Crash Causes section below provides detail on the types of defects cited in these fatal crashes.

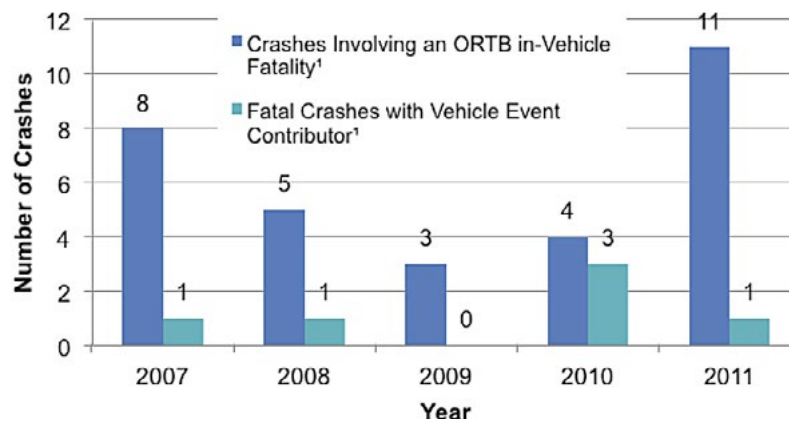
Figure 1-2
OTRB Crashes and
Vehicle Events on High
Speed Roadways²

¹Data from NHTSA's Fatality Analysis Reporting System (FARS) database for years specified. NTD was used to exclude those fatalities that occurred on OTRBs while in public transit service.

²High speed roadway defined as location where speed limit is greater than 45 mph.

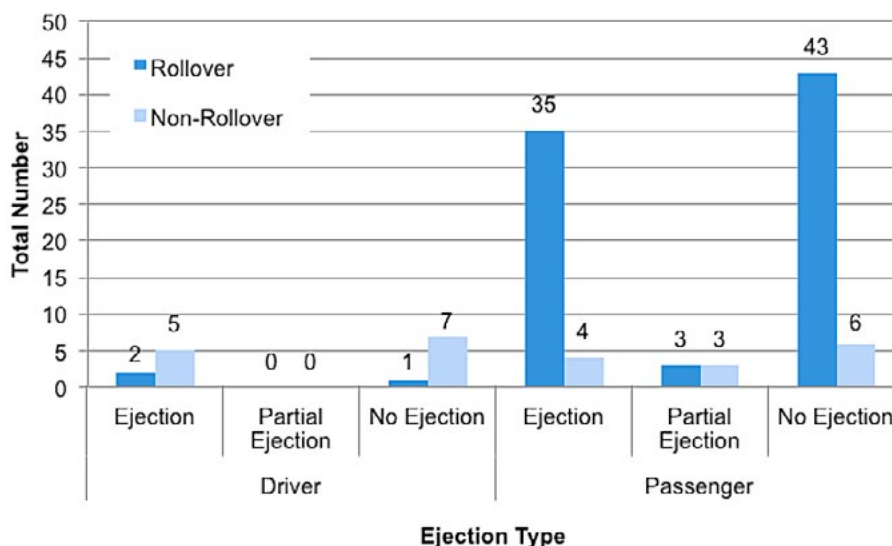
Figure 1-3

*Driver and Passenger
OTRB Fatalities in
Ejections and Vehicle
Rollovers¹*

¹Data from NHTSA's FARS database for the study period 2007–2011.

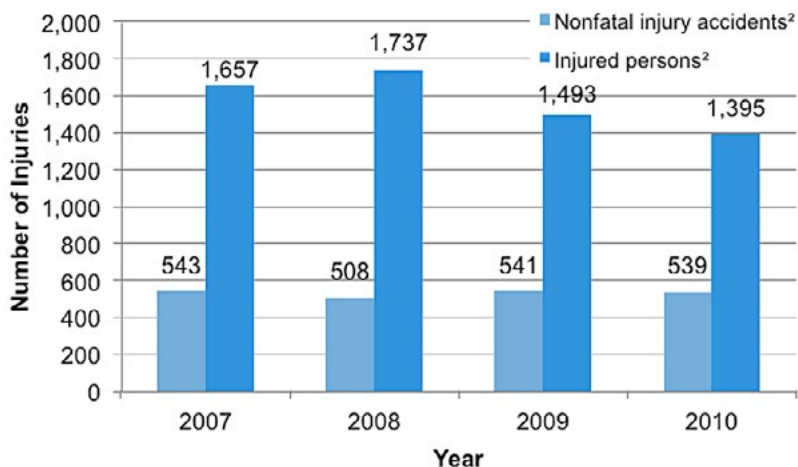
Figure 1-4

*OTRB Carrier¹
Reported Total Non-
Fatal Injury Accidents
and Injured Persons*

¹OTRB/Motorcoach carriers only, does not include vehicles operated by transit agencies.

²MCMIS summary data as cited in NTSB's *Report on Curbside Motorcoach Safety*, includes all persons injured in or outside a vehicle at the scene of the crash who were transported to a medical facility for immediate medical attention.

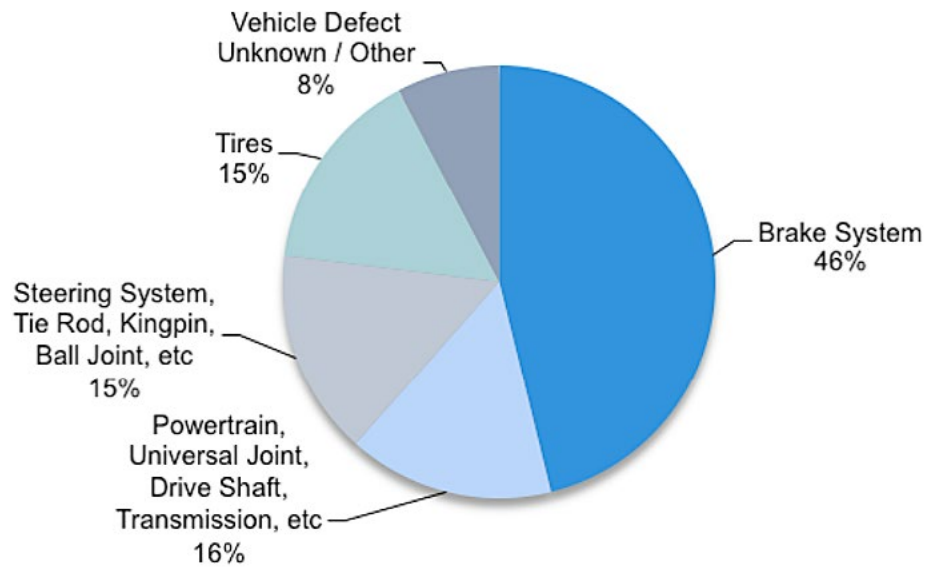
GES Sample of OTRB
Crashes with Vehicle-
related/Contributing
Factors¹

¹From NHTSA's General Estimates System (GES) 2007-2011, OTRB crashes only.

The GES data represented in Figure 1-5 are taken from a sample of approximately 50,000 crashes annually. Brakes were the most commonly-identified vehicle-related or contributing factor in the sampled dataset. Tires were also a common vehicle-related defect cited in crash reports.¹³ For commercial motor vehicles, tire deficiencies found during roadside inspections often resulted in citations for regulatory violations or caused vehicles to be taken out of service.¹⁴

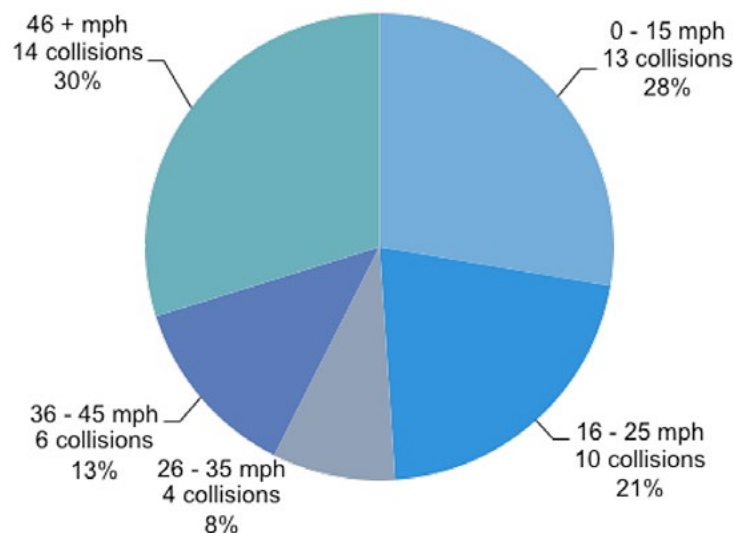
Figure 2-3 provides additional information on the 48 identified collisions by noting the estimated vehicle speeds at which the collisions occurred. Thirteen collisions occurred in stopped traffic or speeds of 15 miles per hour or less. However, 14 collisions occurred at speeds of 46 miles per hour or greater. Reports for one of the identified collisions did not indicate an estimated vehicle speed.

Figure 2-3
NTD Motorbus
Collision Speed
Information Totals
(Transit Systems
Included in the Study),
2008–2012¹

¹Data from NTD for years specified; includes directly-operated and purchased motorbus services, for collisions on identified corridors for this study. It should be noted that the speeds listed are estimated; one collision did not have estimated speed information in its reports.

Of the 14 collisions occurring at speeds of 46 miles per hour or greater, 4 were rear-ending, 2 were rear-ended, 3 were sideswipes, 2 were angle collisions, and 3 were the result of other front impact. Two of these collisions were the result of operator avoidance maneuvers where the bus ended up striking something else (concrete barrier, bridge support). A total of 3 operators and 15 passengers were injured in these collisions; 8 of the injuries were from one collision where the bus operator rear-ended the vehicle in front of it as traffic suddenly slowed.
