Pedestrian Falling Accidents in Transit Terminals

Port Authority of New York
and New Jersey

February 1985
Final Report

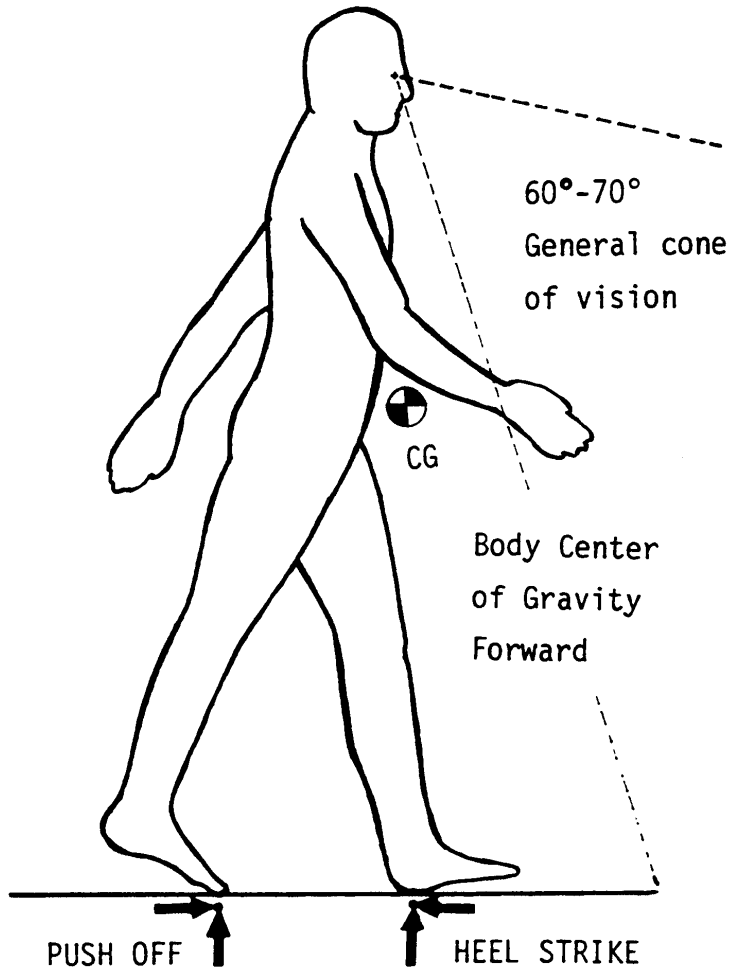
FIGURE 2-1. LEVEL WALKING

"The walking cycle is begun by leaning forward and swinging the leading foot into a heel strike. At about the same time the rear foot begins a rolling push off and is swung forward for a new heel strike and repeat of the cycle."

The walking cycle is begun by leaning forward and swinging the leading foot into a heel strike. At about the same time the rear foot begins a rolling push-off and is swung forward for a new heel strike and repeat of the cycle. Both the heel strike and the push-off are the points in the walking cycle when a person is likely to slip. Tripping would likely occur when the leg is swung forward and there is insufficient ground clearance for the foot. Minimum ground clearances of the toe when the foot is swung forward were observed to average 0.6 in. (14 mm) and range between 3/8 and 1-1/2 in. (10 and 38 mm) in one controlled study. (2.1)

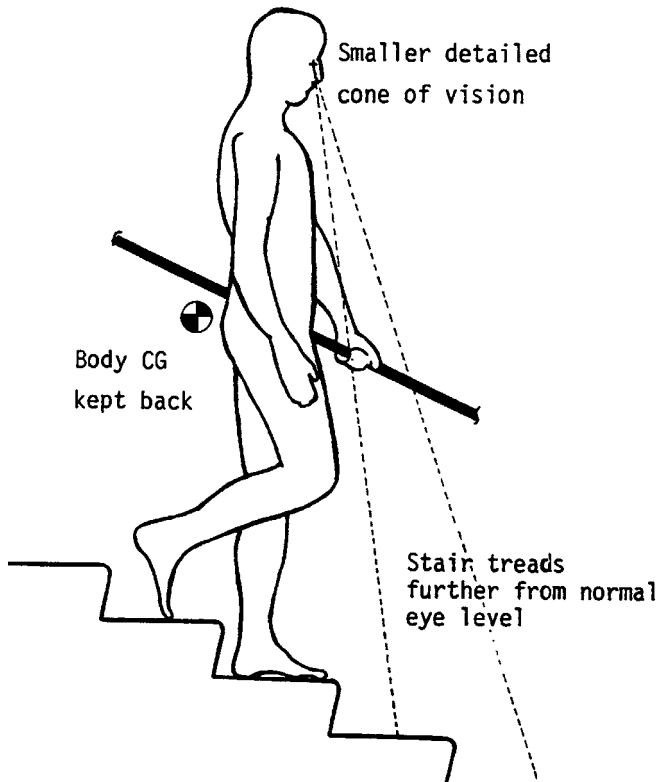
"In descending stairs the body center of gravity is shifted back and the ball of the lead foot is placed on the step below. The lead foot is then leveled for support, and the rear foot lifted, swung forward, and lowered to the next tread."

"...only the handrail can help stop a descending fall in progress and prevent it from being extended further down the stair."

"...extension increases impact and severity."

In descending stairs, the body center of gravity is shifted back and the ball of the lead foot is placed on the step below. The lead foot is then leveled for support, and the rear foot lifted, swung forward, and lowered to the next tread. For the best support and ease of movement the step tread should be wide enough to accommodate the length of the foot from ball to the heel, with added clearance for footwear. Narrow treads can cause an awkward turning of the feet, increasing the probability of a misstep. The eye level above the steps in descent is much higher than in ascent. Because of this, and the necessity of keeping the body center of gravity back, the steps are more difficult to see.

Most stair accidents, and the more severe requiring first aid treatment or hospitalization, occur in descent. Unlike the ascending accident where steps above can help arrest a fall, only the handrail can help stop a descending fall in progress and prevent it from being extended further down the stair. The extension of the fall increases its impact and severity. In addition to increased impact, falls higher up on the stair are more dangerous because the resulting body angle makes a head injury more likely (see Figure 2-3).

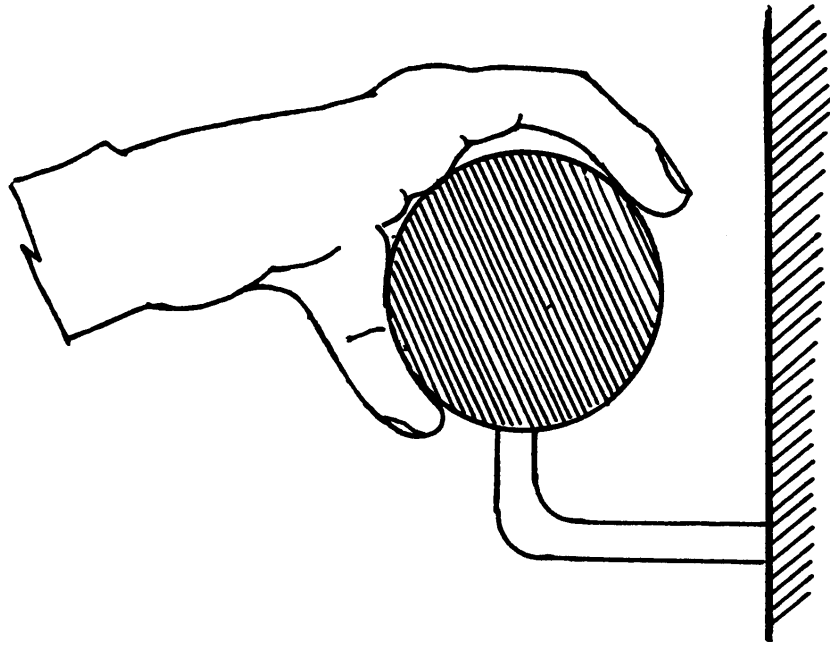
FIGURE 2-4. HANDRAIL GRASPABILITY

Large handrail geometry does not allow a wrap-around of hand for a power grip.

Handrails set too close to the wall can interfere with a "last effort" grab.
