Inspection Form

FOIA Exemption: All (b)(6)

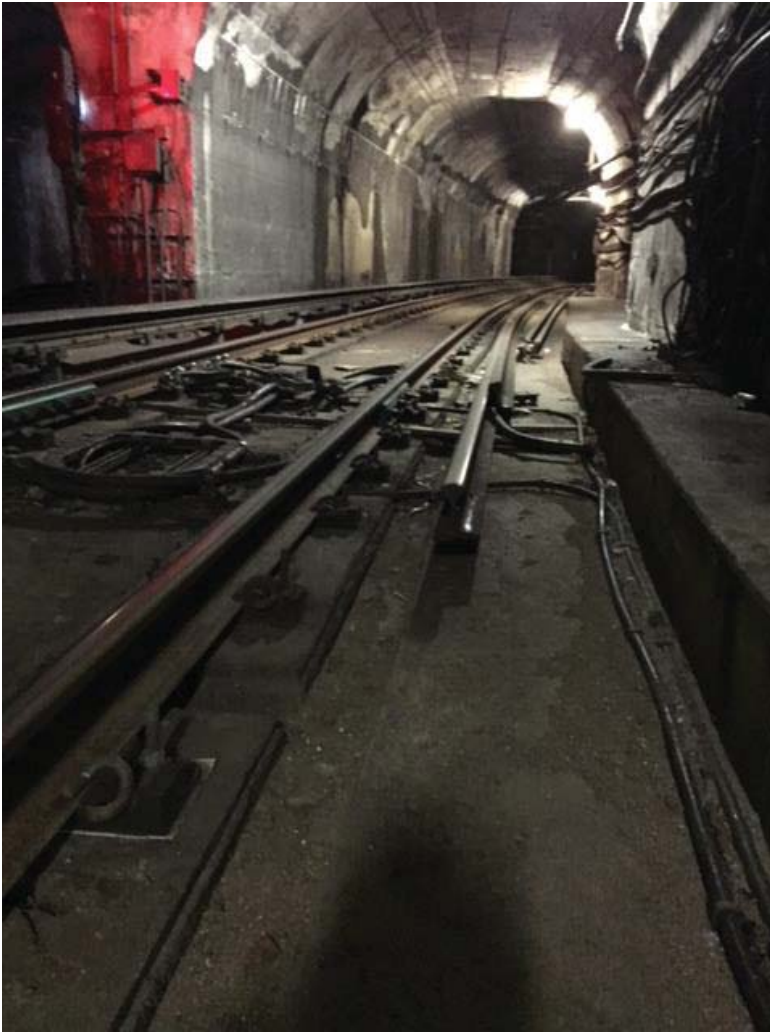
Figure 1: Relay rail tripping hazard at K1 148+00.

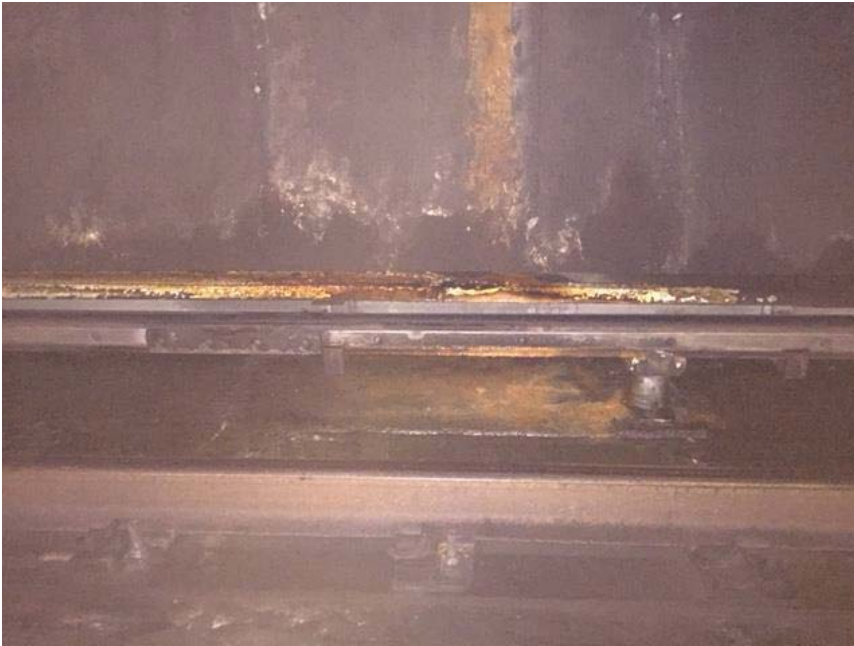
Figure 1: Corroded third rail and cover board from tunnel leak at A1 213+30.

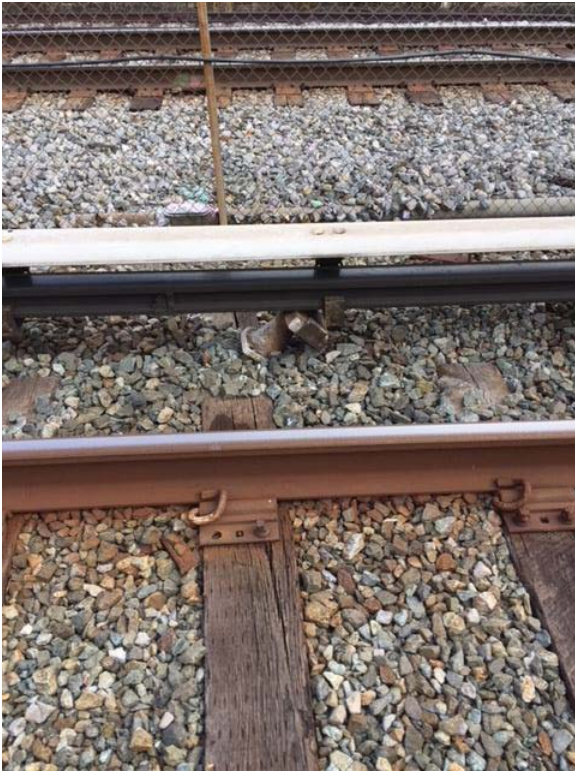
Figure 1: Third rail insulator at B1 269+00

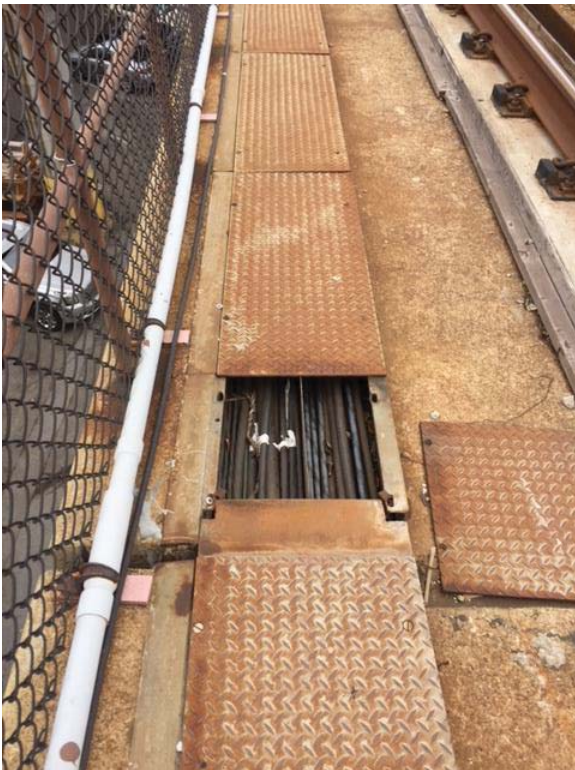
Figure 2: Missing trough plate at B1 169+40

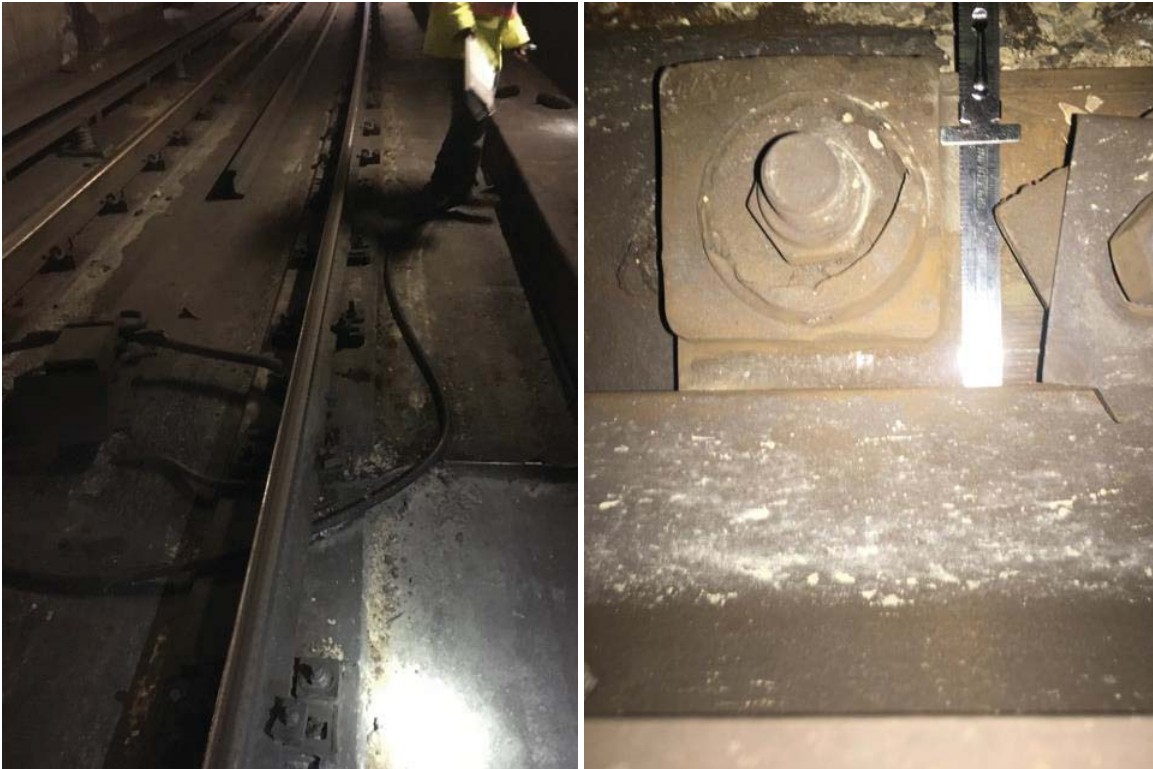
Figures 1 and 2: Five defective fasteners in a row at and dynamic movement between B2 026+35 and 026+50.

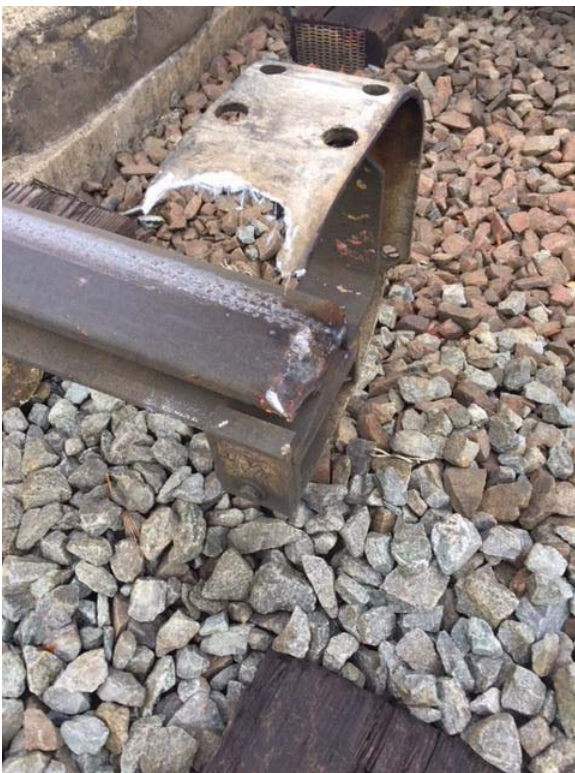
Figure 1: Collector shoe contacting end of third rail at J1 732+50.

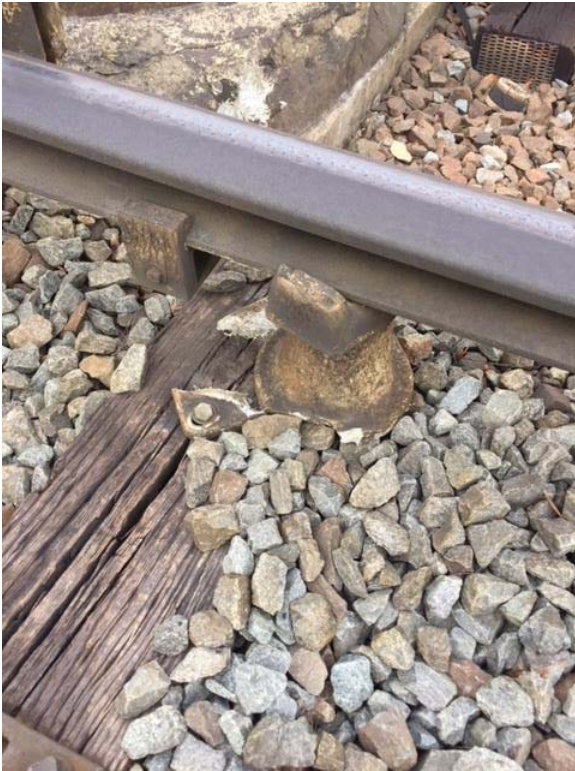
Figure 2: Broken end support third rail insulator at J1 732+50.

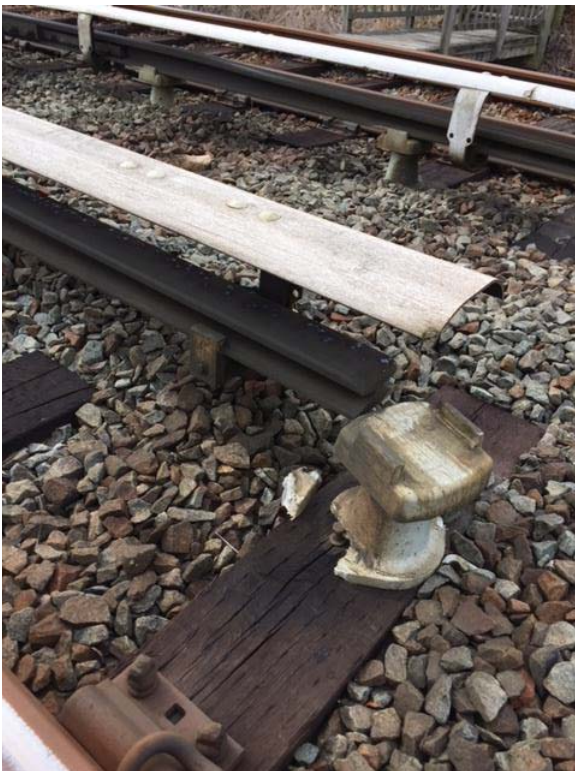
Figure 3: Broken, non-supporting, third rail end approach insulator at J1 826+60.

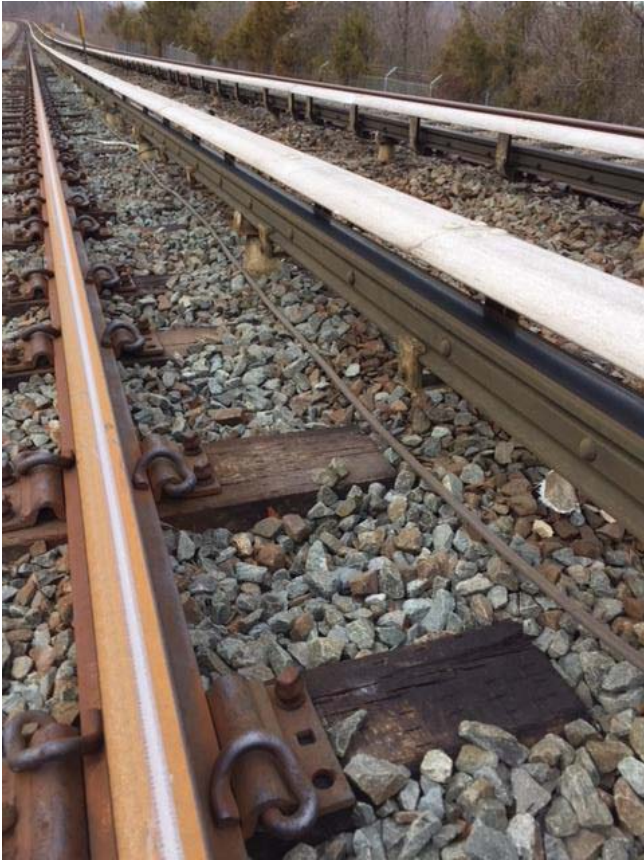
Figure 4: Third rail heat wire on the ground between J1 733+00 and 735+00.

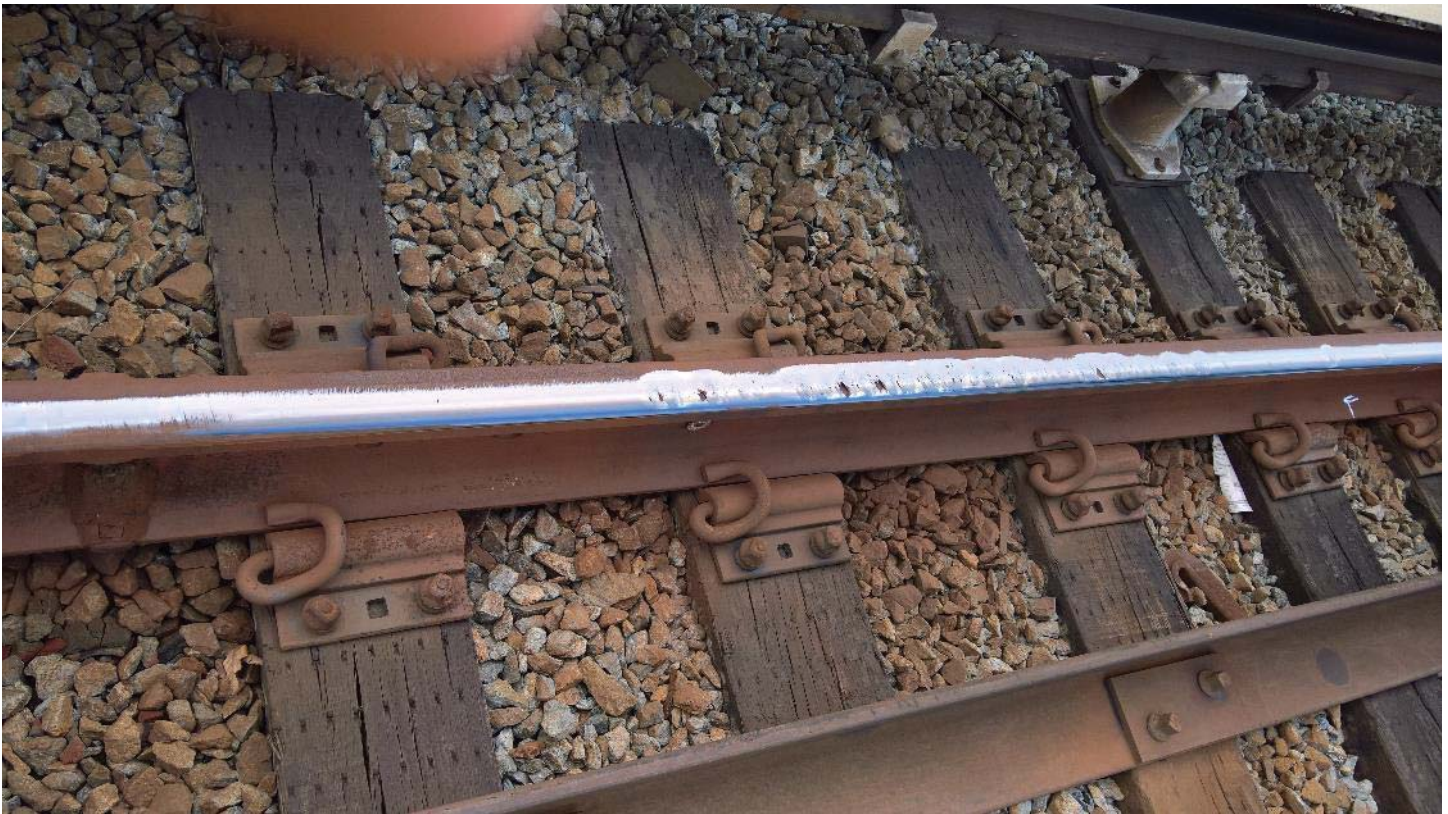
Figure 1: Shelling condition at G2 287+00

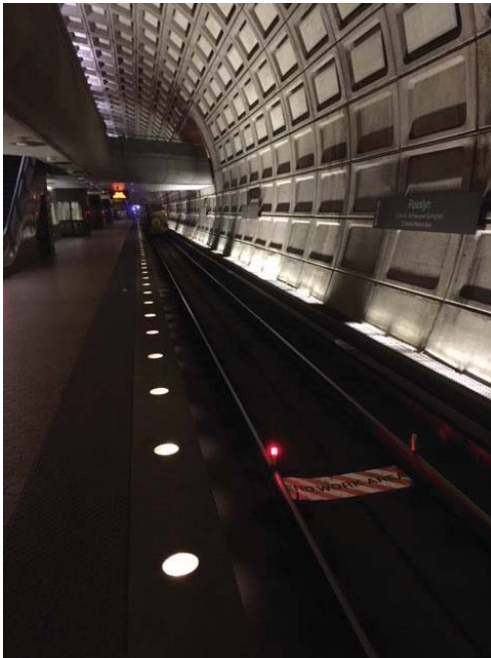
Figure 1: At C2 140+90, e-flare light was not operating.

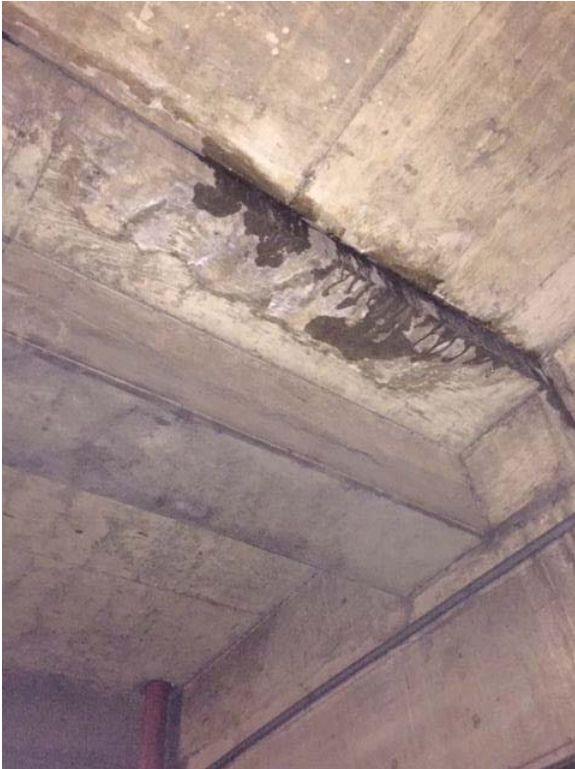
Figure 1: Tunnel leak at B2 718+00.

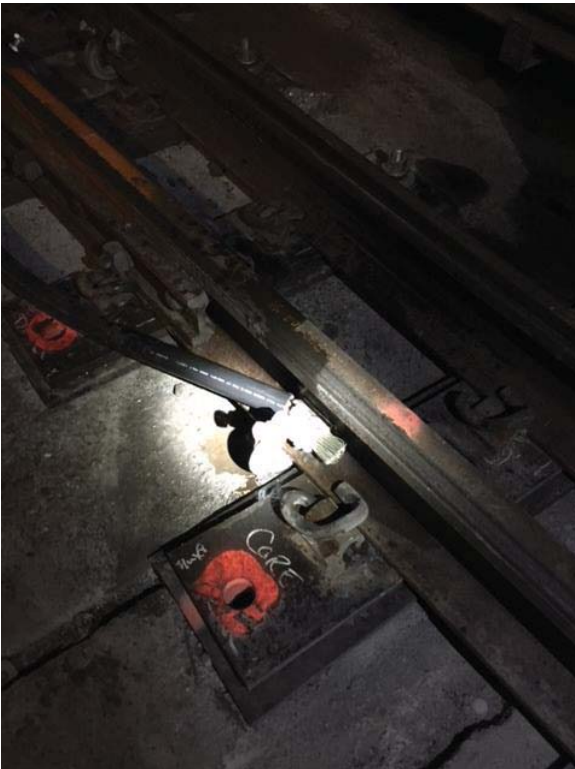
Figure 2: Water striking rail and bond wire at B2 718+00.
