Inspection Form

FOIA Exemption: All (b)(6)

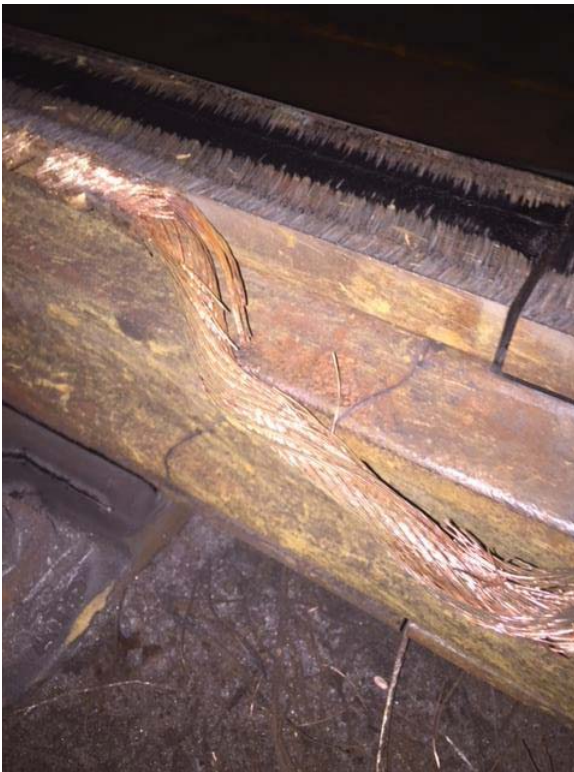
Figure 1: Center cracked angle bar at D2 27+90.

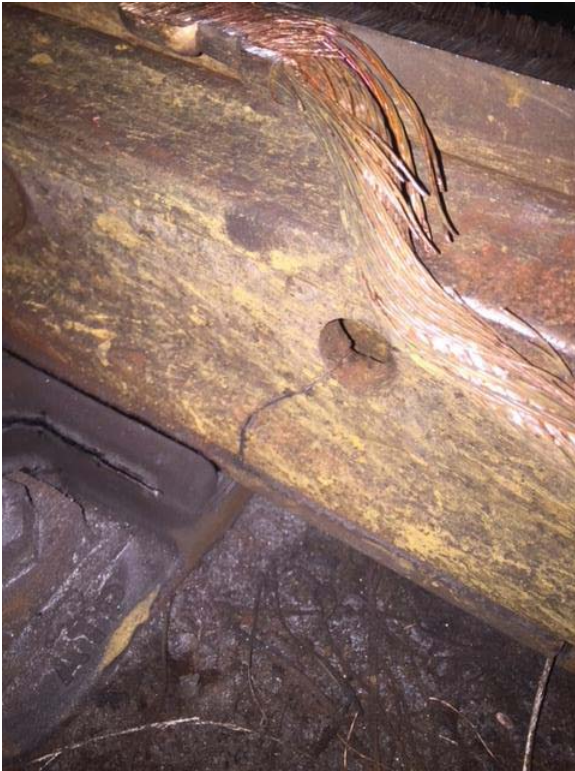
Figure 2: Center cracked angle bar at D2 27+90.

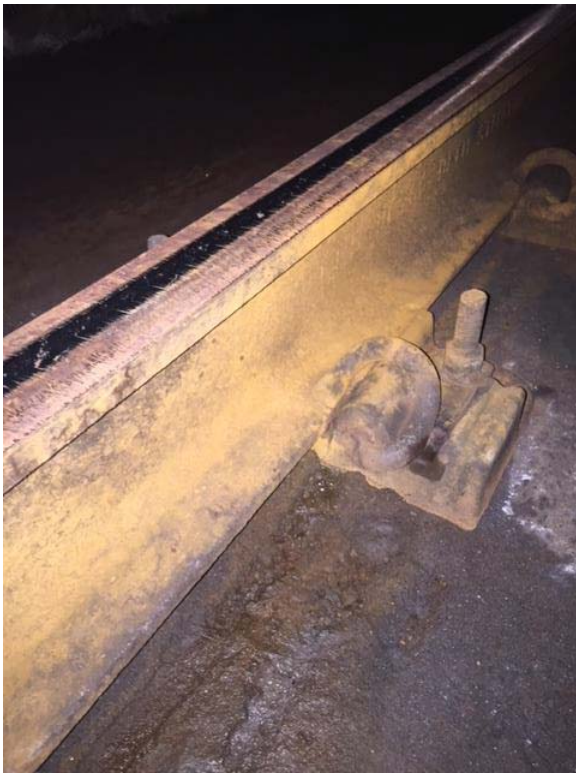
Figure 3: Left rail at D2 20+30.

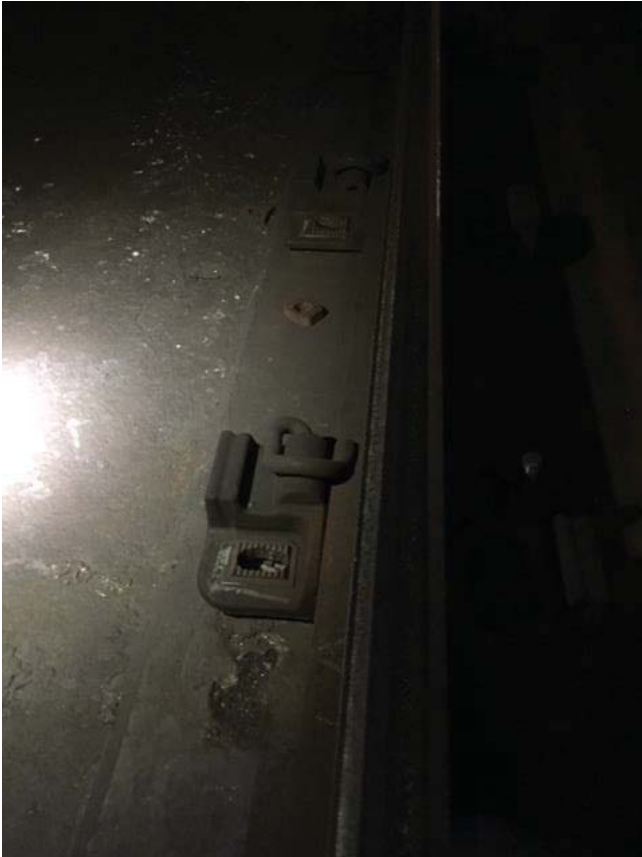
Figure 1: Missing fasteners at B1 059+70

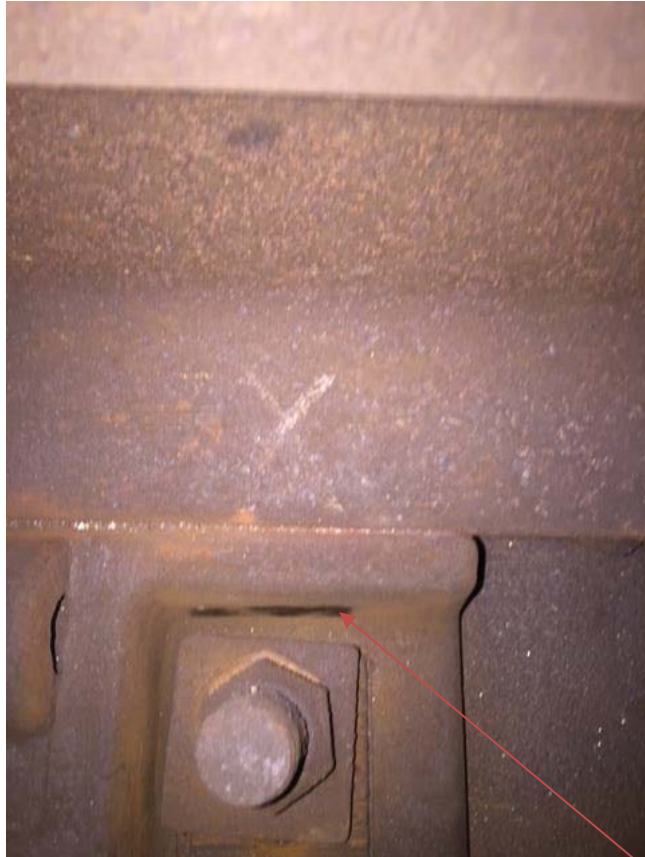
Figure 2: 1/8-inch lateral movement mark affecting gauge at B1 059+70.

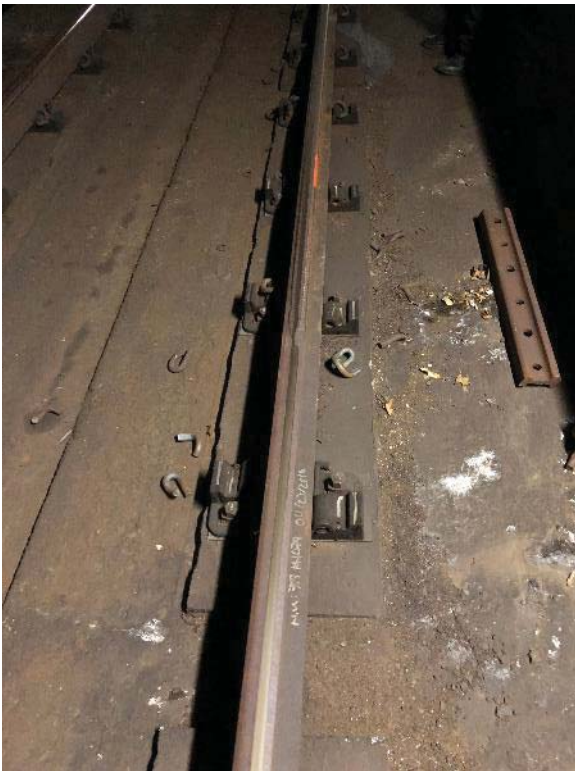
Figure 2: Three consecutive defective fasteners at A1 151+80.

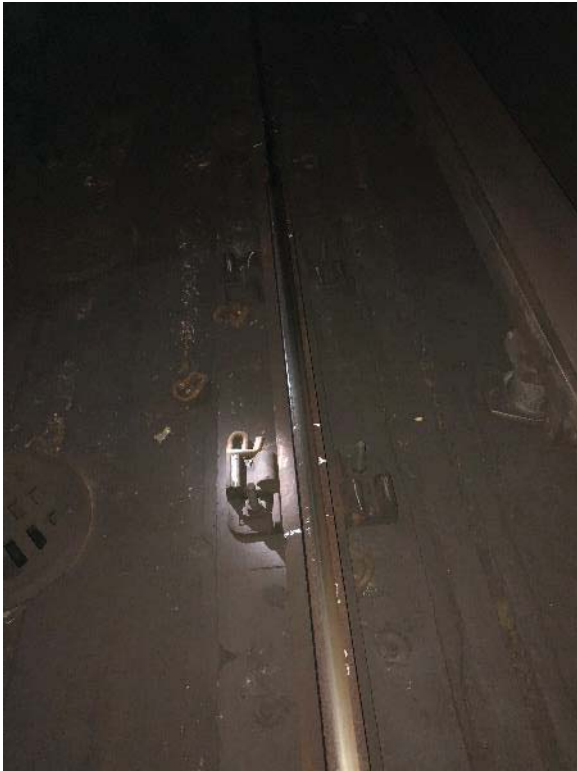
Figure 3: Three consecutive defective fasteners at A1 220+30.

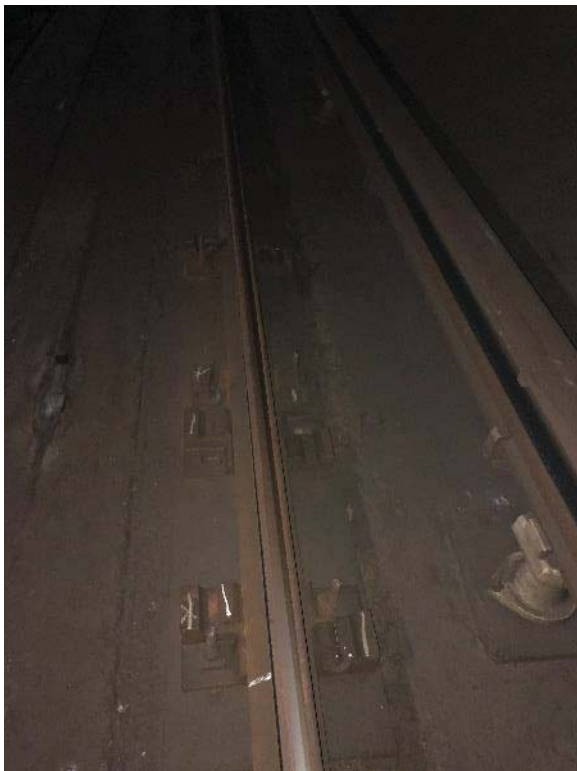
Figure 4: Four consecutive defective fasteners at A1 372+80.

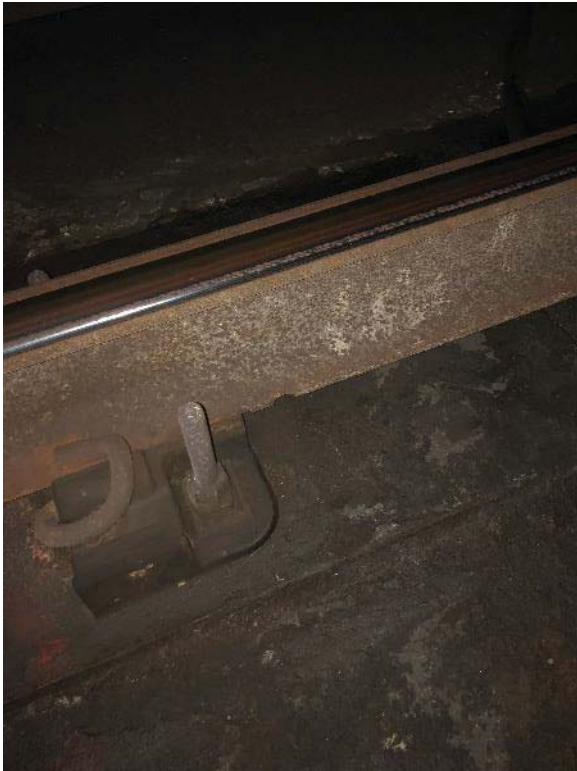
Figure 5: A chip in the base of the rail at A1 289+80.

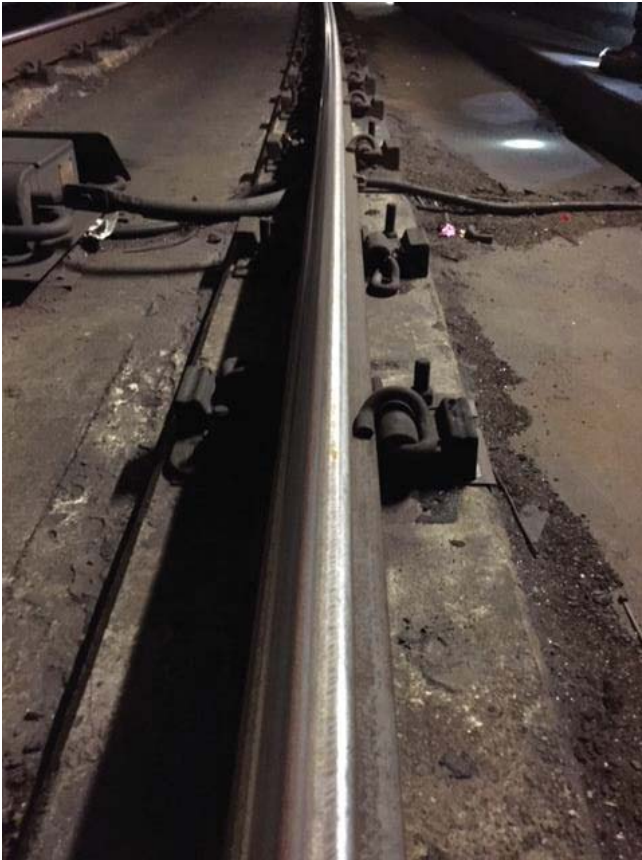
Figure 1: Missing and broken fastener conditions at B2 057+75.

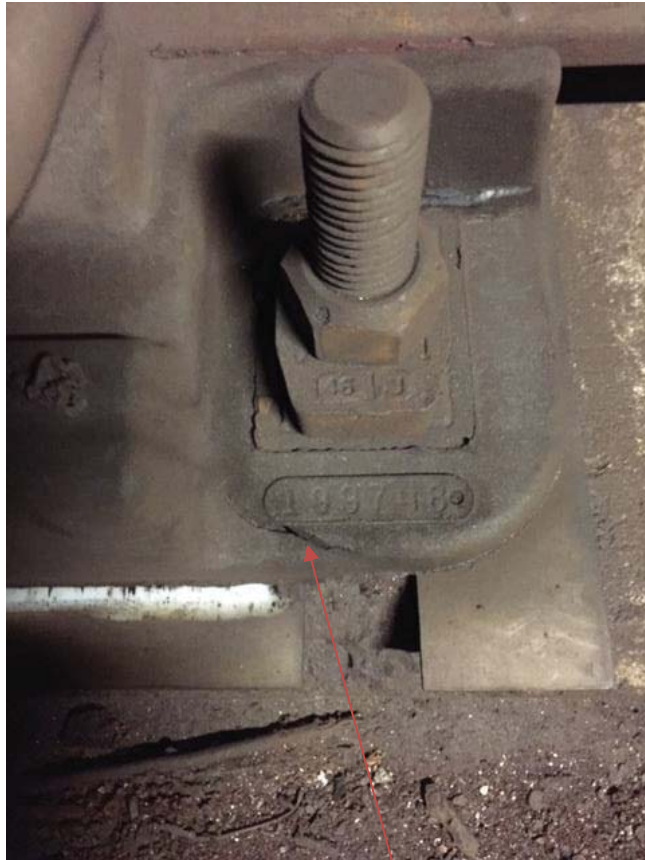
Figure 2: Failed fastener at B2 057+75.

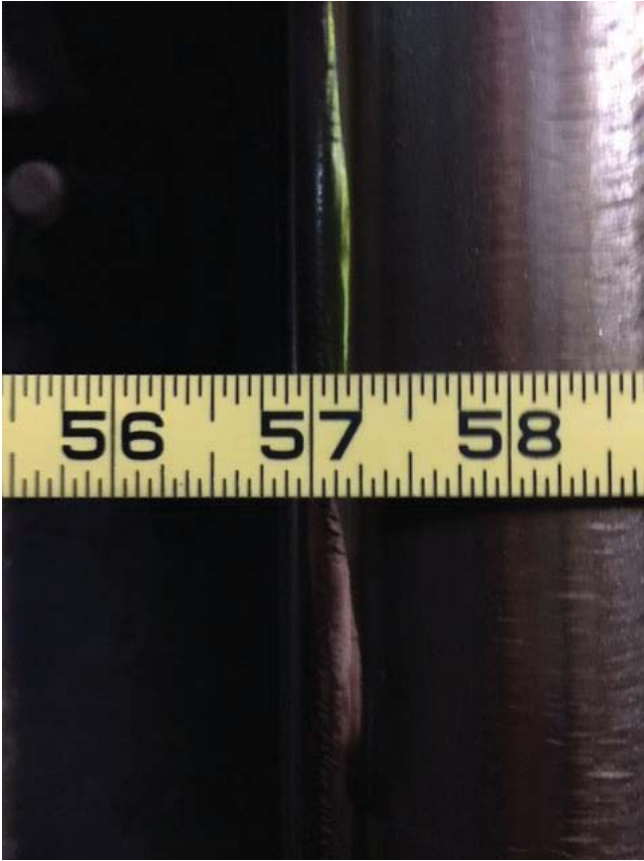
Figure 3: Static track gauge 56 15/16 inches at B2 57+75.

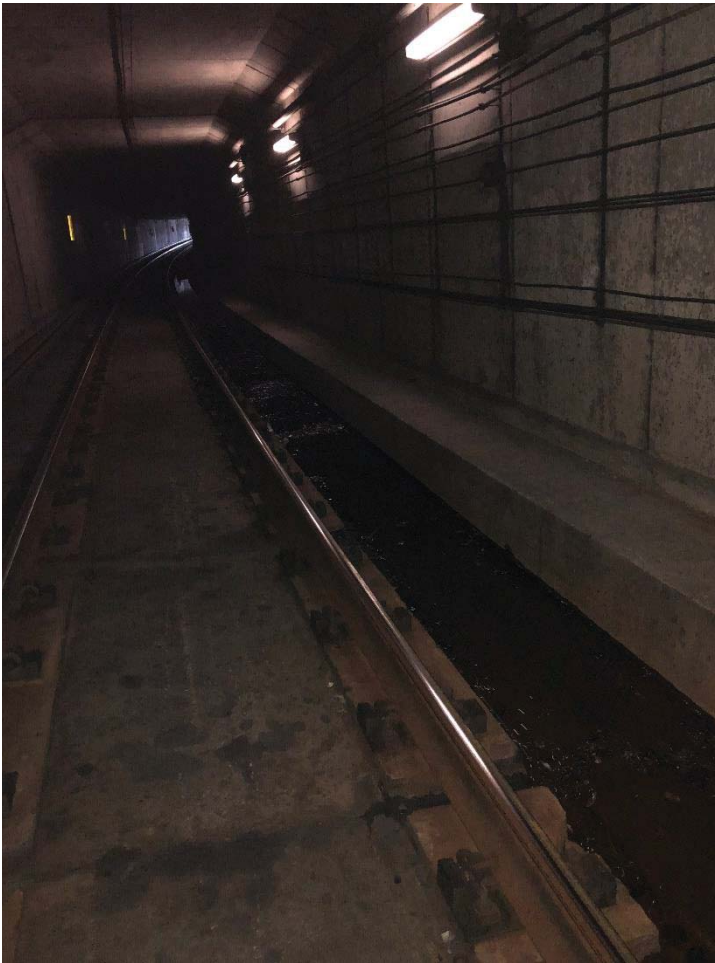
Figure 1: Standing water between J2 510+00 and 512+00.

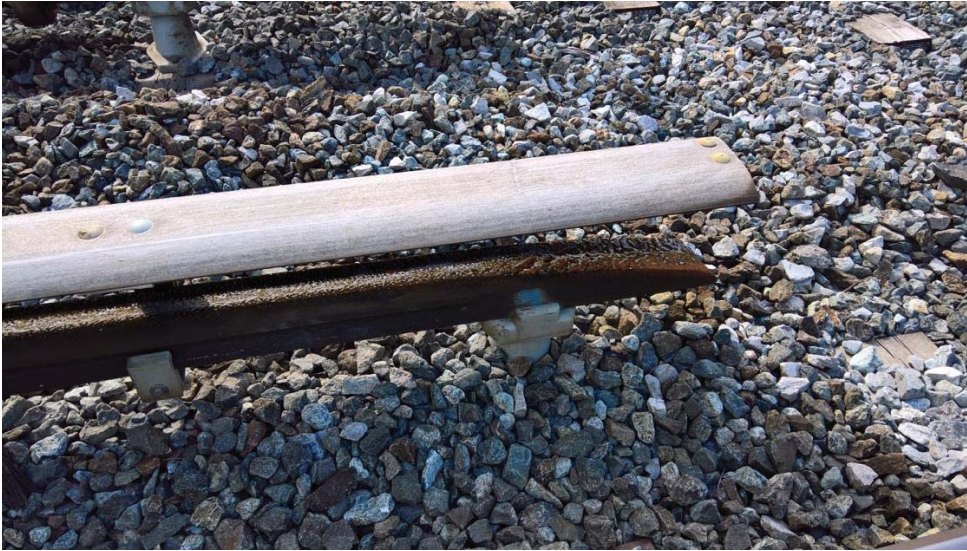
Figure 1: 40% of the third rail end surface was burnt away at D2 347+30.

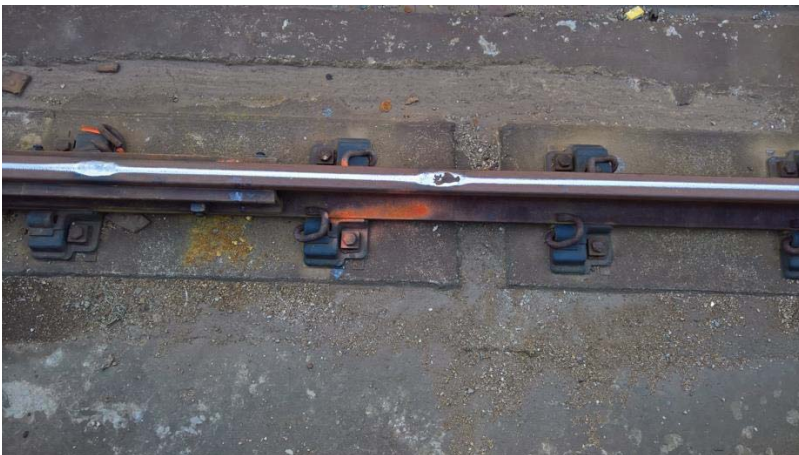
Figure 1: Chipped rail at CM F2 311+00.

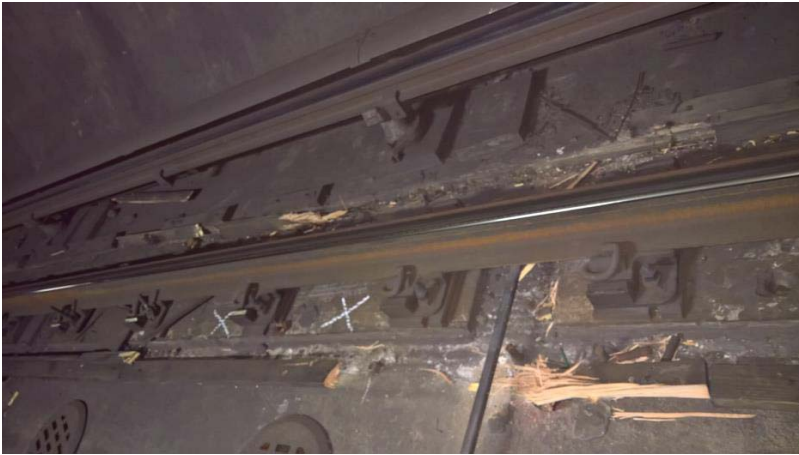
Figure 1: First gauge rod and defective fasteners at CM G1 383+00 to CM G1 348+10.

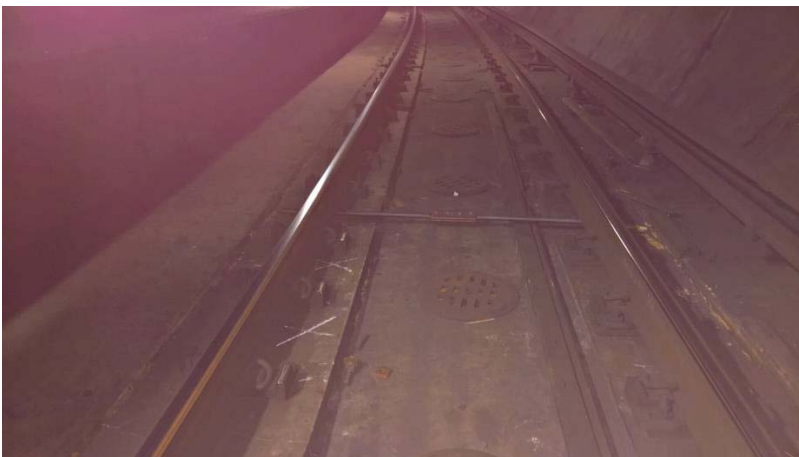
Figure 2: Second gauge rod and defective fasteners at CM G1 383+00 to CM G1 348+10

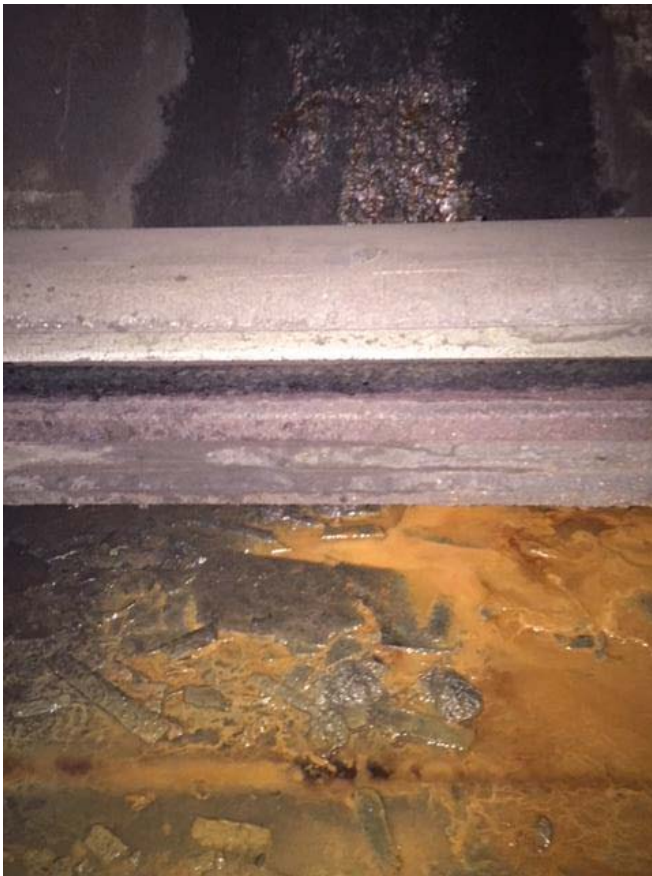
Figure 1: Corroded third rail from leaking tunnel at G1 326+99.

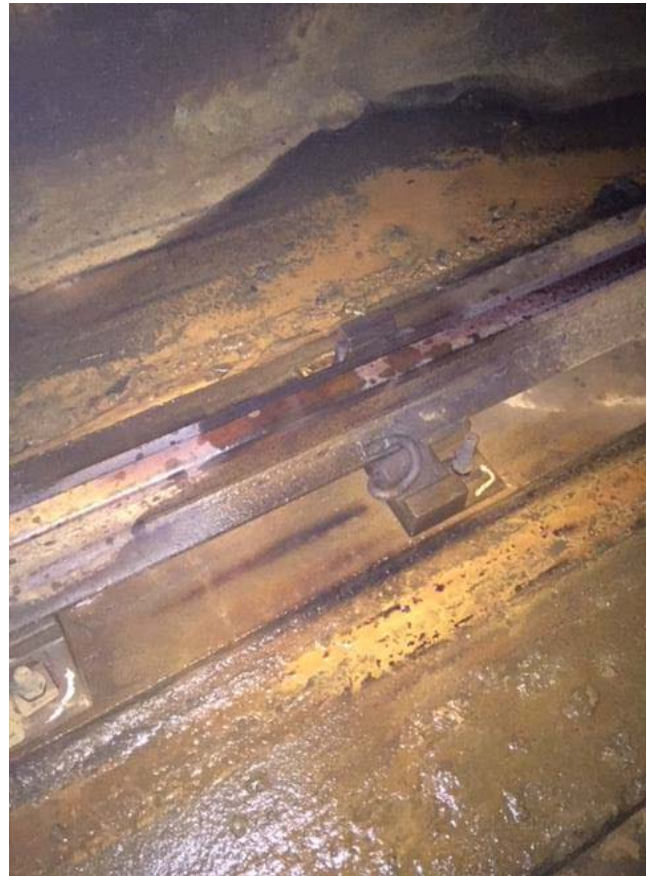
Figure 2: Leak in the tunnel crown allowing water to saturate the ground surface and running rail at G1 318+55.

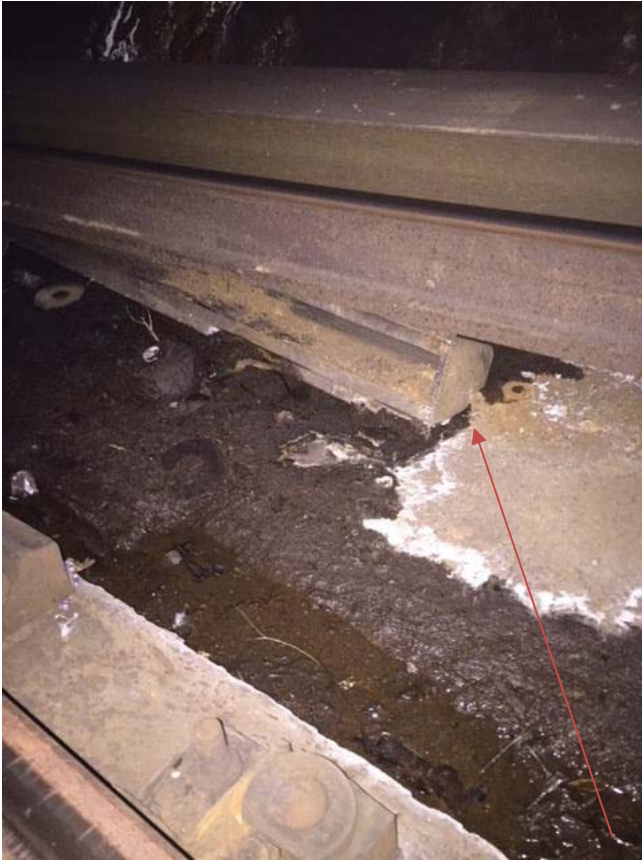
Figure 3: Tunnel light lenses lodged under the third rail at G1 300+40.

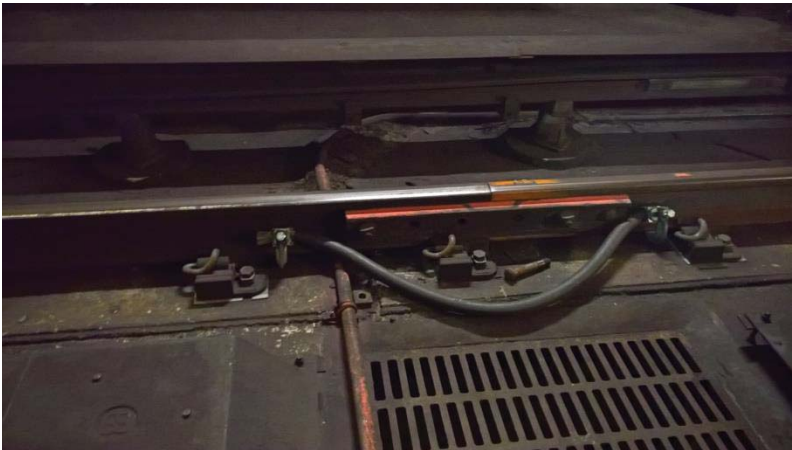
Figure 1: Joint bar at CM B2 717+40.

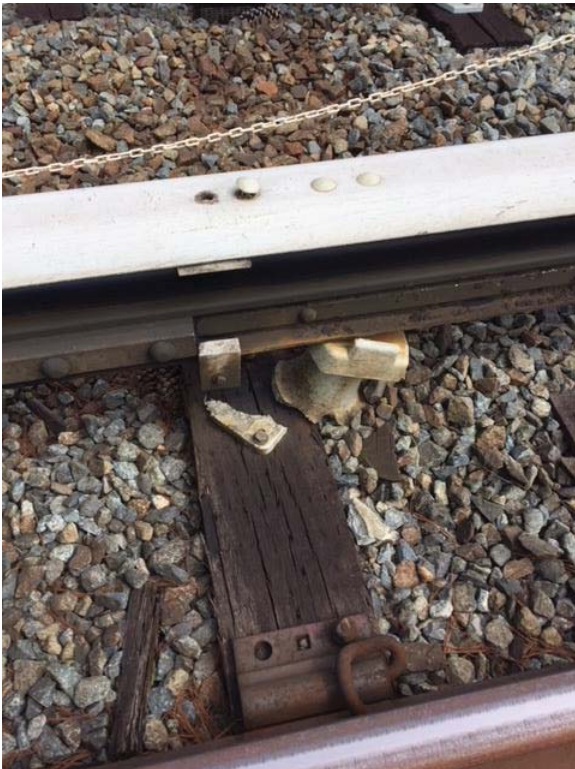
Figure 2: Broken third rail insulator at A1 765+10.

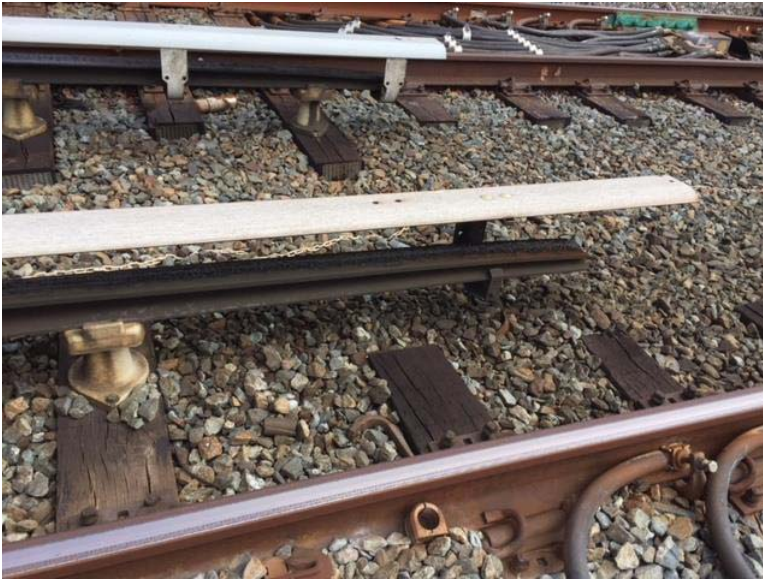
Figure 3: 45 inches of unsupported third rail end approach at A1 766+65.

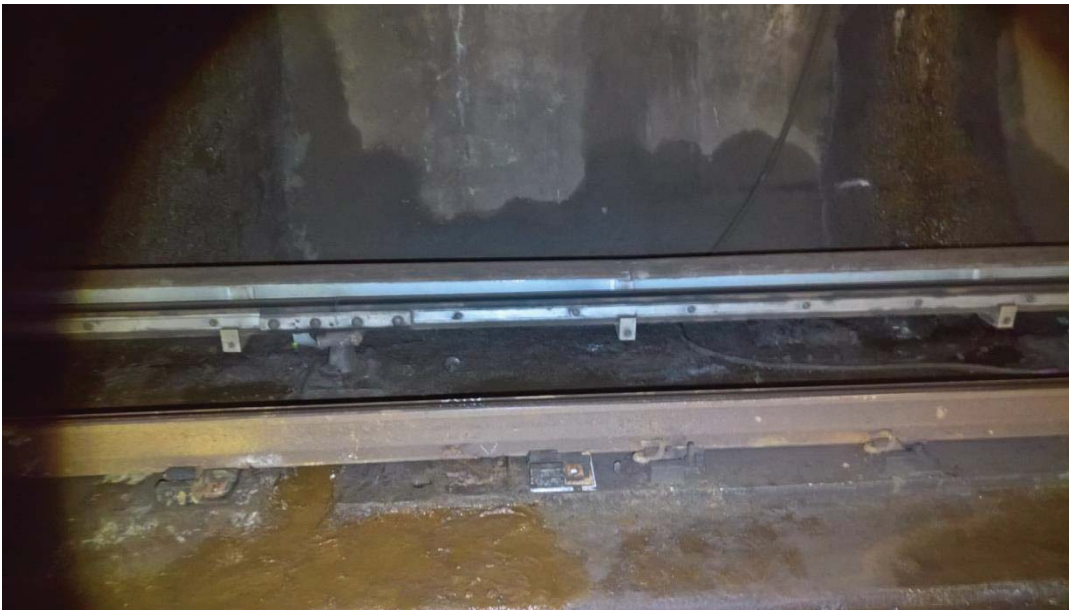
Figure 1: Fasteners at CM A2 281+21.

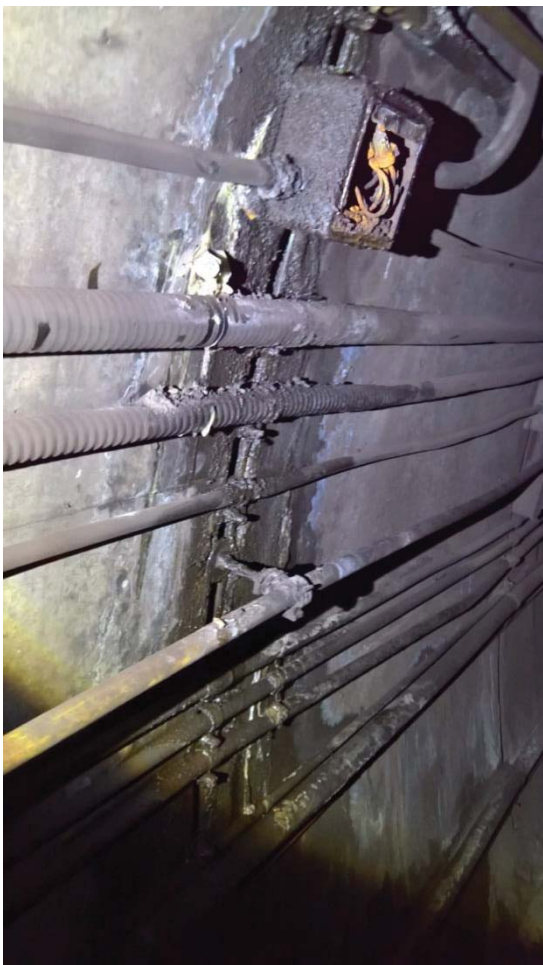
Figure 3: Tunnel leak at A2 358+10.

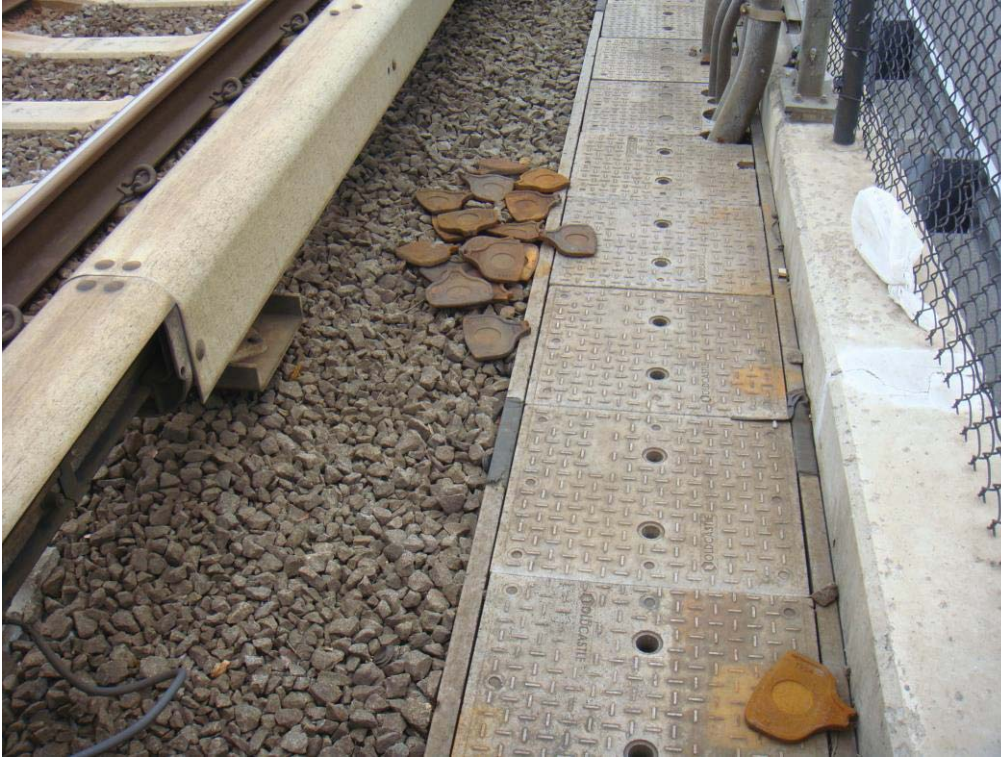
Figure 1: Pile of Collector shoes at N1 1010+00.
