Inspection Form

FOIA Exemption: All (b)(6)

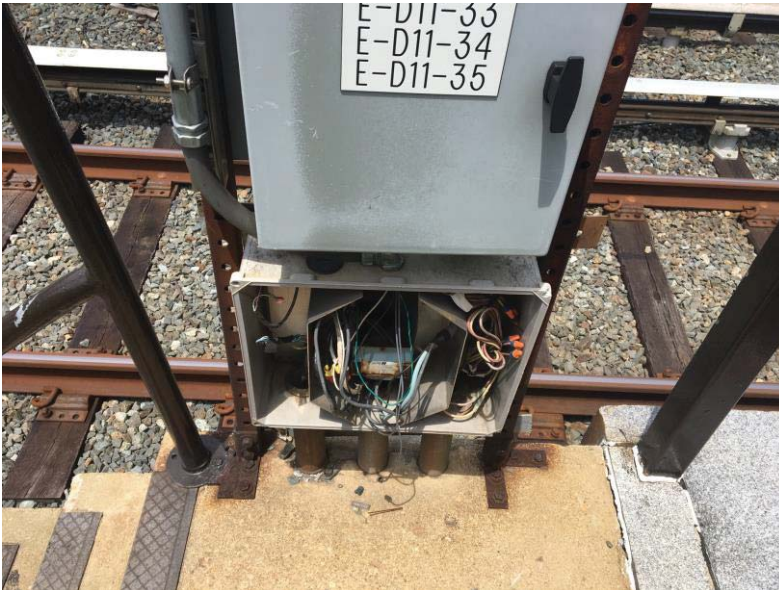
Figure 1: Emergency Trip Station (ETS) box was missing electrical box door at D1 420+30.

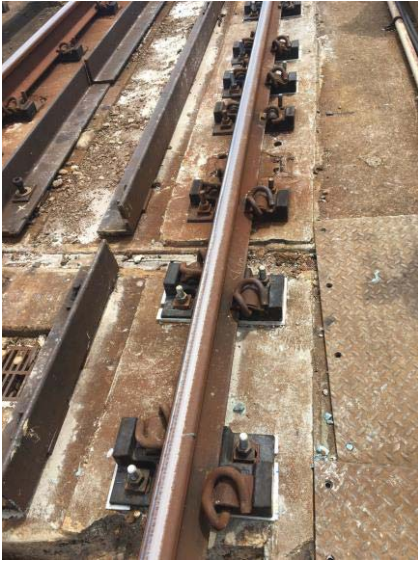
Figure 1: Defective fasteners were replaced at D2 269+7.

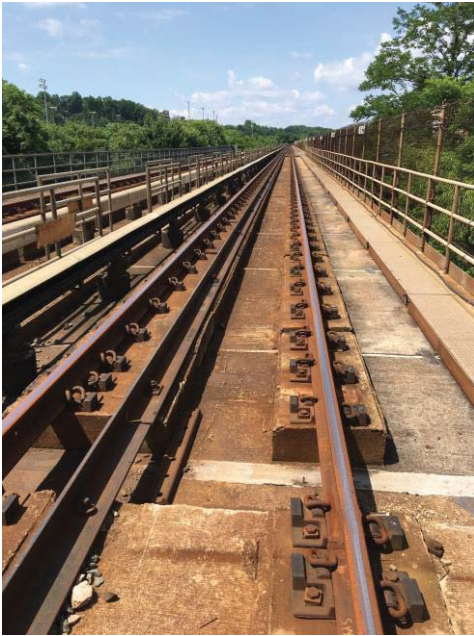
Figure 1: Defective fasteners repaired at J2 630+00.

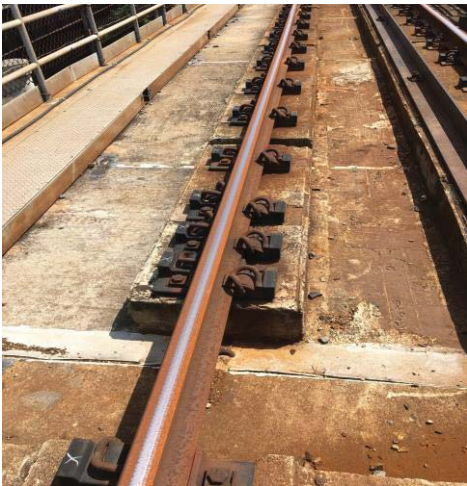
Figure 2: Defective fasteners repaired at J2 633+00.

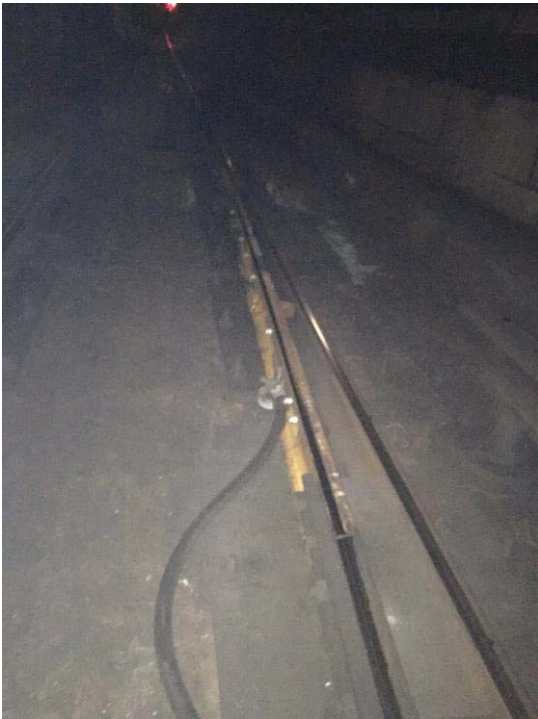
Figure 1: New switch point at E2 283+60.

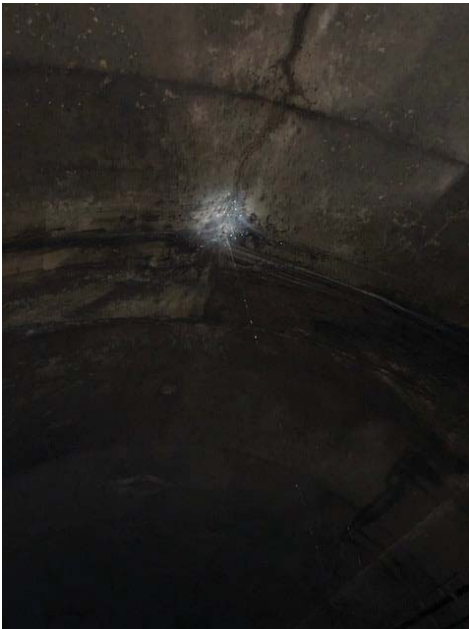
Figure 2: E2 336+70, steady water leak in the crown of the tunnel.

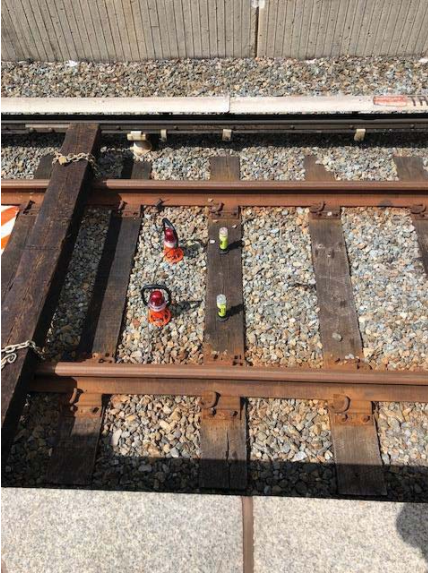
Figure 1: At A1 699+20, red e-flares were not operating; replaced with florescent yellow ones.

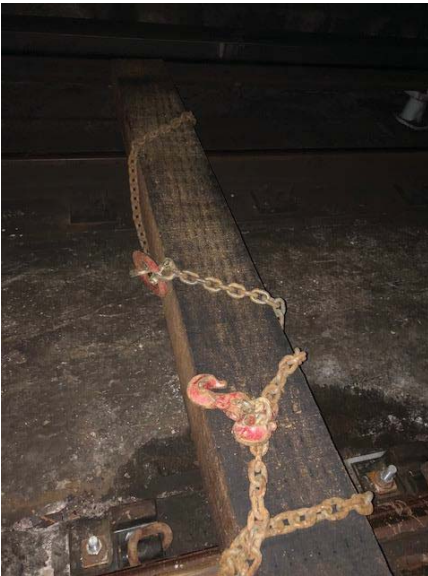
Figure 2: At A1 584+00, tie barrier was unsecured and not locked to the rail.

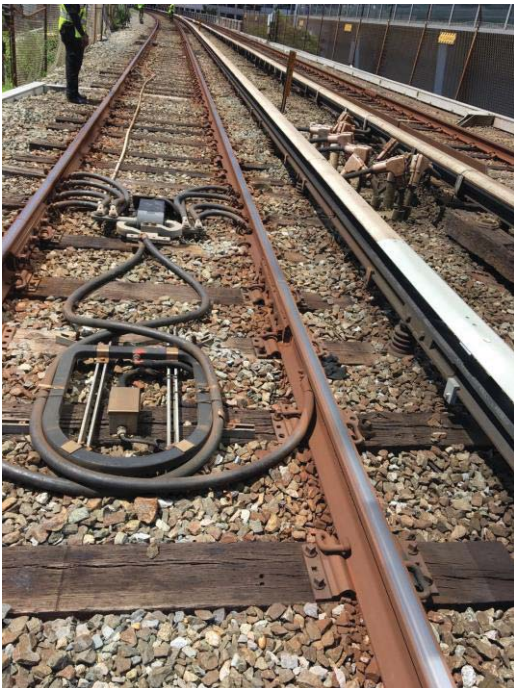
Figure 2: Vertical deflection repaired at B1 087+20.
