# Inspection Form

Form FTA-IR-1

United States Department of Transportation  
Federal Transit Administration

| Inspection Location | Ballston-MU, CM 278+60 to CM 274+00 K1/K2; K04 Crossover, Train Control Room 115 (TCR) | | | | | | |

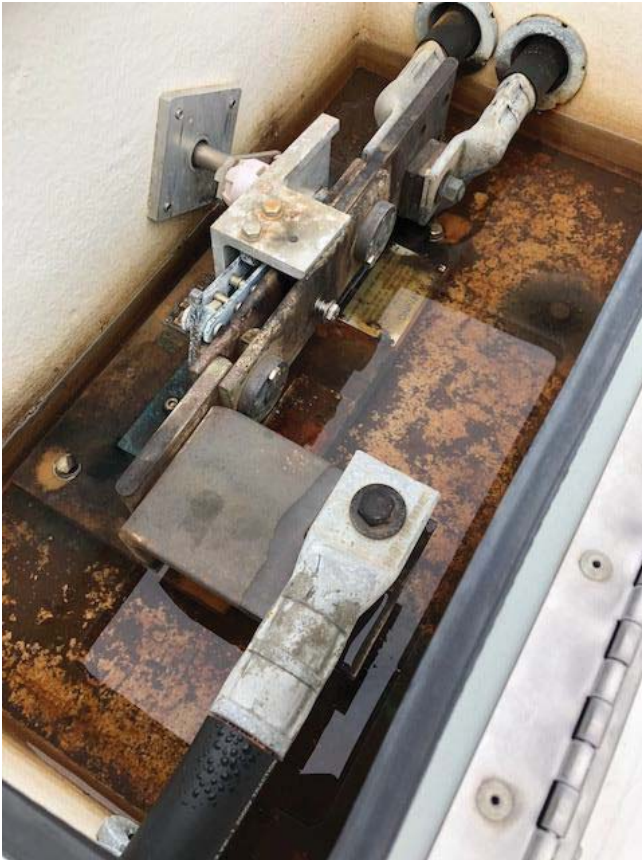
| Description | FWSO inspector observed WMATA power employees perform a power cable inspection of the yard tracks (YCR) in Branch Avenue yard (F99). Inspectors also inspected third rail and track conditions.<br><br><b>The following non-color-coded defects were observed:</b> <ul style="list-style-type: none"><li>• <b>EMI 220272:</b> Third rail power cable was observed contacting the ground at YRC 37, disconnect number 12.</li><li>• <b>EMI 220272:</b> Third rail power cable was observed contacting the concrete slab at YRC 39, disconnect number 11.</li><li>• <b>EMI 220272:</b> At YRC 45, third rail power disconnect number 2 was observed without a cover and partially filled with water. See Figure 1 below.</li><li>• <b>TRST 1000, 13.5.7:</b> Third rail end approach was missing cover board at YCR 50 at switch number 125. Remedial action for this defect is addressed by WMATA's approach to FTA-TPE-17-021-A.</li><li>• <b>TRST 1000, 13.3.7:</b> At YRC 50, switch number 125, the third rail end approach was unsecured for 38-inches.</li><li>• <b>TRST 1000, 13.3.13:</b> At YRC 24 a broken third rail anchor was observed.</li></ul> | | | | | | Number of Defects | 6 | | | |

**Figure 1:** Disconnect box number 2 at YRC 45.

| Remedial Action | To achieve compliance with WMATA's requirements: <ul style="list-style-type: none"><li>• WMATA must elevate the third rail power cable from contacting the ground at YRC 37 disconnect number 12.</li><li>• WMATA must elevate the third rail power cable from contacting the concrete slab at YRC 39 disconnect number 11.</li><li>• WMATA must replace the cover and drain the water from disconnect number 2 at YRC 45.</li><li>• WMATA must secure the end of the approach third rail at YRC 50, switch number 125.</li><li>• WMATA must repair the third rail anchor at YRC 24.</li></ul> | | | | | | | | | | |

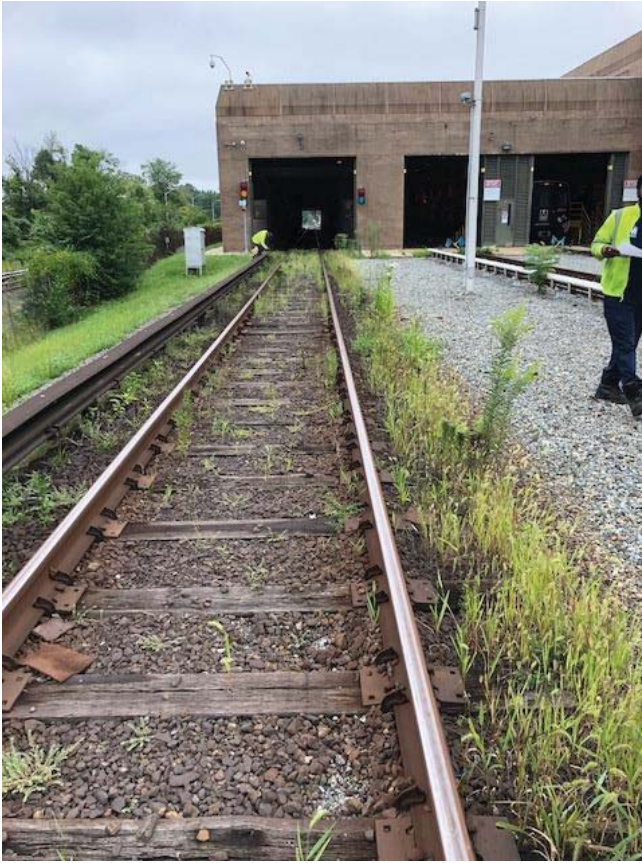
| <b>Description</b> | <p>FWSO inspector observed WMATA employees perform a cable inspection of the yard tracks (YRC). During the cable inspection, FWSO inspector also noted third rail and general track defects to be later verified upon planned equipment upgrades.</p> <p><b>The following non-color-coded defects were observed:</b></p> <ul style="list-style-type: none"> <li><b>EMI 220272:</b> Third rail power cables were observed contacting the ground at YRC 80 at the number 24 disconnect.</li> <li><b>EMI 220272:</b> Third rail power cables were observed contacting the ground at YRC 79 at the number 22 disconnect.</li> <li><b>EMI 220272:</b> At YRC 79, third rail power disconnect box number 2 was observed to have a defective cover.</li> <li><b>EMI 220272:</b> Third rail power cables were observed contacting the ground at YRC 77 at the number 21 disconnect.</li> <li><b>TRST 1000, 8.7.8 (a, &amp; c):</b> At YRC 76, excessive vegetation was observed. See Figure 1 below.</li> <li><b>EMI 220272:</b> Third rail power insulating cover was observed contacting the ground at YRC 71.</li> <li><b>EMI 220272:</b> A tear in the third rail power heat shrink tubing was observed at YRC 71.</li> <li><b>EMI 220272:</b> Third rail power cables were observed contacting the ground at YRC 71.</li> <li><b>DD-TP-SSI-013:</b> A broken stub-up, heat shrink tubing was observed at YRC 71 at the A99-42 signal.</li> <li><b>EMI 220272:</b> Third rail power cables were observed contacting the ground at YRC 71, at the A99-42 signal.</li> <li><b>TRST 1000, 13.5.7:</b> Third rail end approach was missing cover board at YRC 94. Remedial action for this defect is addressed by WMATA's approach to FTA-TPE-17-021-A.</li> <li><b>EMI 220272:</b> Third rail power cables were observed contacting the ground at YRC 95.</li> </ul> | | | | | | <b>Number of Defects</b> | 24 | | | |

| | <ul style="list-style-type: none"><li>• <b>TRST 1000, 13.5.7:</b> Third rail end approach was missing cover board at YRC 49 at the number 53 switch. Remedial action for this defect is addressed by WMATA's approach to FTA-TPE-17-021-A.</li><li>• <b>EMI 220272:</b> A third rail insulating cover was observed contacting the ground at YRC 94, near the A99-60 signal.</li><li>• <b>EMI 220272:</b> A nick was observed in the third rail power cable at YRC 94, near the A99-60 signal.</li><li>• <b>DD-TP-SSI-013:</b> A defective watertight sealing collar was observed at YRC 94, near the A99-60 signal.</li><li>• <b>EMI 220272:</b> A nick was observed in the third rail power cable at YRC 66.</li><li>• <b>DD-TP-SSI-013:</b> A defective watertight sealing collar was observed at YRC 66.</li><li>• <b>TRST 1000, 13.5.7:</b> Third rail end approach was missing cover board at YRC 64 near the A99-52 signal. Remedial action for this defect is addressed by WMATA's approach to FTA-TPE-17-021-A.</li><li>• <b>DD-TP-SSI-013:</b> A defective watertight sealing collar was observed at YRC 64.</li><li>• <b>TRST 1000, 13.5.7:</b> Third rail end approach was missing cover board at YRC 63 near the A99-74 (stinger rail). Remedial action for this defect is addressed by WMATA's approach to FTA-TPE-17-021-A.</li><li>• <b>DD-TP-SSI-013:</b> A third rail power cable pigtail was observed contacting the ground at YRC 63, near the A99-74 signal.</li><li>• <b>EMI 220272:</b> Third rail power cables were observed contacting the ground at YRC 57.</li><li>• <b>DD-TP-SSI-013:</b> A defective watertight sealing collar was observed at YRC 58.</li></ul> | | |

Figure 1: Overgrown vegetation at YRC 76.

| Remedial Action | <p>To achieve compliance with WMATA's requirements:</p> <ul style="list-style-type: none"><li>• WMATA must repair the third rail power cables contacting the ground at YRC 80 at the number 24 disconnect.</li><li>• WMATA must repair the third rail power cables contacting the ground at YRC 79 at the number 22 disconnect.</li><li>• WMATA must repair the defective cover at YRC 79, third rail power disconnect box number 2.</li><li>• WMATA must repair the third rail power cables at YRC 77 at the number 21 disconnect.</li><li>• WMATA must control the vegetation at YRC 76.</li><li>• WMATA must repair the third rail power insulating cover contacting the ground at YRC 71.</li><li>• WMATA must repair the tear in the third rail power heat shrink tubing at YRC 71.</li><li>• WMATA must repair the third rail power cables contacting the ground at YRC 71.</li><li>• WMATA must repair the broken stub-up, heat shrink tubing at YRC 71 at the A99-42 signal.</li><li>• WMATA must repair the third rail power cables contacting the ground at YRC 71, at the A99-42 signal.</li><li>• WMATA must repair the third rail power cables contacting the ground at YRC 95.</li><li>• WMATA must repair the third rail insulating cover contacting the ground at YRC 94, near the A99-60 signal.</li><li>• WMATA must repair the nick in the third rail power cable at YRC 94, near the A99-60 signal.</li><li>• WMATA must repair the defective watertight sealing collar at YRC 94, near the A99-60 signal.</li><li>• WMATA must repair the nick in the third rail power cable at YRC 66.</li><li>• WMATA must repair the defective watertight sealing collar at YRC 66.</li><li>• WMATA must repair the defective watertight sealing collar at YRC 64.</li><li>• WMATA must repair the third rail power cable pigtail contacting the ground at YRC 63, near the A99-74 signal.</li><li>• WMATA must repair the third rail power cables contacting the ground at YRC 57.</li><li>• WMATA must repair the defective watertight sealing collar at YRC 58.</li></ul> | | |

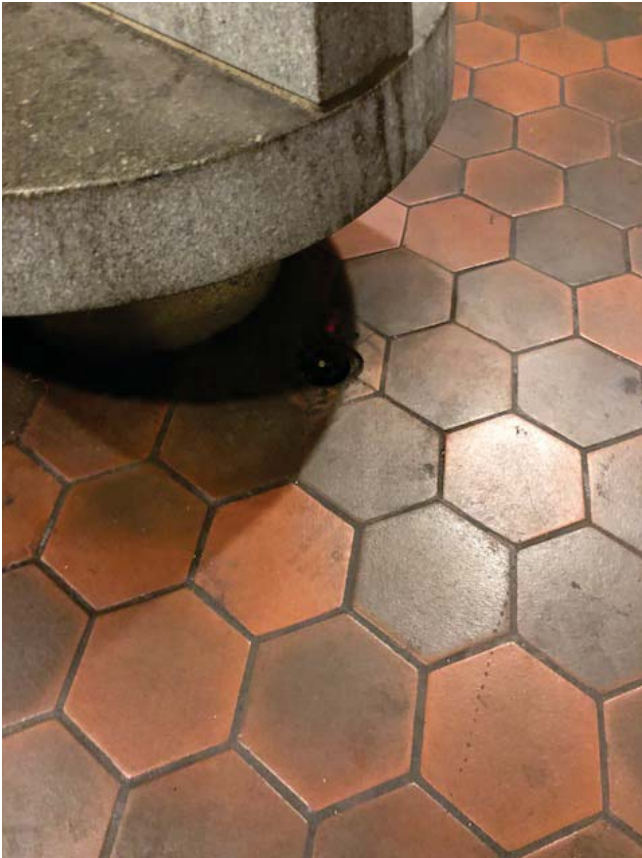
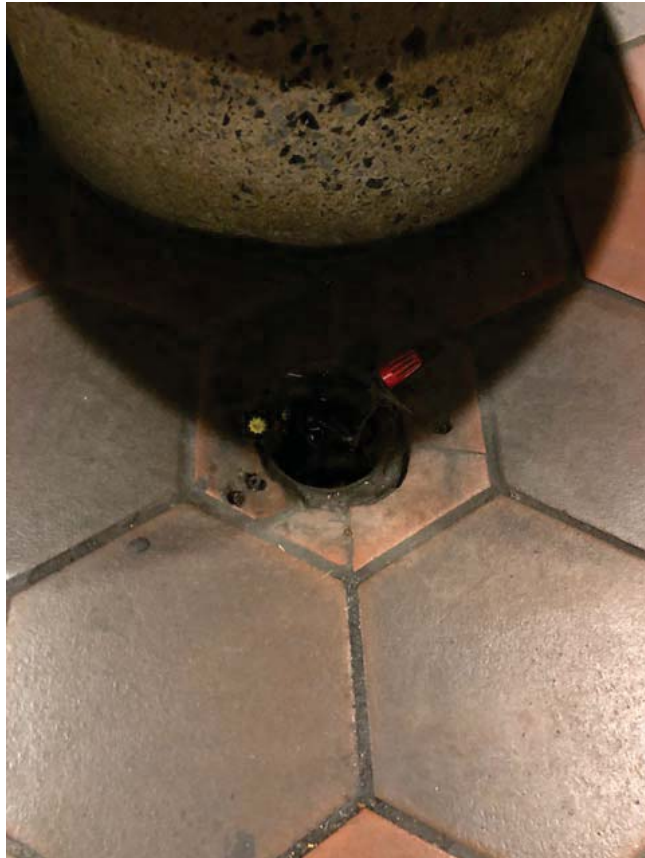
| Description | <p>FWSO inspector performed a station platform and track observation between Metro Center (A01) and Stadium Armory (D08).</p> <p><b>The FWSO inspector noted the following non-color-coded defects:</b></p> <ul style="list-style-type: none"><li>• <b>WMATA, TRST 3.1.2.7:</b> At the north end of L'Enfant Plaza platform at the passenger bench, a floor junction box without a cover was observed. Wires were exposed as a result of this condition. See Figure 1 below. Remedial action for this defect is addressed in WMATA's approach to TOC-EGR-15-005-A.</li><li>• <b>WMATA, TRST 3.1.2.2:</b> At Federal Center on track one, blocked center catch basins allowed water to pool in the scuppers and not drain as designed. Remedial action for this defect is addressed in WMATA's approach to FTA-16-4-T-9.</li><li>• <b>WMATA, TRST 3.1.2.2:</b> At Eastern Market on tracks one and two, blocked center catch basins allowed water to pool in the scuppers and not drain as designed. Remedial action for this defect is addressed in WMATA's approach to FTA-16-4-T-9.</li></ul> | Number of Defects | 3 |

Figures 1: Exposed wires at the north end of L'Enfant Plaza under the customer waiting bench.

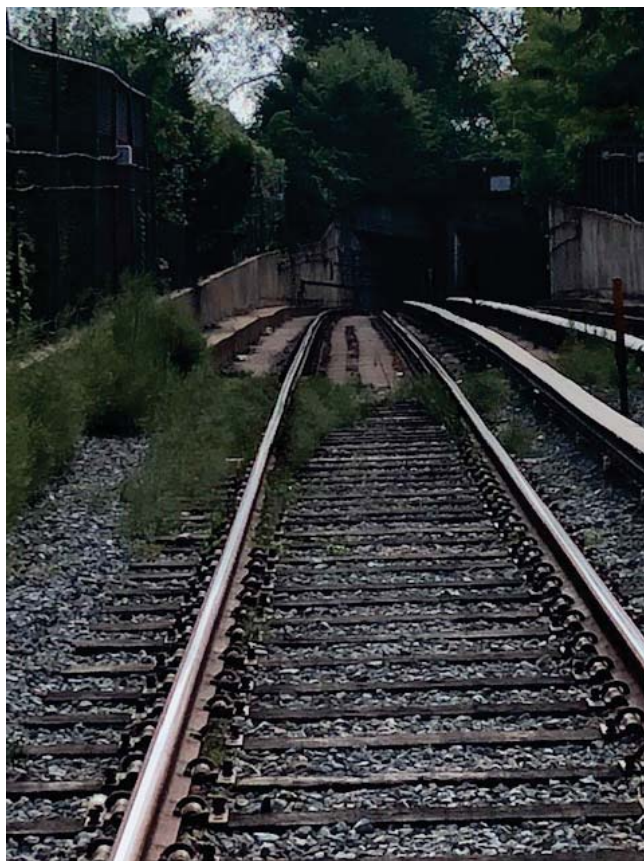
| <b>Description</b> | <p>FWSO inspectors performed a remedial action verification between Twinbrook (A13) and Grosvenor-Strathmore (A11), on track 1. Inspectors also observed general conditions between those areas. Four remedial actions were verified as complete.</p> <p><b>The following color-coded defects were observed:</b></p> <ul style="list-style-type: none"> <li><b>TRST 1000, Table 7.1:</b> At A2 658+00 on the left rail, three consecutive fasteners with no studs on either side were observed with 100 inches between non-defective holding fasteners. Defect was determined to be a maintenance condition. <b>Yellow condition.</b></li> <li><b>TRST 1000, Table 7.1:</b> At A2 657+30 on the left rail, three consecutive non-holding fasteners were observed with 95 inches between non-defective holding fasteners. Defect was determined to be a maintenance condition. <b>Yellow condition.</b></li> </ul> <p><b>The following non-color-coded defects were observed:</b></p> <ul style="list-style-type: none"> <li><b>TRST 1000, 13.5.7:</b> At A2 657+60, the end approach coverboard was missing. Remedial action for this defect is addressed in WMATA's approach to FTA-TPE-17-021-A.</li> <li><b>TRST 1000, 13.5.7:</b> At A2 601+00, a new end approach coverboard was installed incorrectly. It did not cover the end of the third rail as designed. Remedial action for this defect is addressed in WMATA's approach to FTA-TPE-17-021-A. See Photo 1 below.</li> <li><b>TRST 1000, 10.17.4.1:</b> Between A2 613+00 and 609+00, relay rail was observed in the gauge of the track.</li> <li><b>TRST 1000, 10.17.4.1:</b> At A2 595+60, relay rail was observed between the catwalk and the field side track.</li> <li><b>TRST 1000, 8.7:</b> At A2 679+00 between the ballasted track and the portal direct fixation, vegetation was observed in the gauge and field side of the track. See Photo 2 below.</li> <li><b>TRST 1000, 8.7:</b> At A2 678+00, vegetation was growing through the fence line and striking the side of passing rail vehicles. See Photo 3 below.</li> </ul> | | | | | | <b>Number of Defects</b> | 9 | | | |

Photo 2: At A2 679+00, overgrown trackside vegetation.

| Remedial Action | <p>To achieve compliance with WMATA's requirements:</p> <ul style="list-style-type: none"><li>• WMATA must repair the defective fasteners on the left rail at A2 658+00.</li><li>• WMATA must repair the defective fasteners on the left rail at A2 657+30.</li><li>• WMATA must remove the relay rail between A2 613+00 and 609+00.</li><li>• WMATA must remove the relay rail at A2 595+60.</li><li>• WMATA must control the vegetation at A2 679+00.</li><li>• WMATA must control the vegetation at A2 678+00.</li><li>• WMATA must control the vegetation at A2 676+20.</li></ul> | | |

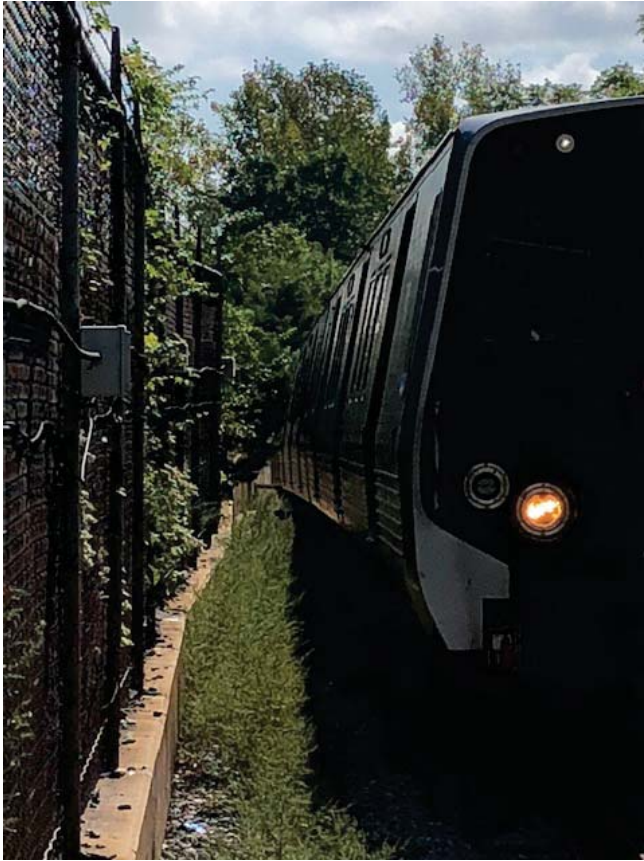
**Photo 3:** At A2 678+00, track-side vegetation contacting on-track vehicles.

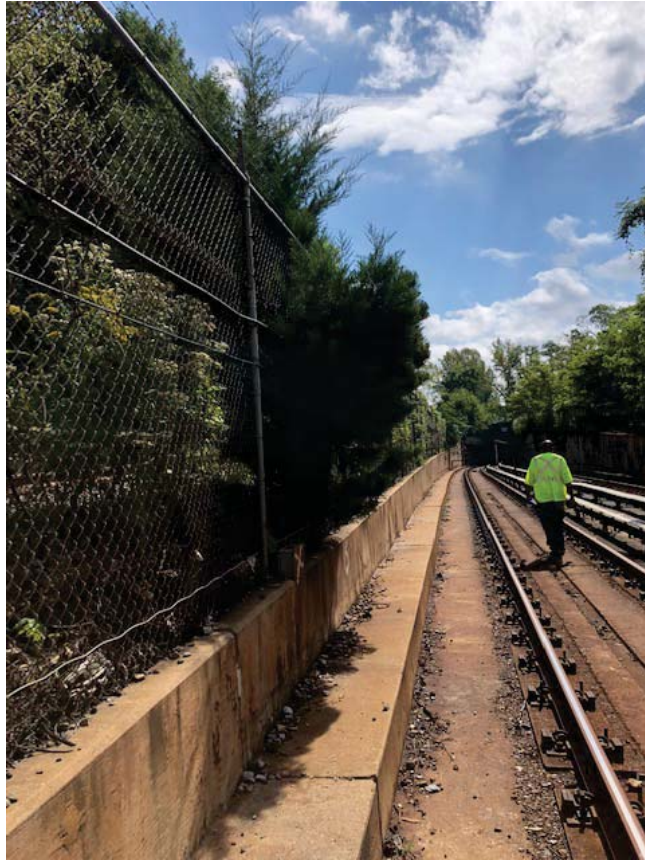
| | <ul style="list-style-type: none"><li>• <b>TRST 1000, 8.7:</b> At A2 676+20, vegetation was growing through the fence line and striking the side of passing rail vehicles. See Photo 4 below.</li></ul> <p>The following remedial actions were verified as complete:</p> <ul style="list-style-type: none"><li>• At A2 571+00, the missing bolts have been replaced in the stock rail joint of the number seven switch.</li><li>• At A2 579+80, the missing bolts have been replaced in the stock rail joint of the number 11B switch.</li><li>• Between A2 613+00 and 610+00, the defective fasteners have been replaced.</li><li>• At A2 638+45, the two phases of the platform edge lights have been repaired and are in proper working order.</li></ul> | | |

**Photo 3:** At A2 676+20, overgrown vegetation.

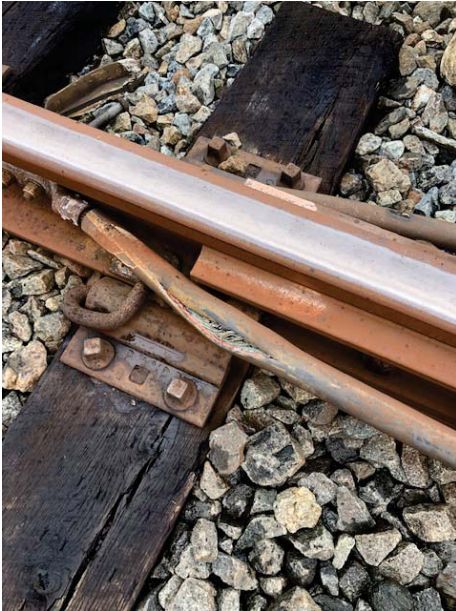
| <b>Description</b> | FWSO inspectors performed a remedial action verification between Shady Grove (A15) and Rockville (A14) on track 2. Inspectors also observed general conditions between those areas.<br><br><b>The following non-color-coded defects were observed:</b> <ul style="list-style-type: none"> <li><b>TRST 1000, 13.5.7:</b> At A2 937+50, 1B switch, the number four switch rod was loose.</li> </ul> <b>Other Notable Observation:</b> <ul style="list-style-type: none"> <li>At A2 940+40 at the A15-06 switch, the negative return bond wire at the left rail joint was nicked, exposing bare wires. See Photo 1 below.</li> </ul> | | | | | | <b>Number of Defects</b> | 1 | | | |

**Photo 1:** At A2 940+40, damaged negative return bond wire.
