Inspection Form
FOIA Exemption: All (b)(6)

Form FTA-IR-1

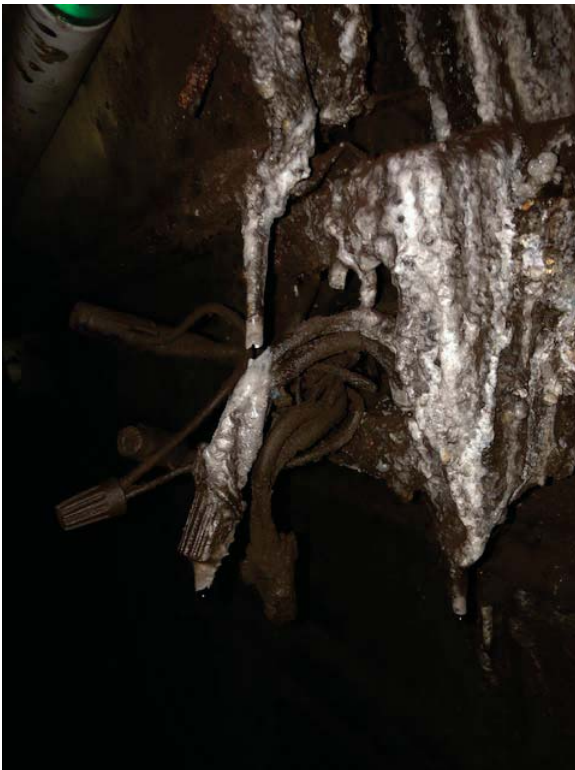
Figure 1: Exposed wires on the catwalk at A2 324+00.

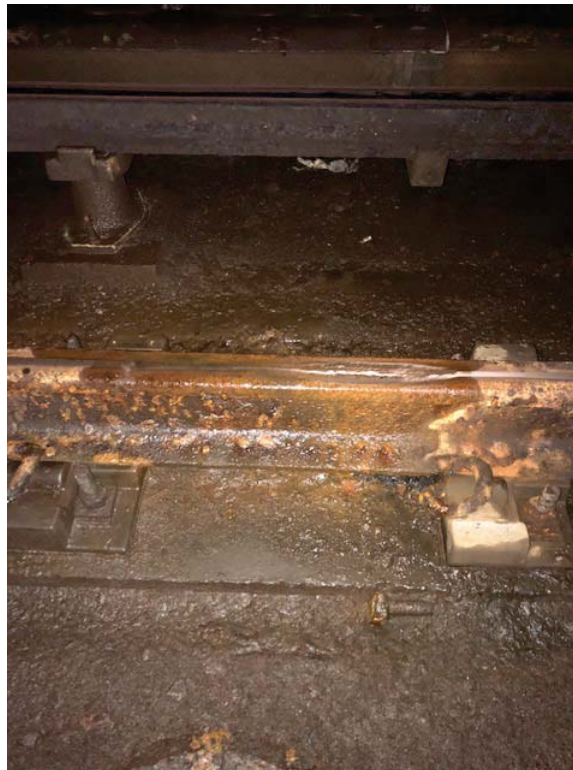
Figure 2: Tunnel leak striking left rail at A2 306+80.

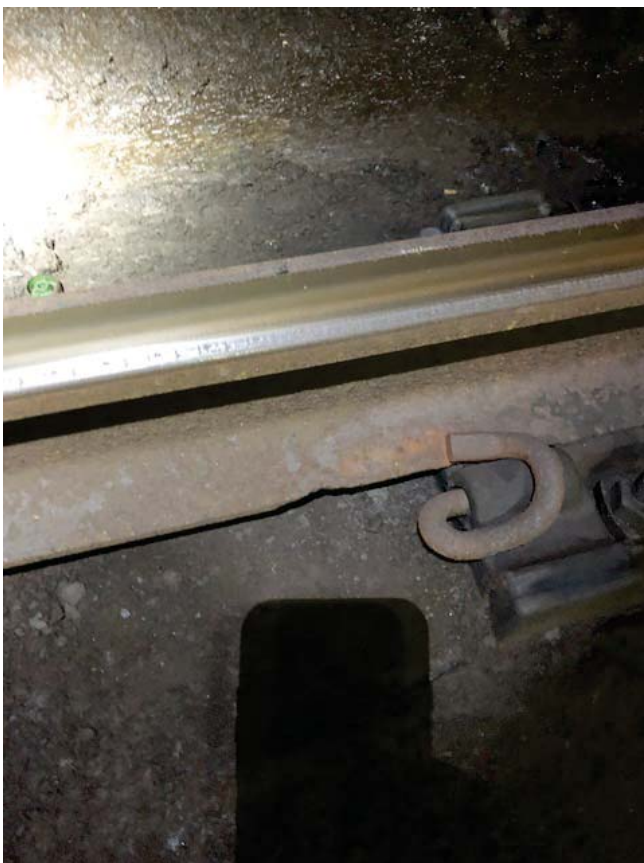
Figure 1: At A2 222+55, right rail web and base corrosion.

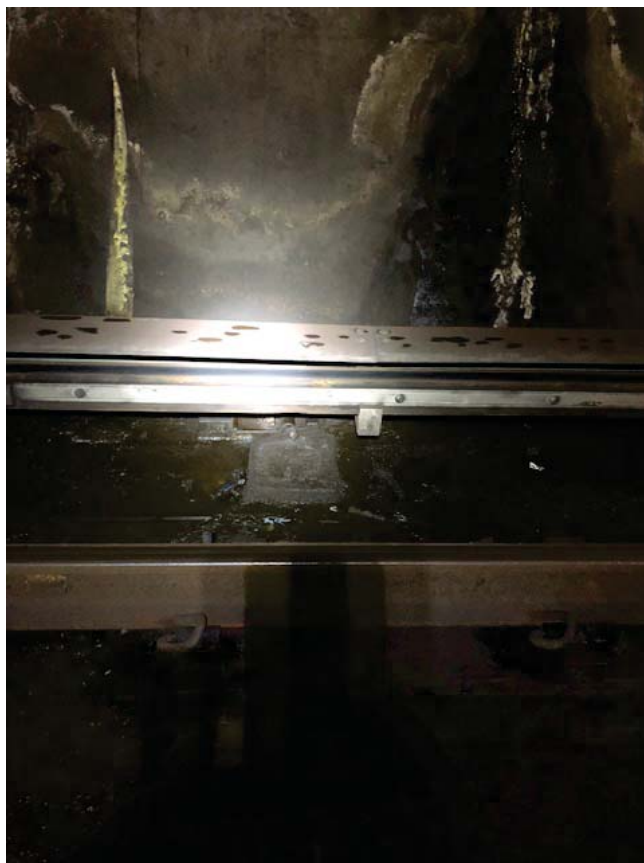
Figure 2: At A2 195+50, missing third rail insulator support.

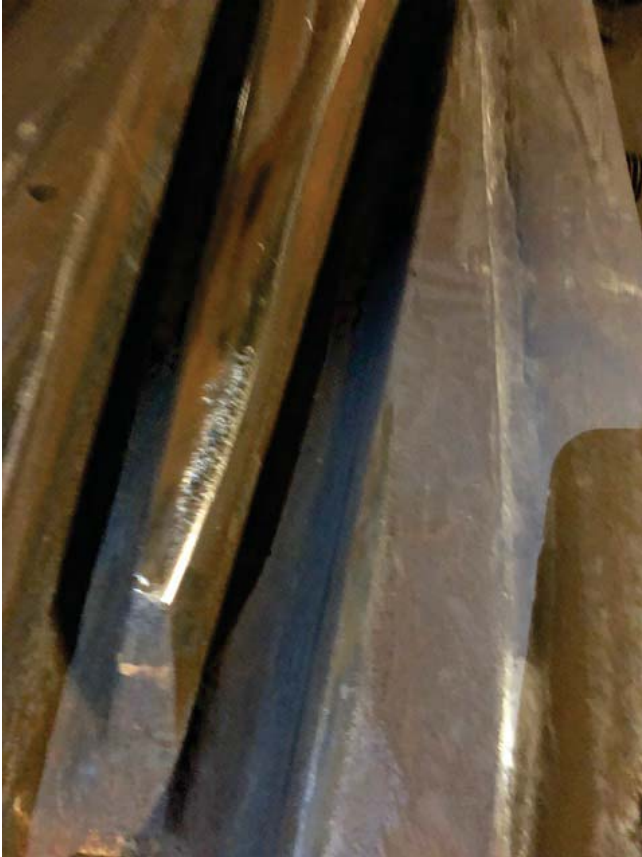
Figure 1: E1 023+00 1A switch, frog point.

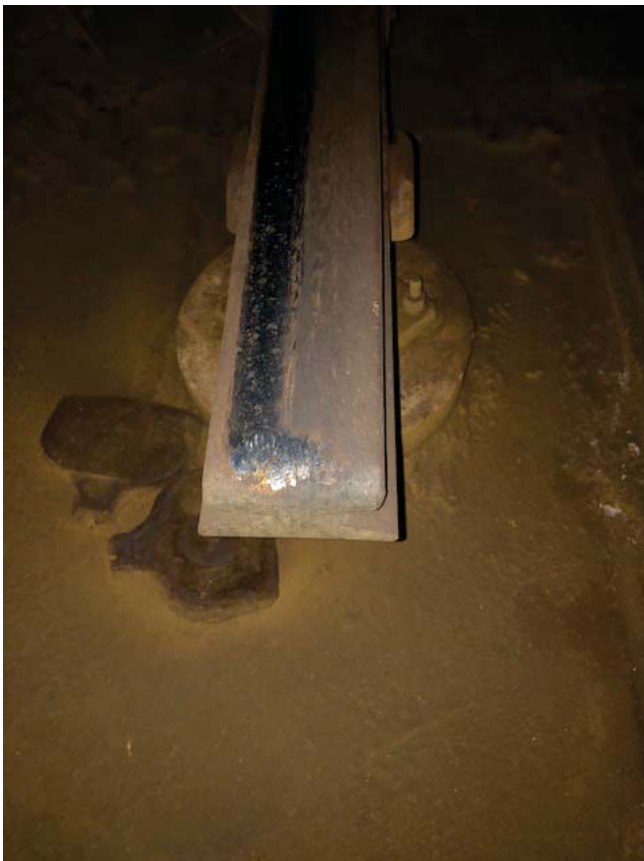
Figure 1: At F1 198+30, strike marks and broken collector shoes at third rail end approach.

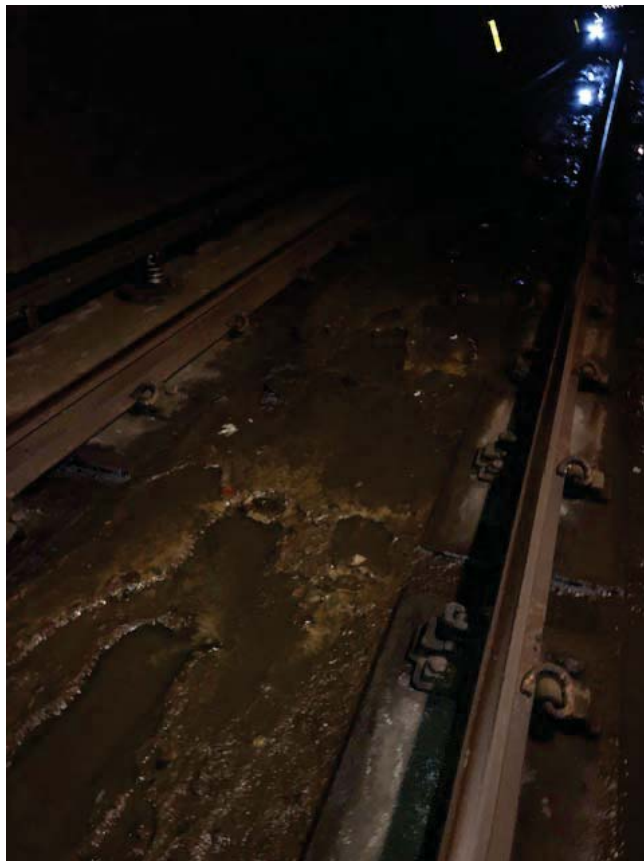
Figure 2: Between F1 220+00 and 221+50, gauge of track filled with mud, blocking the scuppers and not allowing water to drain as designed.

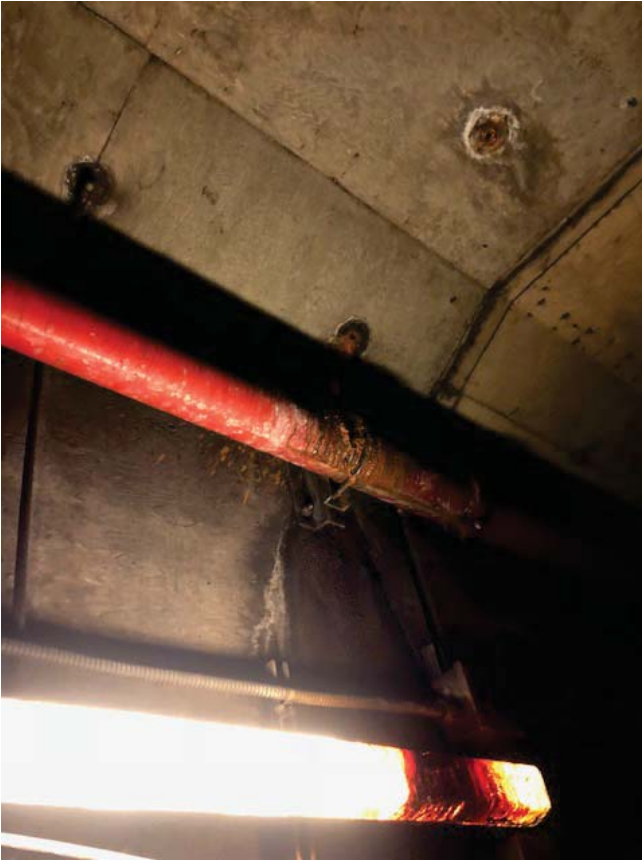
Figure 3: F1 248+40, leak in the side wall of the tunnel striking the water line and light.

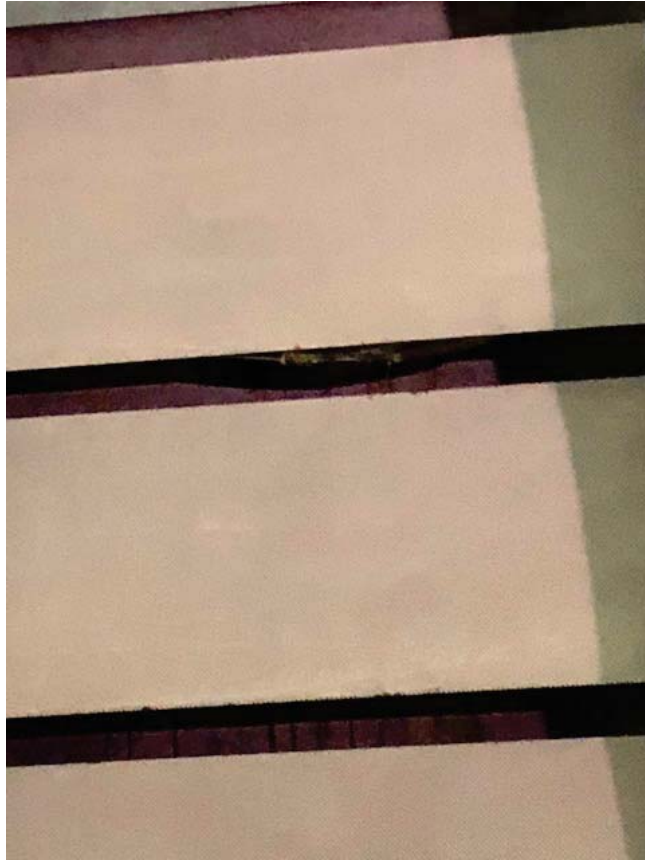
Figure 4: F1 261+30 at the Congressional Heights Station Platform, a broken plastic water line behind the acoustical ceiling block was allowing water to leak onto the track.

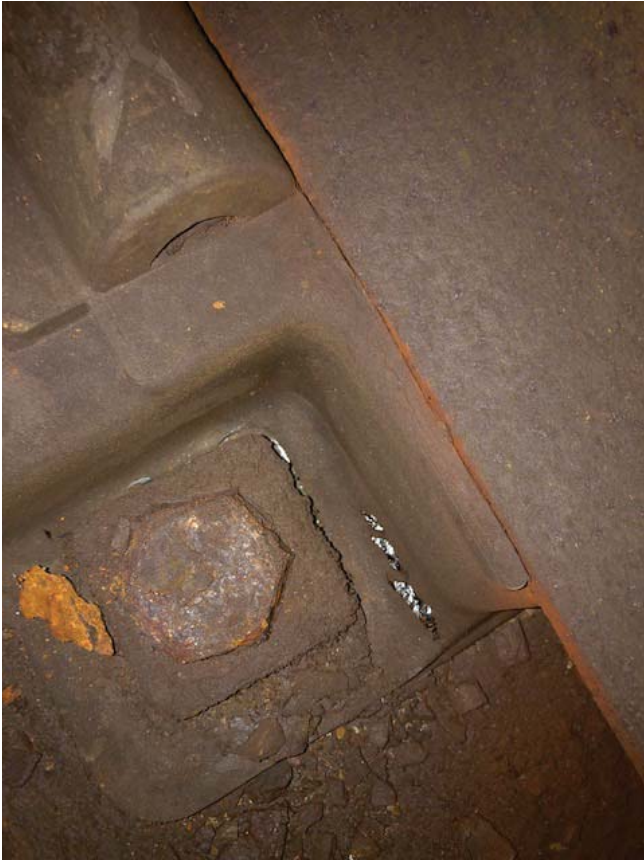
Figure 5: Example of the failing and cracked fasteners in the curve between F1 200+00 and 205+00.
