**Inspection Form**  
FOIA Exemption: All (b)(6)

**Form FTA-IR-1**

<b>Inspection Date</b>	YYYY	MM	DD	<b>Report Number</b>	20181201-WMATA-WP-1		
	2018	12	01				
<b>Rail Agency Name</b>	Washington Metropolitan Area Transit Authority			<b>Rail Agency Department</b>	TRST	<b>Sub- Department</b>	TKIN
<b>Rail Agency Department Contact Information</b>	<b>Name</b>		<b>Email</b>		<b>Office Phone</b>		<b>Mobile Phone</b>
	[REDACTED]		[REDACTED]		[REDACTED]		[REDACTED]
	[REDACTED]		[REDACTED]		[REDACTED]		[REDACTED]
	[REDACTED]		[REDACTED]		[REDACTED]		[REDACTED]
<b>Inspection Location</b>	D-Line, Track 2, Capitol South (D04) to Stadium Armory (D08)

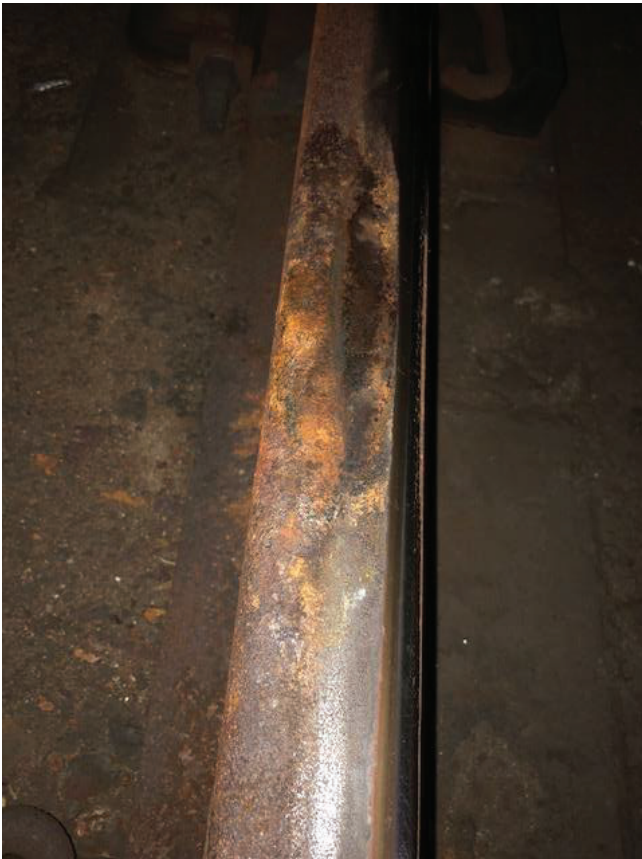
Description	<p>FWSO inspector performed a remedial action verification and track inspection between Capitol South (D04) and Stadium Armory (D08) on track two.</p> <p>The following color-coded defect was observed:</p> <ul style="list-style-type: none"> <li><b>TRST 1000, 7.7, table 7.1 and Note 1:</b> At D2 087+50 on the left rail, three consecutive non-holding fasteners were observed. The distance between holding fasteners was 96 inches. Directly adjacent on the right rail, two defective non-holding fasteners were observed. The condition on the right rail was allowing ½-inch to 5/8-inch dynamic vertical deflection between the base of the rail and the fastener and between the base of the fastener and the grout pad. A taper gauge was used to obtain the measurements. Movement under load was evaluated by WMATA and deemed a maintenance condition. <b>Red Condition</b></li> </ul> <p>The following non-color-coded defects were observed:</p> <ul style="list-style-type: none"> <li><b>TRST 1000, 13.5.7:</b> At D2 087+00, the third rail end approach coverboard was missing. Remedial action for this defect is addressed in WMATA's approach to FTA-TPE-17-021-a.</li> <li><b>TRST 1000, 9.12.6. (d):</b> At D2 087+50 at the 1B switch, the frog had one missing wedge brace.</li> <li><b>TRST 1000, 9.22:</b> At D2 087+50 at the 1B frog, four broken-loose bolts were observed on the brace plate.</li> <li><b>TRST 1000, 9.10:</b> At D2 087+50 at the 1B switch, the numbers three and four switch rods were loose.</li> <li><b>TRST 1000, 5.11.4:</b> At D2 087+90 on the right rail, corrosion was observed on the running surface. See Figure 1 below.</li> <li><b>TRST 1000, 3.2.2.4:</b> At D2 107+00, a crown tunnel leak was observed that was allowing water to strike the right rail. Remedial action for this defect is addressed in WMATA's approach to TOC-SRT-15-002.</li> <li><b>TRST 1000, 3.2.2.4:</b> At D2 155+35, a side wall tunnel leak was observed. Remedial action for this defect is addressed in WMATA's approach to TOC-SRT-15-002.</li> </ul>	Number of Defects	10

Figure 1: Corroded right rail at D2 087+90.

<ul style="list-style-type: none"><li>• <b>TRST 1000, 3.2.2.4:</b> At D2 107+00, a crown tunnel leak was observed that was allowing water to strike the right rail. Remedial action for this defect is addressed in WMATA's approach to TOC-SRT-15-002.</li><li>• <b>TRST 1000, 3.1.2.2:</b> Between D2 191+00 and 191+20, the center cuppers were blocked and not allowing water to drain as designed. Remedial action for this defect is addressed in WMATA approach to FTA-16-4-T-9.</li></ul>		
Remedial Action	<p>To achieve compliance with WMATA's requirements:</p> <ul style="list-style-type: none"><li>• WMATA must repair the defective fastener condition at D2 087+50.</li><li>• WMATA must repair the disconnected frog wedge brace at D2 087+50, 1B switch.</li><li>• WMATA must repair the four loose-broken bolts at D2 087+50, 1B switch frog brace plate.</li><li>• WMATA must tighten the numbers three and four switch rods at the 1B switch, D2 087+50.</li><li>• WMATA must change the corroded right rail at D2 087+90.</li></ul>

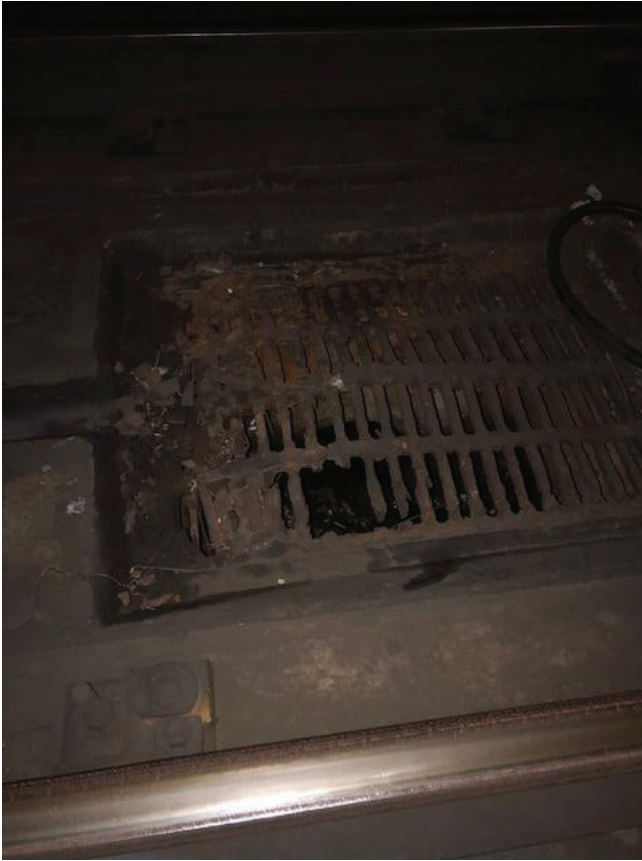
**Figure 1:** Corroded center drain at L2 152+50.

Recommended Finding?	No								
							Remedial Action Required?	Yes								
							Recommended Reinspection?	Yes								
Remedial Action	<p>To achieve compliance with WMATA's requirements:</p> <ul style="list-style-type: none"> <li>WMATA must replace the corroded center grate at L2 152+50.</li> </ul>

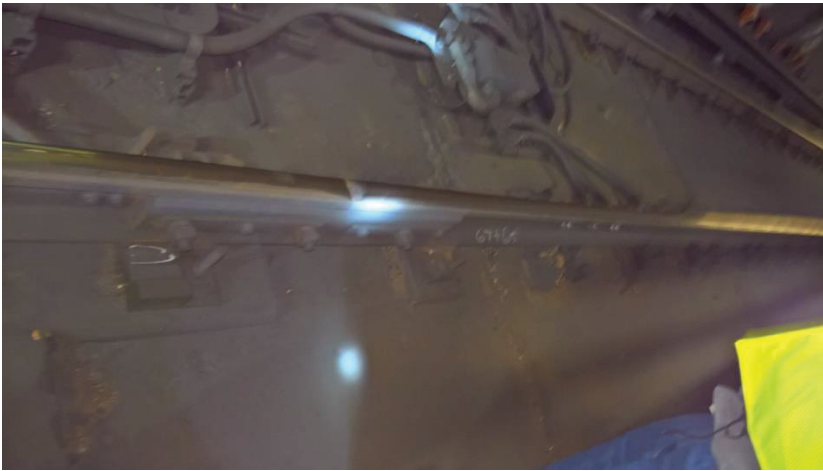
Description	The FWSO inspector observed WMATA ATC personnel perform an interlocking inspection in accordance with the ATC 3000 manual - 3003 interlocking inspection. FWSO inspectors went wayside on mainline track at Foggy Bottom (C04) from C1/C2 CM 064+40 to CM 068+70. The switches 1A/3A on track 1 and switches 1B/3B on track 2 were inspected.  The following color-coded defect was observed: <ul style="list-style-type: none"><li>TRST 1000 Table 7-1: At CM C1 067+65, three defective fasteners in a row were observed at the holding gauge on left rail. No speed restriction was applied. <b>Yellow condition.</b> See figure 1 below.</li></ul> The following non-color-coded defects were observed: <ul style="list-style-type: none"><li>TRST 1000, 13.5.7: Third rail was missing cover board at CM C1 065+30. Remedial action for this defect is addressed by WMATA's approach to FTA-TPE-17-021-A.</li><li>TRST 1000, 13.5.7: Third rail was missing cover board at CM C1 065+90. Remedial action for this defect is addressed by WMATA's approach to FTA-TPE-17-021-A.</li></ul> The following remedial actions were verified as complete: <ul style="list-style-type: none"><li>WMATA repaired the rail tread mismatch at C1 066+30.</li><li>WMATA repaired the fasteners at C04, switch 1B, at C2 66+00.</li><li>WMATA repaired the defective weld at C2 065+90.</li><li>WMATA repaired the frog brace wedges on switch 3B at C2 066+35.</li></ul>							Number of Defects		3

**Figure 1:** Defective fasteners at CM C1 067+65.

Recommended Finding?		No	
								Remedial Action Required?		Yes	
								Recommended Reinspection?		Yes	
Remedial Action		To achieve compliance with WMATA's requirements: <ul style="list-style-type: none"><li>WMATA must repair the fasteners at CM C1 067+65.</li></ul>

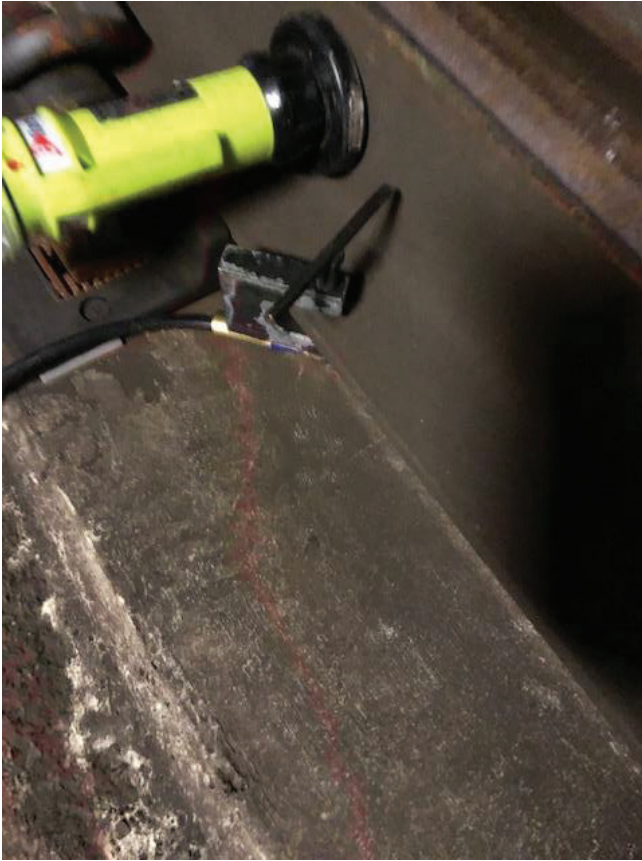
<b>Description</b>	FWSO inspector performed a work zone set-up verification and track inspection between Gallery Place (B01) and Farragut North (A02), track one. The scope of work for the evening was joint elimination (orgo-thermite welding).  <b>The FWSO inspector did not note any defects.</b>  <b>Other Notable Observations:</b> <ul style="list-style-type: none"> <li>During the observation, at the A1 007+00 work zone, the old type, non-locking shunt was being used. See Figure 1 below.</li> </ul>						<b>Number of Defects</b>	0			
							<b>Recommended Finding?</b>	No			
							<b>Remedial Action Required?</b>	No			
							<b>Recommended Reinspection?</b>	No			
<b>Remedial Action</b>	N/A

**Figure 1:** A1 007+00, old type non-locking shunt in use.

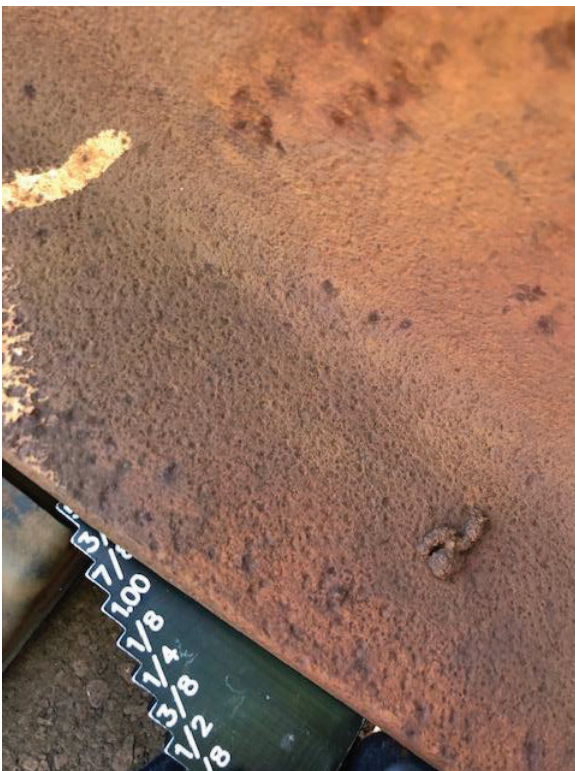
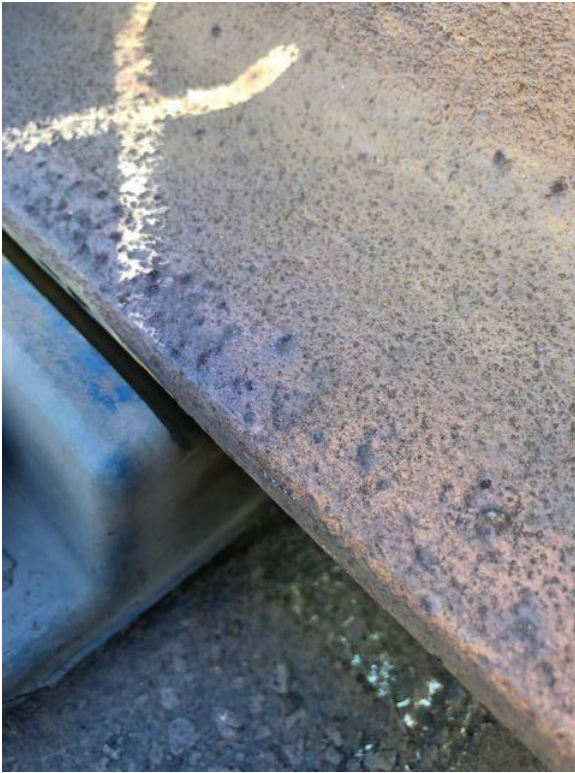
<b>Description</b>	<p>FWSO inspector performed a track inspection between Van Dorn St (J02) to King St-Old Town (C13), track two.</p> <p><b>The following non-color-coded defects were observed:</b></p> <ul style="list-style-type: none"> <li><b>TRST 1000, 10.14:</b> At J2 640+50, emergency trip station (ETS) box J40 and electrical junction box did not have covers. See Figure 1 below.</li> <li><b>TRST 1000, 10.14:</b> At J2 639+40, an ETS electrical junction box J38 had a broken cover.</li> </ul> <p><b>Other notable observations:</b></p> <ul style="list-style-type: none"> <li>During the observation, between J2 616+25 and 616+30, on the left (low) rail, a gap measuring 5/8-inch was observed that was affecting seven consecutive fasteners. This condition allowed dynamic horizontal and vertical deflection, a step gauge was used to acquire exact measurements. See Figure 2 and 3 below.</li> <li>During the observation, on the aerial structure between J2 668+00 and 658+00, cracked and deteriorating fasteners were observed. See Figure 4 below.</li> </ul>						<b>Number of Defects</b>	2

Figure 2: Between J2 616+25 and 616+36, a 5/8-inch gap between the base of the rail and the fastener plate. Step gauge used to obtain measurement.

**Figure 3:** Between J2 616+25 and 616+36, a 5/8-inch gap between the base of the rail and the fastener plate. Step gauge used to obtain measurement.

<b>Recommended Finding?</b>	No			
							<b>Remedial Action Required?</b>	Yes			
							<b>Recommended Reinspection?</b>	Yes			
<b>Remedial Action</b>	<p>To achieve compliance with WMATA's requirements:</p> <ul style="list-style-type: none"> <li>WMATA must repair ETS Box J40 at J2 640+50.</li> <li>WMATA must repair ETS Box J38 at J2 639+40.</li> </ul>

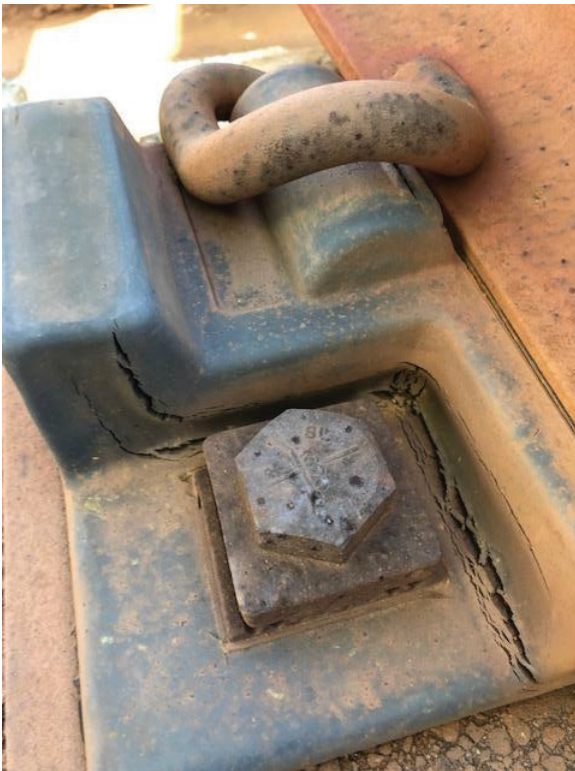
**Figure 4:** Between J2 668+00 and 658+00 on the aerial structure, failing fasteners were observed.

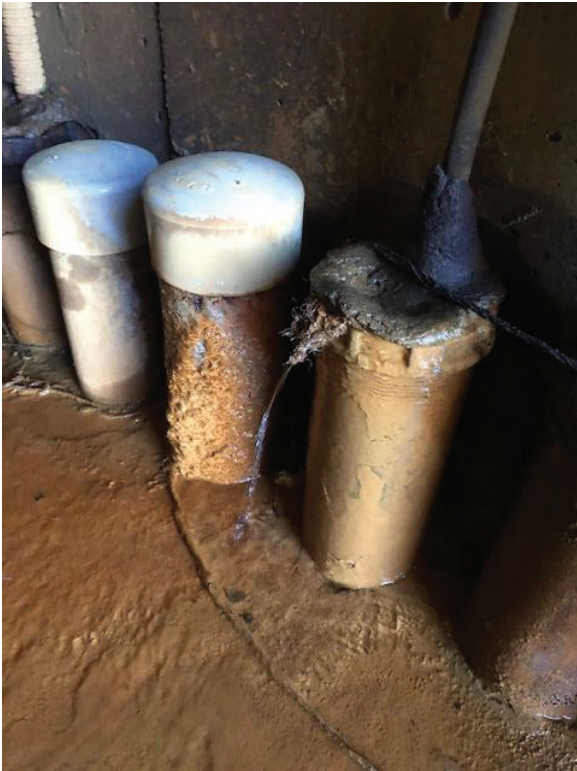
**Figure 1:** At F1 343+00, water extruding from conduit stub-up draining onto the track bed.

Recommended Finding?	No			
							Remedial Action Required?	Yes			
							Recommended Reinspection?	Yes			
Remedial Action	<p>To achieve compliance with WMATA standards:</p> <ul style="list-style-type: none"> <li>WMATA must install heat shrink cover on the stub-up at F1 343+00 to prevent water draining onto the track bed.</li> </ul>
