## Connected Vehicle (CV) Infrastructure – Urban Bus Operational Safety Platform

FTA Report No. 0133  
Federal Transit Administration

PREPARED BY  
Battelle Memorial Institute

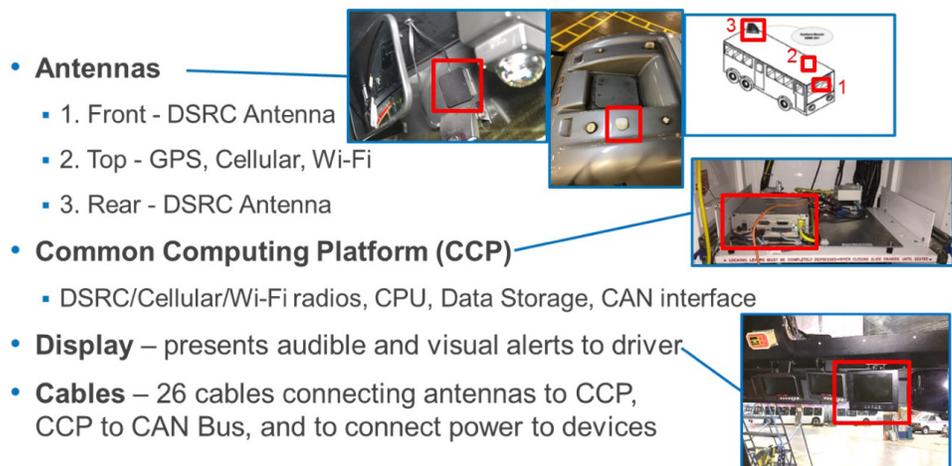
**Figure 2-1**  
*On-board subsystem equipment*

The E-TRP system leveraged the technologies and applications developed under TRP and included additional capabilities to enhance and improve transit vehicle and pedestrian safety in an operational context (1). The system relied heavily on technologies and approaches demonstrated in previous USDOT deployment projects and vehicles. The E-TRP System consisted of two physically-separate subsystems—an on-board, transit vehicle-based subsystem and an infrastructure-based subsystem—at each of the selected street intersections. Figure 2-1 shows the major components of the on-board subsystem, which was installed as a retrofit kit (like the TRP project) on each of the 24 transit vehicles. Figure 2-2 shows the major components of the infrastructure subsystem installed at each of the three street intersections. A summary of their requirements and design is included in Section 3.

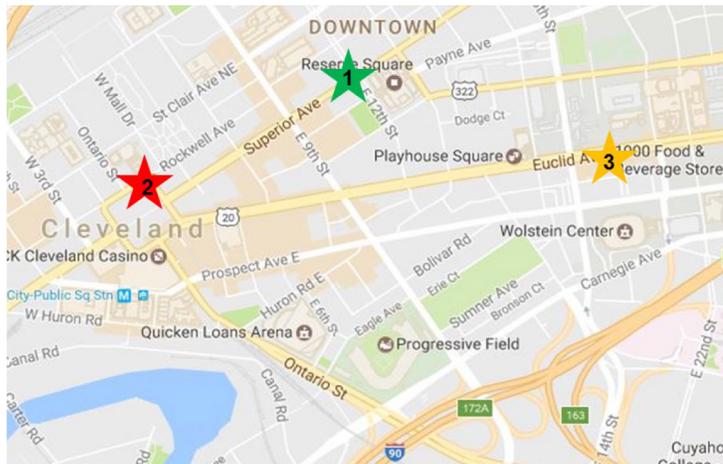
**Figure 2-3**  
*Map of intersections with E-TRP technology deployed*

Table 2-1 and Figure 2-3 show the location and type of deployed intersections. Each of these intersections was equipped with Forward-Looking Infrared (FLIR®) cameras and other equipment to detect pedestrians and transmit messages to the equipped transit vehicles to generate E-PCW alerts when appropriate. Figures 2-4, 2-5, and 2-6 show the layout of equipment at each of the deployed intersections.

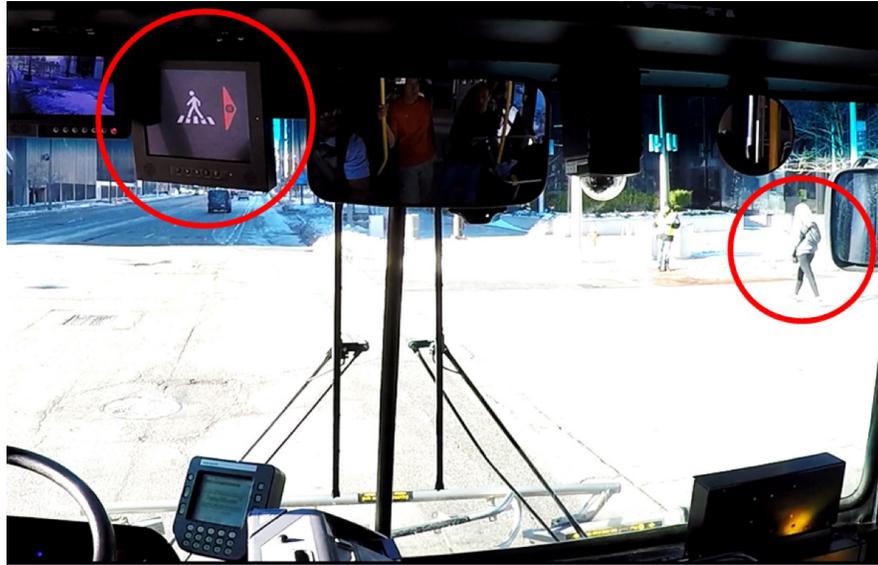
**Figure 2-7**

Figure 2-7 shows a real-world E-PCW warning displayed to a driver along with the pedestrian triggering the warning.

*E-TRP in transit vehicle, E-PCW warning*

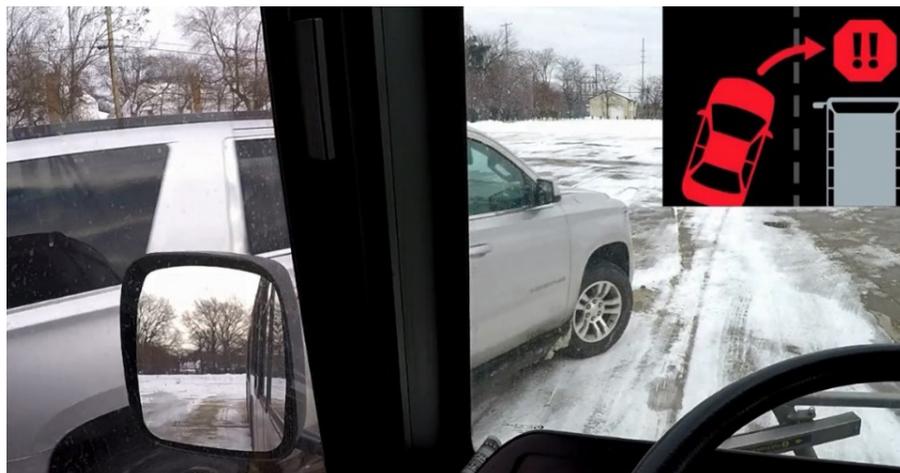
**Figure 2-8**

Figure 2-8 shows an E-VTRW warning displayed to a driver in a closed-loop test environment, where the warning image is overlaid so that both the remote vehicle and the warning can be seen. E-VTRW was tested in the closed-loop environment but was not part of the evaluation, as there were no other vehicles (e.g., light vehicles) equipped with DSRC other than the 24 buses. Thus, E-VTRW alerts were not seen in the field, other than a rare occurrence of a DSRC-equipped bus turning in front of another DSRC-equipped bus that was departing from a near-side bus stop.

*E-TRP in transit vehicle, E-VTRW warning*

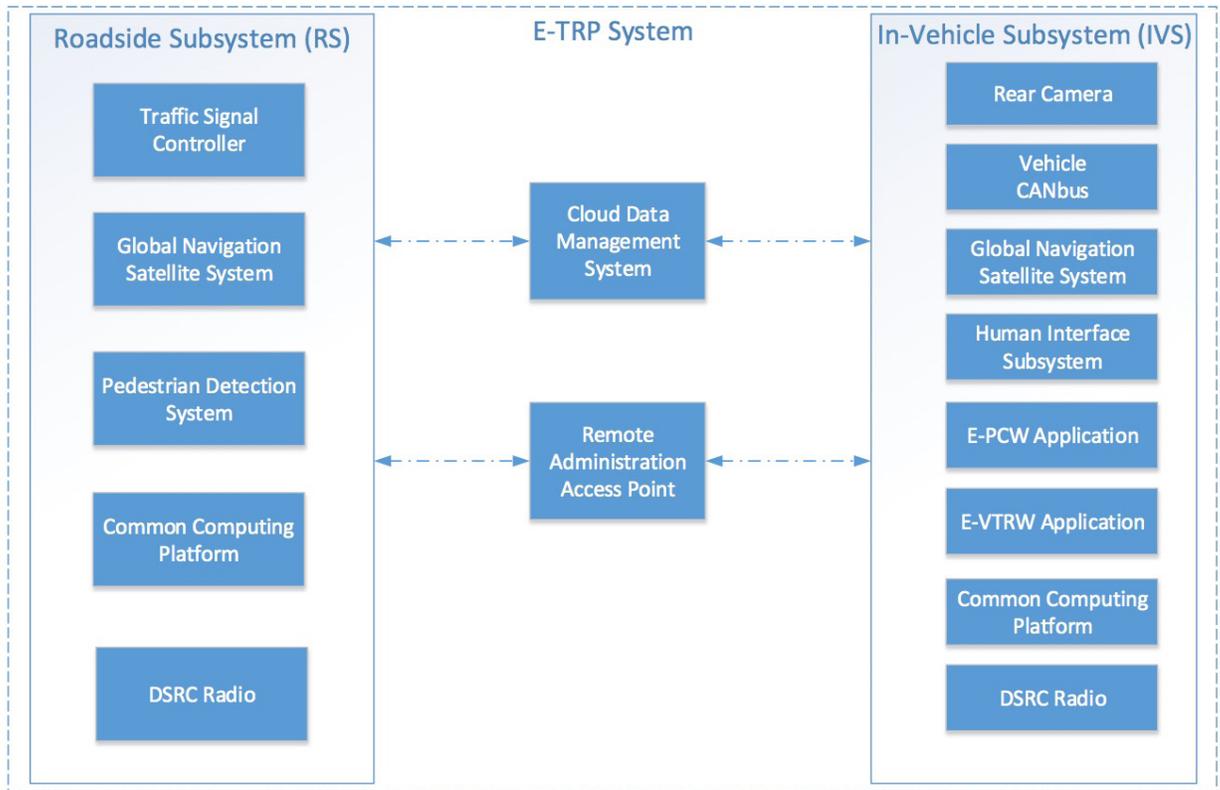
**Figure 3-1**

External to the E-TRP system of interest, but supporting its mission, was the transit vehicle itself, which provided data to the E-TRP system CCP about the operational situation of the vehicle, including GNSS data and vehicle telematics data such as speed, turn signal operations, and brake status. The DSRC-enabled Personally Remote Vehicle (ROV) subsystem represented other DSRC-enabled non-transit vehicles that may have interacted with the E-TRP transit vehicles on the roadway. The E-PCW application was deployed at both signalized and un-signalized crosswalks (at the three designated intersections). The E-PCW application leveraged the SPaT data from the Siemens M50 traffic signal controller at the E 12th Street and Superior Avenue signalized intersection.

*Diagram of E-TRP system*

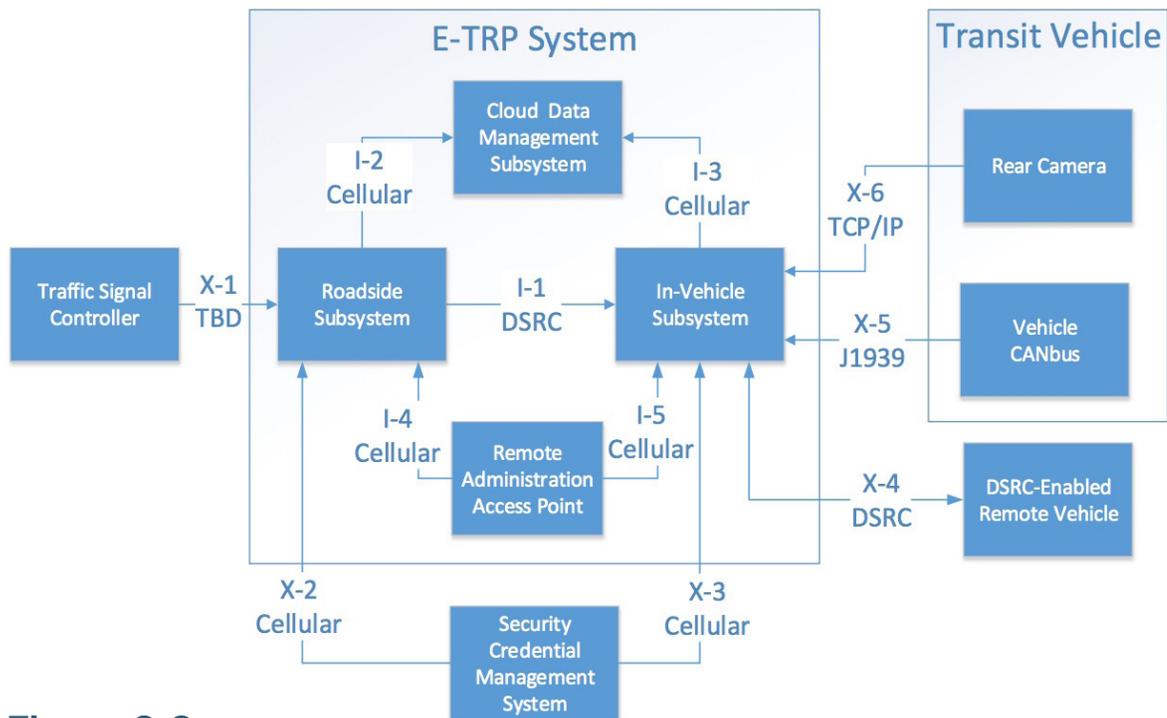
**Figure 3-2**  
E-TRP architecture

Figure 3-2 provides a high-level architectural view of the E-TRP System, including communication protocols between subsystems and external components. Note that the USDOT Security Credential Management System (SCMS) was planned but not implemented due to timing (SCMS was not available in time for use on this project). For the purposes of this project, DSRC message security was not employed based on the low risk of a DSCR security breach and the low impact in the unlikely event that one was to occur.

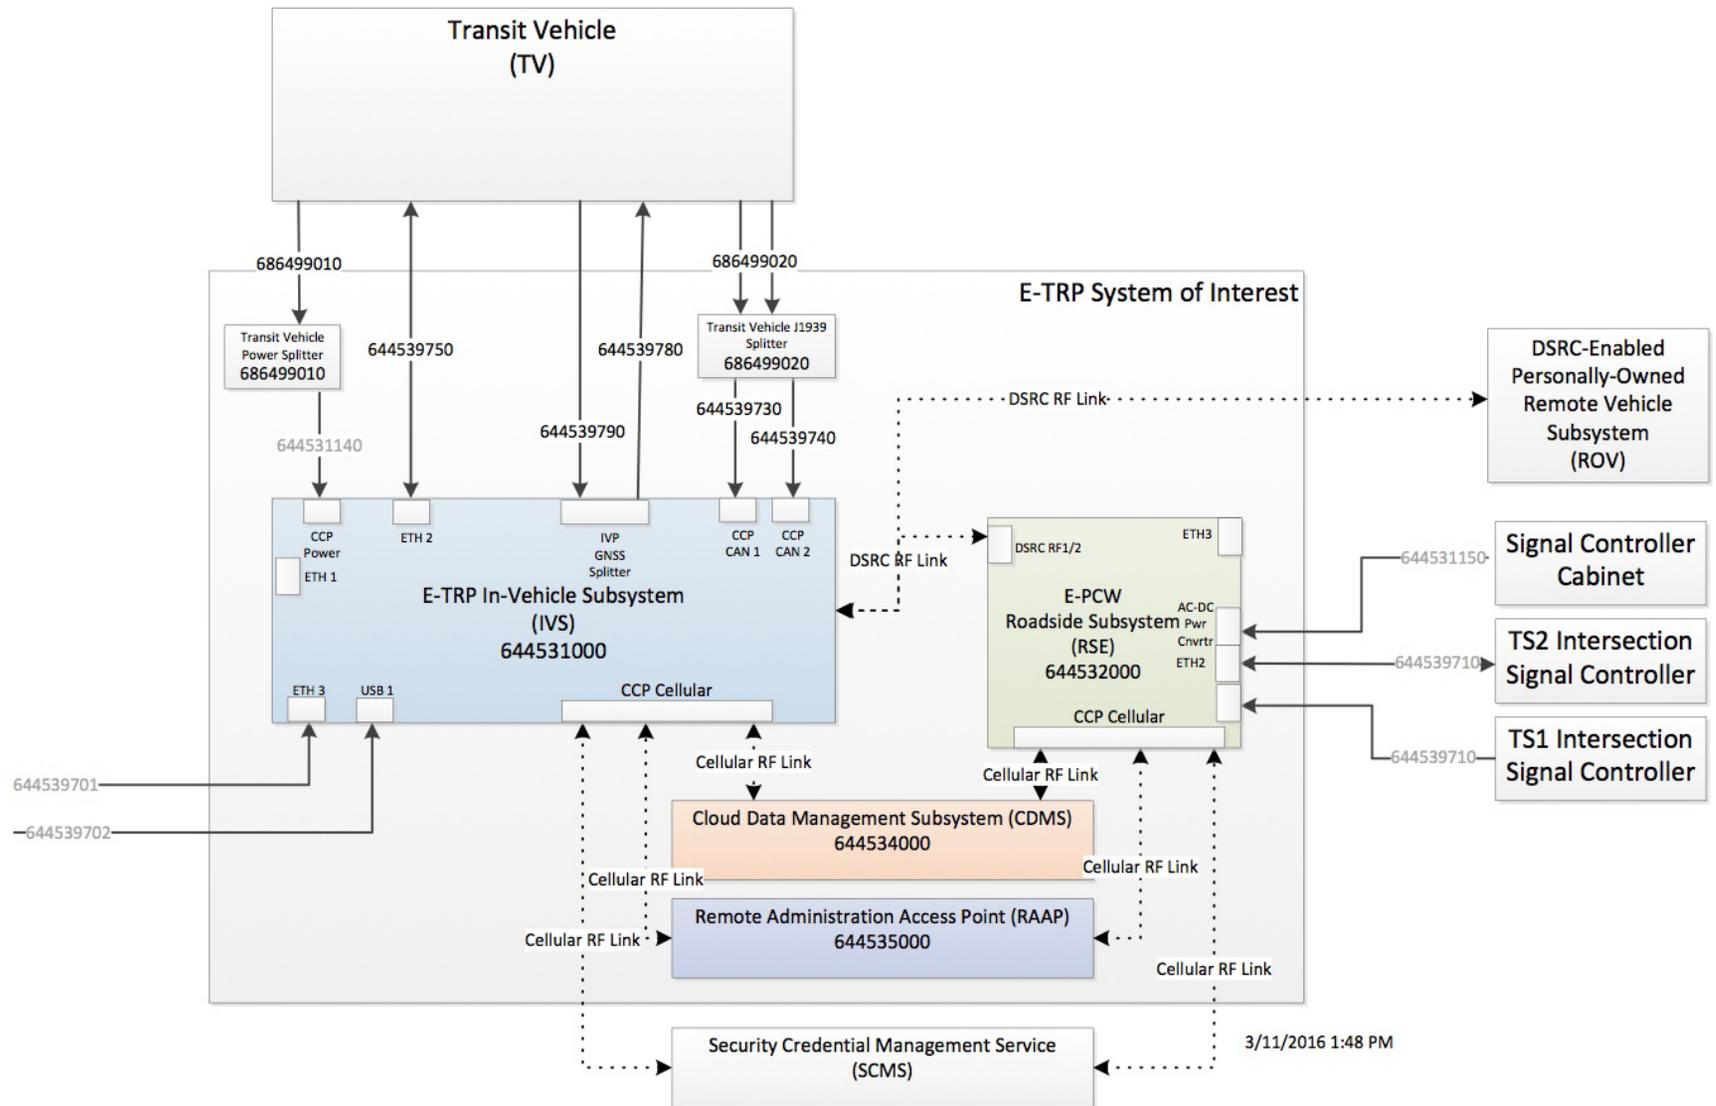
**Figure 3-3**  
Hardware block diagram

A hardware block diagram for the E-TRP and supporting equipment is shown in Figure 3-3. This figure identifies the main components and the associated interconnections that are required.

The Transit Vehicle CAN Bus is based on the SAE J1939 specification. The specific format and payload definitions of the messages are J1939-compliant. The E-TRP IVS interfaced to the existing transit vehicle's Vehicle CAN Bus to decode the information listed in Table 3-2.

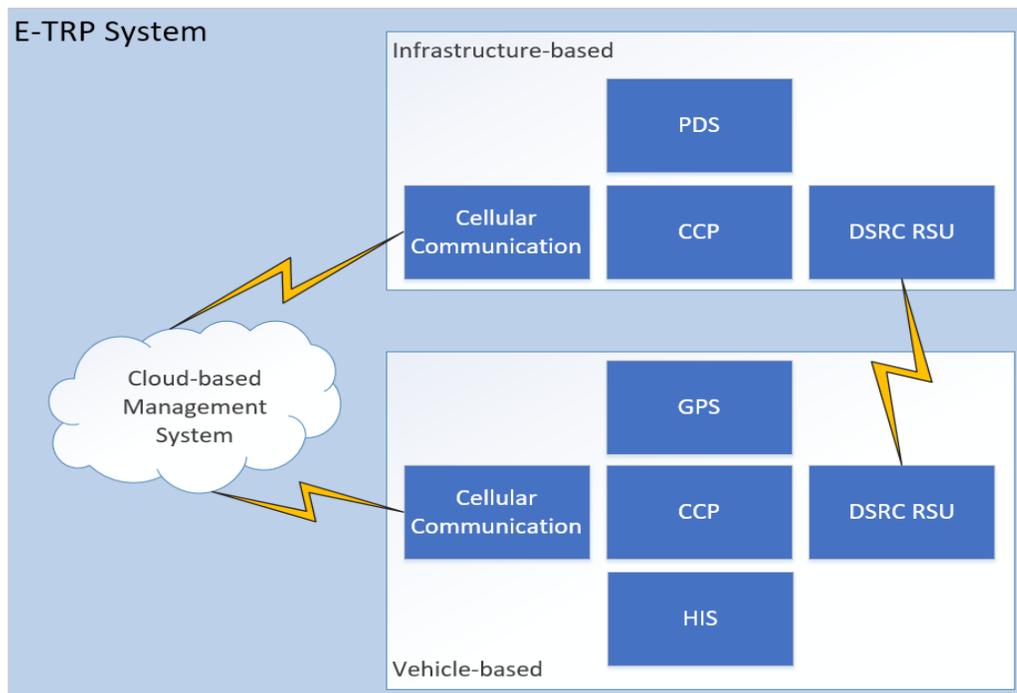
**Figure I-2. Conceptual E-TRP Architecture**

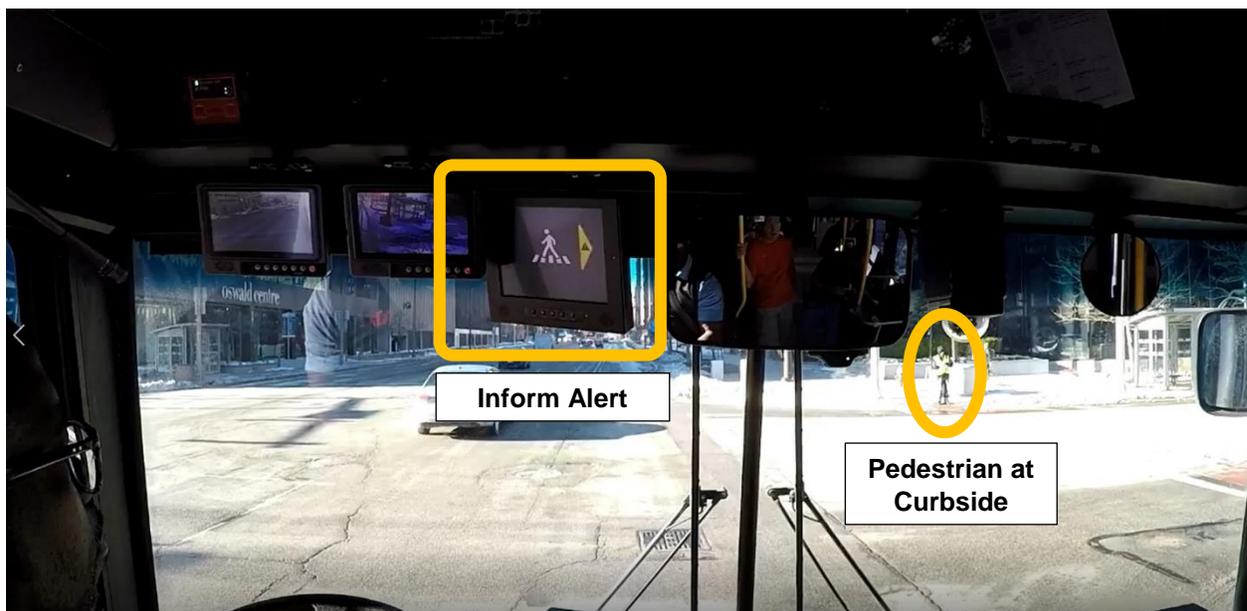
**Figure 1-3. Inform Alert – Yellow Display for Curbside Pedestrian**

The E-PCW application detects pedestrians in crosswalks or at the curb whose location or movement establishes a potential safety conflict for both signalized and non-signalized crossings. The application delivers information in the form of alerts that either inform or warn the transit vehicle operator of a potential conflict or imminent danger based on the detected location of the pedestrian(s) and location and state of the bus. Figure 1-3 highlights the driver display, alert type, and associated pedestrian location. Alerts are generated only when the system detects pedestrian presence in predefined locations and the bus is expected to traverse the potential path of the pedestrian; the system cannot detect pedestrians outside of designated camera locations.

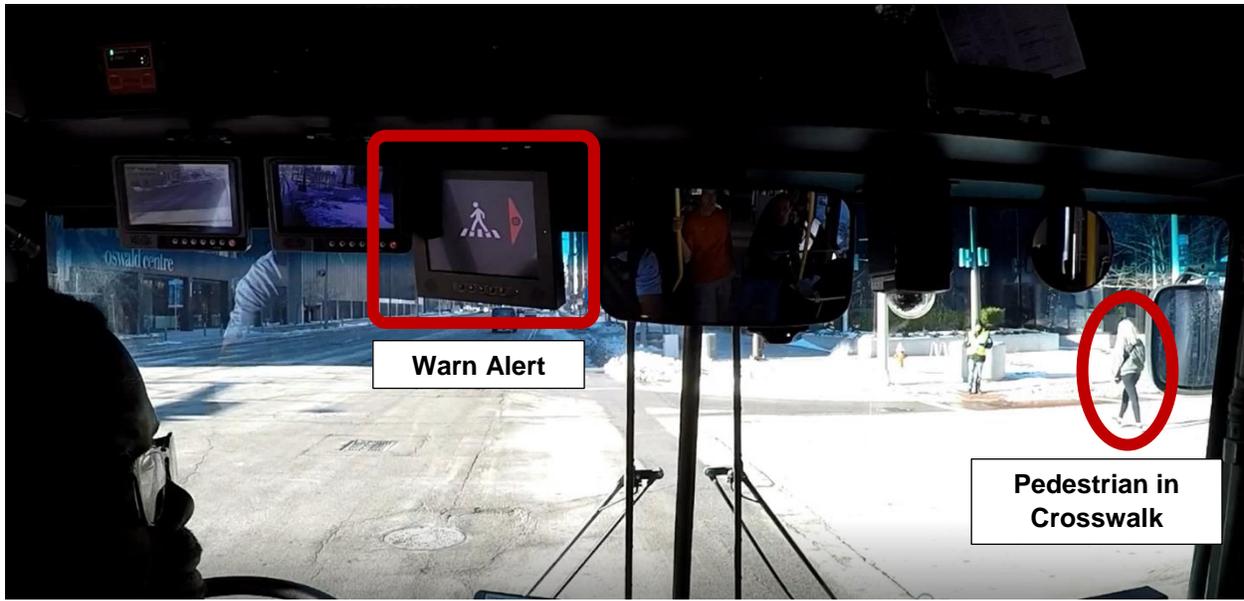
**Figure I-4. Warn Alert – Red Display for Pedestrian in Crosswalk**

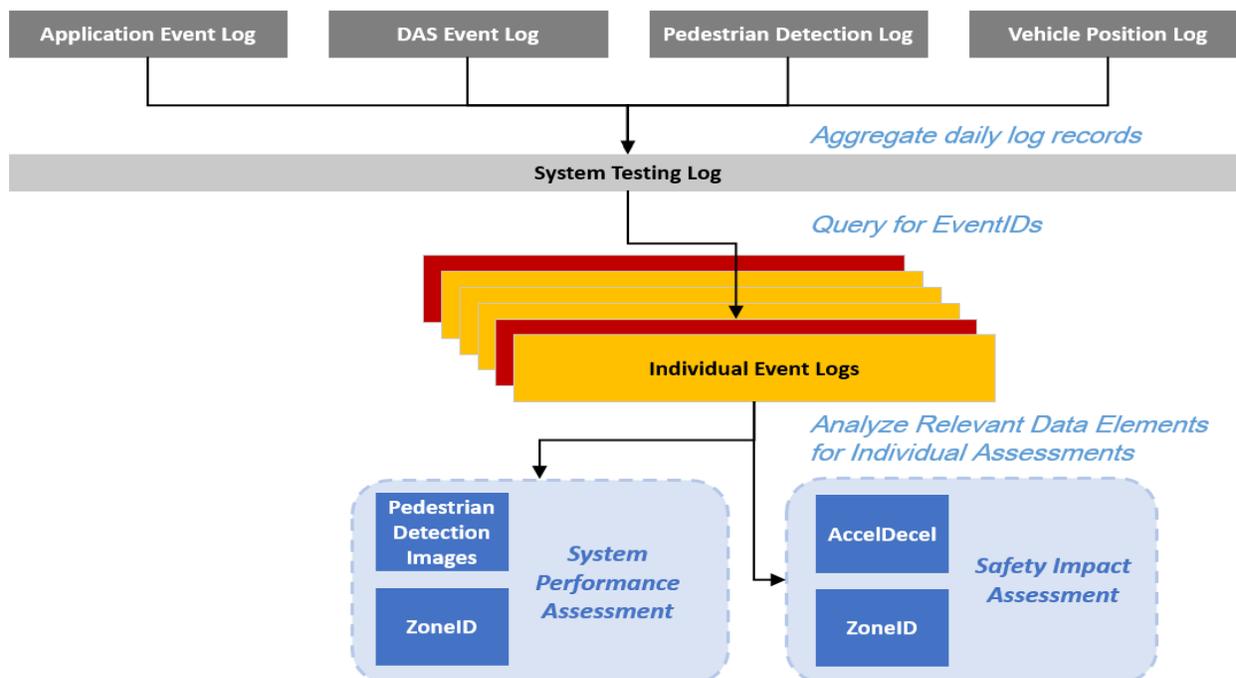
Objective data consisted of numerical data from a variety of sources—system log files, historical transit collision, system cost data, and image files from the pedestrian detectors as depicted in Figure I-6.

**Figure I-6. High-Level Data Analysis Flow Chart**

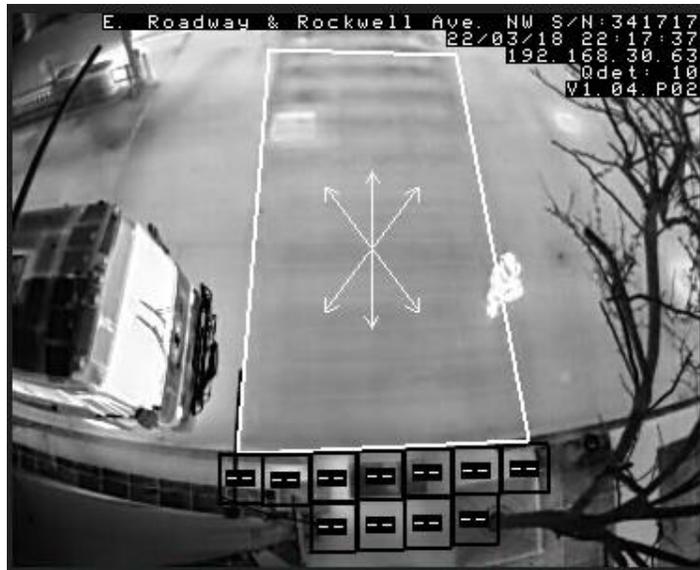
Figure 2-2 is an example of the classification for a “correct alert” in the warning scenario. In the image, the crosswalk zone is highlighted in white, indicating the detection of a pedestrian, and the person in the image is located in the highlighted zone, crossing the street in front of the bus.

**Figure 2-1. Example of Correct “Warn” Alert**

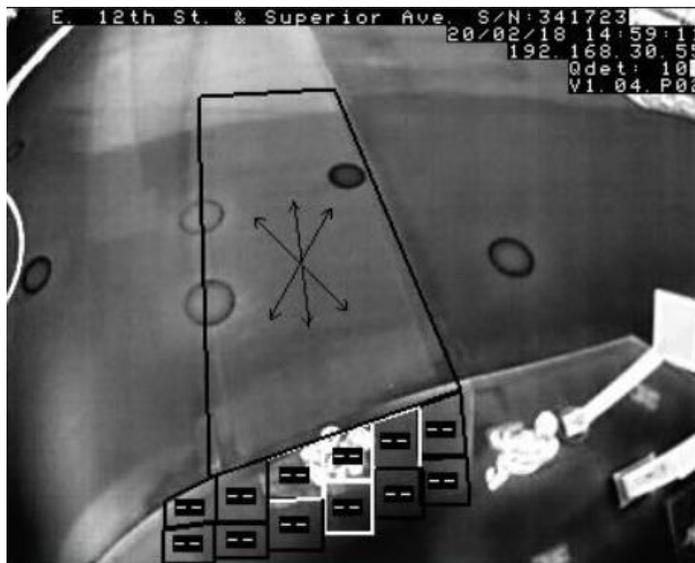
Figure 2-2 is an example of the classification for a “correct alert” in the inform scenario. In the image, the sidewalk zone is highlighted in white, indicating the detection of a pedestrian, and the person in the image is located in the highlighted zone, standing near the curb on the sidewalk.

**Figure 2-2. Example of Correct “Inform” Alert**

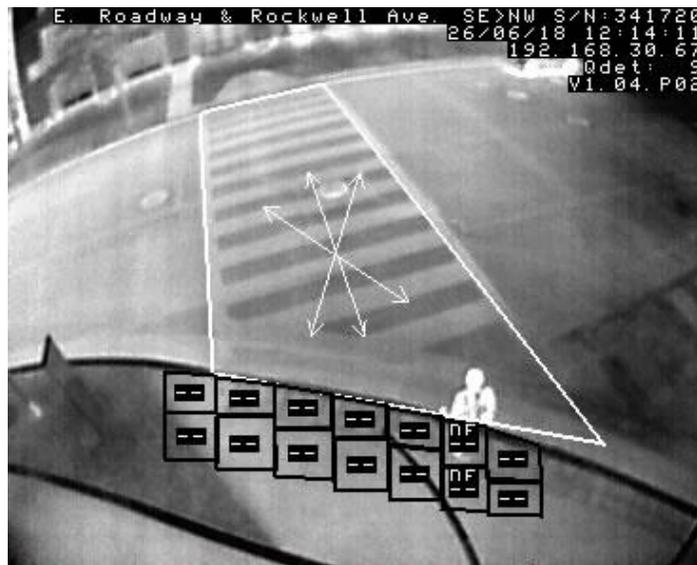
person in the image is standing on the curb. Due to the camera angle, the person's torso appears in the warning zone of the image creating an incorrect alert.

**Figure 2-3. Example of Incorrect “Warn” Alert**

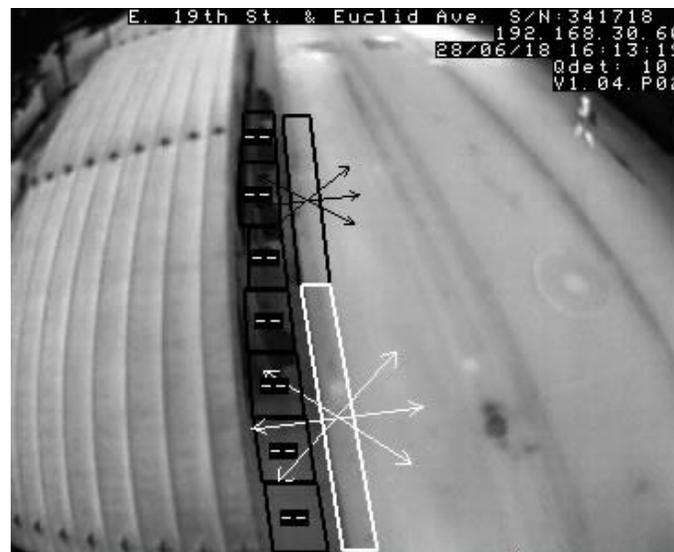
Figure 2-4 is an example of the classification for a “false alarm” in the “Warn” alert scenario. In the image, one of the designated curb zones is highlighted in white, indicating the detection of a pedestrian, when there are no pedestrians present.

**Figure 2-4. Example of False Alarm (Warn)**

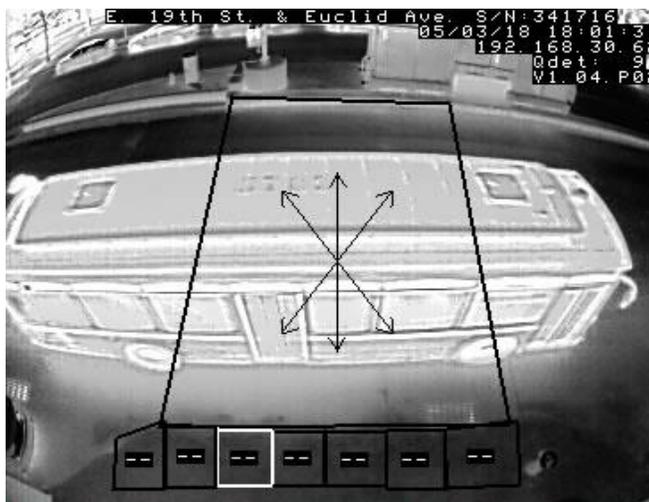
Figure 2-5 is an example of the classification for a “false alarm” in the “Inform” alert scenario. In the image, one designated curb zone is highlighted in white, indicating the detection of a pedestrian, when there are no pedestrians present.

**Figure 2-5. Example of False Alarm (Inform)**

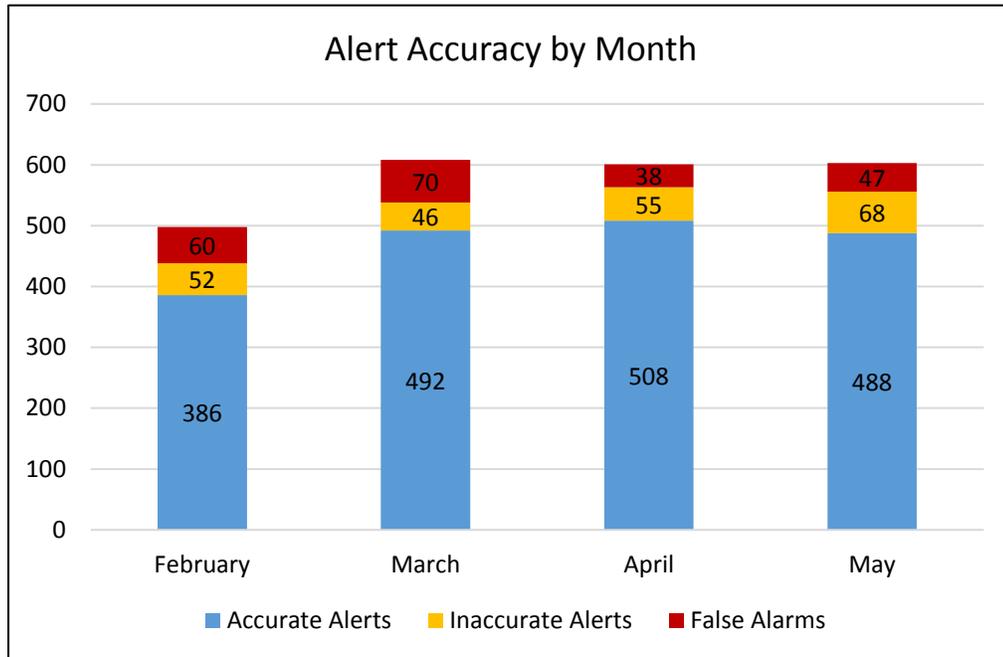
location. Figure 2-6 illustrates the alert accuracy by month and indicates that the number of false alarms and inaccurate alerts was relatively consistent across the test period. Qualitative analysis of the pedestrian detector images, including examples described on the next page, indicates that the primary causes of false alarms were lighting and environmental conditions, non-pedestrian moving objects, and equipment failure.

**Figure 2-6. System Performance – Alert Accuracy by Month**

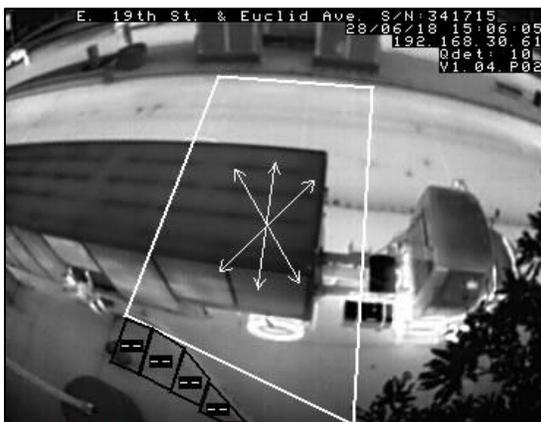
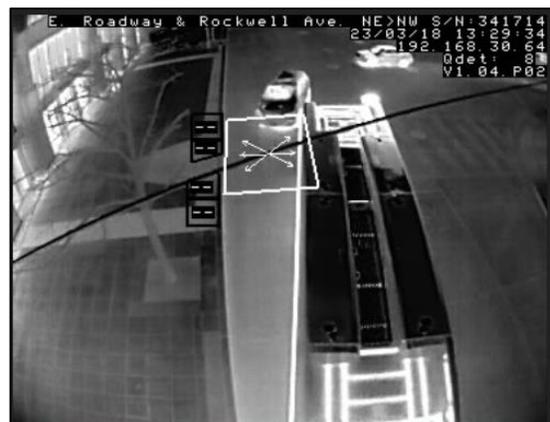
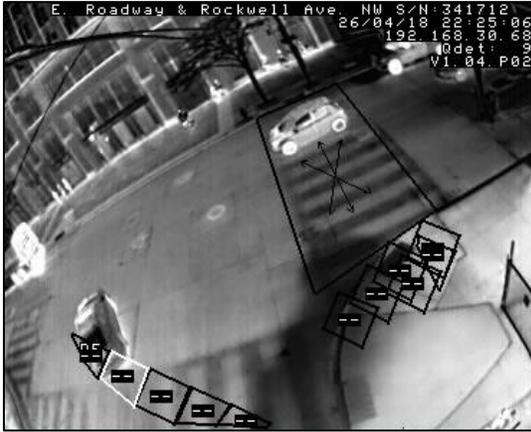
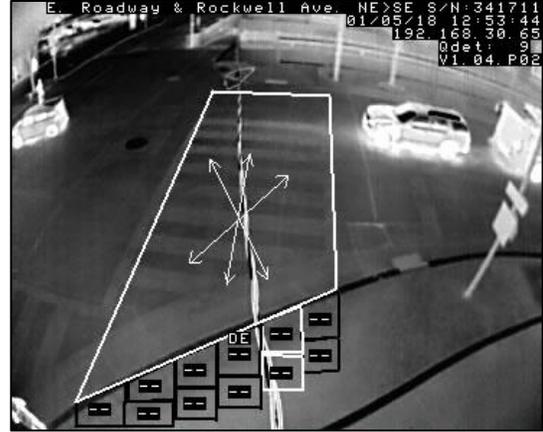
The images below illustrate instances where a false warn alert was issued in response to the detection of a vehicle in the crosswalk zone. Calibration of the pedestrian detector software to prevent vehicle-initiated detection may increase system performance.

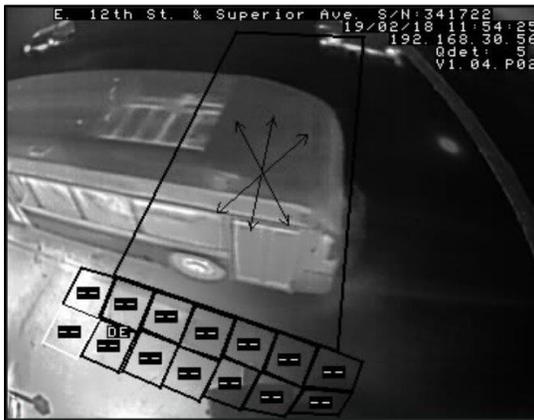
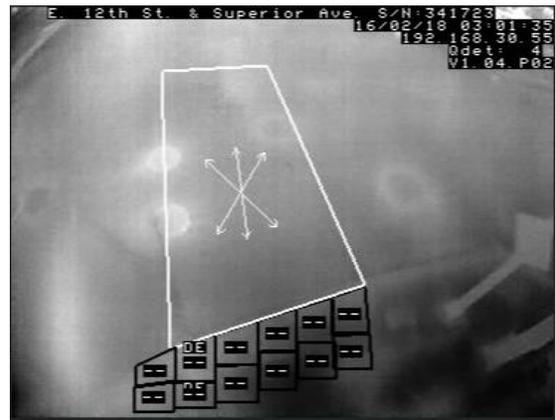
The images below illustrate examples of false alarms caused by lighting and environmental conditions. The image on the left shows an instance in which light bouncing off the pavement caused a false detection in the “Inform” alert zone. The image on the right contains circular light patterns that were present in many of the false alarm images. Calibration of the detectors and investigation of the source of the circular light patterns may increase system performance significantly.
