# Inspection Form

United States Department of Transportation  
Federal Transit Administration

Inspection Date	YYYY	MM	DD	Report Number	20160703-WMATA-MRV-1		
	2016	07	03				
Rail Agency Name	Washington Metropolitan Area Transit Authority			Rail Agency Department	TRST	Sub- Department	
Rail Agency Department Contact Information	Name		Email		Office Phone		Mobile Phone
	[REDACTED]		[REDACTED]		[REDACTED]		
Inspection Location	SafeTrack Surge 2-D&G Junction

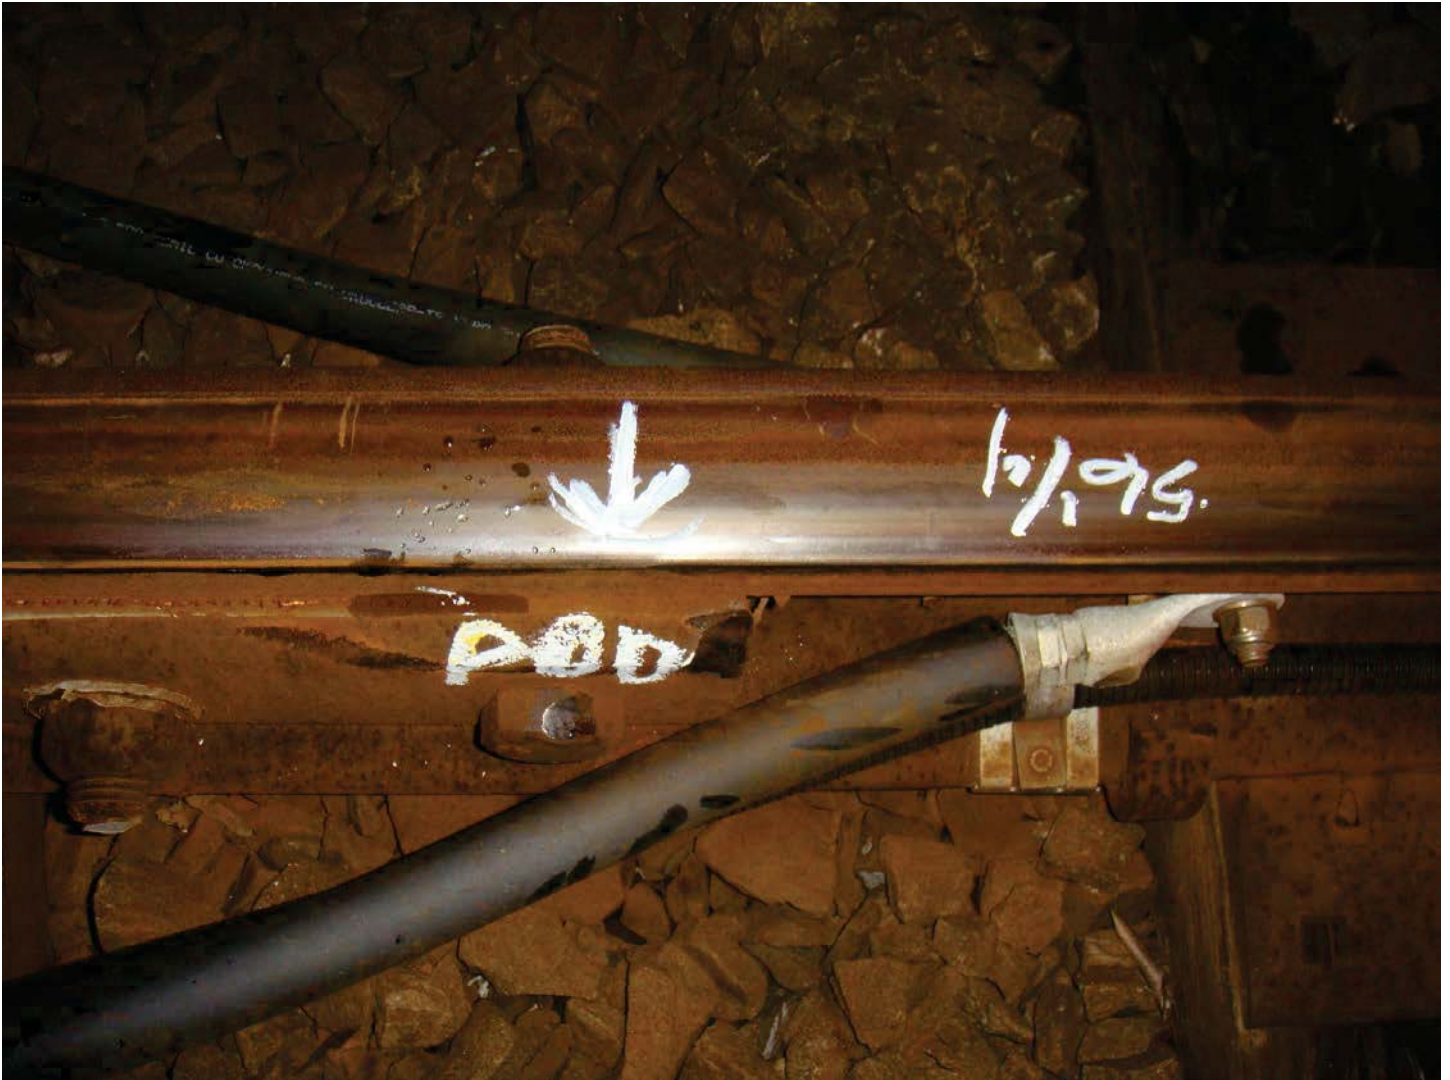
Photo taken at POD of 56  $\frac{1}{4}$ " – when combined with lateral movement the gage would be 59  $\frac{1}{4}$ "

The tie condition is also evident in this photo. The center is completely rotted.
