Inspection Form

United States Department of Transportation
Federal Transit Administration

Inspection Date	YYYY	MM	DD	Report Number	20161201-WMATA-WP-1		
	2016	12	01				
Rail Agency Name	Washington Metropolitan Area Transit Authority			Rail Agency Department	Track	Sub- Department	
Rail Agency Department Contact Information	Name		Email		Office Phone		Mobile Phone
	[REDACTED]		[REDACTED]				
Inspection Location	Twinbrook (A13) to Rockville (A14)

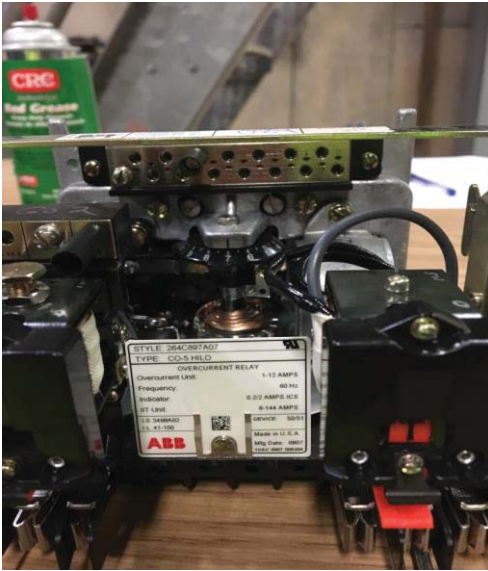
FIGURE 1 - ABB CO-5 HILO OVERCURRENT (50/51) RELAY

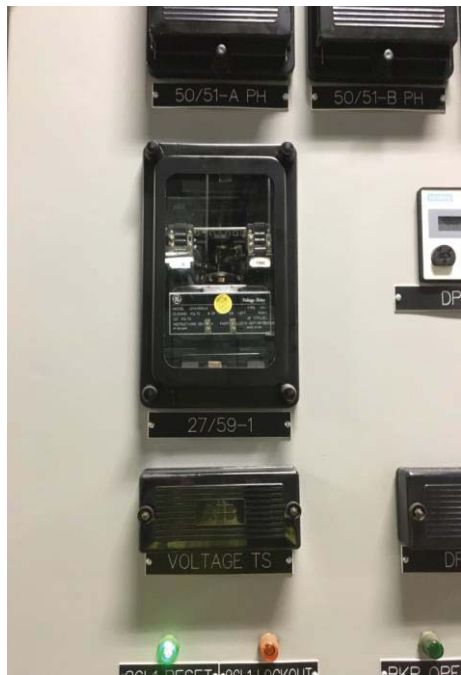
FIGURE 3 - GE UNDER/OVER VOLTAGE (27/59) RELAY

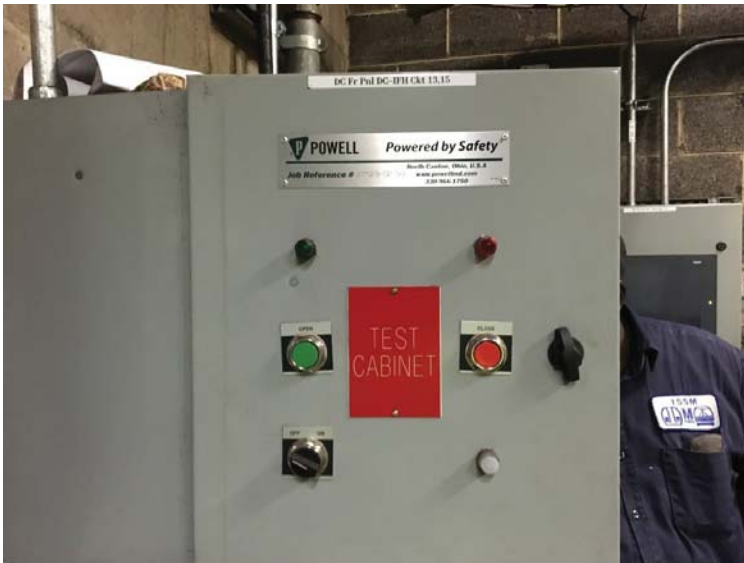
Figure 7 – POWELL BREAKER TEST CABINET

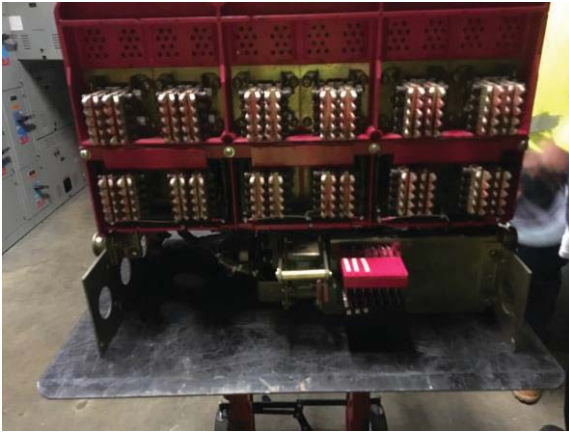
FIGURE 3 – POSTERIOR OF SECONDARY MAIN BREAKER, COPPER BUS STABS

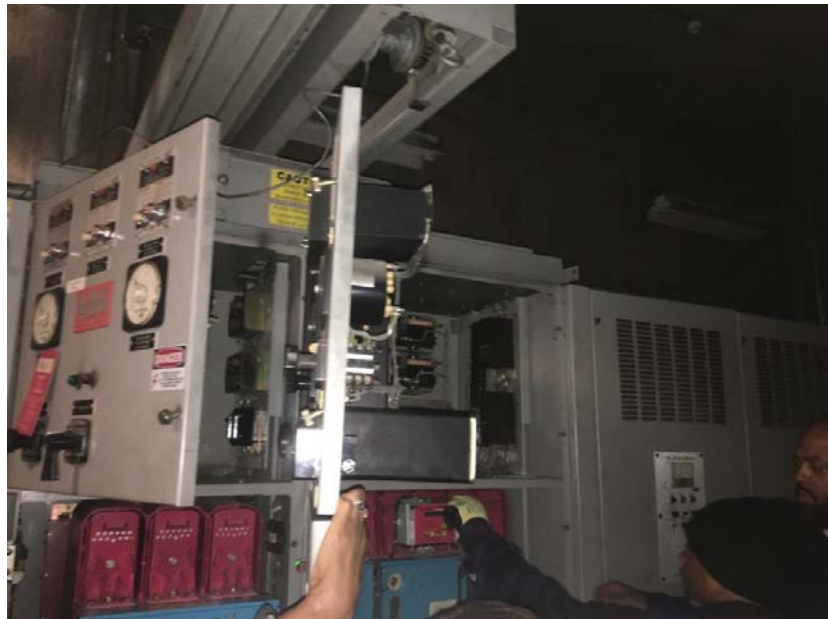
FIGURE 6 – SECONDARY MAIN BREAKER CUBICLE ON AC SWGR, TRYING TO TROUBLESHOOT THE RELAYS

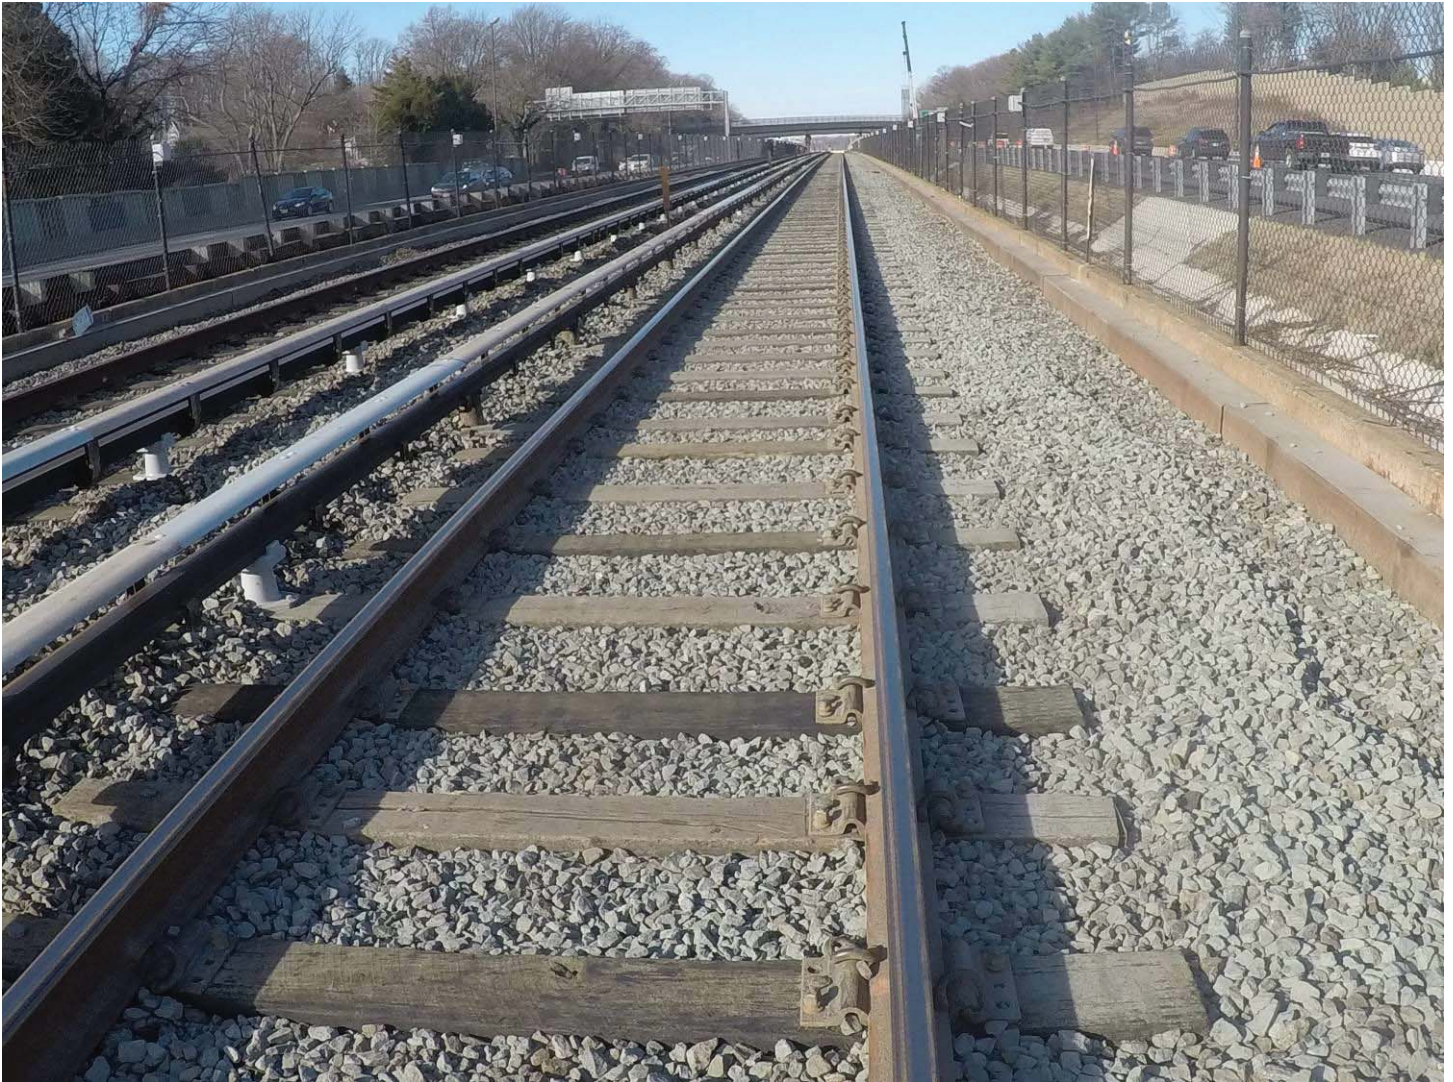
Recently Completed Tie Replacement and Ballast addition and regulation

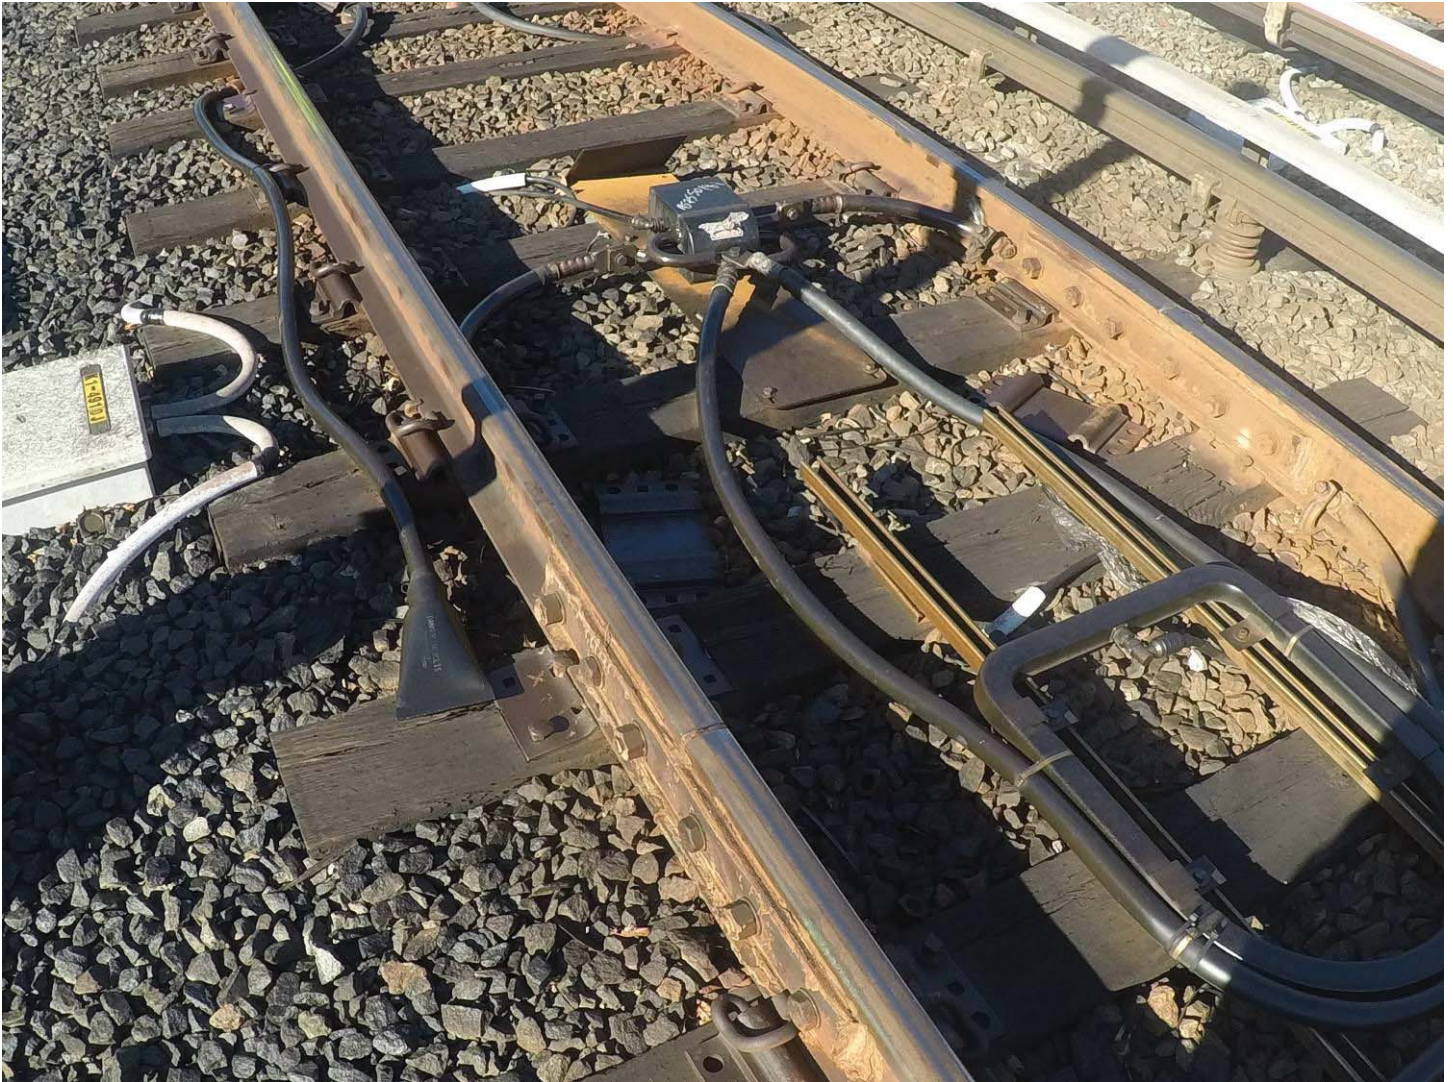
ATC cables booted at K1 491+00

Remedial Action	<ol style="list-style-type: none"> WMATA must replace or repair the ETS door at K1 451+50. WMATA should elevate the ATC cables off the ballast or implement a similar solution in order to preserve the insulation of these cables.
-----------------	---
