Recommended Fire Safety Practices for Rail Transit Materials Selection

Project No. DC-26-5243-00

Prepared for the
U.S. Department of Transportation
Federal Transit Administration
Office of Safety and Security
Technical Assistance Program

Submitted by the National Association of State Fire Marshals November 2008

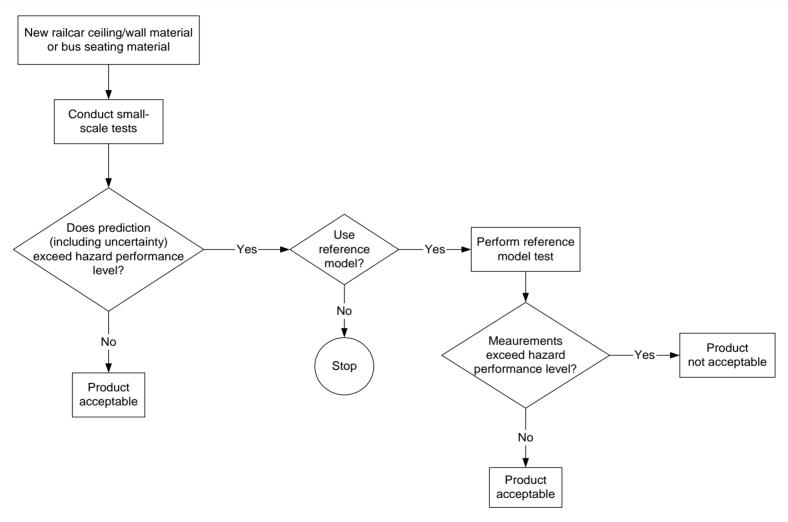
Assessment of materials (Slide provided by UL, from the UL Study)

Flowchart illustrating the assessment of materials using fire performance metrics

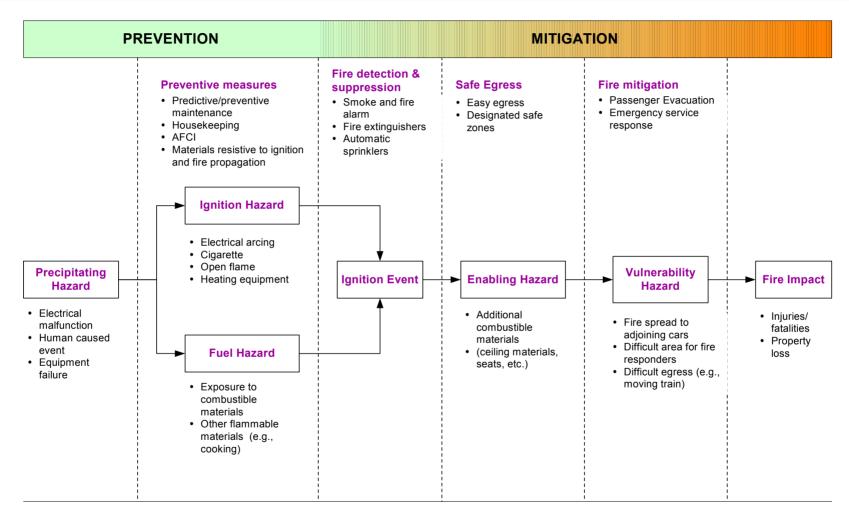
Fire development stages

Stages of fire development within fire prevention and mitigation

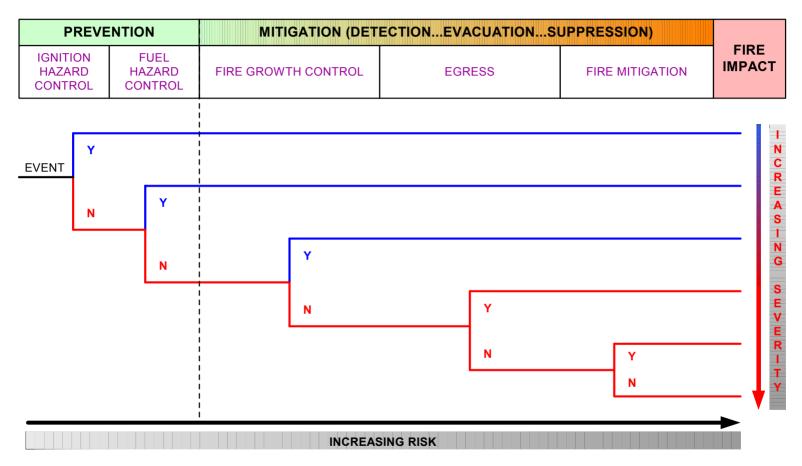
Fire protection strategy

Event tree illustrating that as fire continues to develop, the overall risk and severity of the fire impact will increase

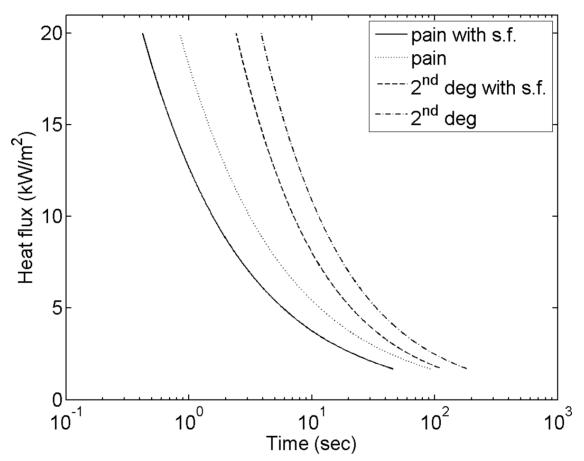
Prevention in favor of mitigation

Incident heat flux as a function of exposure time for limits on pain and second degree burns, with and without safety factors (s.f.) applied (Wieczorek & Dembsey, 2001)

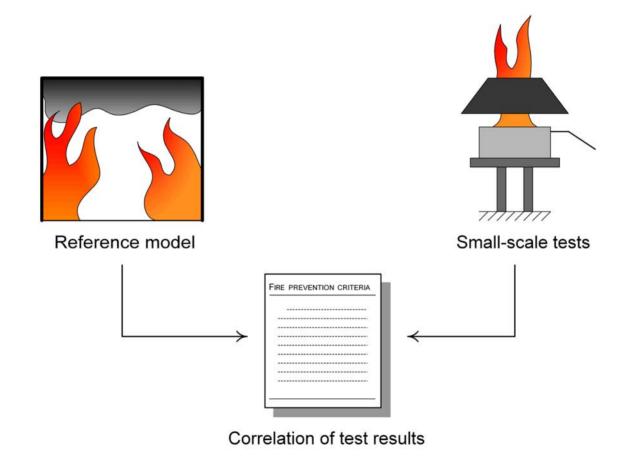
Scaling test results from small- to large-scale

Hazard-based regulations through the scaling of small-scale test metrics to large-scale hazard parameters

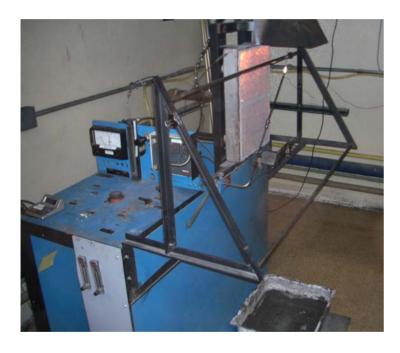
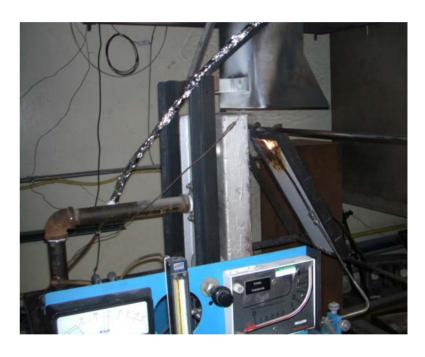
Overview of apparatus without specimen

Detail of apparatus with specimen

Experimental arrangement for ASTM E 162, downward flame spread along inclined oriented sample

ASTM E 162 [23] is a test method for evaluating surface flammability (see Figure 2). A flame is placed at the top of the inclined test specimen while the specimen is exposed to a radiant heat source. A flame spread index, I_S , is then calculated from the rate of heat liberation and the rate of downward progression of the flame front. Both the FRA and the NFPA require that this factor not exceed 35; in addition, materials cannot exhibit any flaming running or flaming dripping [21,22].

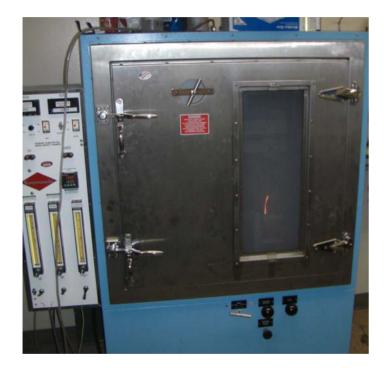
Overview of apparatus

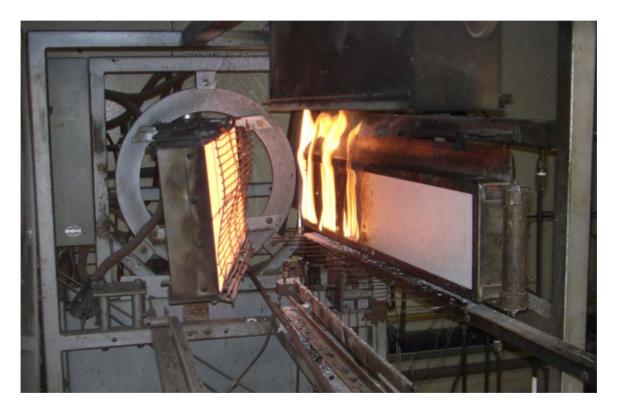
ISO 5658-2

Experimental arrangement for ISO 5658-2, lateral flame spread along surface of vertically orientated sample

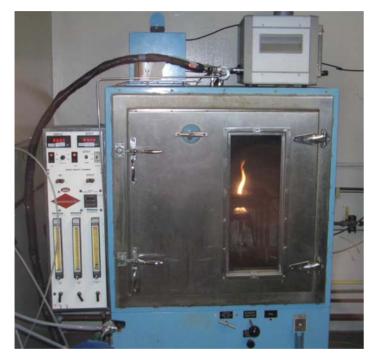
ISO 5659-2

Overview of apparatus

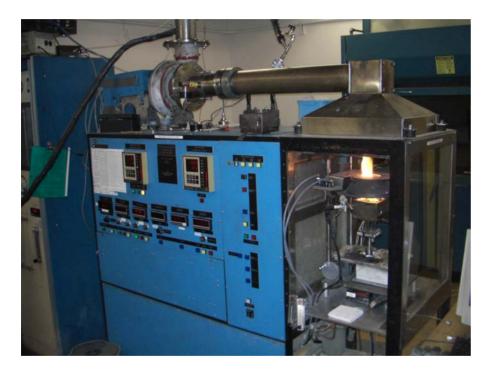
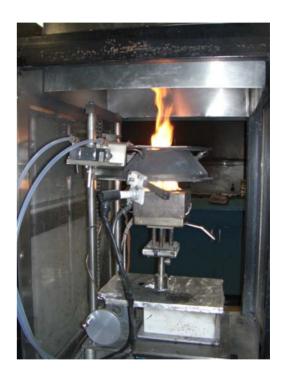
ISO 5660-1

Overview of apparatus

Detail of apparatus

Experimental arrangement for ISO 5660-1, combustibility for horizontally oriented sample (50 kW/m²)

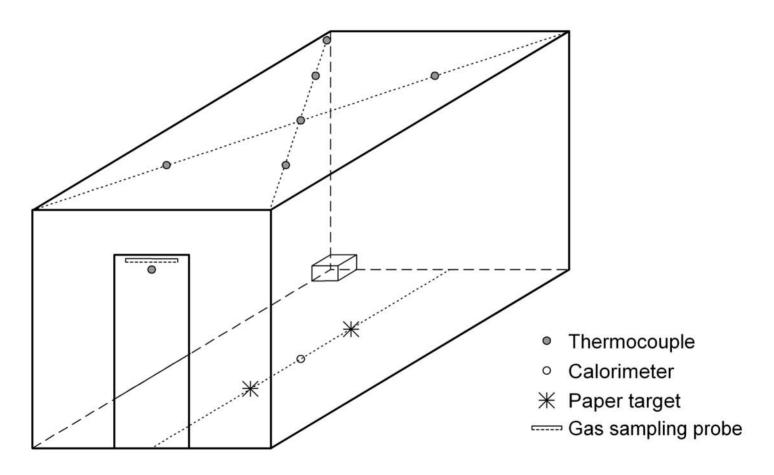
NFPA 286 (reference model)

Experimental arrangement for NFPA 286 room corner test (reference model)

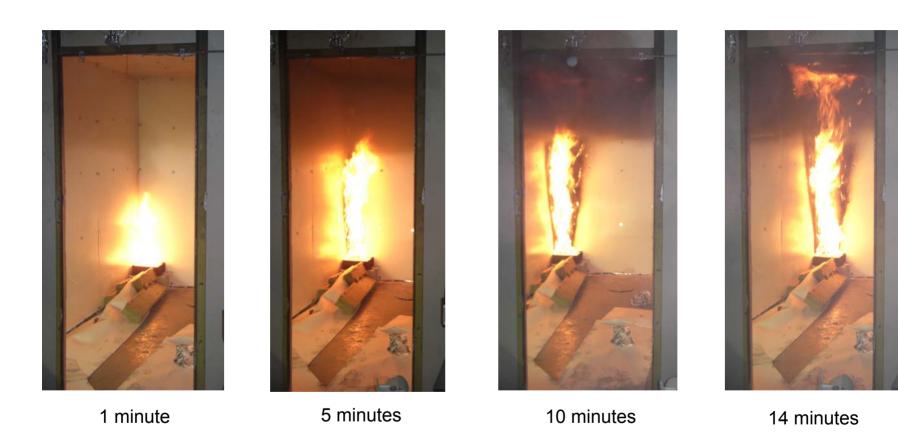
Room corner test according to NFPA 286 for FRP

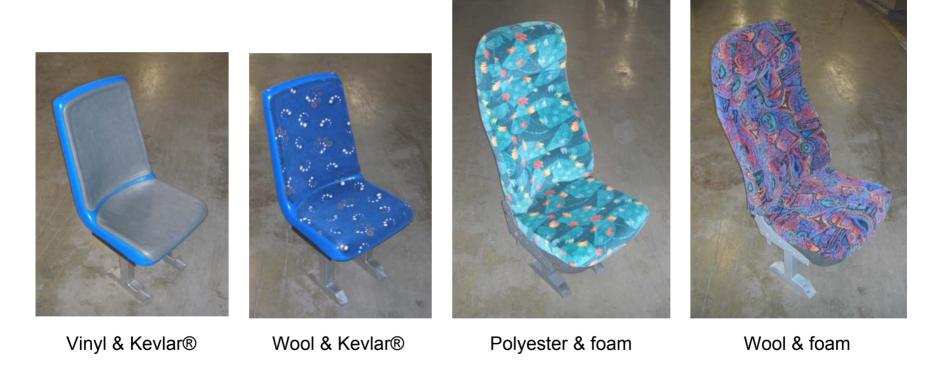
Bus seat assemblies used for bus investigation

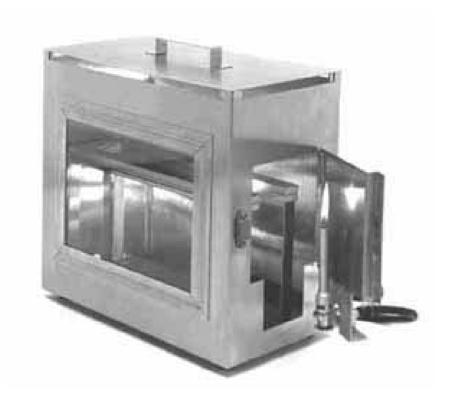
FMVSS 302

Experimental arrangement for FMVSS 302, flammability of a horizontally oriented sample

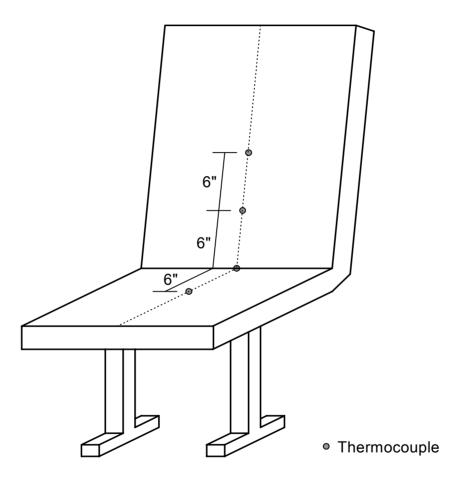
ASTM E 1537 (reference model)

Thermocouple placement on bus seat for ASTM E 1537

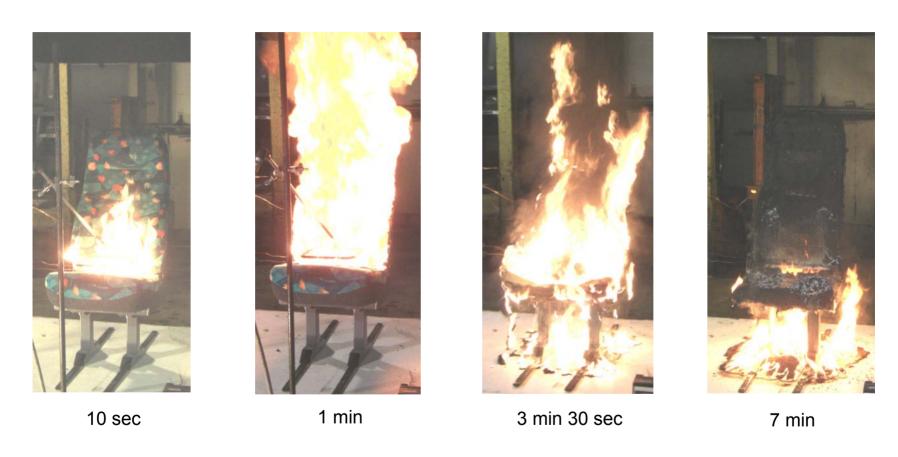
Polyester & foam

Bus seat test according to ASTM E 1537 for polyester & foam

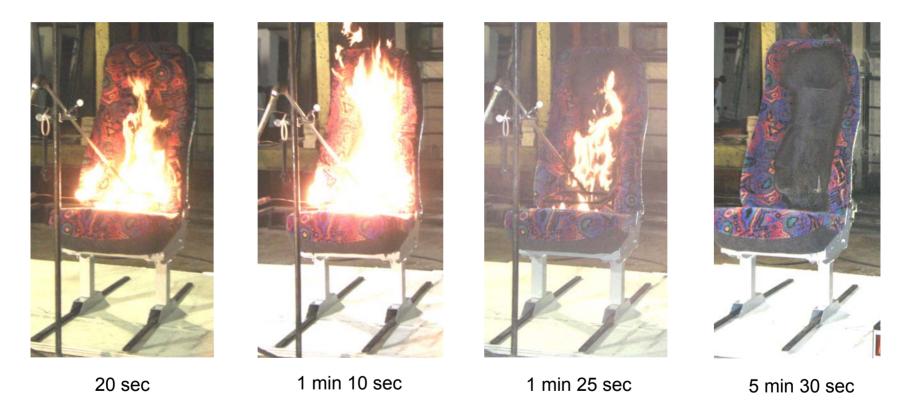
Wool & foam

Bus seat test according to ASTM E 1537 for wool & foam

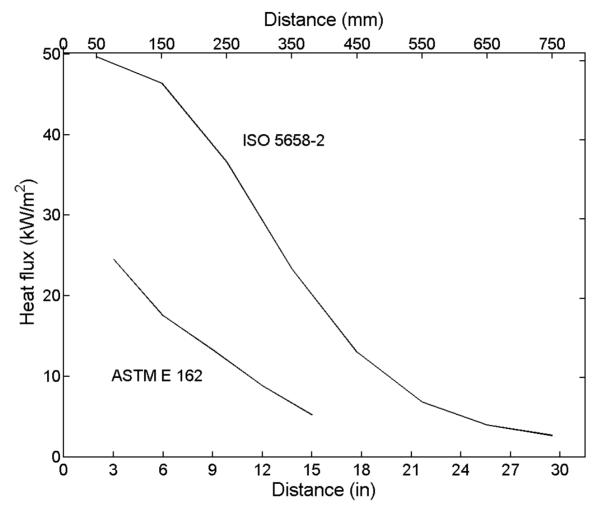
ASTM E 162 versus ISO 5658-2

Comparison of heat flux distributions for ASTM E 162 and ISO 5658-2

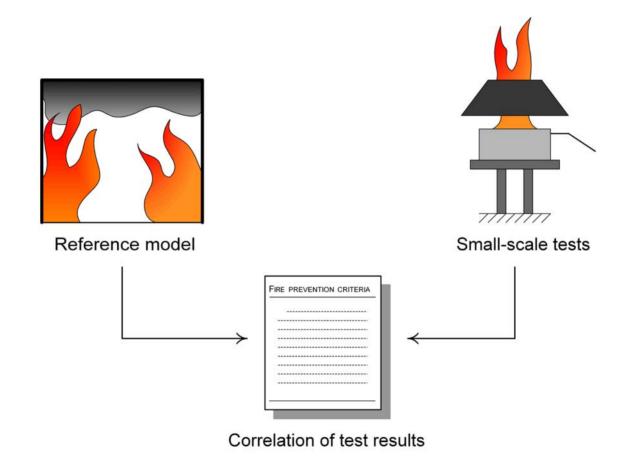
Scaling test results from small- to large-scale

Hazard-based regulations through the scaling of small-scale test metrics to large-scale hazard parameters

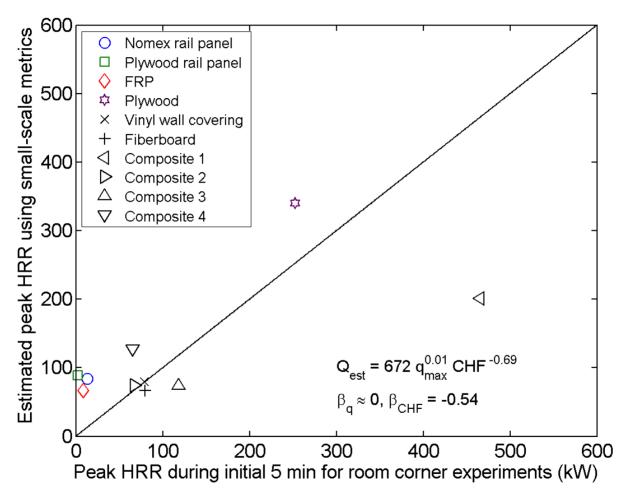
Scaling performance: peak HRR at 5 min

Comparison of estimated and experimental peak HRR at 5 minutes

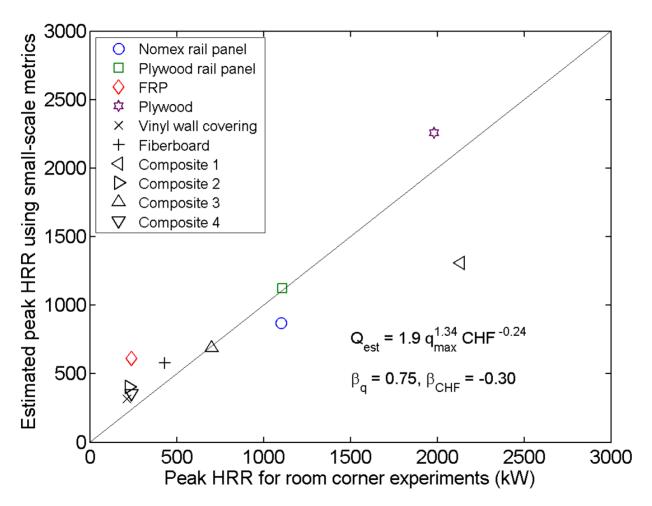
Scaling performance: peak HRR

Comparison of estimated and experimental peak HRR up to point of flashover

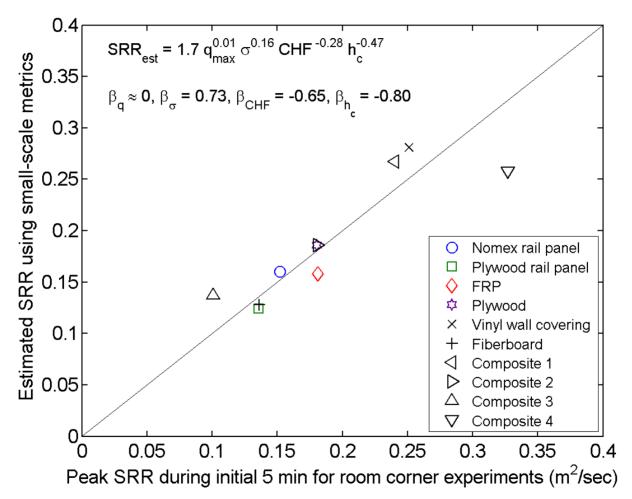
Scaling performance: peak SRR at 5 min

Comparison of estimated and experimental peak SRR at 5 minutes

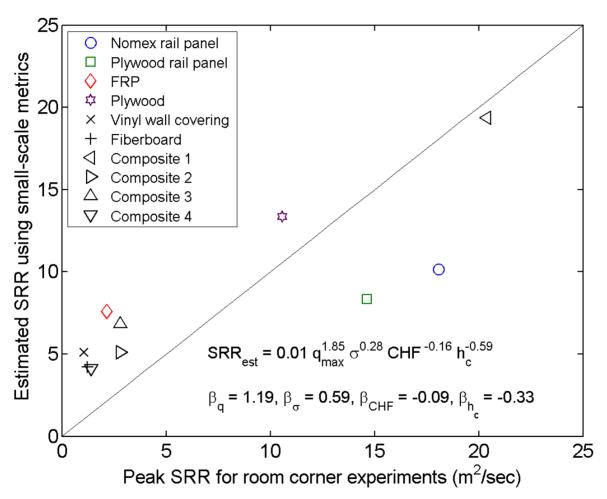
Scaling performance: peak SRR

Comparison of estimated and experimental peak SRR up to point of flashover

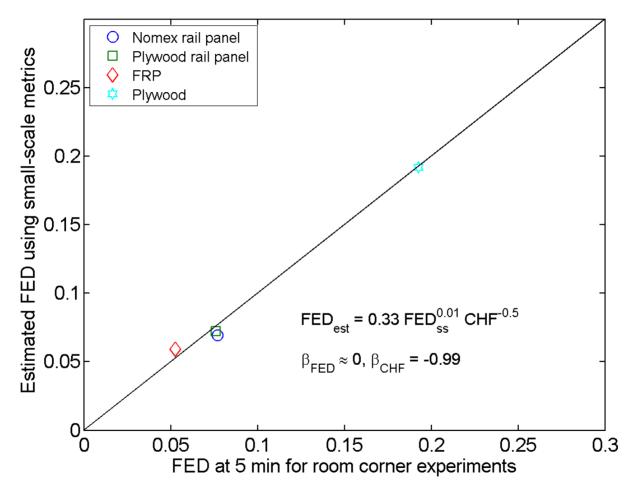
Scaling performance: FED at 5 min

Comparison of estimated and experimental peak fractional effective concentration (FED)

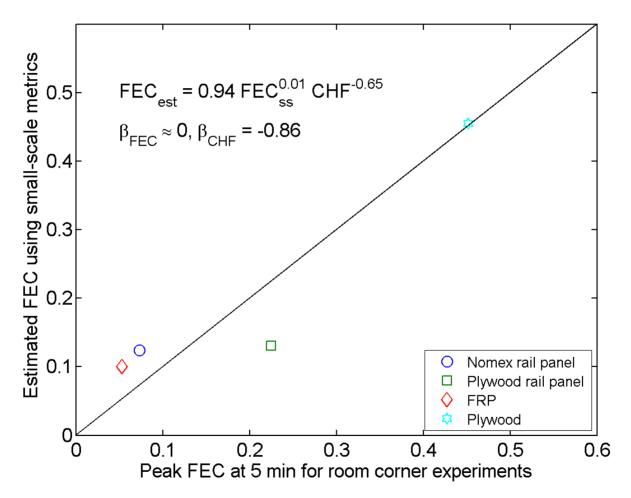
Scaling performance: peak FEC at 5 min

Comparison of estimated and experimental peak fractional effective concentration (FEC)

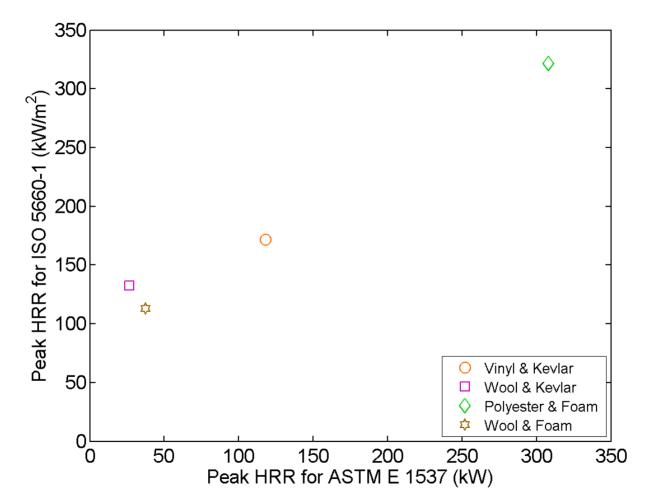
Scaling performance: peak HRR

Comparison of ISO 5660-1 and ASTM E 1537 peak HRR

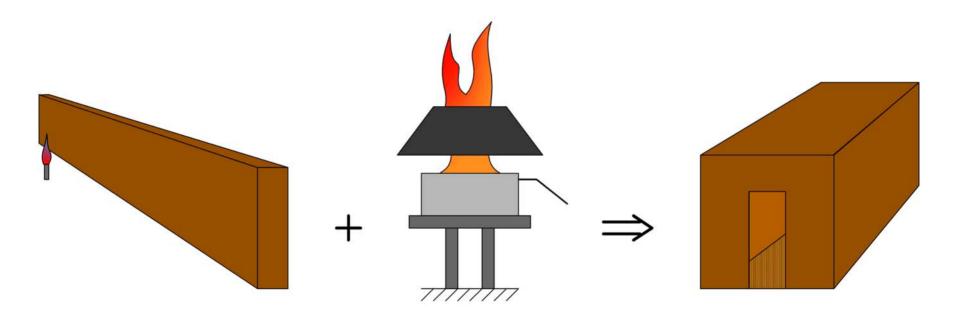
Task 4: Identify fire performance metrics

Use of small-scale fire performance metrics to to assess fire growth in reference model

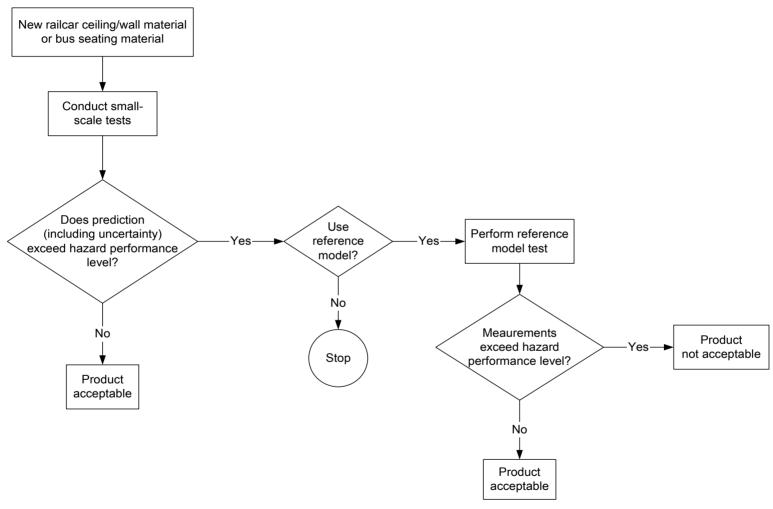
Assessment of materials

Flowchart illustrating the assessment of materials using fire performance metrics

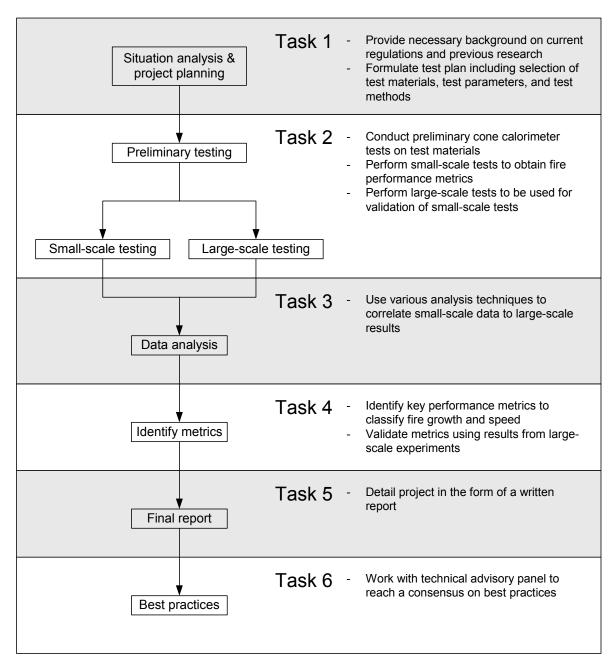
Figure 1: Schematic flow chart giving an overview of the tasks for the research investigation

A schematic flow chart giving an overview of the tasks for this research investigation is depicted in Figure 1; specific deliverables for each task are also provided.

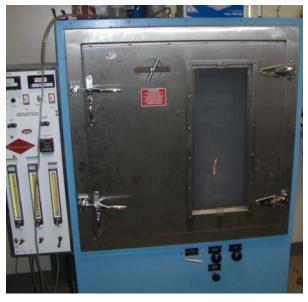
(a) Overview of apparatus

ASTM E 662 [24] assesses the density of smoke. The method measures the attenuation of a light beam due to the smoke generated when a specimen is exposed to a flux level of 25 kW/m². The FRA and NFPA require the application of ASTM E 662 [24], testing both flaming and nonflaming exposure at a heat flux of 25 kW/m². Both organizations specify that the specific optical density, D_S , should not exceed 100 and 200 at 1.5 and 4.0 minutes, respectively [20-22]. Figure 3 shows a typical test in progress for ASTM E 662 [24].

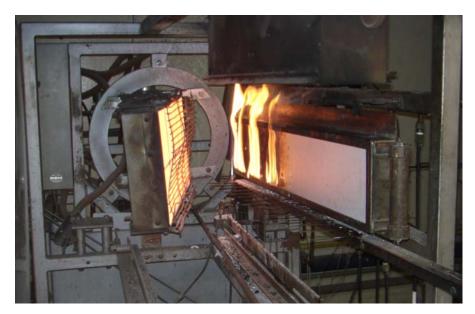
Figure 4: Experimental set-up for ISO 5658-2 [28]

ISO 5658-2 [28] measures the lateral flame spread along the surface of a vertically orientated sample. This method, similar to ASTM E 162 [23], measures the flame propagation and heat development in a sample when subjected to an ignition source. EN regulations [26,27] specify minimum values for the critical heat flux at extinguishment depending upon the design and environment of the railcar, as shown in Table 4. For example, a railcar with a hazard level of 3 (i.e. HL3 being the worst case scenario) would require $CFE \ge 20$. Figure 4 shows the experimental arrangement for ISO 5658-2 [28].

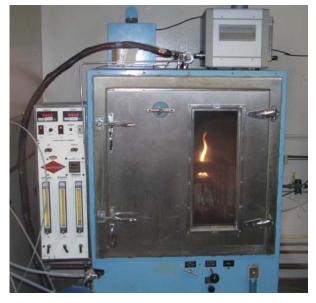
(a) Overview of apparatus

ISO 5659-2 [29] is similar to ASTM E 662 [24]; it measures the smoke density. The primary differences between the two approaches are the radiant heater used to heat the sample and the sample orientation. Contrary to U.S. regulations, European regulations require a heat flux of 50 kW/m² without a pilot flame for smoke measurements [27]. Figure 5 shows the experimental arrangement for 5659-2 [29].

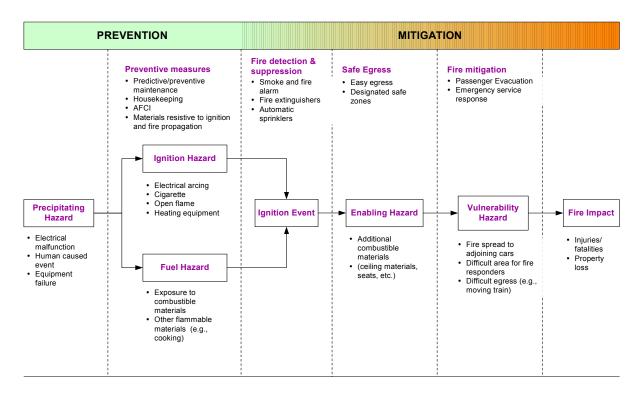
Figure 7: Schematic diagram showing stages of fire development within fire prevention and mitigation

There are several stages of fire development, starting with a precipitating fire event (e.g. electrical malfunction, overheating, discarded cigarette), causing ignition of combustible item(s) in the proximity, and then leading to fire growth. At each stage of fire growth, specific strategies may be identified, such as: preventive measures, fire growth control, egress, and fire mitigation. Figure 7 shows these stages of fire development within fire prevention and mitigation.

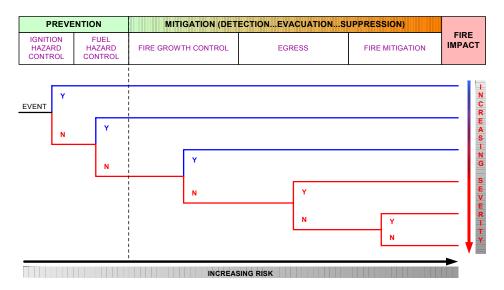
Figure 8: Event tree showing that as the fire continues to develop, the overall risk and severity of the fire impact will increase

An alternative view of the fire prevention approach is to examine an event tree, as shown in Figure 8. The specific fire protection strategies are provided along the top-level bar and the outcome of the strategy (i.e. Y for success and N for failure) is provided at each element of the event tree. Thus, successive failures of the strategies would lead to an increased severity of the consequences.

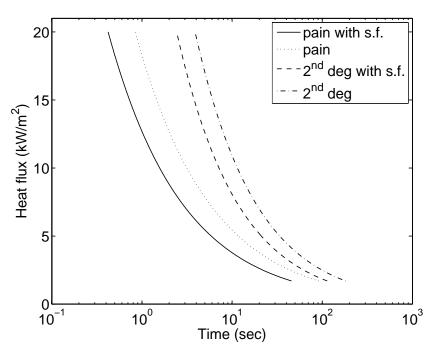
Figure 9: Incident heat flux as a function of exposure time for limits on pain and second degree burns, with and without safety factors (s.f.) applied [42]

The importance of prevention and limiting fire growth may be illustrated by Wieczorek and Dembsey's investigation [42]. In this study, two simplified models were provided for determining the time to achieve pain and second-degree burns, based on the incident radiant heat flux (see Figure 9). Figure 9 (adapted from Wieczorek and Dembsey's paper) shows incident heat flux as a function of exposure time for limits on pain and second degree burns. As one might expect, as the incident heat flux increases, the time required to attain pain/burns decreases rapidly. For ease of comparison, Table 6 provides exposure times for pain and second degree burns to the skin for four different incident heat fluxes. Figure 9 and Table 6 show that for relatively low amounts of heat, only a short exposure time is needed for an individual to sustain injuries.

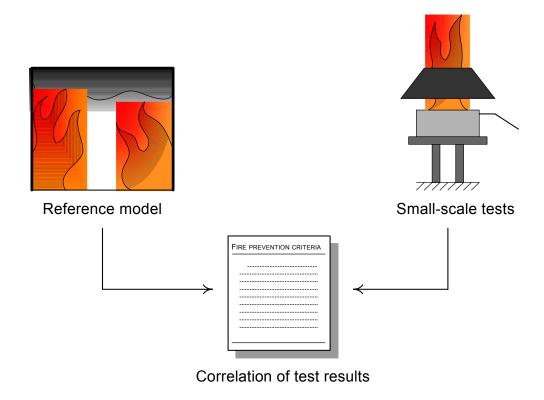
Figure 10: Schematic diagram showing hazard-based regulations through the scaling of small-scale test metrics to large-scale hazard parameters

The fire prevention approach that is implemented in this study, first evaluates the interior materials of railcars and buses by measuring several different fire hazard metrics using small-scale tests. These hazard metrics obtained from small-scale tests will then be used to describe fire growth in a larger-scale environment. Large-scale tests are used as reference models to provide a context to interpret the results of the small-scale tests. In addition, the reference models provide an alternative method to evaluate fire performance of materials. This concept of developing hazard-based criteria through the use of small- and large-scale testing (reference model) is illustrated in Figure 10.

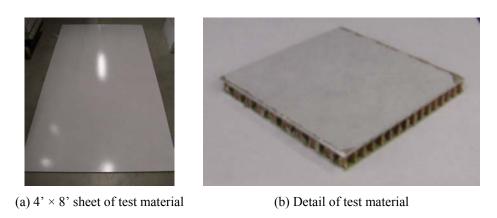
Figure 11: Melaminium (melamine and aluminum) face, Nomex® honeycomb core, aluminum backer

Table 7 lists the materials that have been chosen for the railcar portion of the investigation; these materials represent different interior applications, in addition to varying fire performances. A detailed physical description of the materials can be observed in Figure 11 through Figure 14.

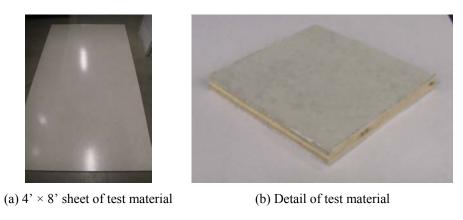
Figure 12: Melaminium (melamine and aluminum) face, plywood core, aluminum backer

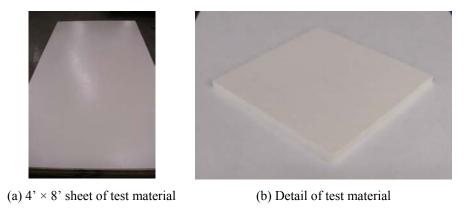
Figure 13: Fiberglass-reinforced plastic

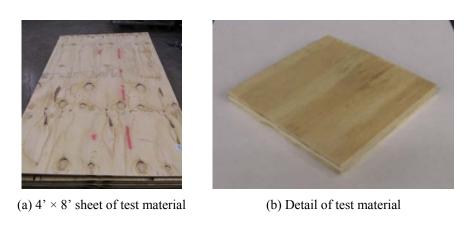
Figure 14: Plywood, C-D Exposure 1 (CDX)

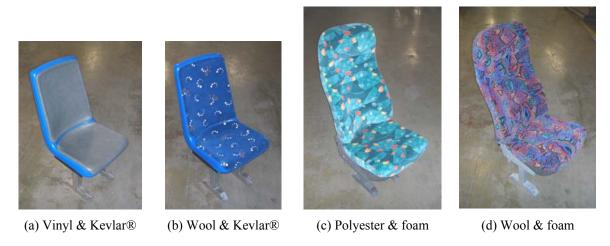
Figure 15: Bus seat assemblies used for bus investigation

City buses are typically upholstered in vinyl or fabric with or without a Kevlar® backing layer². Conversely, coach buses will tend to possess seats upholstered in fabric with a core of polyurethane foam. Table 8 shows the test materials selected for the bus investigation. These materials are typical for city and intercity (i.e. coach) buses, in addition to exhibiting diverse reactions to fire. Figure 15 show the four different bus seat constructions that were examined in this study.

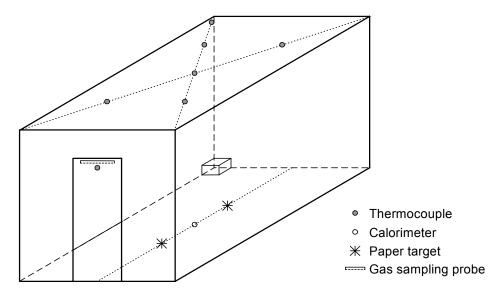
Figure 16: Experimental set-up for NFPA 286 [43]

The room corner tests were conducted in accordance with NFPA 286 [43]. Figure 16 gives a schematic diagram of the room that was used in the experiments. The three walls nearest to the burner and the ceiling were lined with the respective material (the wall with the door was not lined).

In addition to the typical experimental arrangement, an FTIR probe was placed approximately 50 mm below the top of the doorway, parallel with the ground. The sampling probe was approximately 800 mm in length with a 3.5 mm inside diameter and consisted of 5 sampling ports. The parameters for data collection were the same as previously described in Section 5.1.4.

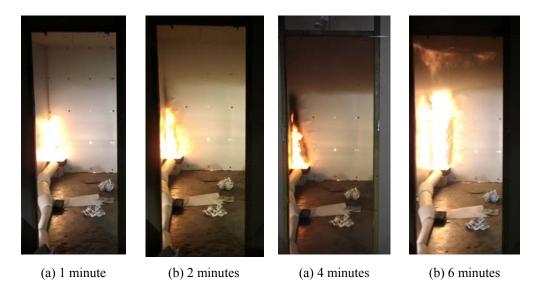
Figure 17: Representative room corner test according to NFPA 286 [43] for Nomex® rail panel

The purpose of the room corner fire tests was to provide fire performance data for materials in an environment similar to the interior of a railcar. These tests were then used to help validate the results from the small-scale tests. Table 16 and Table 17 provide summaries of the room corner test results. Figure 17 through Figure 20 shows representative room corner tests at specific increments in time.

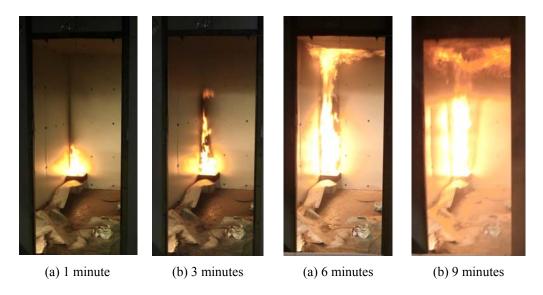
Figure 18: Representative room corner test according to NFPA 286 [43] for plywood rail panel

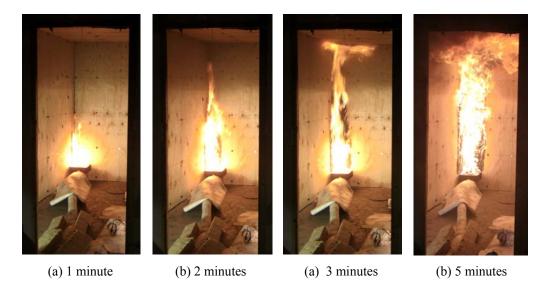
Figure 19: Representative room corner test according to NFPA 286 [43] for plywood

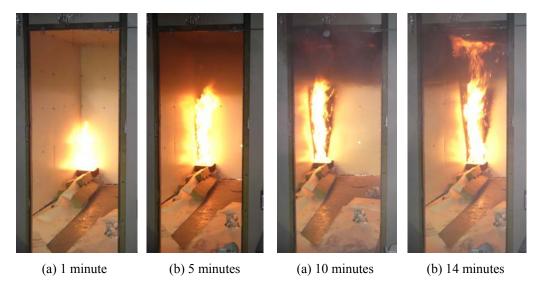
Figure 20: Representative room corner test according to NFPA 286 [43] for FRP

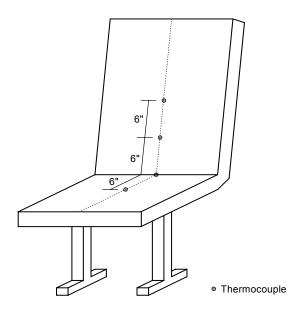
Figure 21: Thermocouple placement on bus seat for ASTM E 1537 [44]

Bus seats were tested in accordance with ASTM E 1537 [44]; tests were performed in an open calorimeter (i.e. furniture calorimeter). Figure 21 shows the placement of the thermocouples on the seat. This test provided fire performance data for bus seating material when applied to an actual seat assembly.

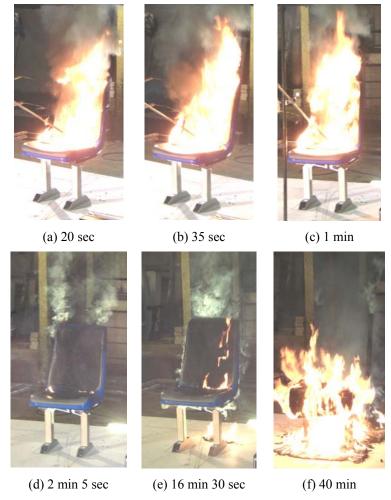
Figure 22: Representative bus seat test according to ASTM E 1537 [44] for vinyl & Kevlar® with severe damage

Table 23 provides a summary of bus seat test results. It should be noted that the second experiment conducted on the vinyl-Kevlar® seat did not yield similar results to the first experiment. As a result, a third experiment was conducted. Figure 22 through Figure 26 shows representative bus seat tests at specific increments in time. Figure 22 shows images representing the first experiment conducted on the vinyl-Kevlar® seat, while Figure 23 shows images representing the second and third experiments. Based on observations made during the three tests, the difference in the experimental results for the vinyl-Kevlar® seat appears to be the consequence of a manufacturing flaw/defect in the stitching of the vinyl on the seat back. Experiments conducted on the other seating combinations gave relatively consistent results. For comparative purposes, recall that the TB 133 requirements [45] specify that the maximum heat release rate must be less than 80 kW and the total heat released in the first 10 minutes must be less than 25 MJ.

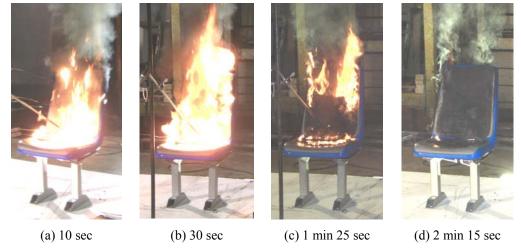
Figure 23: Representative bus seat test according to ASTM E 1537 [44] for vinyl & Kevlar® showing mild damage

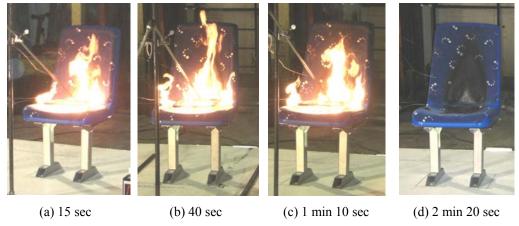
Figure 24: Representative bus seat test according to ASTM E 1537 [44] for wool and Kevlar®

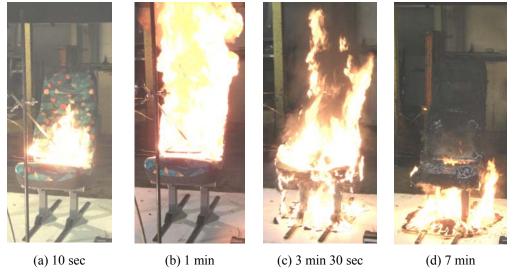
Figure 25: Representative bus seat test according to ASTM E 1537 [44] for polyester and foam

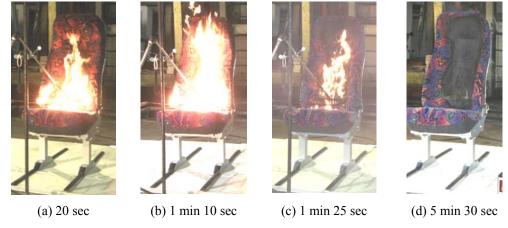
Figure 26: Representative bus seat test according to ASTM E 1537 [44] for wool and foam

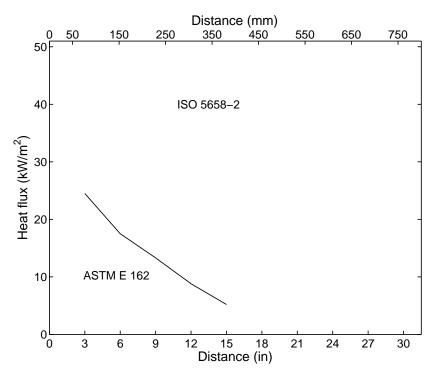
Figure 27: Comparison of heat flux distributions for ASTM E 162 [23] and ISO 5658-2 [28]

In an attempt to better understand the differences between the radiant panels for ASTM E 162 and ISO 5658-2, the heat flux distribution was determined along the length of the 18-inch sample at prescribed increments (i.e. 3, 6, 9, 12, 15 inches) and was compared to that of LIFT apparatus. Figure 27 shows the experimentally determined distributions. Here, it can be seen that a sample tested in accordance with ASTM E 162 [23] is subjected to a lower heat flux, when compared to ISO 5658-2 [28].

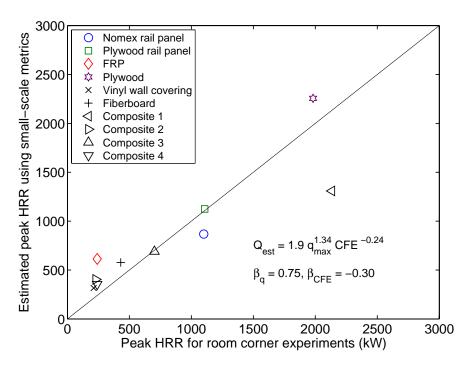
Figure 28: Comparison of estimated and experimental peak HRR up to point of flashover

Figure 28 shows the correlation between the estimated and experimental peak HRR for the reference model (NFPA 286) up to the point of flashover. A correlation line (at a 45 degree angle) is shown in Figure 28, which illustrates the perfect correlation; data points below the line underestimate the large-scale test results, while points above the line overestimate the large-scale results. Note that the correlation line should not be confused with a best-fit line. Figure 28 contains data from the current study and data from a previous project [51] conducted by UL for GE Advanced Materials Research (Composite 1, 2, 3, and 4), in addition to data obtained from an internal UL study. This additional set of six materials was used to strengthen the correlation. The beta coefficients (i.e. beta weights) were then calculated to evaluate the relative importance of the different metrics. Here, it was found that the peak heat release rate from the cone calorimeter was more significant than the critical heat flux at extinguishment. The correlation in Figure 28 appears to be relatively strong, given a wide range of materials with varying fire performances.

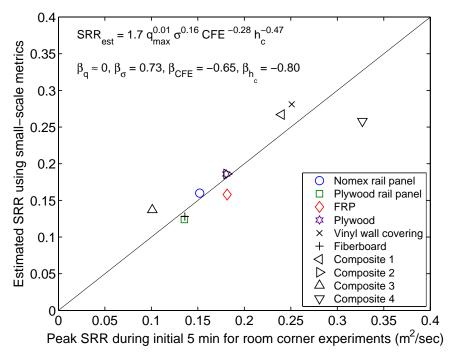
Figure 29: Comparison of estimated and experimental peak SRR at 5 minutes

Figure 29 shows a comparison of estimated and experimental peak SRR at 5 minutes. The extinction cross-sectional area, heat of combustion, critical heat flux at extinguishment all have approximately the same impact ($\beta_{\sigma} = 0.73$, $\beta_{CFE} = -0.65$, $\beta_{hc} = -0.80$), with the heat of combustion and extinction cross-sectional area being the most significant. Based on the data presented, there appears to be a correlation between the small-scale metrics and the large-scale SRR measurement at early phases in the fire.

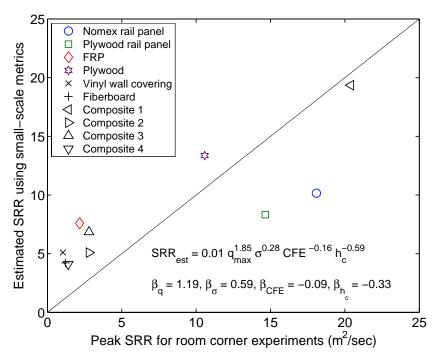
Figure 30: Comparison of estimated and experimental peak SRR up to point of flashover

Figure 30 gives a comparison of the estimated and experimental peak SRR up to point of flashover. Comparing Figure 29 and Figure 30, it can be observed that the relative impact of the flame spread parameter is less during the late phase of the fire, while the heat release rate is more critical during the late phase.

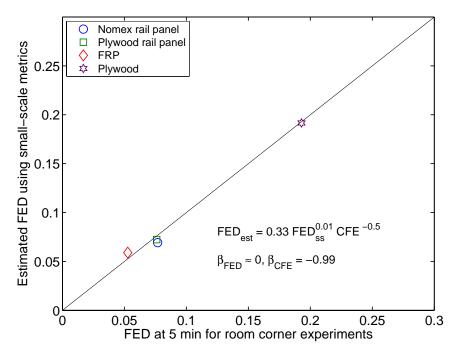
Figure 31: Comparison of estimated and experimental peak fractional effective dose (FED) at 5 minutes

Figure 31 and Figure 32 show the relationship between the small-scale parameters and the reference model (i.e. the room corner test). The FED calculated from the cone calorimeter was done over the duration of the whole experiment, 33 minutes; for the room corner tests the FED was calculated up to 5 minutes. Figure 32 uses the peak FEC for the duration of the whole cone calorimeter test and the peak FEC for the first 5 minutes of the room corner test. Interestingly the toxicity metrics (i.e. FED and FEC) have little impact on the relationship; both correlations are dominated by the CFE. The calculation of the beta coefficients shows how dominate the CFE metric is in the relationship. While there are only four data points, Figure 31 and Figure 32 indicate that there may be a relationship between the small-scale metrics and the toxic components in the large-scale test.

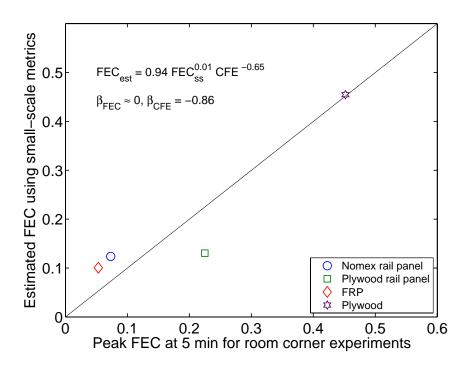
Figure 32: Comparison of estimated and experimental peak fractional effective concentration (FEC) at 5 minutes

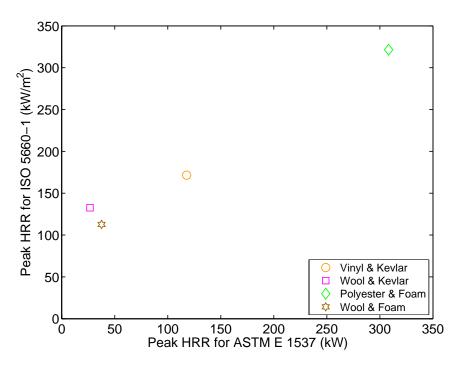
Figure 33: Comparison of peak heat release rate per unit area from ISO 5660-1 [3] and peak heat release rate from ASTM E 1537 [44]

Figure 33 compares the peak heat release rate per unit area from ISO 5660-1 [3] and the peak heat release rate from ASTM E 1537 [44]. Because of the simplified relationship presented here, no empirical correlation was developed. While only four different types of chairs were tests, based on this limited set of data (see Figure 33), the peak heat release rate per unit area measured from the cone calorimeter gives an indication of the peak heat release rate for the full-size chair.

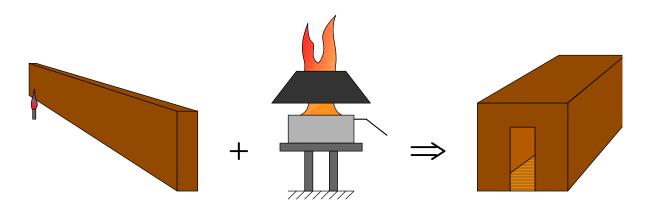
Figure 34: Schematic diagram showing the use of small-scale fire performance metrics to assess fire growth in reference test model

Based on the analysis in the preceding section, small-scale fire performance metrics that describe fire hazards in a real-scale environment were identified; this concept is illustrated in Figure 34.

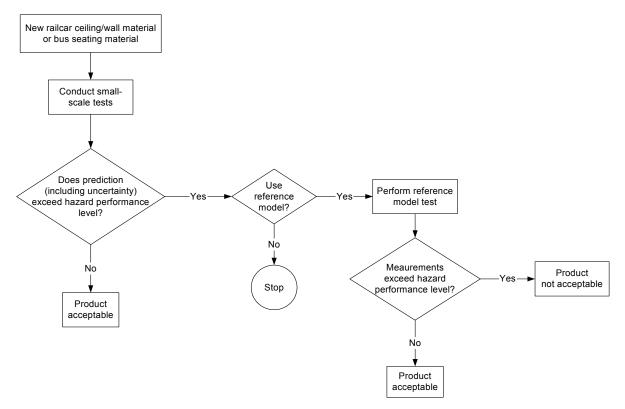
Figure 35: Schematic flowchart showing the assessment of materials using fire performance metrics

Once the hazard levels for the reference model are identified, the developed relationships (i.e. correlation results) may be used to estimate the large-scale fire performance of the materials, based on the small-scale tests. Due to the limited number of samples tested in this study, additional test data should be generated to provide a better statistical basis for the correlation and to develop ranges of uncertainty. An approach for assessing new materials using fire performance metrics is shown in Figure 35.

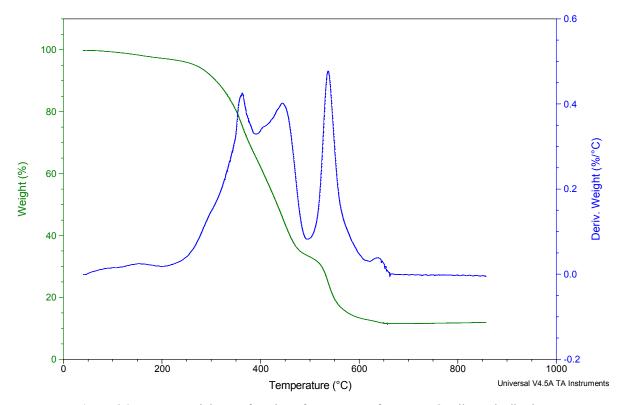
Figure 36: Percent weight as a function of temperature for Nomex® rail panel adhesive

Thermogravimetric analysis (TGA) is a testing procedure, in which the changes in weight of a specimen are recorded as the specimen is heated. In this test, a sample is lowered into a furnace and the temperature of the furnace is then increased to a maximum temperature of 850 °C at a rate of 10 °C/min. The change in sample weight is then monitored during the test.

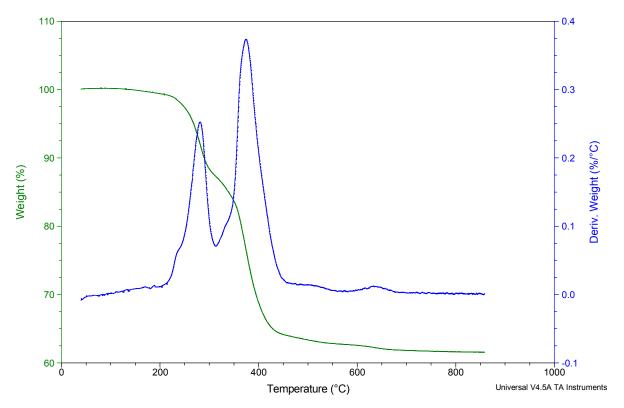
Figure 37: Percent weight as a function of temperature for FRP

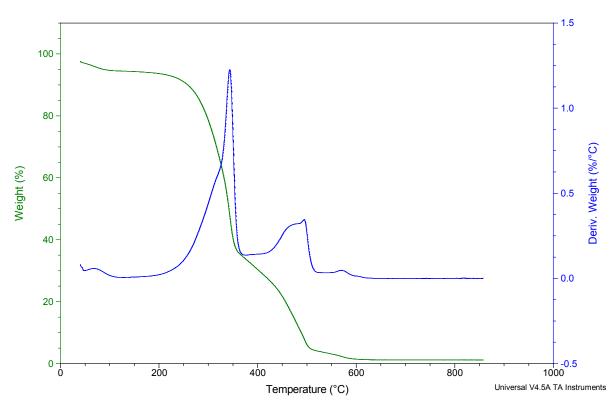
Figure 38: Percent weight as a function of temperature for plywood

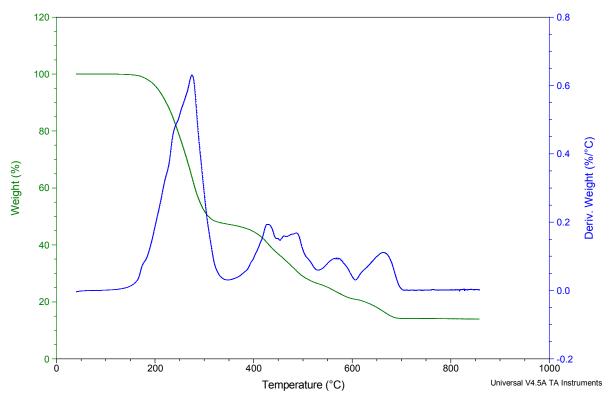
Figure 39: Percent weight as a function of temperature for vinyl

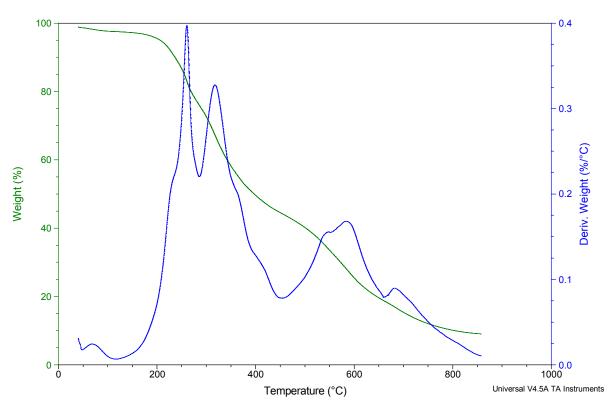
Figure 40: Percent weight as a function of temperature for wool

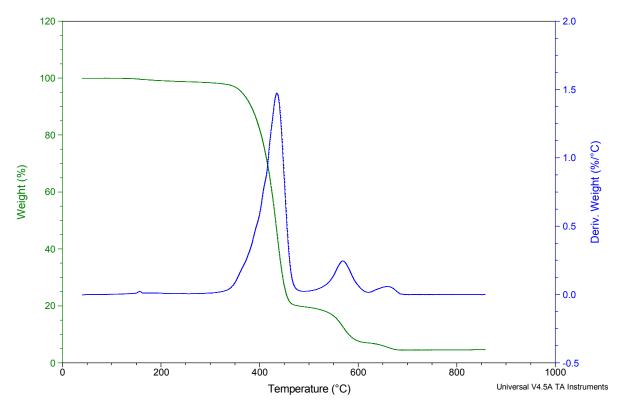
Figure 41: Percent weight as a function of temperature for polyester

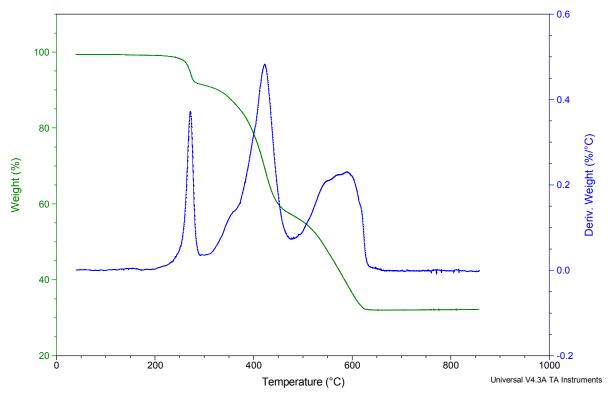
Figure 42: Percent weight as a function of temperature for Kevlar®

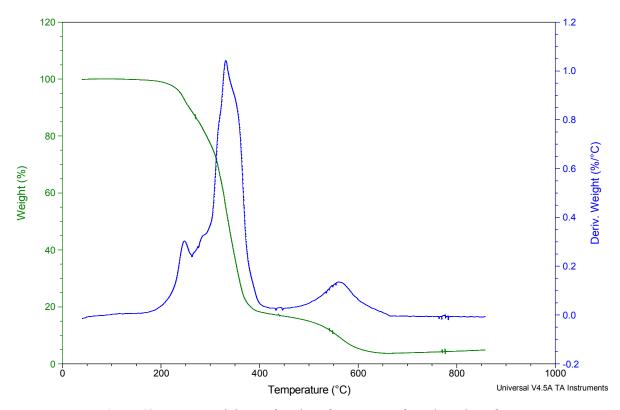
Figure 43: Percent weight as a function of temperature for polyurethane foam
