Evacuation and Rescue of Elderly and Disabled Passengers from Paratransit Vans and Buses

Ketron, Inc.
58 Charles St.
Cambridge, MA 02141

October 1984
Final Report

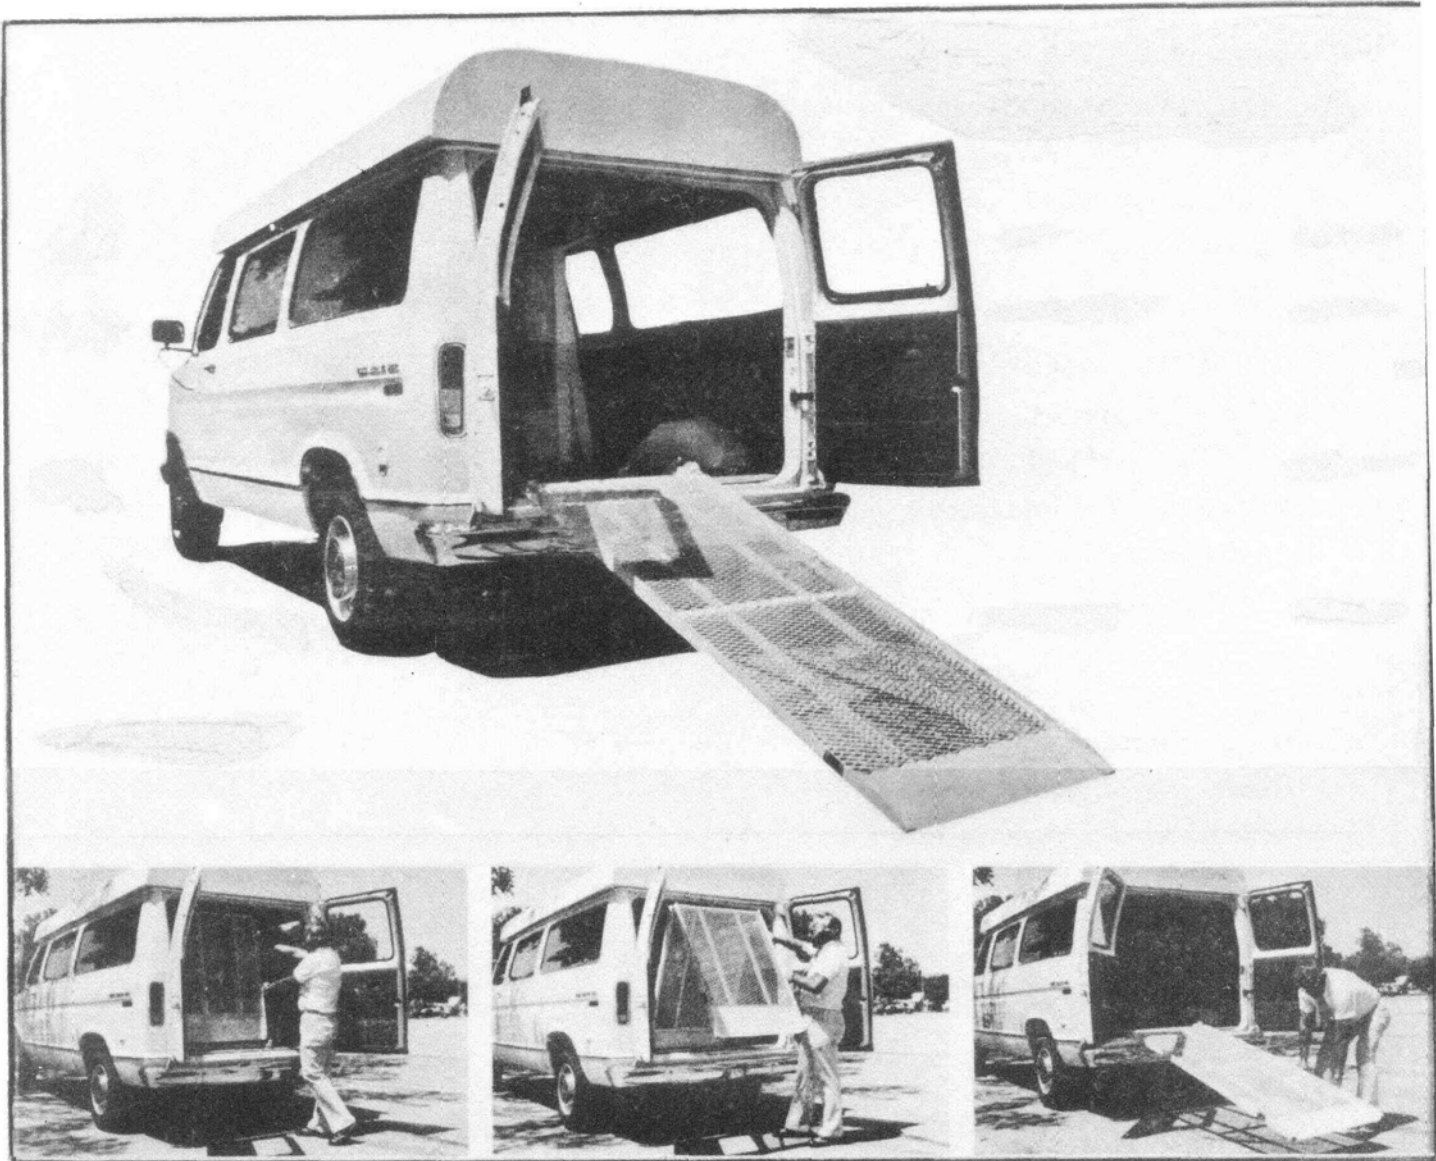
Lifts and Ramps. Lifts or ramps are often installed in paratransit vans as an aid to wheelchair users and others who have difficulty negotiating the step into the van. Figure 3-3 shows one

FIGURE 3-3. REAR MOUNTED WHEELCHAIR RAMP

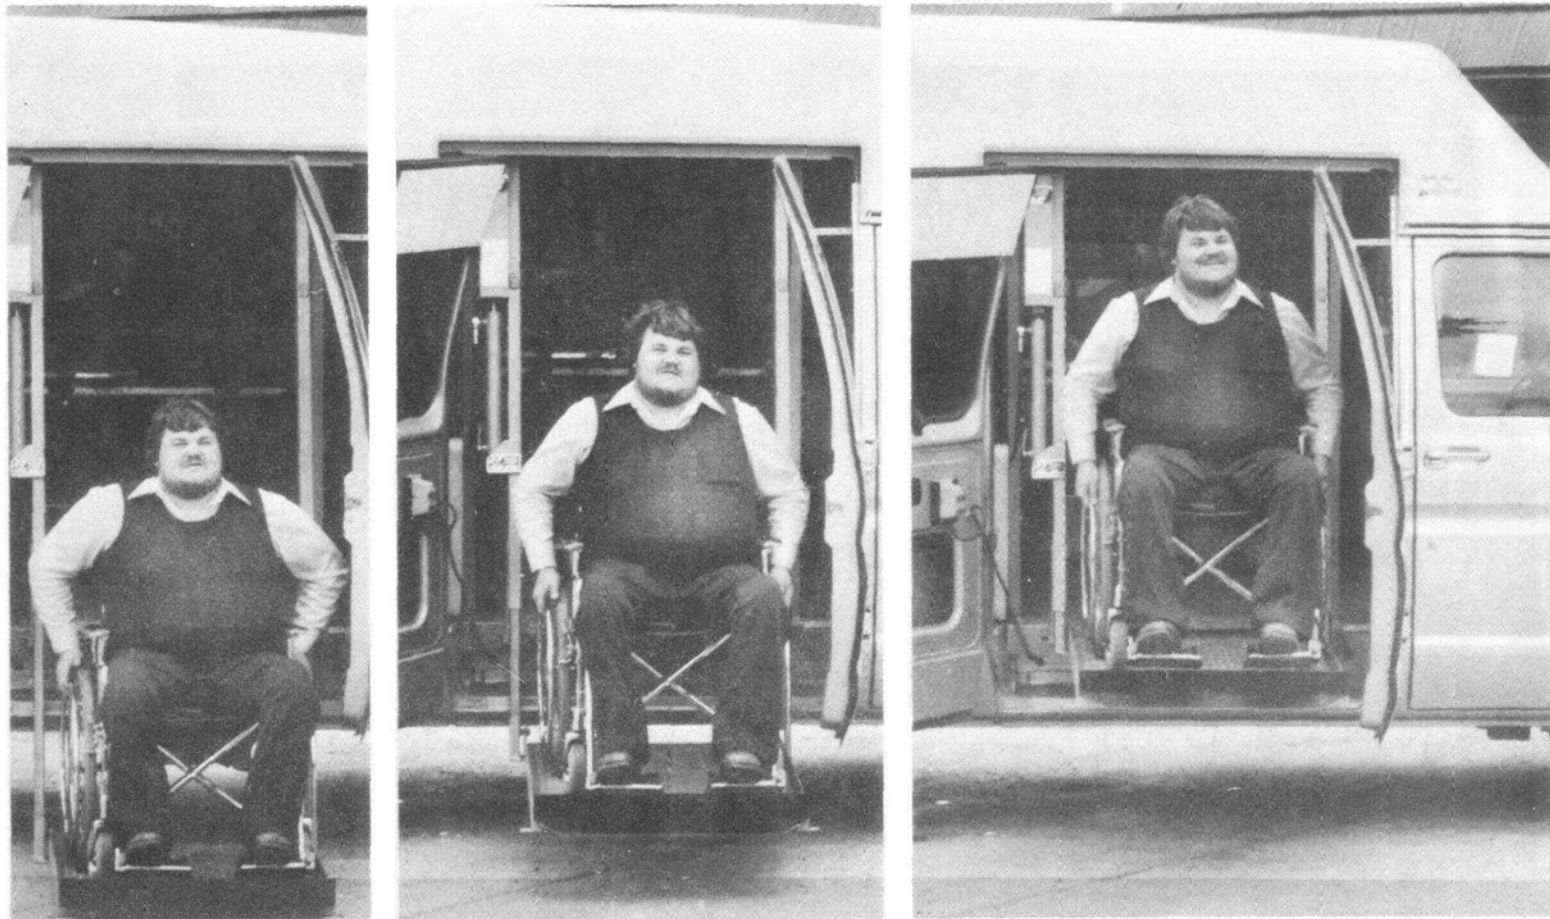
FIGURE 3-4. POWERED WHEELCHAIR LIFT INSTALLED IN MODIFIED VAN

Figure 3-4 shows a powered lift installed in a modified van and being operated by a wheelchair user. Figure 3-5 shows a lift in its stored position in a van. This typical lift fully blocks the side door while stored and may become inoperative in an accident. Rescue personnel would have to use the rear or cab doors or to cut through the side of the van to gain access. In contrast, another type of side-mounted lift (Figure 3-6) folds in half when stored, thus allowing some access by rescue personnel.

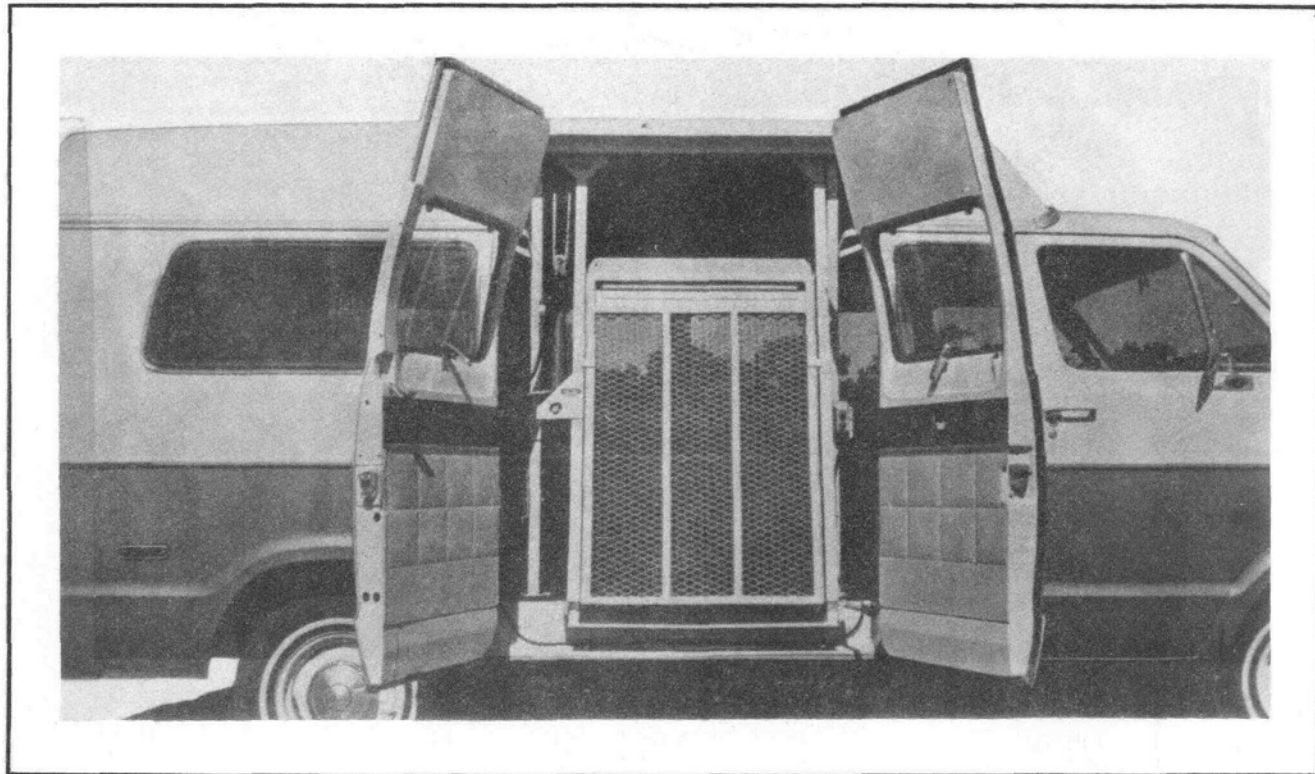
FIGURE 3-5. POWERED WHEELCHAIR LIFT IN ITS STORED POSITION ON A MODIFIED VAN

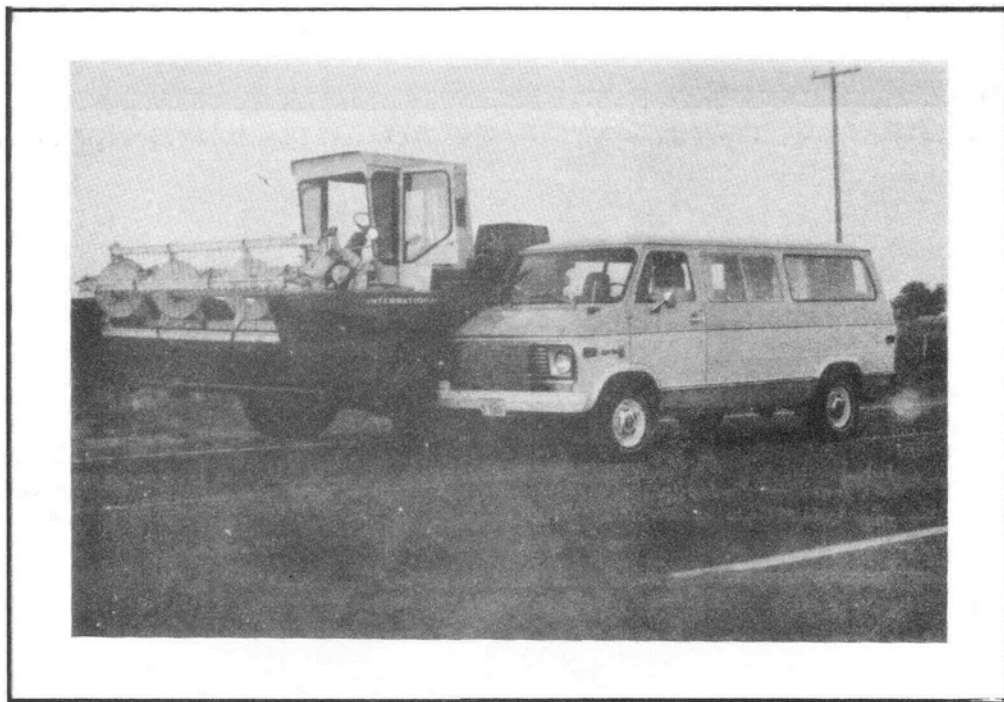
FIGURE 3-7. IMPACT SIMULATION OF DELTA, UTAH, ACCIDENT USING SIMILAR VEHICLES

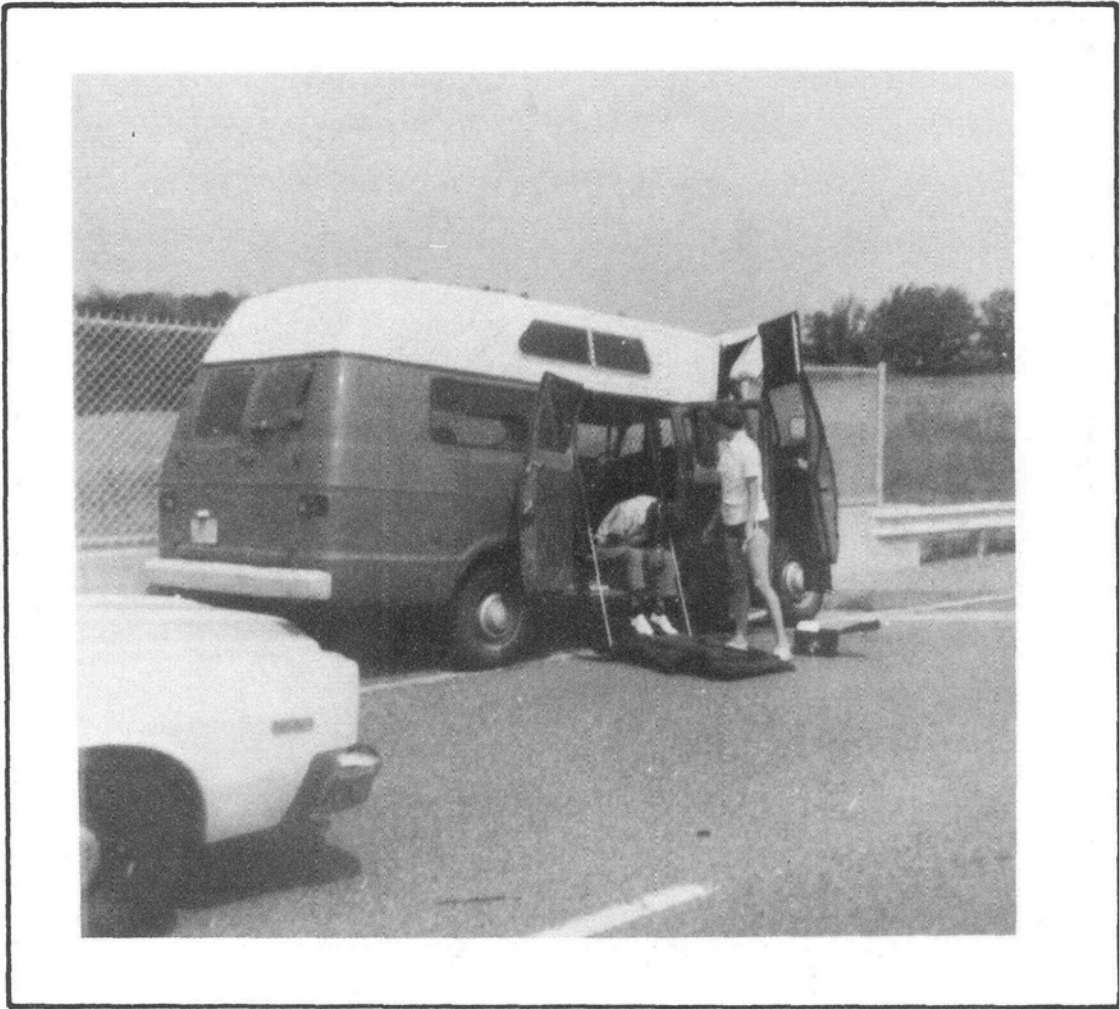
FIGURE 3-13. PARATRANSIT VAN AGAINST BRIDGE PARAPET; HOWARD COUNTY, MARYLAND

Despite the four collisions, the van remained nearly intact. Figure 3-12 shows the front of the van crushed considerably, but the raised roof stayed in position and the wheelchair lift at the side doors remained operable (Figure 3-13). Figure 4-14 shows emergency first aid being provided to one of the six persons (aged 68, 74, 80+, 84, and 89) on board. It appears from Figure 3-14 that one of the passenger bench seats partially failed as a result of the collisions. Evacuation of the passengers was facilitated by using the side doors and by lowering the wheelchair lift.

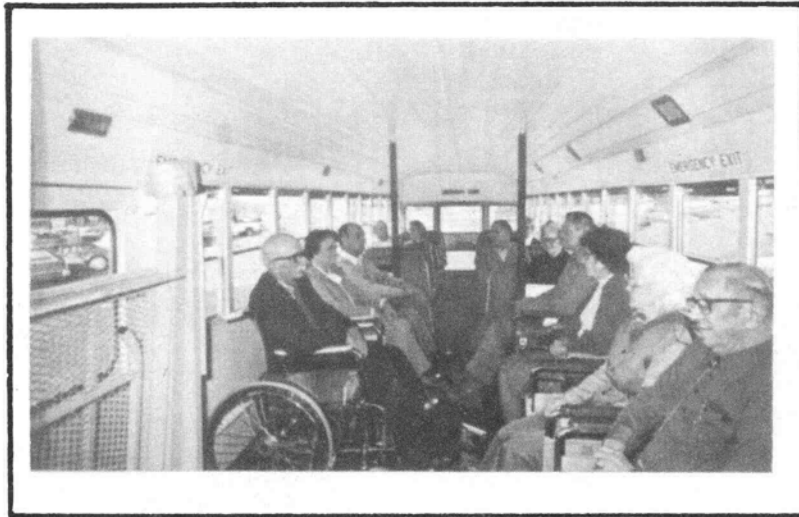
FIGURE 4-3. TYPICAL BLOCKAGE OF AN ENTRYWAY BY A LIFT
REQUIRES AN ADDITIONAL ENTRYWAY

Vehicle Manufacturers. The manufacturers of buses should supply instructions for passengers on how to get out of the bus and instructions for rescue forces on how to get in. For example, the notice on emergency exits shown in Figure 4-3 is clearly visible and is prominently and permanently displayed inside the vehicle. Each passenger should be able to leave by more than one exit. The information should include instructions on how to open the exit. Manufacturers should standardize the symbols they use and the places where they put this information.

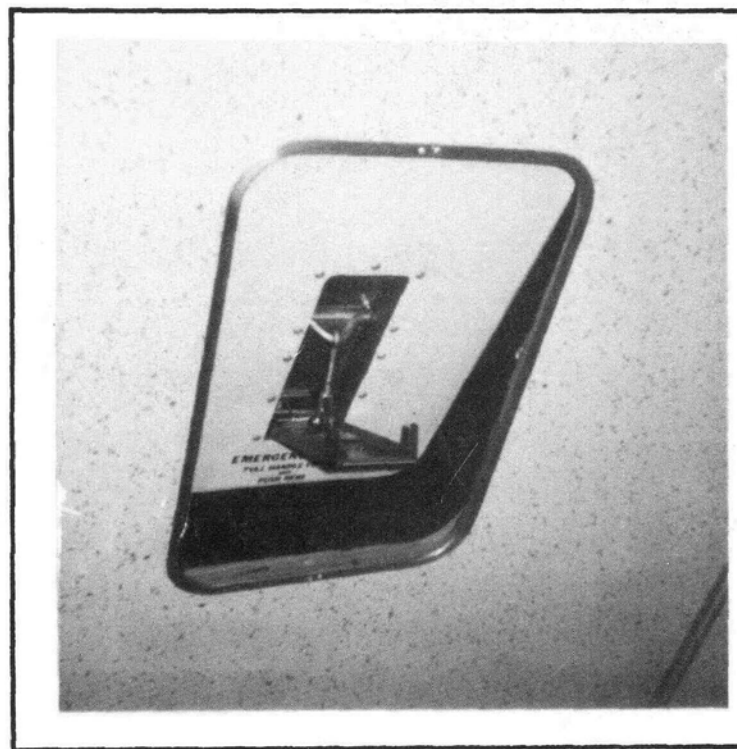
FIGURE 4-12. CLOSED AND OPEN EMERGENCY HATCHES IN ROOF OF MCI INTERCITY BUS

There are three escape routes from the vehicle in addition to the main door. They are: the side windows, each of which is hinged as shown in Figure 4-11; the windshields, which are removable when the rubber inserts are pulled out; and two emergency escape hatches in the roof. A closed hatch and a partially open one are shown in Figure 4-12. The hatches are actuated by a simple pull-push quick release mechanism and can easily accommodate someone standing 6 feet tall and weighing 240 pounds, as can be attested to by the author who easily negotiated one of these hatches.

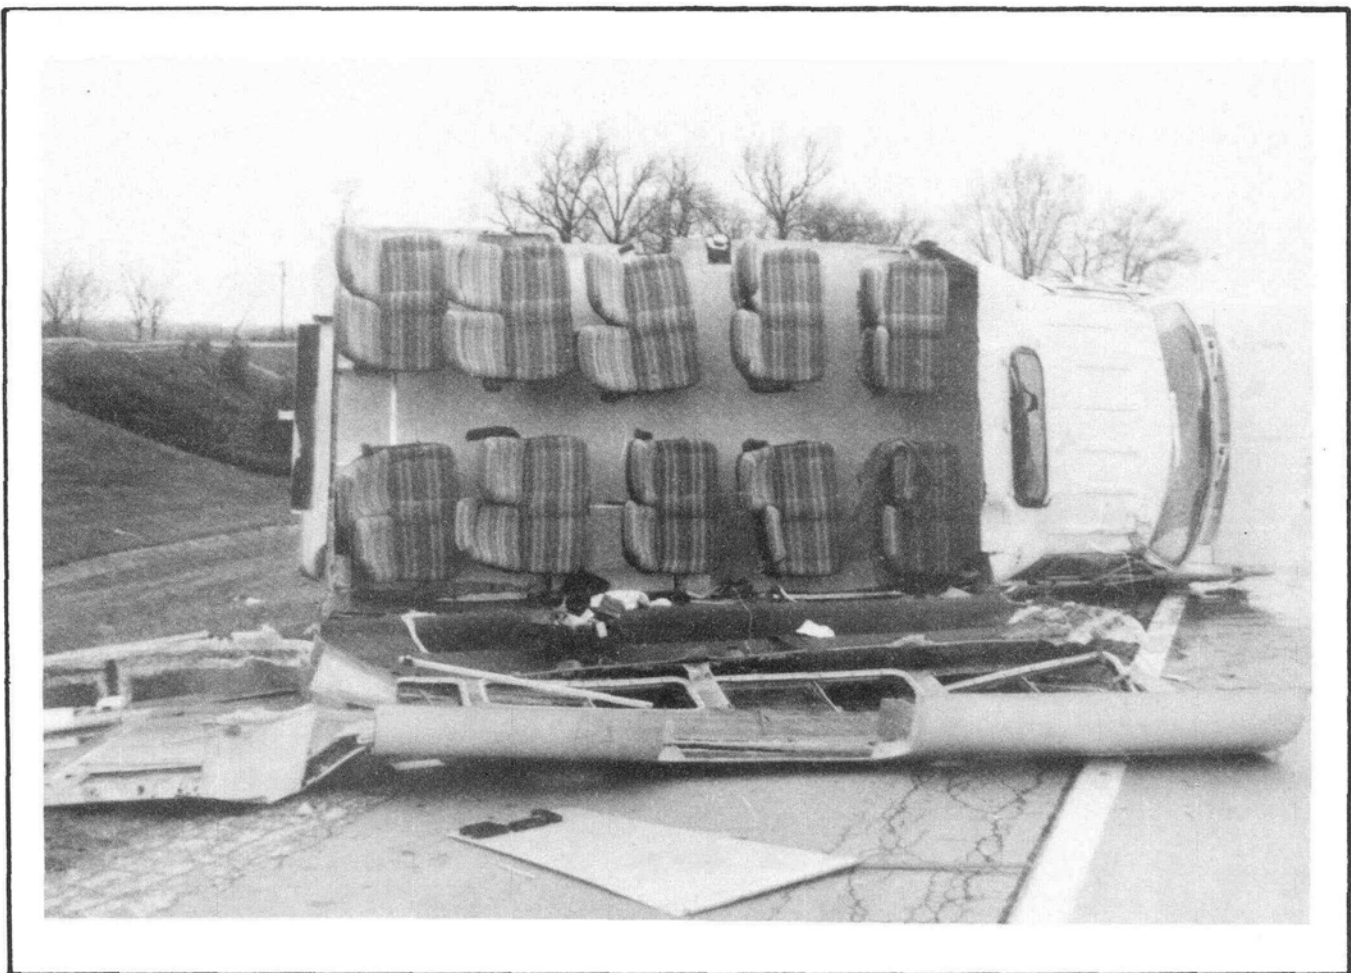
FIGURE 4-13. BODY-ON-CHASSIS SMALL BUS ACCIDENT: SCOTT COUNTY, KENTUCKY

Figure 4-13 shows the bus in its final resting position on its side. Note that the left side wall of the body became detached at the floor line, allowing the side wall and the roof to peel off and unfold onto the pavement. The rear portion of the body also appears to have come away at the floor level and is resting on the shoulder of the roadway. Figure 4-14 shows a front view of the vehicle. It appears that the Ford cab and chassis functioned quite well and demonstrated adequate crashworthiness. Rescue forces experienced little difficulty in gaining access to the victims.

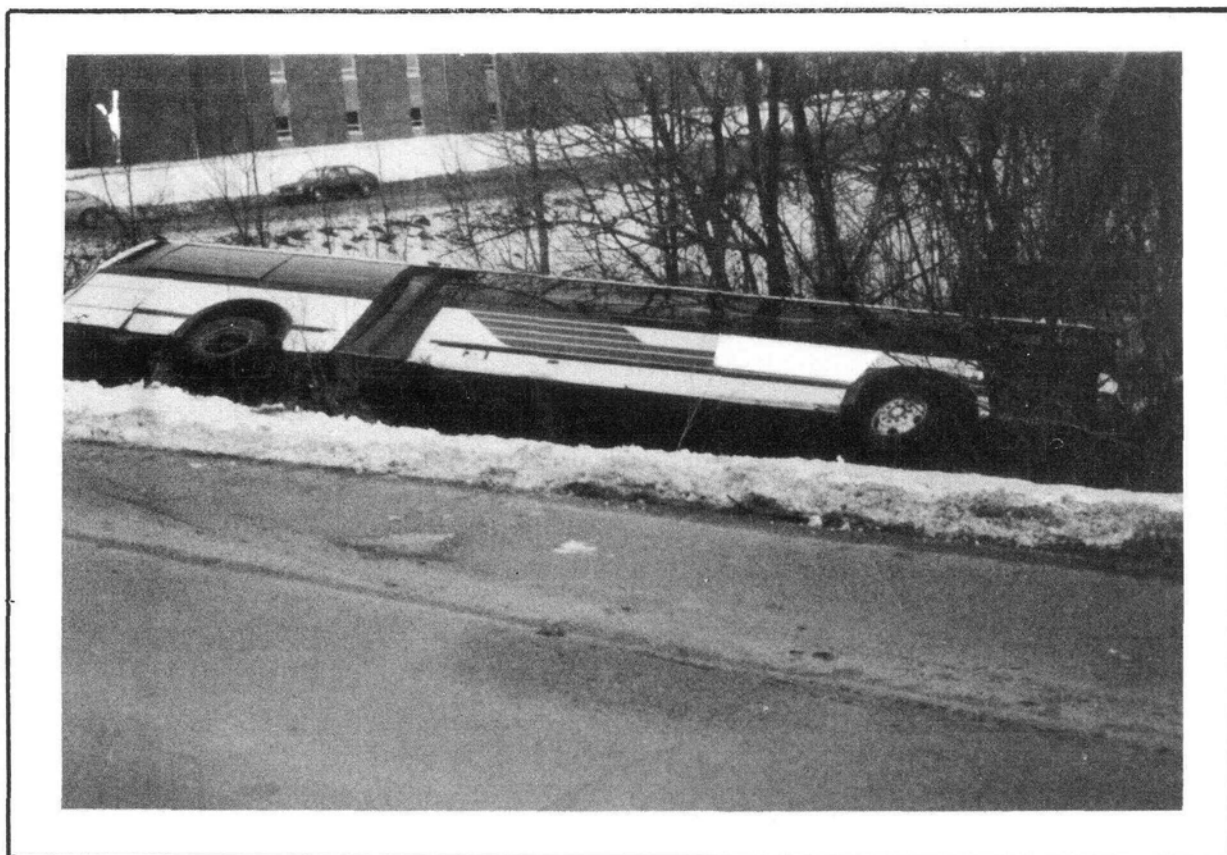
FIGURE 4-15. URBAN TRANSIT BUS ACCIDENT IN MIDWESTERN CITY

Figure 4-15 shows the bus at rest. Note that the front door was still operable and was used in the rescue. Also note, in Figure 4-16, that the last side window on the right side and one of the middle windows are ajar and were presumably used by the passengers or rescuers. It is not known if the escape hatches in the roof were used. Of the 29 passengers on board, 17 were shown in the police report to have had "probable-not apparent" injuries. The passengers ranged in age from 20 to 62.

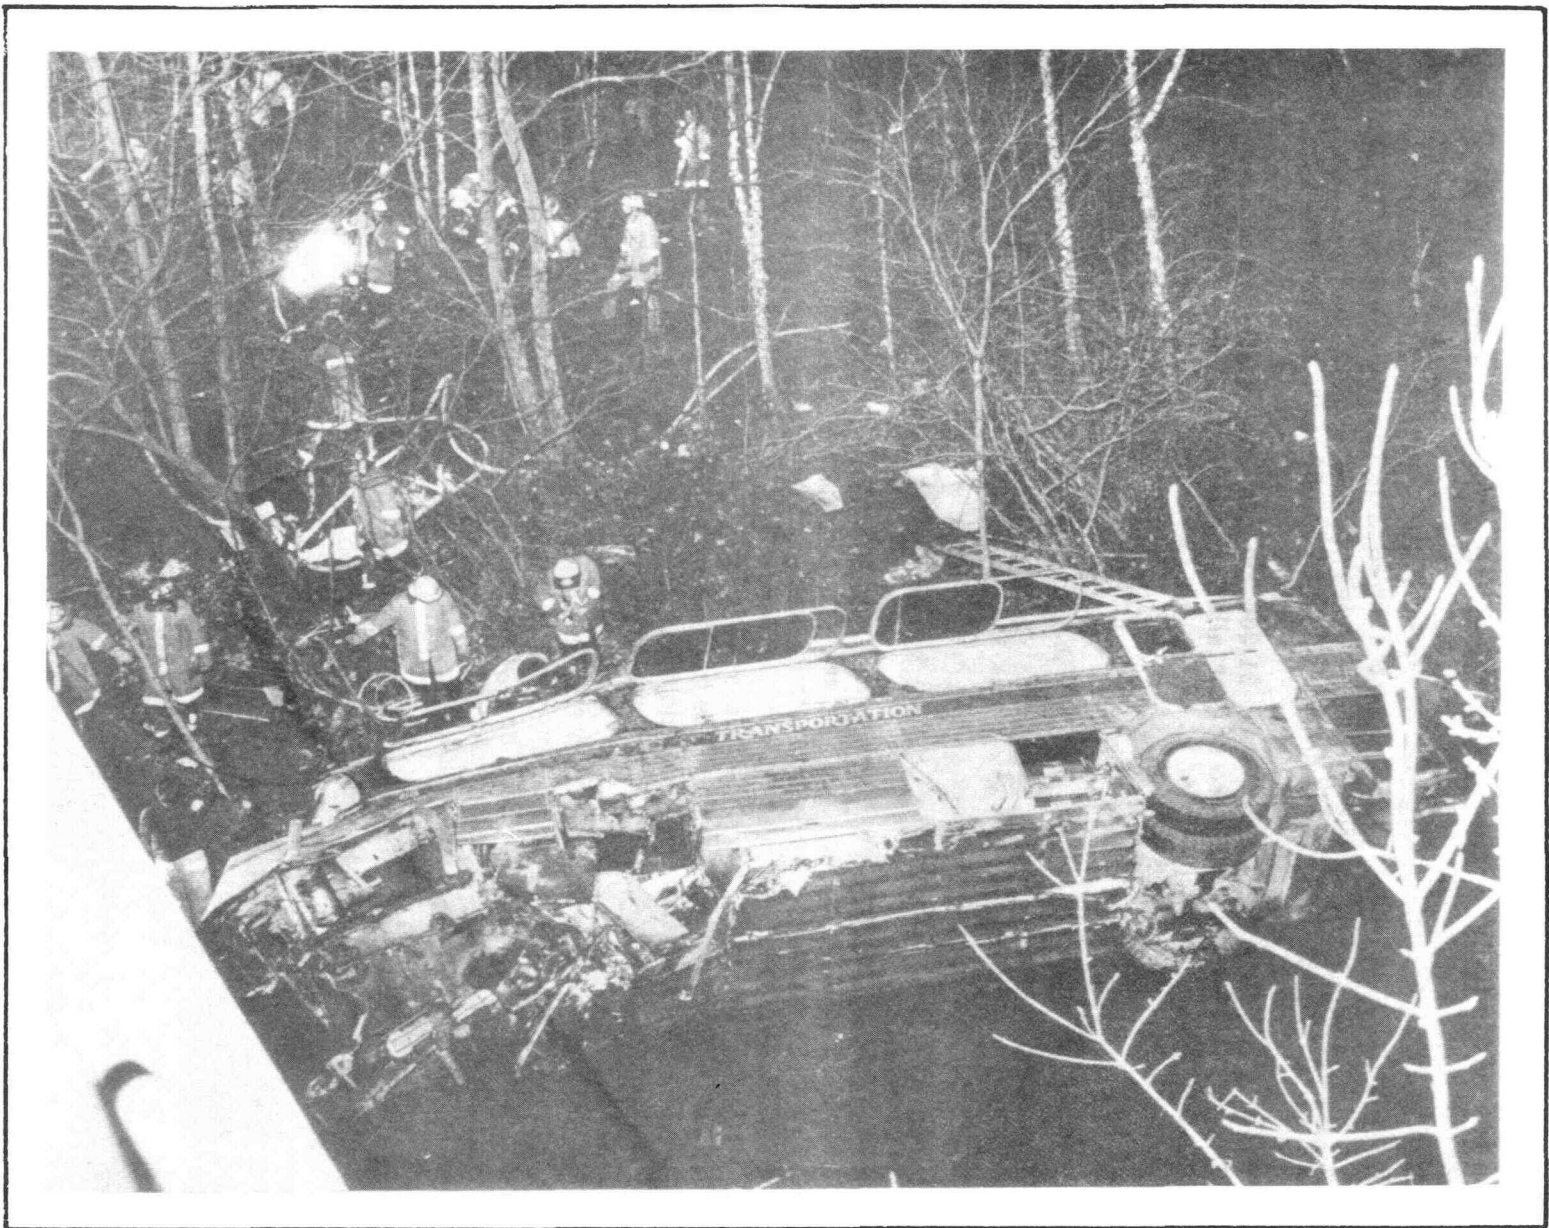
FIGURE 4-17. TRIANGLE, VIRGINIA, TRANSIT BUS ACCIDENT: FINAL RESTING POSITION

Figure 4-17 shows the bus in its final position. Note that access to the interior was gained through the side windows and the left rear emergency door of this rather old bus. Figure 4-18 shows the frontal area of the bus after it had been uprighted. Note the severe crush and damage to the vehicle. The windshield and rear window were missing. There was severe buckling of the roof for the entire length of the bus, but it was less severe toward the rear. The right side panels of the bus buckled and the underfloor cargo loading doors were torn from both sides. Numerous bus seat legs came away from the floor, because their anchor bolts were pulled from the floor pan.

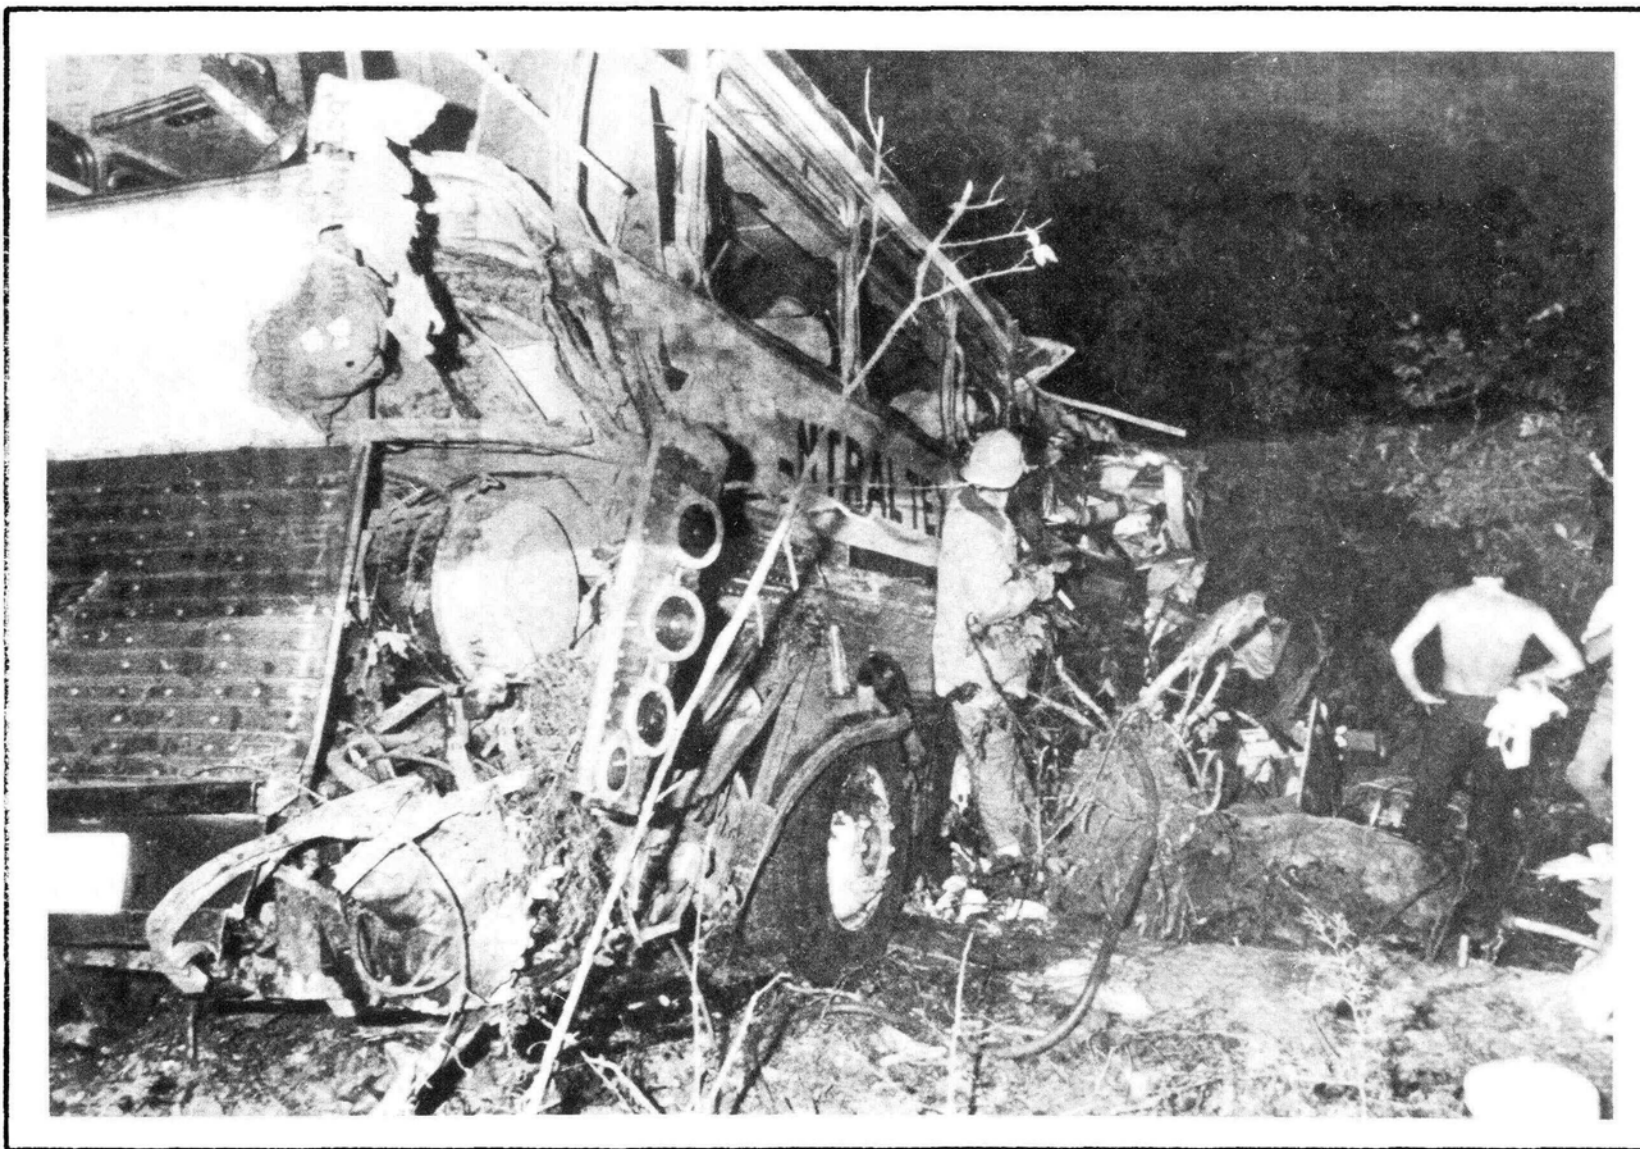
FIGURE 4-20. JASPER, **ARKANSAS**, **INTERCITY** MOTOR COACH BUS ACCIDENT:
FINAL RESTING POSITION

The driver and two passengers were ejected when the bus struck the berm. Two more passengers were ejected when the bus went down the embankment, and several were ejected when the bus came to rest against the rock (Figure 4-20).

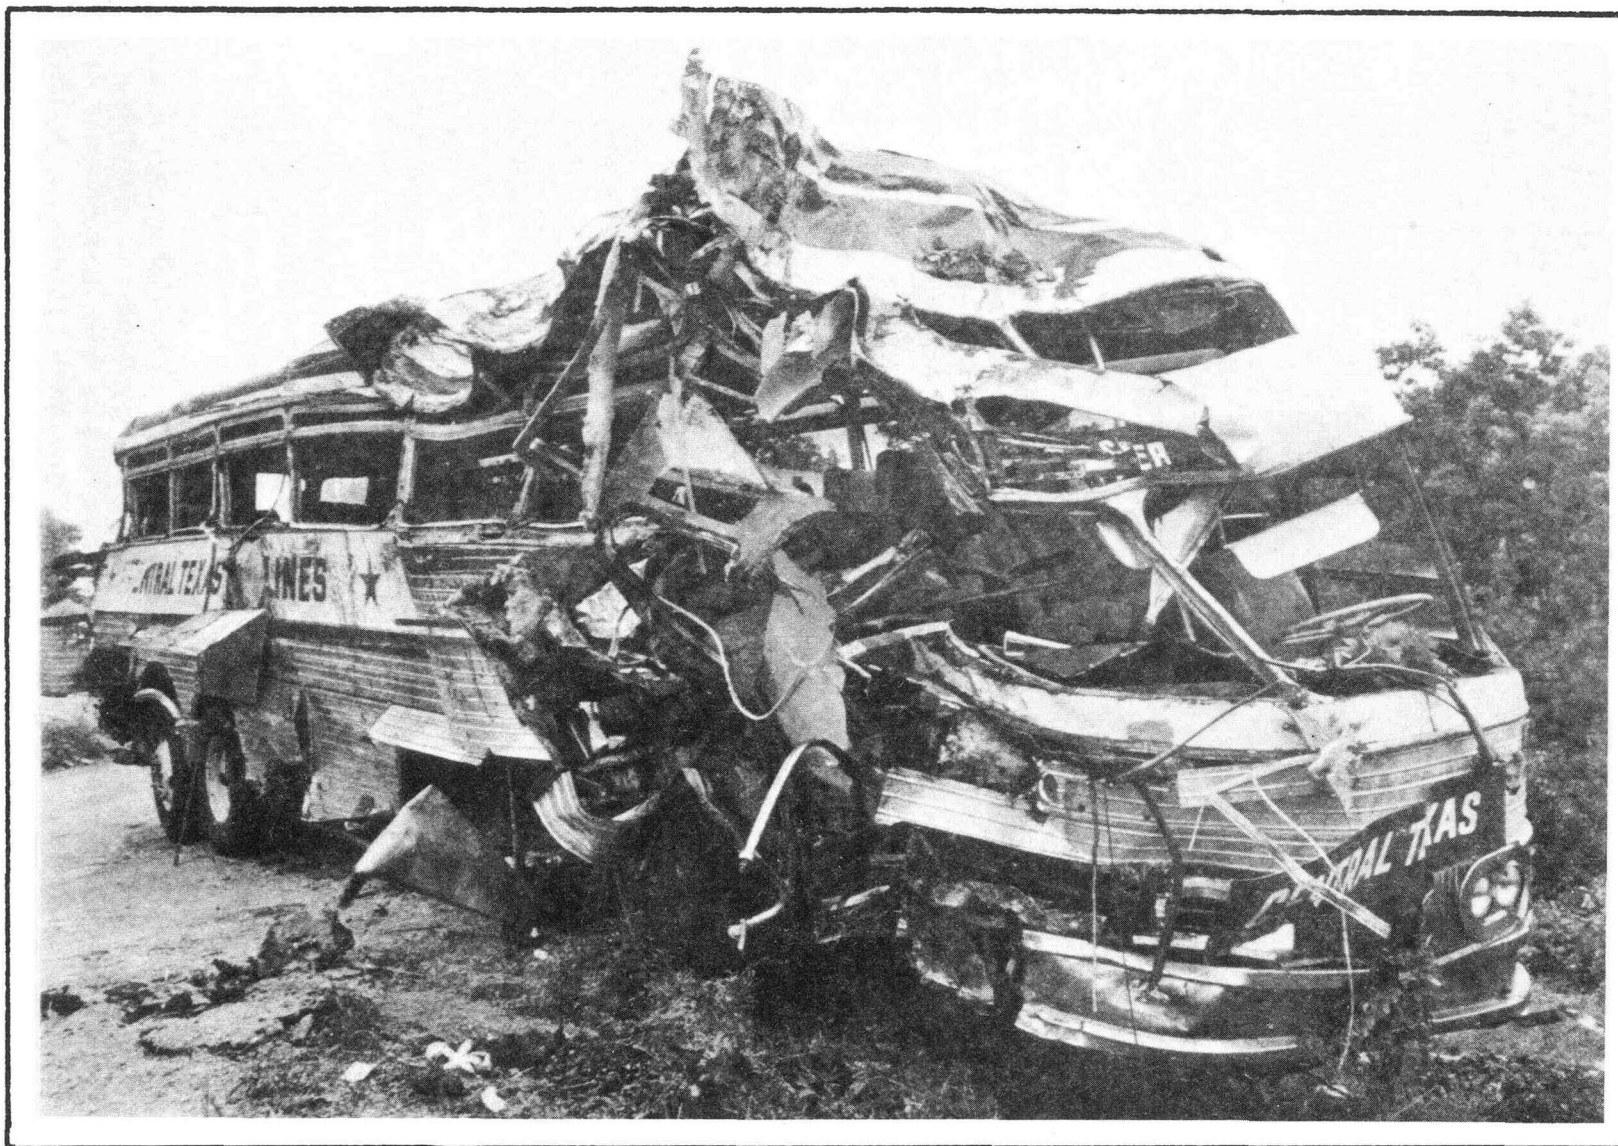
FIGURE 4-21. JASPER, ARKANSAS, INTERCITY MOTOR COACH BUS ACCIDENT:
RIGHT SIDE VEHICLE DAMAGE

The front of the bus was crushed rearward and was skewed to the right. The right front corner was crushed about 4.5 feet rearward. Several panels in the right-front area and both windshields were missing. As shown in Figure 4-21, the right forward roof structure was displaced about 2 feet inboard and rearward. Sheet metal along the right side of the bus buckled severely and was crushed inward. The passenger loading door was torn from its supporting structure as it was twisted rearward. All right side windows were missing, and the window pillars were displaced inward. The roof buckled inward as much as 2 feet in some places. Body structural members were forced rearward and contacted the outside tire of the right drive axle. The rear window was missing, and its frame was distorted.
