# State of Good Repair Assessment Dallas Area Rapid Transit

Mike Hubbell Vice President, Maintenance Dallas Area Rapid Transit FTA SGR Roundtable – Philadelphia, PA July 17, 2012

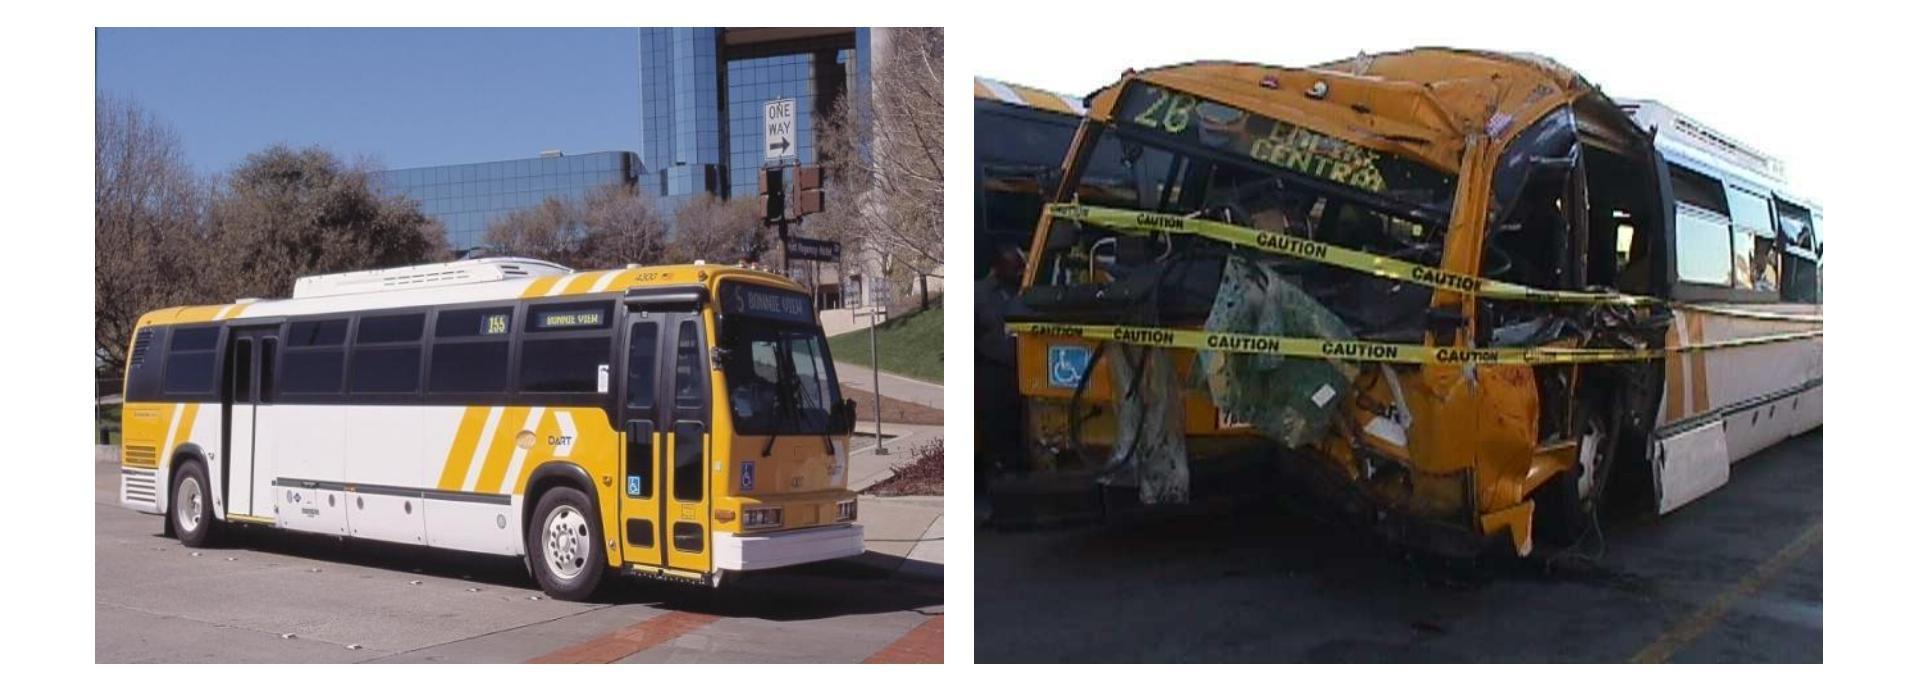
# Examples Clearly #5 Clearly #1

Rating	Description
5	In basically like-new condition, any difference being minor cosmetic damage or deterioration.
4	In typically good working order and requiring only routine maintenance. May have major cosmetic damage or deterioration or may have a minor defect indicative of possible fleet-wide issue.
3	Has non-critical defect needing attention or the asset is nearing the end of life requiring overhaul or replacement.
2	Has critical or safety related defect. Not suited for revenue service before repair.
1	Non-functional requiring major repair, structural repair, or replacement.
