Evaluation of Transit Bus Turn Warning Systems for Pedestrians and Cyclists

Draft Final Report

FTA Report No. 0084
Federal Transit Administration

Applied Engineering Management Corporation (AEM)
Portland State University (PSU)

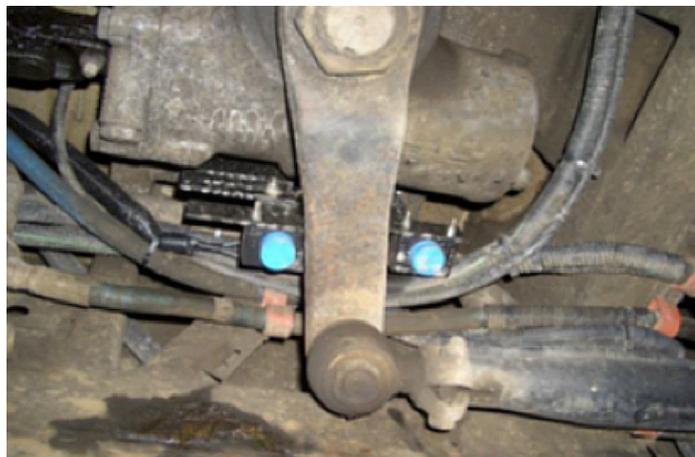
Figure 2-1

Pitman arm sensor associated with System A

The type, length, and frequency of the auditory warning also can be customized. Using standard computer sound files, the warning can be developed by an agency and installed onto the system's electronic computer unit (ECU), which is housed inside the bus behind the bus operator cabin. The auditory warning can be a verbal message or a sound/tone, can vary in length, and can be set to play only once or multiple times during the turn.

This system also has a maximum speed threshold feature that can be used to prevent the warning from being broadcast during a normal lane change or other turn of the steering wheel that might move the pitman arm past the system sensors. In this case, the system would be deactivated at speeds over a pre-set maximum speeds threshold.³

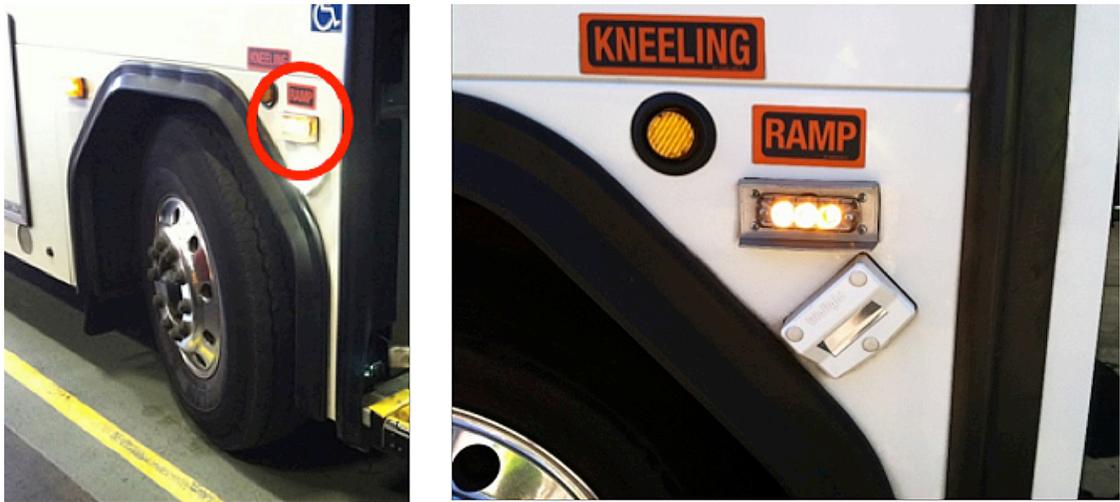
Figure 2-2

System A also features optional LED warning strobe lights on the sides of the bus (Figure 2-2). The strobe lights flash simultaneously with the auditory warning.⁵

LED strobe light associated with System A

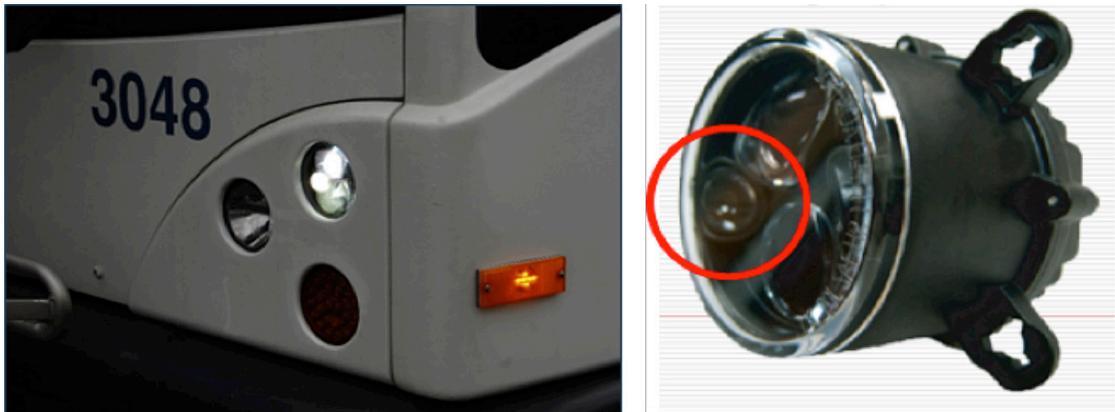
Figure 2-4

System C is commercially-available and is primarily a directional LED headlight system. The directional LED headlights are housed with the main headlights and are activated via use of the turn signal (Figure 2-4). When illuminated, these LED headlights aim in the direction of the turn (either right or left) and provide an additional 35-degree viewing angle (Figure 2-5). The directional LED headlights also provide illumination on the pavement up to 35 feet without causing any glare to oncoming vehicles.

Directional LED headlights associated with System C

Programmable light points down by 5-20degrees

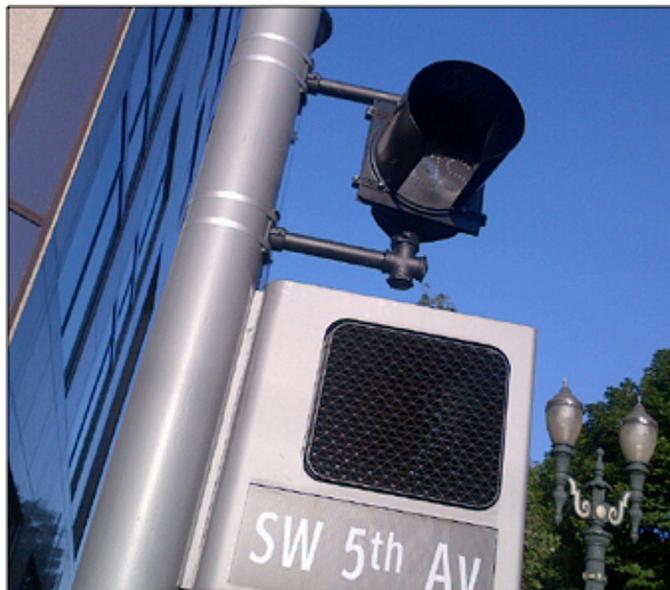
Figure 2-8

Prototype BUS blank-out sign mounted above pedestrian signal head

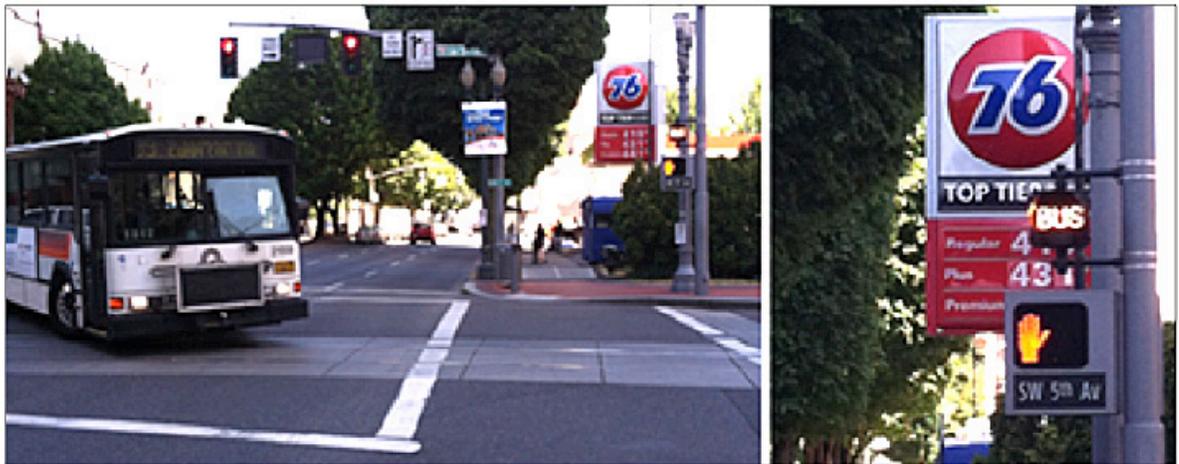
Figure 2-9

The signs could be configured to activate during protected left turns, permissive left turns, right turns, or all of the above, depending on the intersection and movements of interest. If the signs were used to warn pedestrians of a protected left-turn movement through a crosswalk, they would be active during the pedestrian DON'T WALK. On the other hand, if the signs were used to warn pedestrians of permissive left turns and/or right-turns (on green), they would be active during the pedestrian WALK and/or flashing DON'T WALK. For this demonstration test, the BUS blank-out signs were used only to warn pedestrians that a bus was making a protected left turn through the treated crosswalk (Figure 2-9).

BUS blank-out sign at SW 5th and W Burnside.

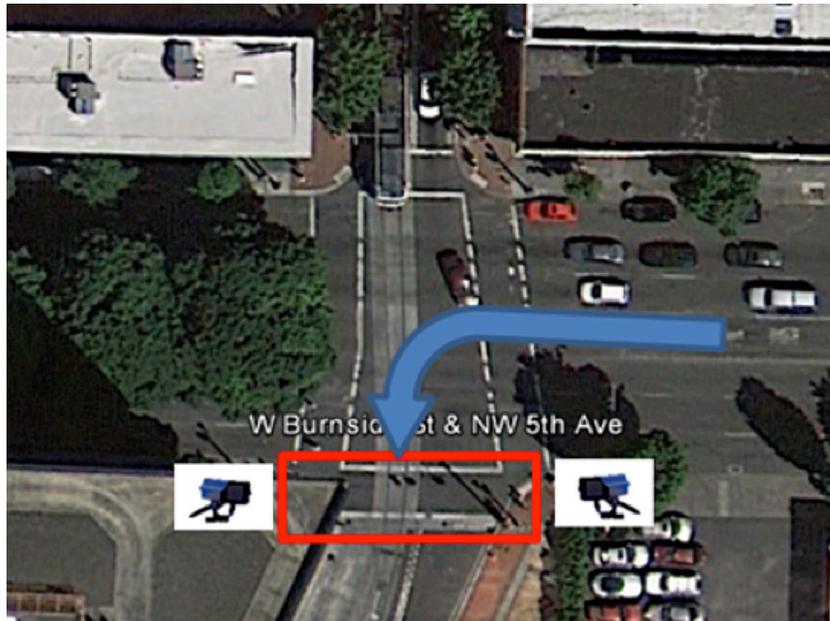
Figure 5-8
Video equipment
location at SW 5th &
W Burnside

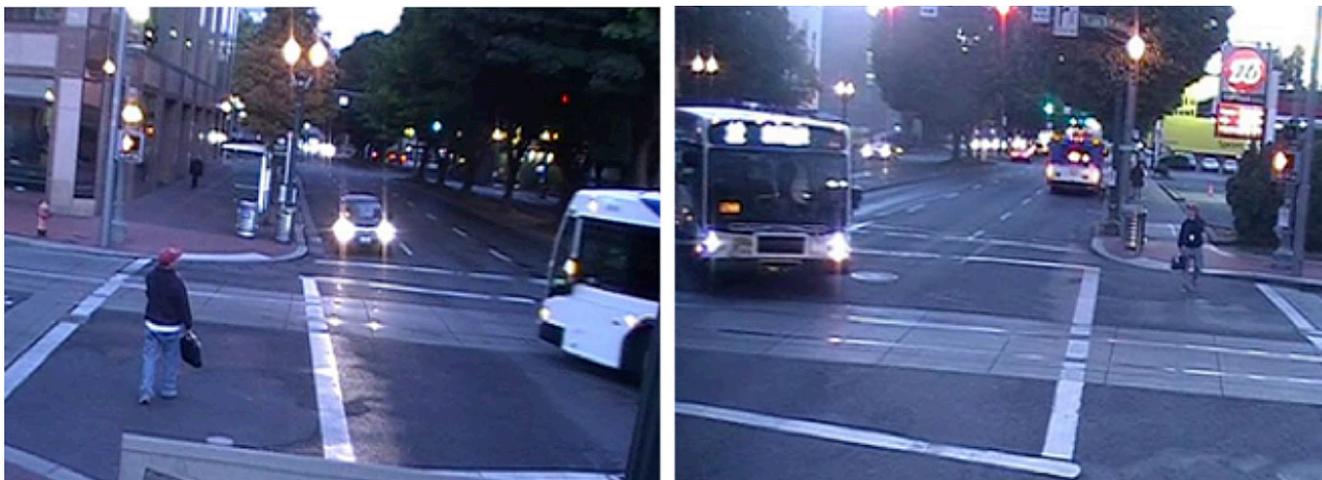
Figure 8-4

In some of the cases (seven, including six pedestrians and one cyclist, or 26%), the pedestrians/cyclist waited on the curb until the pedestrian WALK signal (or until the bus turned), which would indicate that they acknowledged the sign and/or the pedestrian DON'T WALK and complied with the signal/sign. In most of the remaining cases, the pedestrians appeared to have ignored the BUS blank-out sign and the pedestrian DON'T WALK signal altogether. Some walked or ran across before the bus turned. Others began crossing, but then stopped and/or stepped back in the crosswalk or onto the curb to allow the bus to turn. In a couple of these cases, the bus operator even had to honk at the pedestrians as the bus was turning. And in each of these cases, the pedestrian crossed immediately after the bus had turned. In one particular case, the pedestrian appeared to acknowledge the sign/signal at first, stopping at the curb and looking to the right for oncoming traffic (the bus had not yet started to turn), and then began crossing against the sign/signal. It was not until the bus began to turn, and he saw the bus, that he acknowledged the bus, stopped, and waved the bus operator to continue to turn (Figure 8-4).

Observations at SW 5th & W Burnside (BUS blank-out sign)

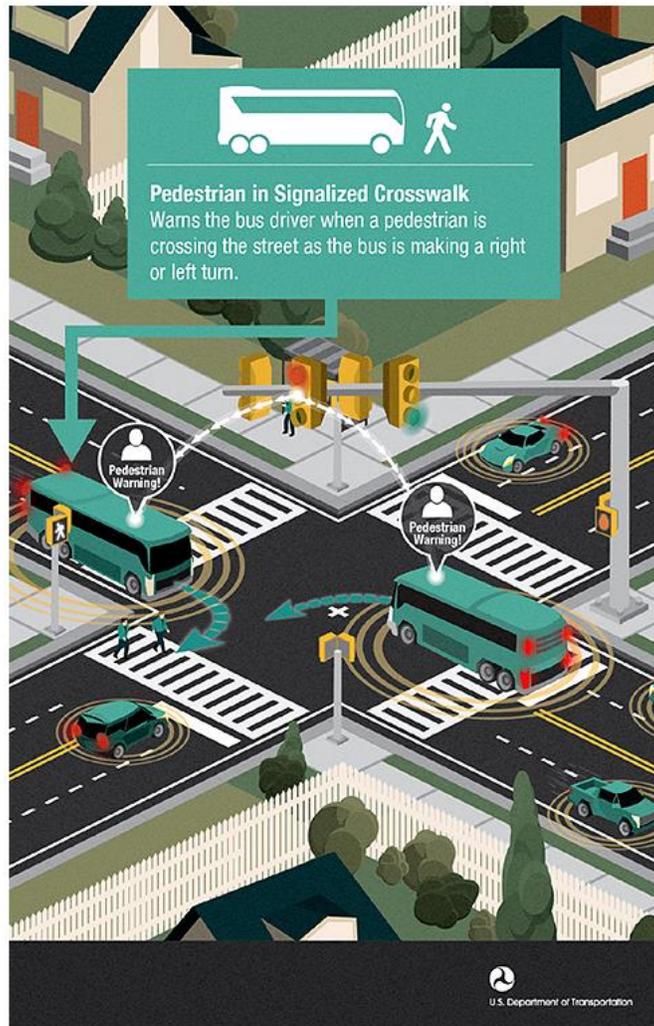
Figure F-1 Connected Vehicle V2I pedestrian warning system

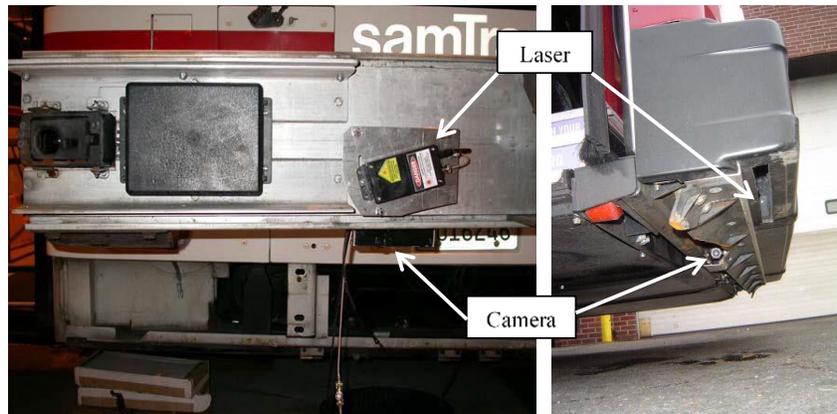
Robotics Institute in 2007. The Integrated Collision Warning System (ICWS) program was a continuation of previous research on individual frontal and side collision warning systems for buses.² The goals of the research effort were to improve the algorithms from the Frontal Collision Warning System (FCWS) and Side Collision Warning System (SCWS) projects and to test improvements of an integrated system in both controlled and operational environments. Figure F-3 shows the ICWS equipment installed on the front bumper of a transit bus. The ICWS utilized several technologies, including radar/LIDAR, video cameras, object sensors, host-bus sensors, and complex object detection and collision warning algorithms as part of an integrated system to detect front and side collisions.

Figure F-3 UCB PATH's ICWS Collision Warning System

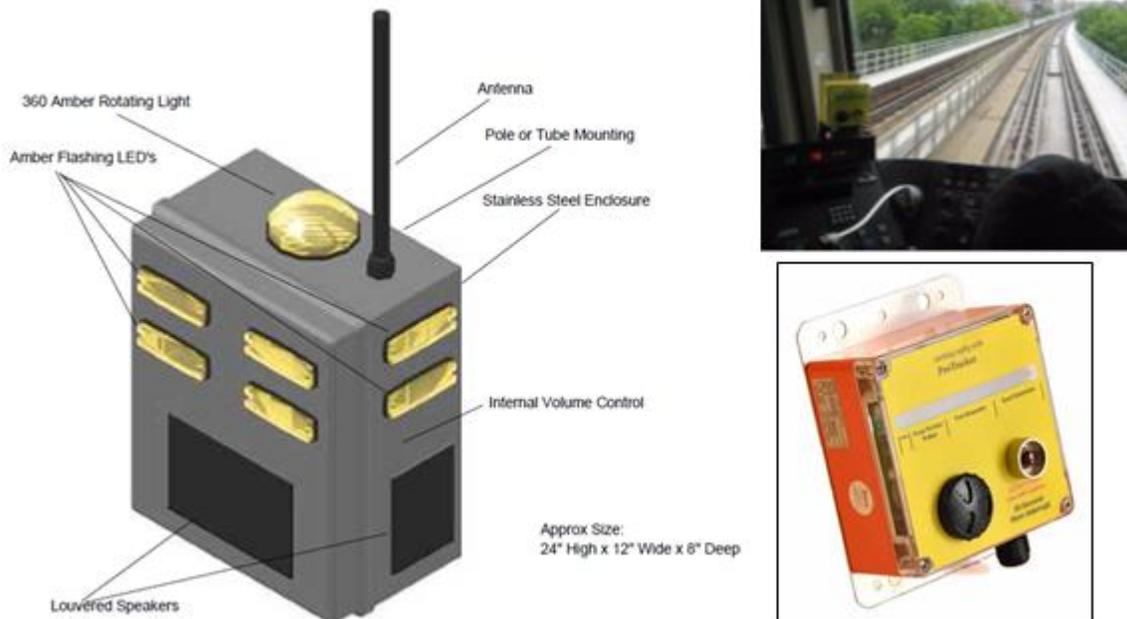
Figure F-4 Features of Protran pedestrian crossing warning system (left) and installation in field (right)
