Inspection Form

United States Department of Transportation
Federal Transit Administration

Inspection Date	YYYY	MM	DD	Report Number	20161201-WMATA-WP-1		
	2016	12	01				
Rail Agency Name	Washington Metropolitan Area Transit Authority			Rail Agency Department	Track	Sub- Department	
Rail Agency Department Contact Information	Name		Email		Office Phone		Mobile Phone
	[REDACTED]		[REDACTED]				
Inspection Location	Twinbrook (A13) to Rockville (A14)

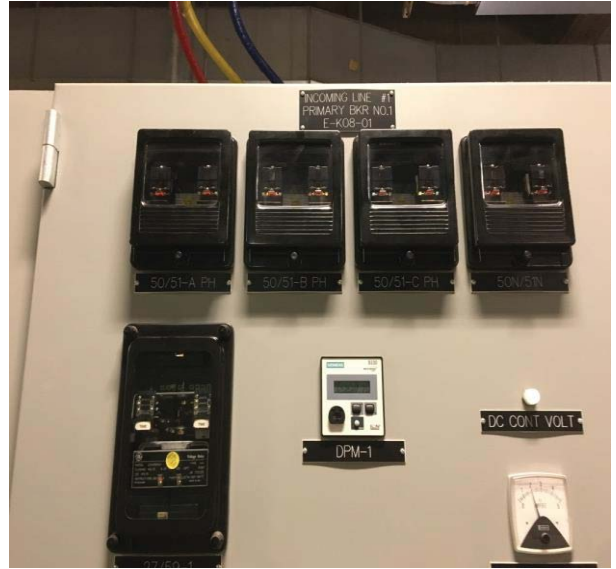
FIGURE 2 - AC SWGR CUBICLE WITH 50/51 RELAYS PER PHASE ON FRONT PNL

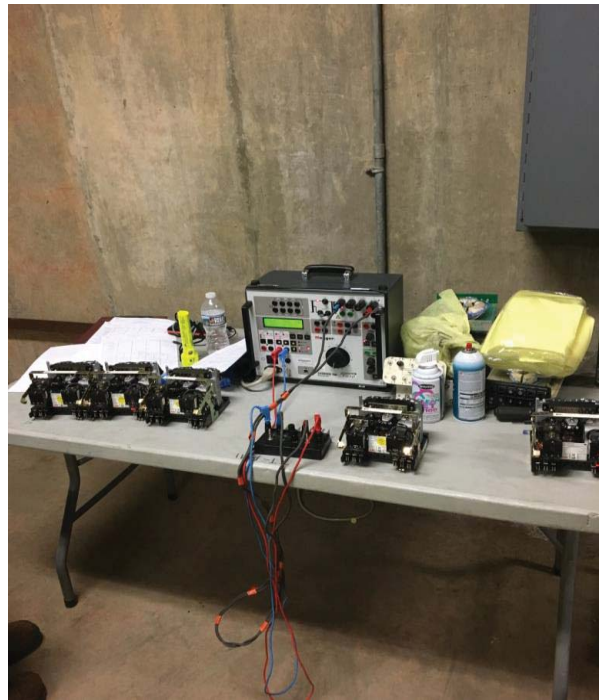
FIGURE 4 - TEST APPARATUS FOR RELAYS

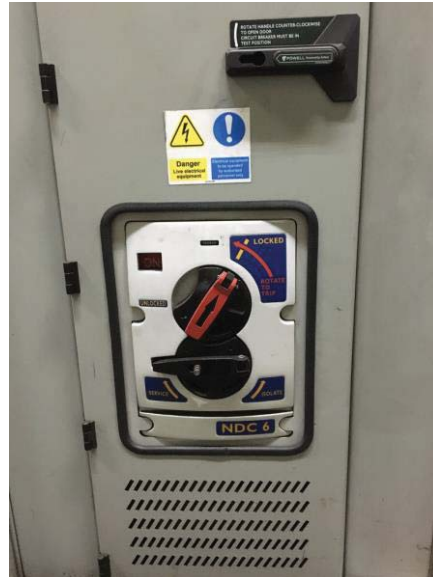
Figure 1 – HARDCOPY PMI FOR 750V DC TYPE NDC HIGH SPEED BREAKER

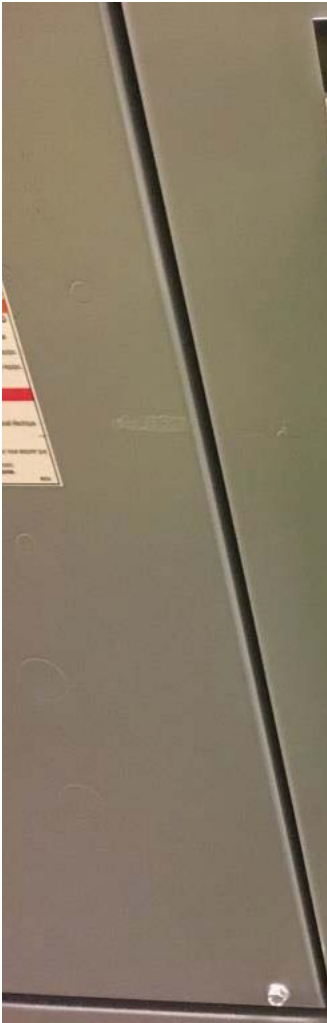
FIGURE 2 – TIE BREAKER IN MAIN-TIE-MAIN BREAKER SCHEME (NORMALLY OPEN)

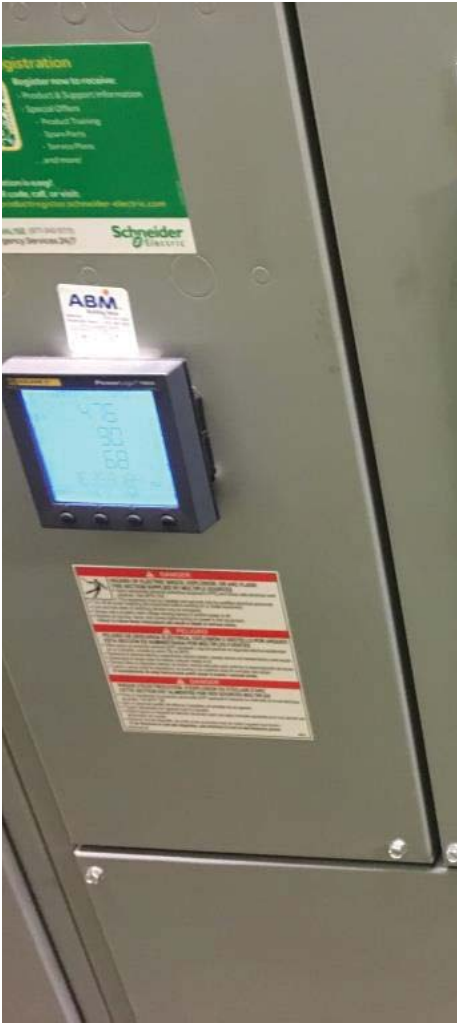
FIGURE 3 – SECONDARY MAIN BREAKER (NORMALLY CLOSED)
