Inspection Form

United States Department of Transportation
Federal Transit Administration

Inspection Date	YYYY	MM	DD	Report Number	20160404-WMATA-JMC-1		
	2016	04	04				
Rail Agency Name	Washington Metropolitan Area Transit Authority			Rail Agency Department	Rail Transportation	Sub-Department	Shady Grove Subdivision
Rail Agency Department Contact Information	Name		Email		Office Phone		Mobile Phone
	[REDACTED]		[REDACTED]		[REDACTED]		[REDACTED]
Inspection Location	WMATA Grosvenor-Strathmore Station, 10300 Rockville Pike, Bethesda, MD 20852

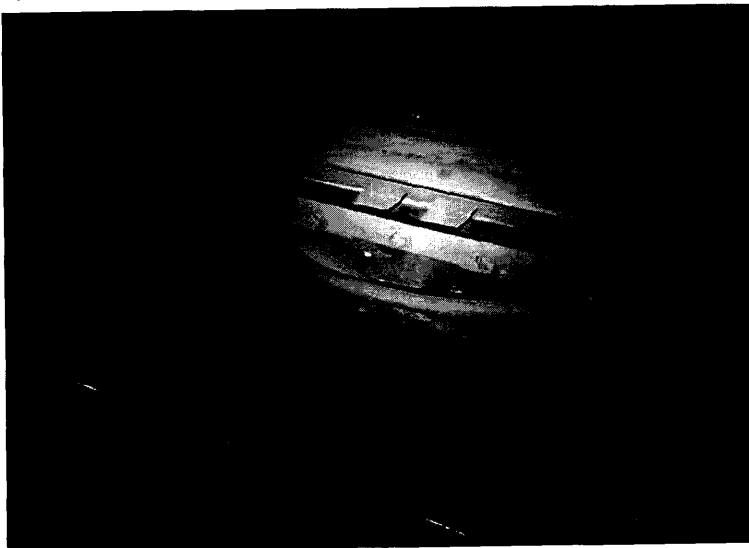
New Cable at D2 CM 134+00

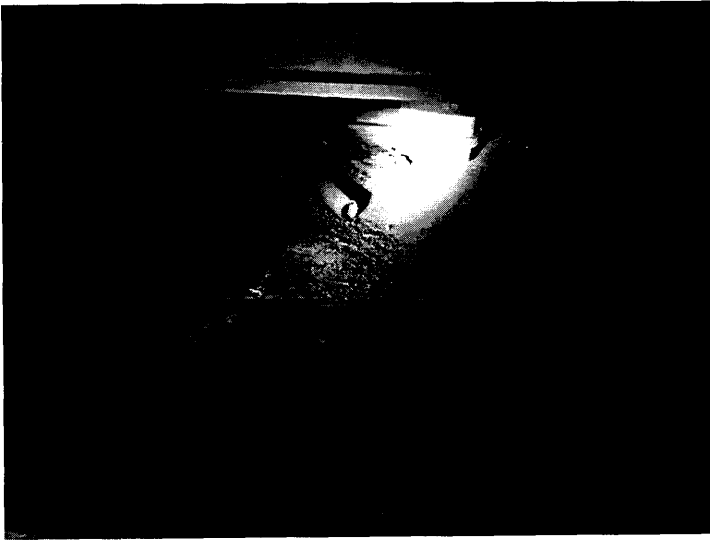
Kicker Rail Boot on ground at C1 CM 27+20
